# Impacts to Circle Oaks Drive

Project No. VV4147  
17 October 2016

Subject: Circle Oaks Drive  
Napa County, California  
**GEOLOGIC AND GEOTECHNICAL REVIEW & RECONNAISSANCE**

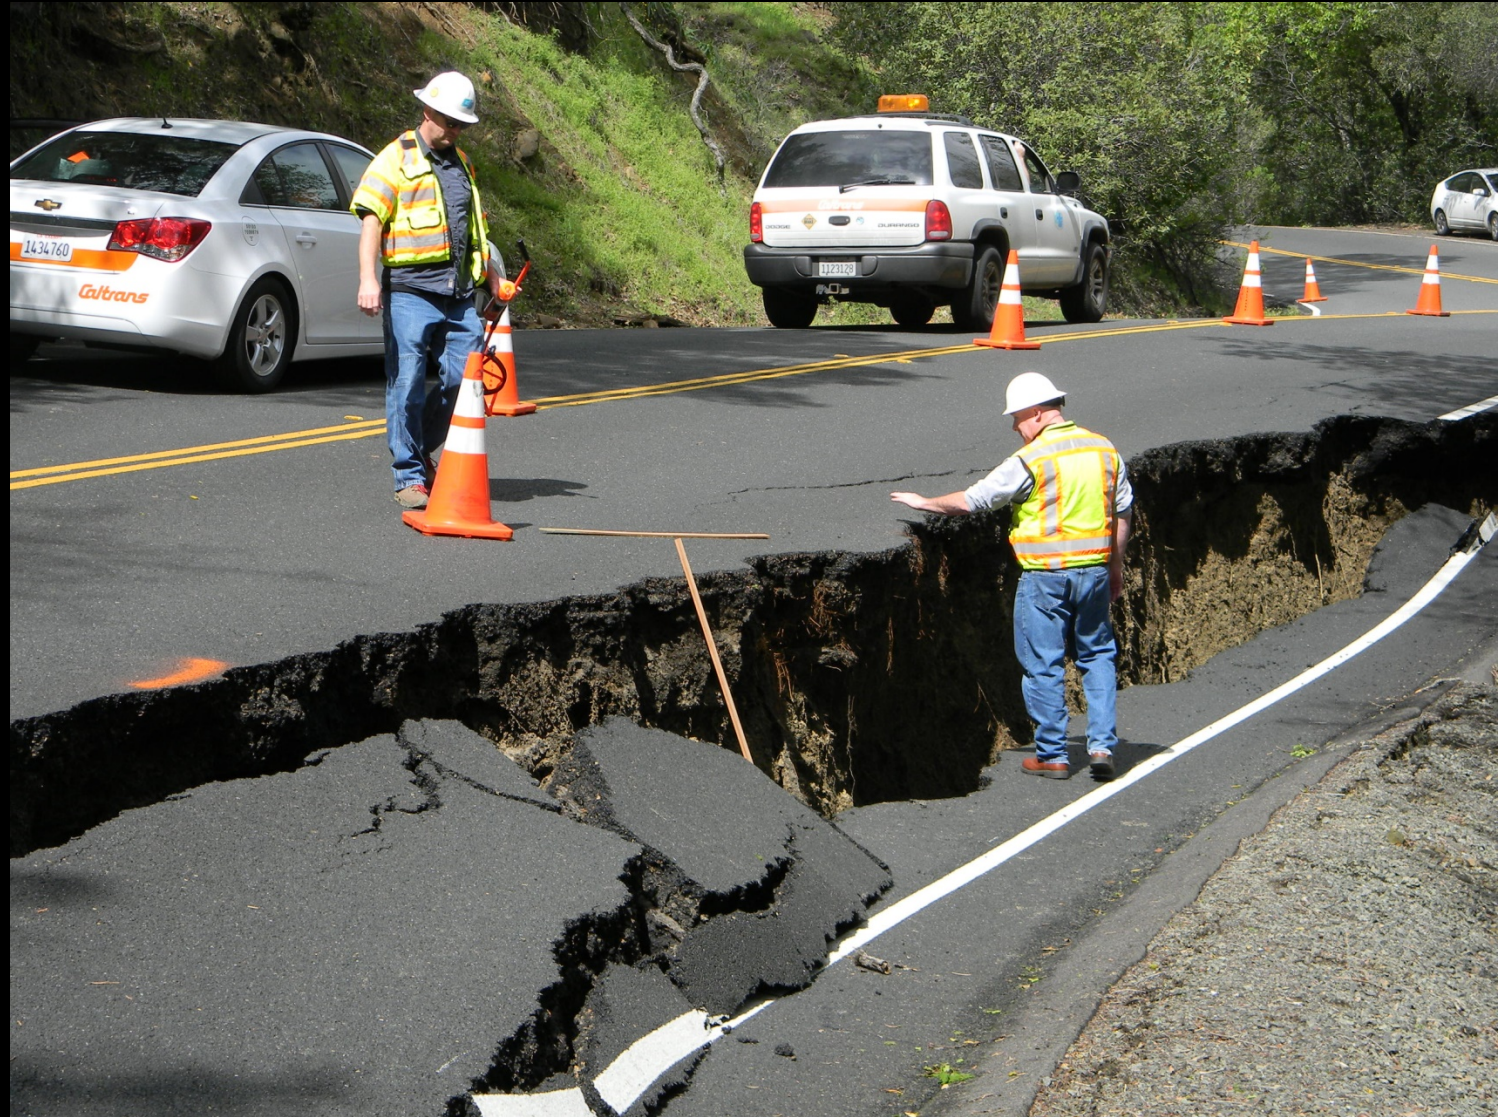
**Highway  
121 road  
failure,  
March 2016,  
1-1/2 miles  
from Circle  
Oaks Drive**

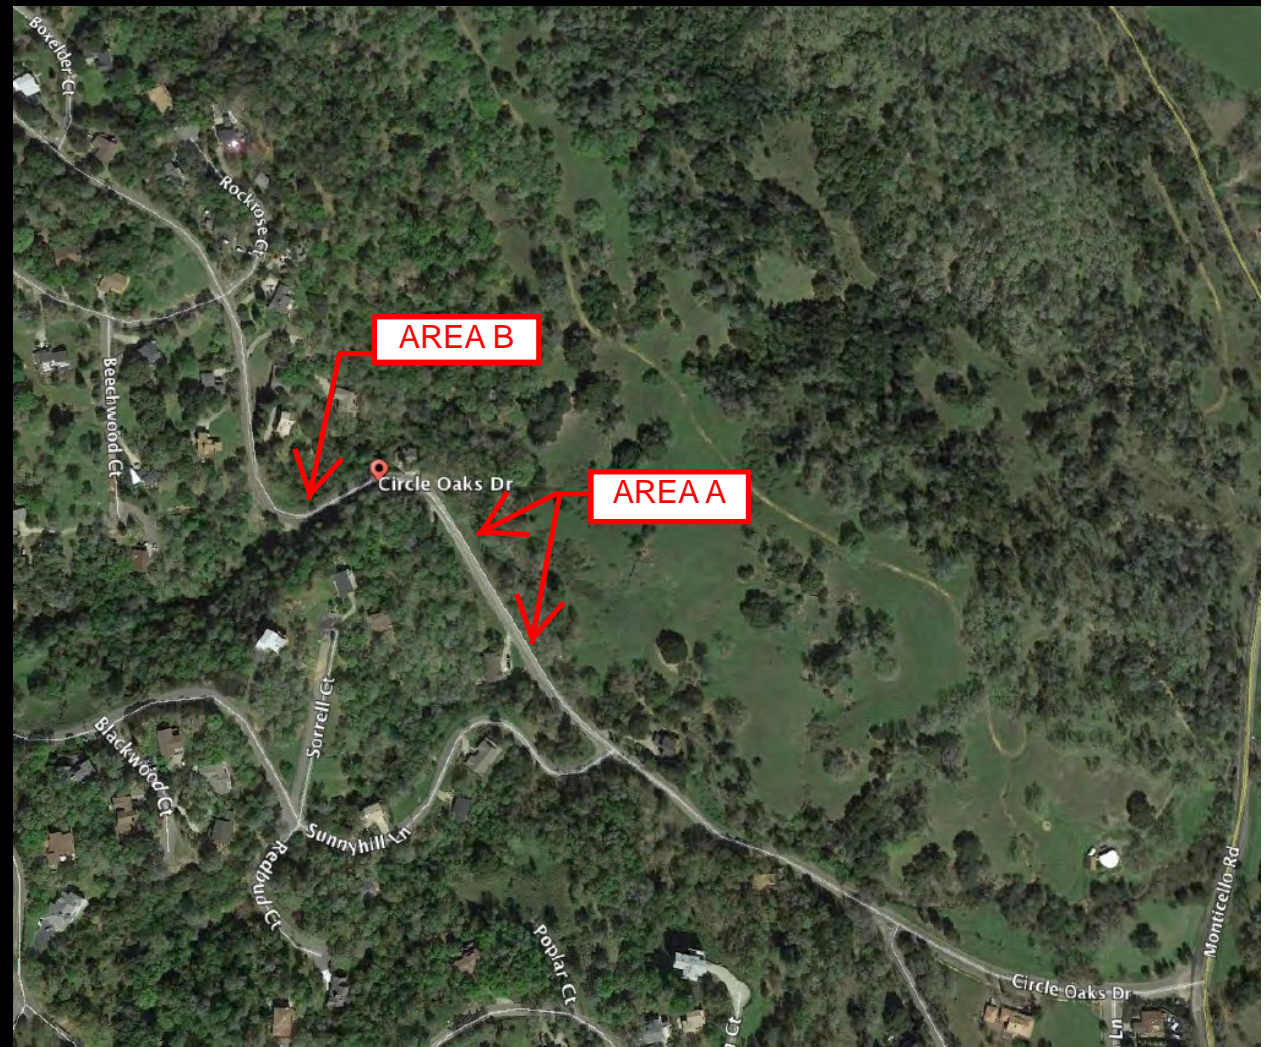
# Areas of Road Failure

**Areas of Failure  
addressed in  
geotechnical  
report and  
addressed in  
public comments,  
April 2016**

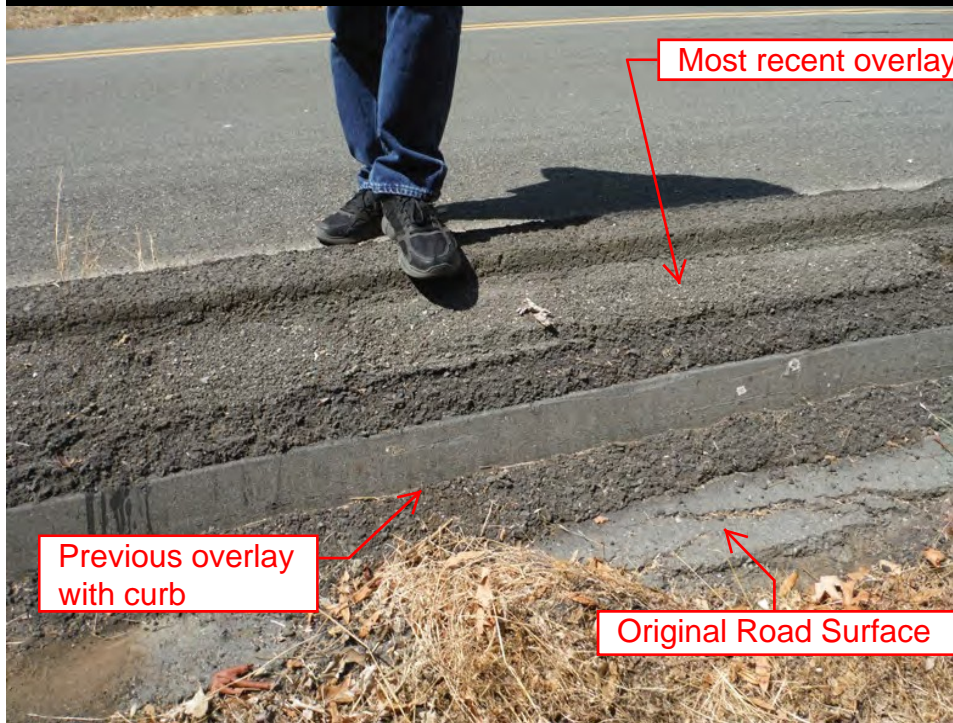
Area A includes an area of extensive road settlement and cracking located along a linear portion of Circle Oaks Drive. The road in this area was constructed by cut/fill techniques and the eastern lane consists of a large fill embankment. The fill bank appears to extend down the slope approximately 25 vertical feet and has inclinations of about 1.5H:1V (horizontal to vertical). In this area we observed severe pavement cracks over a zone approximately 300 feet in length (see attached photographs). The cracks range up to approximately 1 inch in width and extend approximately to the centerline of the existing road. Some of these cracks have vertical offsets in excess of 1 inch. In addition, our observations found that the area has been repeatedly repaved to compensate for previous settlement in the area of more than 1 foot. Circle Oaks

**Area A – asphalt overlays indicate previous road settlement**

In our opinion, the County should retain a qualified Geotechnical Engineering consultant to perform an evaluation of both areas and provide recommendations for pavement rehabilitation and slope stabilization. The investigation should include test borings and laboratory shear strength and R-value testing to establish the subsurface soil conditions and to determine the embankment slope stability factor of safety. Geotechnical road stabilization and repair recommendations should be provided based on the findings of the field and lab investigation. A Civil Engineering consultant should also be retained to evaluate the site and road hydraulics, perform an analysis of surface water drainage and provide mitigative design drawings. A traffic study should also be performed to evaluate the appropriate traffic index and pavement section.

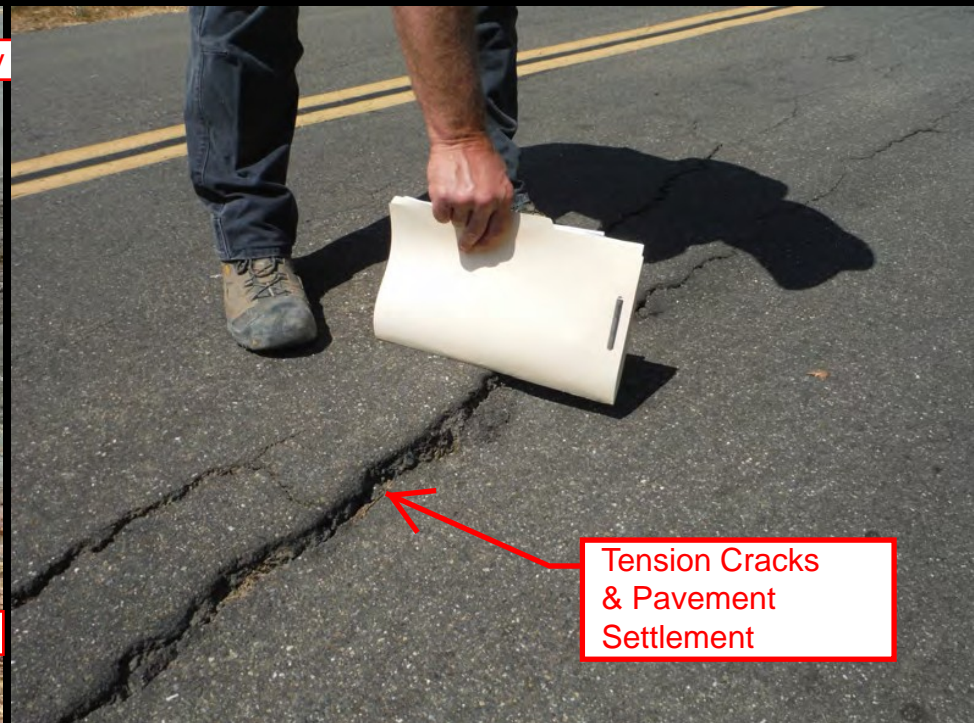
Of particular concern is the ongoing subsidence and pavement distress occurring in Area A. Our observations indicate that more than one foot of vertical movement has occurred in the area since construction of the road. The observed cracking indicates that soil creep, settlement and instability of the roadway fill is ongoing. Experience on similar projects has shown that

**Area A – pavement cracks with vertical displacement**

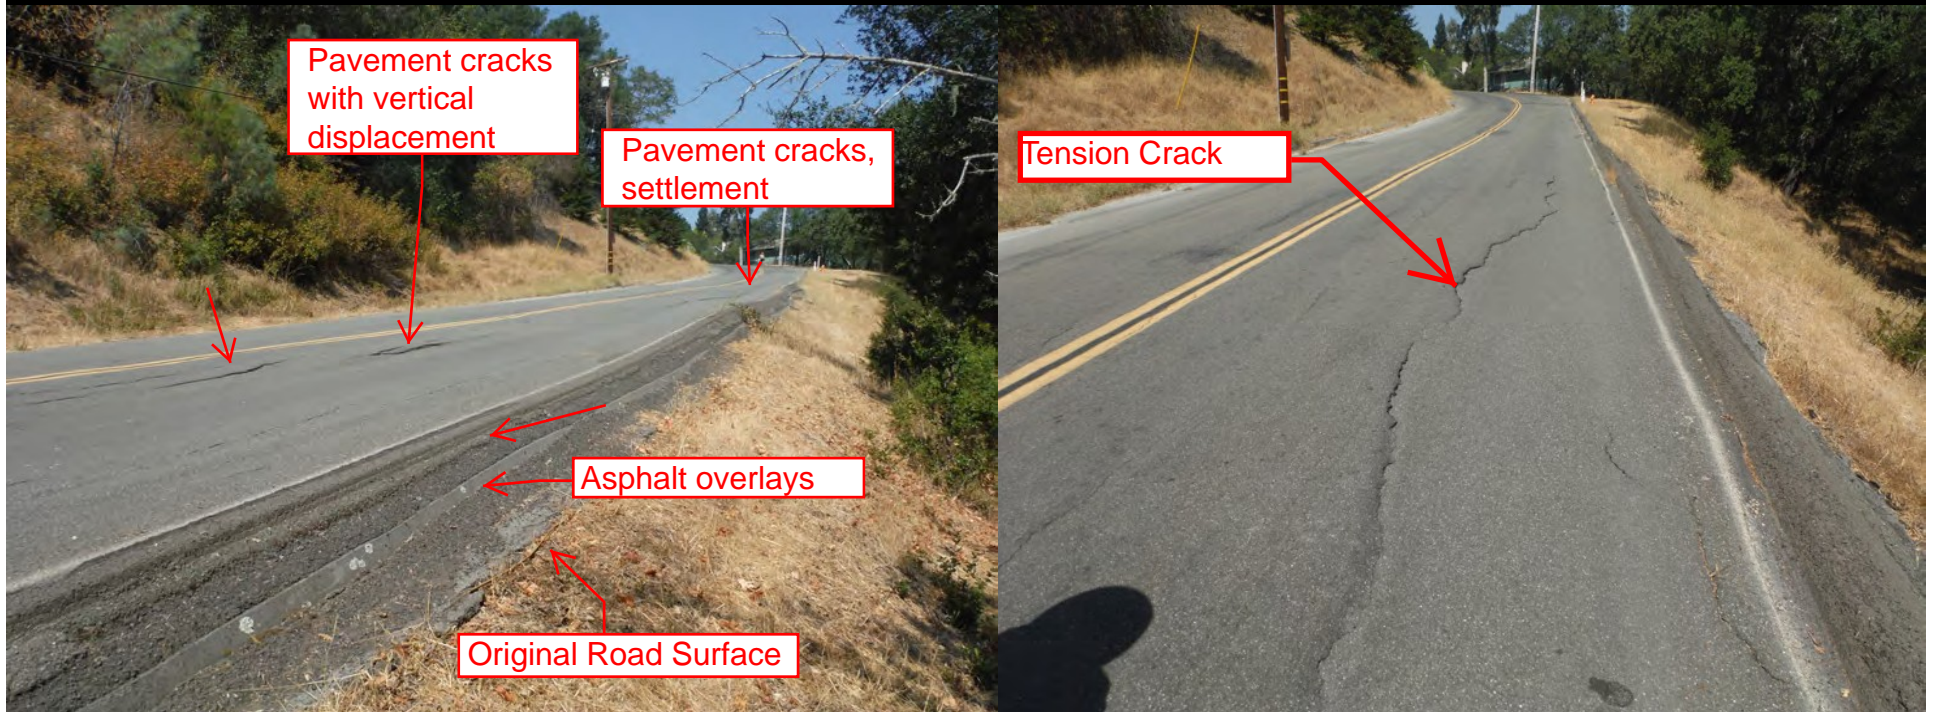
**AREA A – looking northwest**

Drive in this area is not adequately sloped into the hill, but rather towards the outer embankment fill slope.

Our observations also indicate that during times of high flow from heavy rainfall events, water coming down the road sheets flows onto the roadway reaching the area of the cracks and top of fill slope. According to Mr. Heitzman, water does flow across the roadway in this area during major storms. We also observed evidence of erosion on the slope below this area. In our opinion, the future stability of the road embankment in this area is a critical concern. The fill portion of the roadway roughly northeast of the centerline is already experiencing excessive movement with cumulative movement since construction of more than 12 inches. The numerous open cracks allow the infiltration of water into the subgrade and the underlying fill. Experience on previous projects has shown that embankments of this type can fail suddenly as a result of heavy rain and the infiltration of water into road cracks. The result can be failure of the fill embankment and loss of the road, as well as underground utilities.

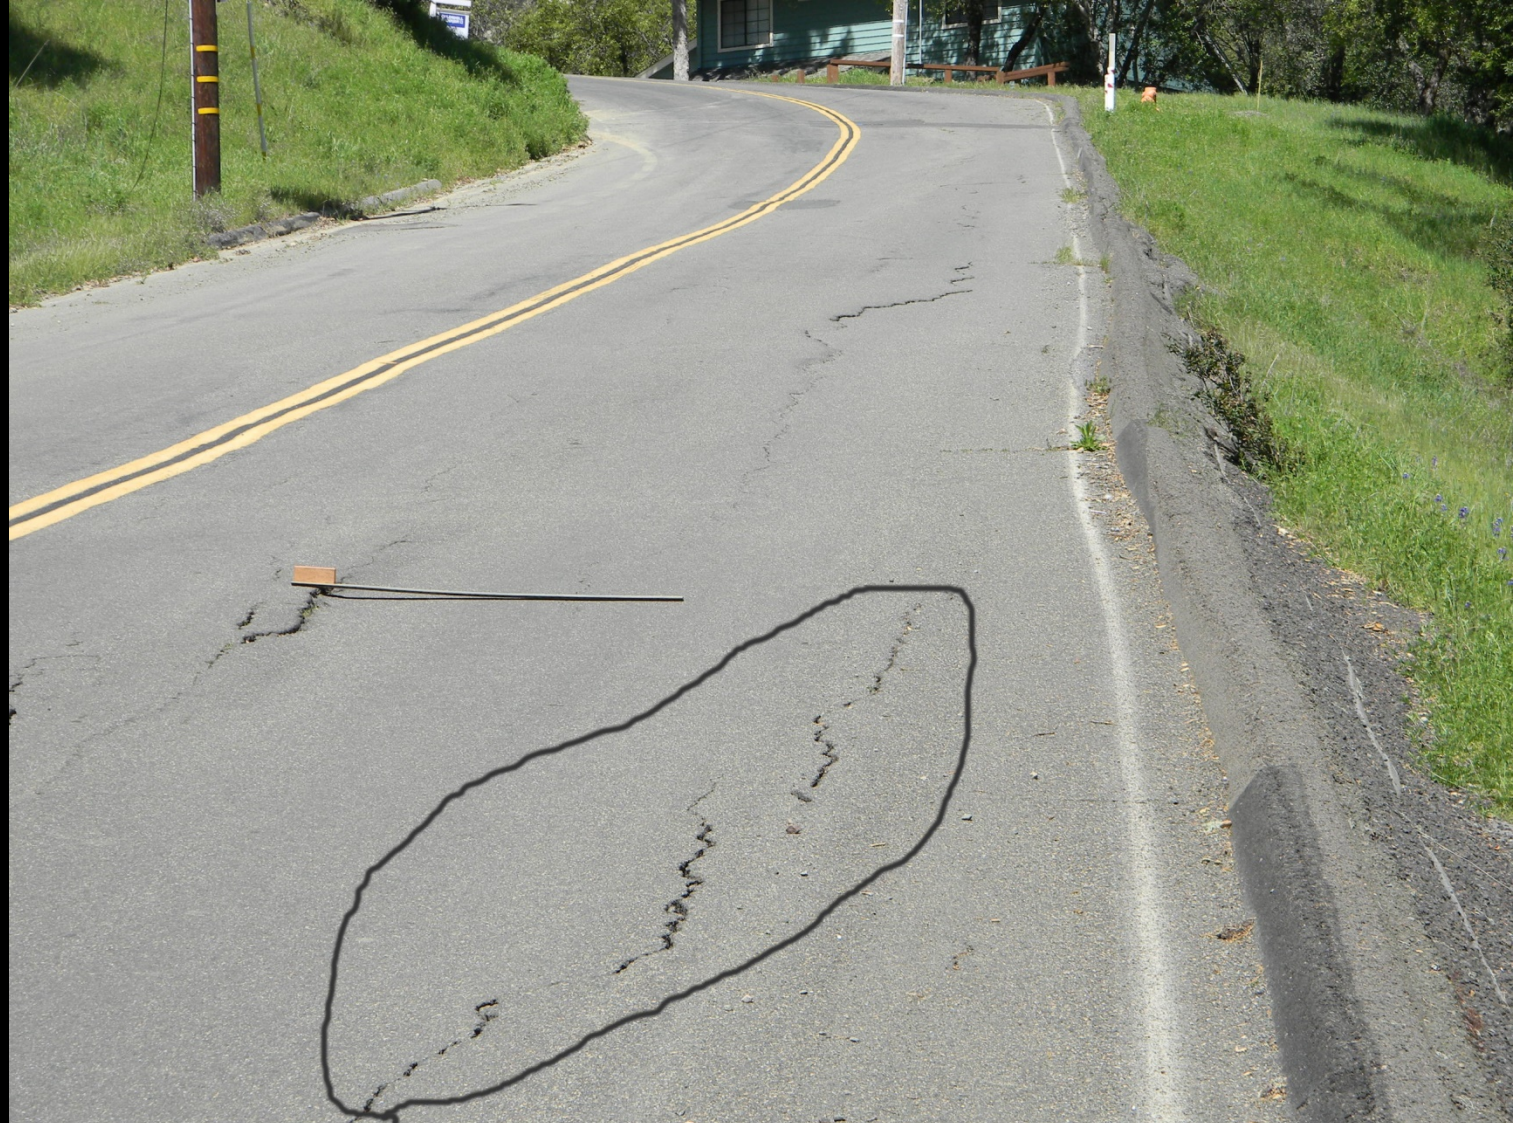
# Road Conditions, 11/2014: 189 – 214 Circle Oaks Drive

**New  
cracks in  
road,  
3/2016**

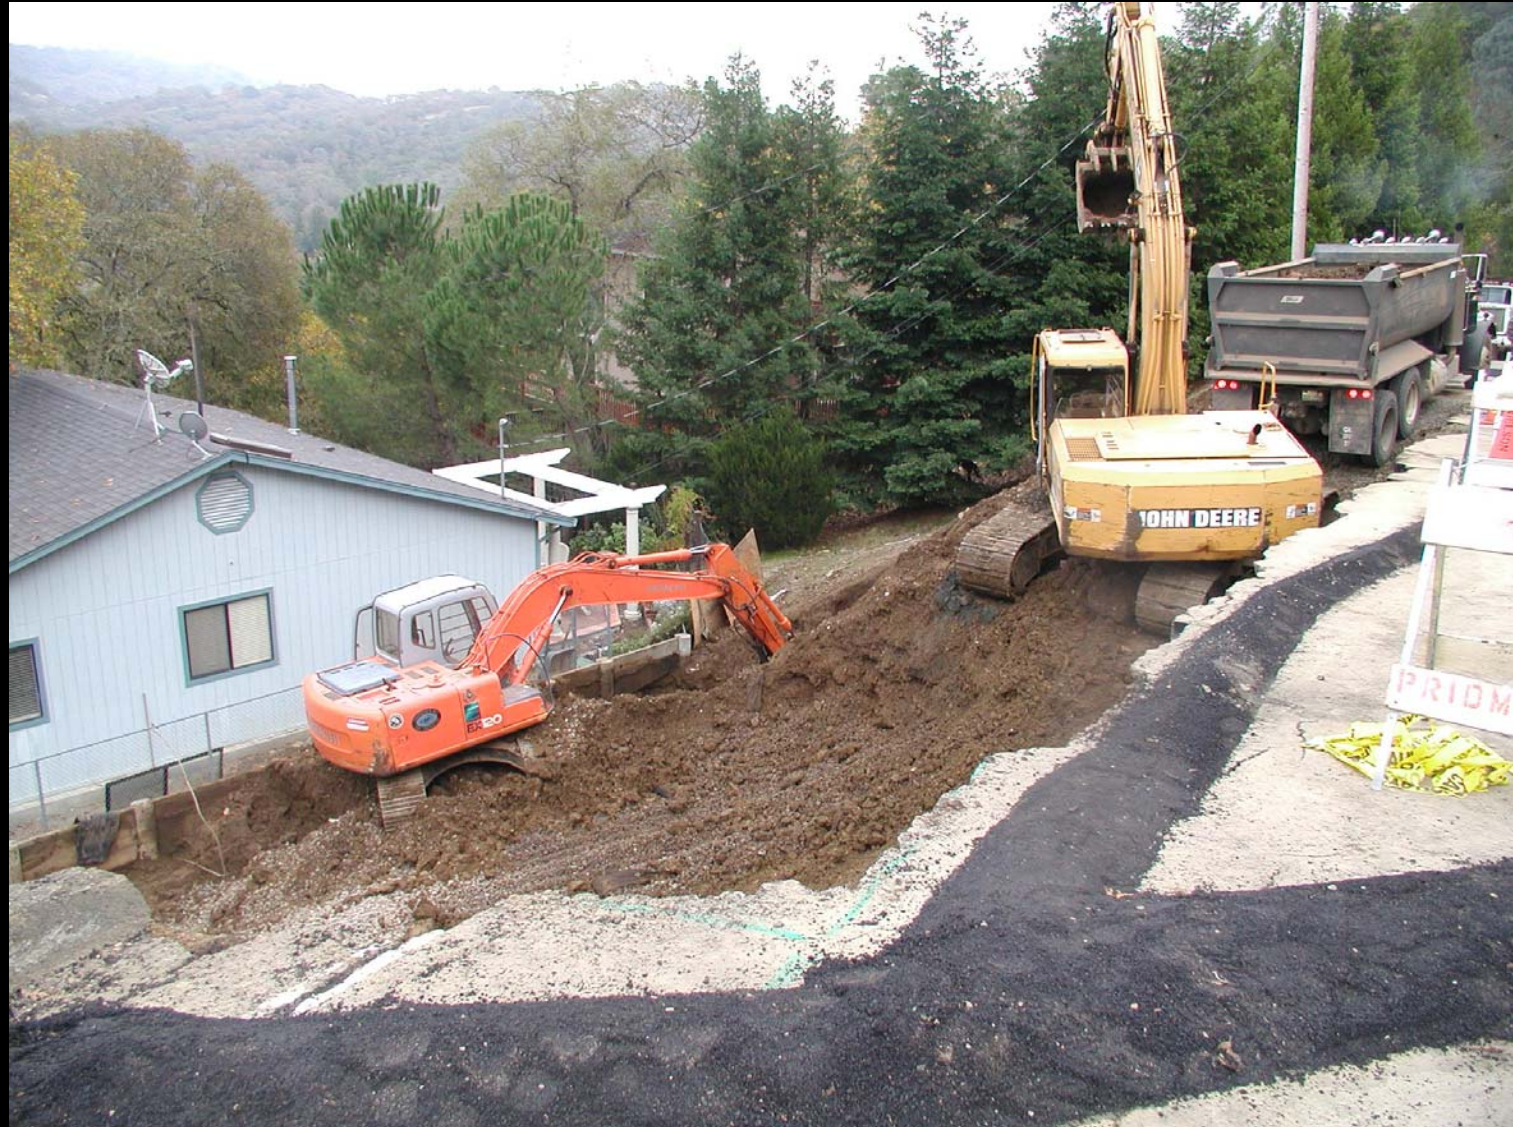
# 254 Circle Oaks Drive, Road Failure Repair, 2006

**Early  
stage of  
landslide  
repair**
