SURFACE MINING INSPECTION REPORT

I. Mine Name as reported by Operator on Mining Operation Annual Report Pope Creek Quarry	Inspection Date: 3/30 and 12/3, 2010	CA MINE ID#: 91 - 28-0007
---------------------------------------------------------------------------------------------	-----------------------------------------	------------------------------

To:	File #P10-00385	From:	Donald Barrella Conservation Division
Date:	February 24, 2011	Re:	Pope Creek Quarry, Mine ID#91-28-0007 APN 018-080-023 Supplement to the 2009-2010 Annual SMARA Inspection Report

To: File #P10-00385	From: Donald Barrella Conservation Division
Date: February 24, 2011	Re: Pope Creek Quarry, Mine ID#91-28-0007 APN 018-080-023 Photo Supplement 09/10 Inspection Report

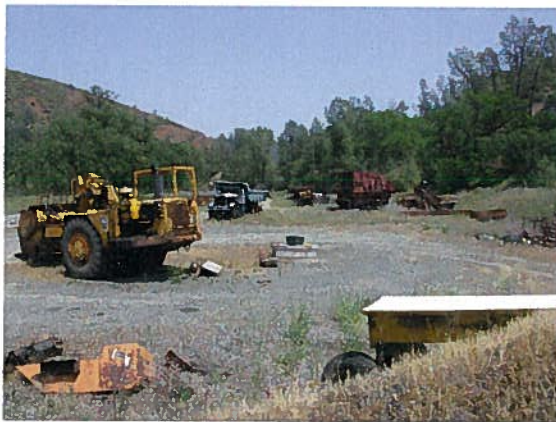
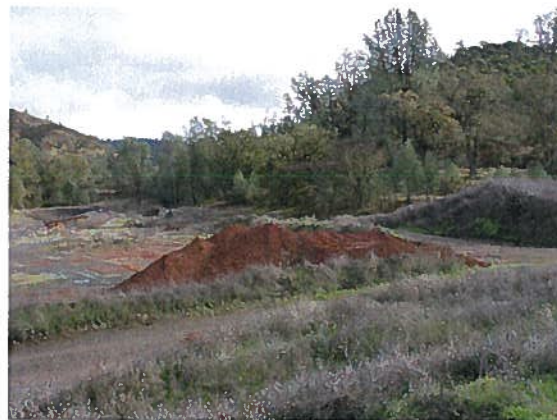
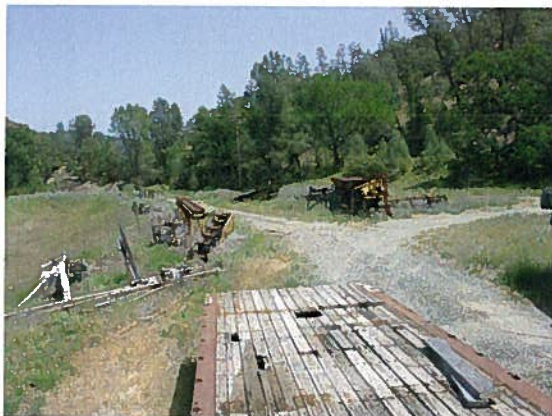
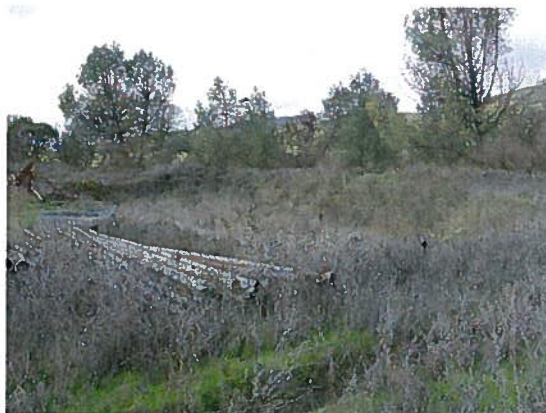
Eastern Portion

- Within the eastern portion of this area, several pieces of large equipment (scraper, dump trucks, flat bed trailer) and other miscellaneous debris (equipment parts, axels, hopper, water tank, conveyor arms, and other metal scrap) have been removed (see attached photos).
- Within the eastern portion of this area, there still remains a conveyor arm, several metal pipes, a couple miscellaneous pieces of metal scrap, and a concrete pad that need to be removed.
- Within the western portion of this area, several pieces non-mining related debris (car, van, pickup truck, tires, pallets, boats, snow mobile trailer, fire wood, bricks) and some miscellaneous scrap have been removed (see attached photos).
- Within the western portion of this area, there still remains several large pieces of equipment, scrap and debris (scrapers, dump truck, cube van, large trailers, drill rig, earth movers),

- It appears that a few pieces of equipment may have been moved from the eastern portion of the site to the western; however overall there is less equipment, scrap and debris at the Batch/Wash Plant area than in the previous inspection.

- Efforts to remove equipment, structures, scrap, and debris will need to continue and all such materials need to be removed within 3 months (i.e. by **May 31, 2011**).

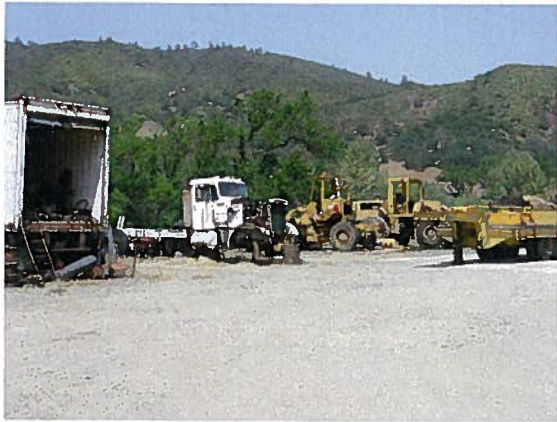
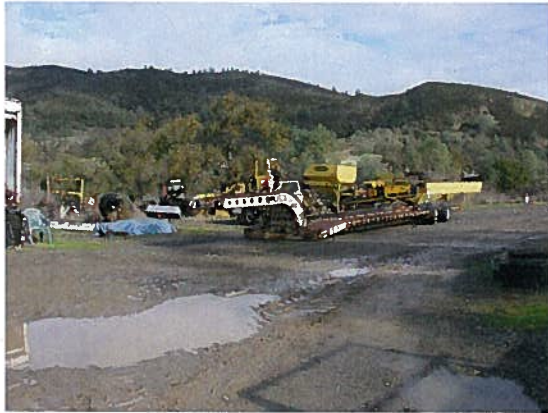
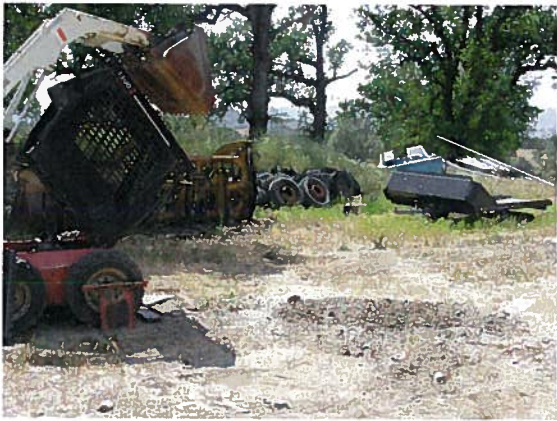
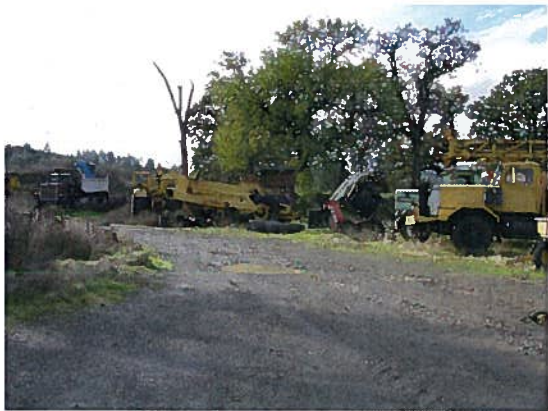
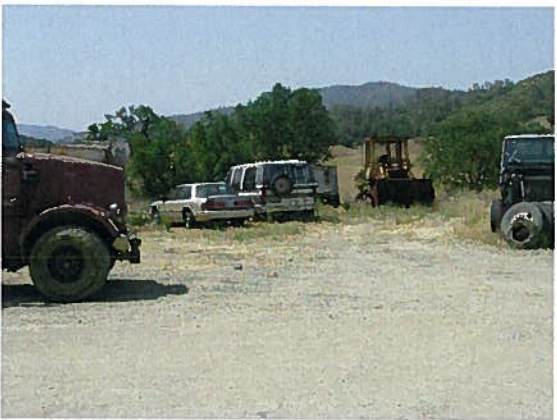
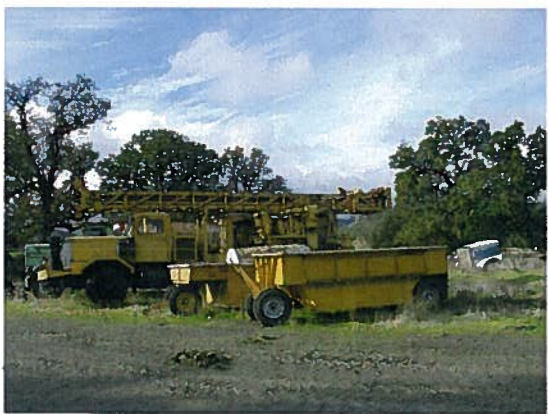
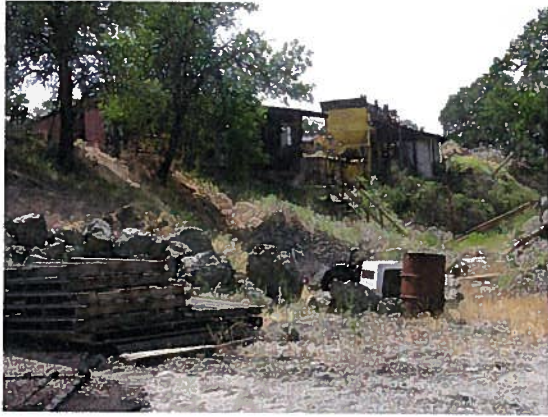
Western Portion

structures (batch plant, shop, shed) and miscellaneous pieces of scrap and other debris, that need to be removed.

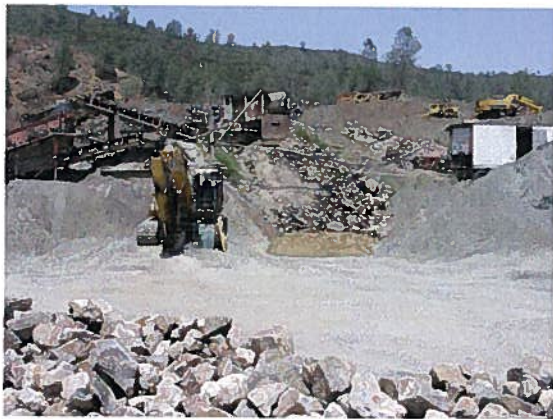
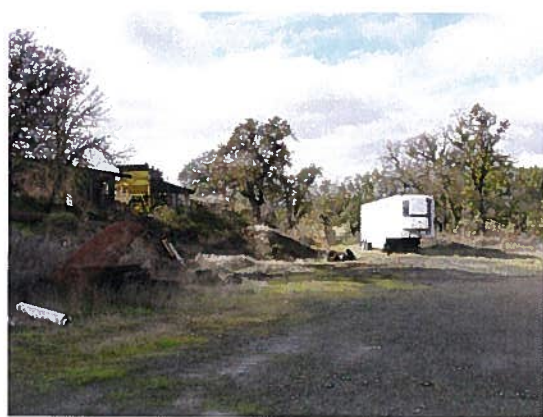
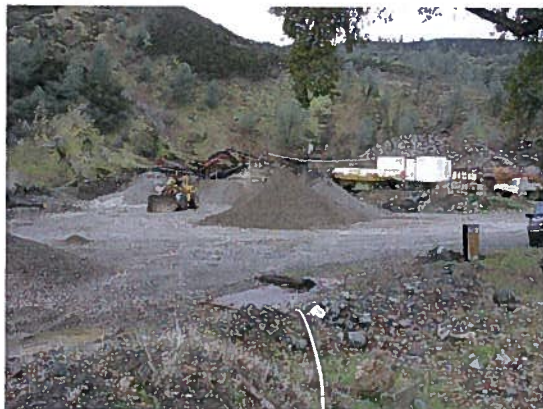
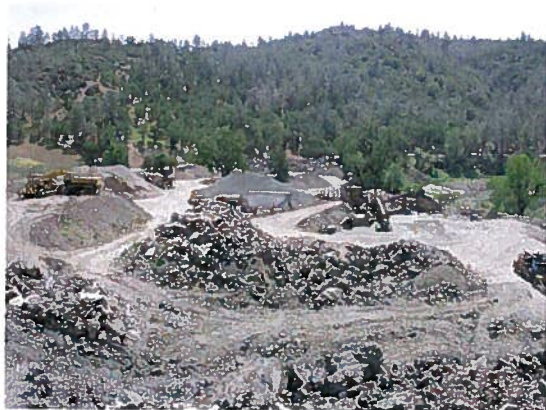
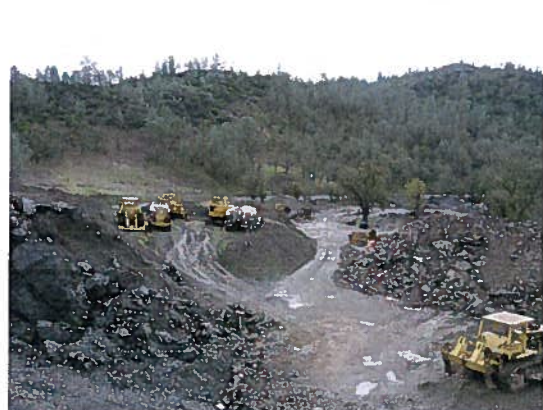
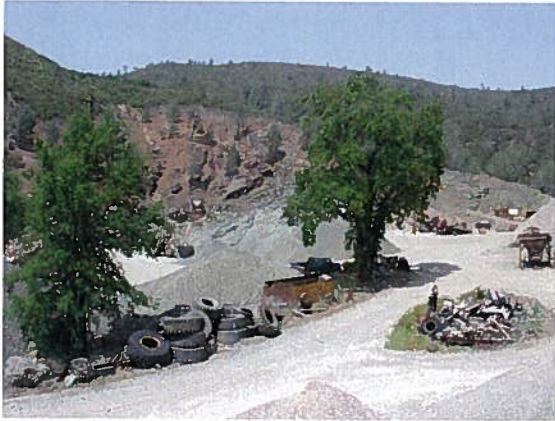
Rock Quarry Area:

- There has been some limited removal of scrap and other debris from this area (tires, hopper, and miscellaneous scrap). It appears that some pieces of equipment (tanker trailers) have been moved to this area from the Batch/Wash Plant area.
- Generally, non-operational large equipment and scrap has not been removed from this area on a regular basis (see attached photos) – equipment, scrap and debris not associated with the operation needs to be removed within 3 months (i.e. by **May 31, 2011**).

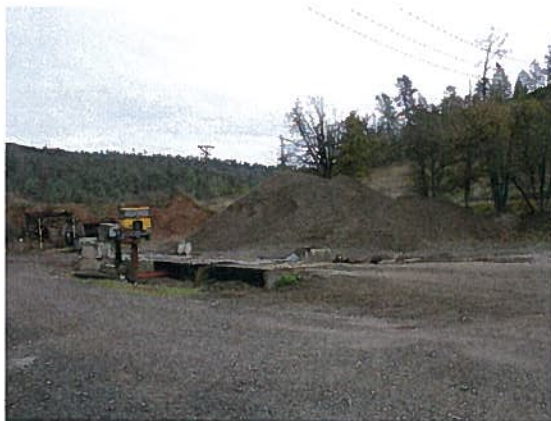
Discharge and Runoff – Hard Rock Quarry area:
 March 30, 2010

The runoff basin/area located within the southwestern portion of the Hard Rock Quarry (i.e. southwest of the quarry pit and crushing plant) was inspected on March 30, 2010 (a day after a rain events) and on December 3, 2011 (after several days of rain). The basin appears to have adequate capacity at the current level of filling and no evidence was discovered that indicated this basin had overtopped and discharged into Pope Creek (see attached photos). However, a large conveyer arm has recently been placed within this area. This piece of equipment shall be removed from this area within 30 days (i.e. by **March 28, 2011**) so that it does not interfere with the functioning of the basin or adversely affect water quality.

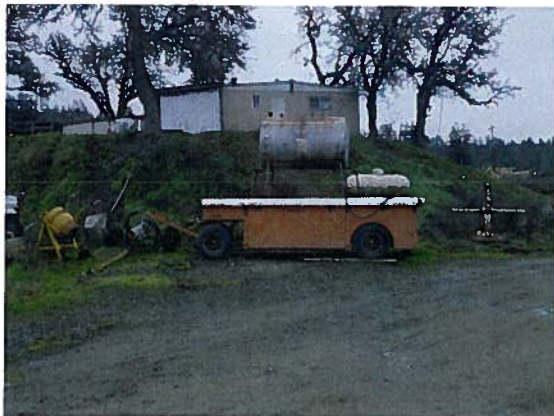
Fuel Tank Containment –Batch/Wash Plant area:

The 550 gallon above ground fuel storage tank has been placed within a containment unit (i.e. grape gondola) with an anticipated capacity of 1,500 gallons (see photo). This containment approach should be considered a temporary measure and the operator will need to work with the County Department of Environmental Management (DEM) to properly maintain and contain the fuel tank. The operator has a permit from the DEM to store hazardous material; CDP will request that DEM inspect the site within the next 6 months to ensure compliance with that permit and State laws pertaining to petroleum storage.
