AETNA SPRINGS PRESERVATION PLAN

For:
Aetna Preserve, LLC

Prepared by:
Architectural Resources Group
Smith & Smith

October 3, 2011

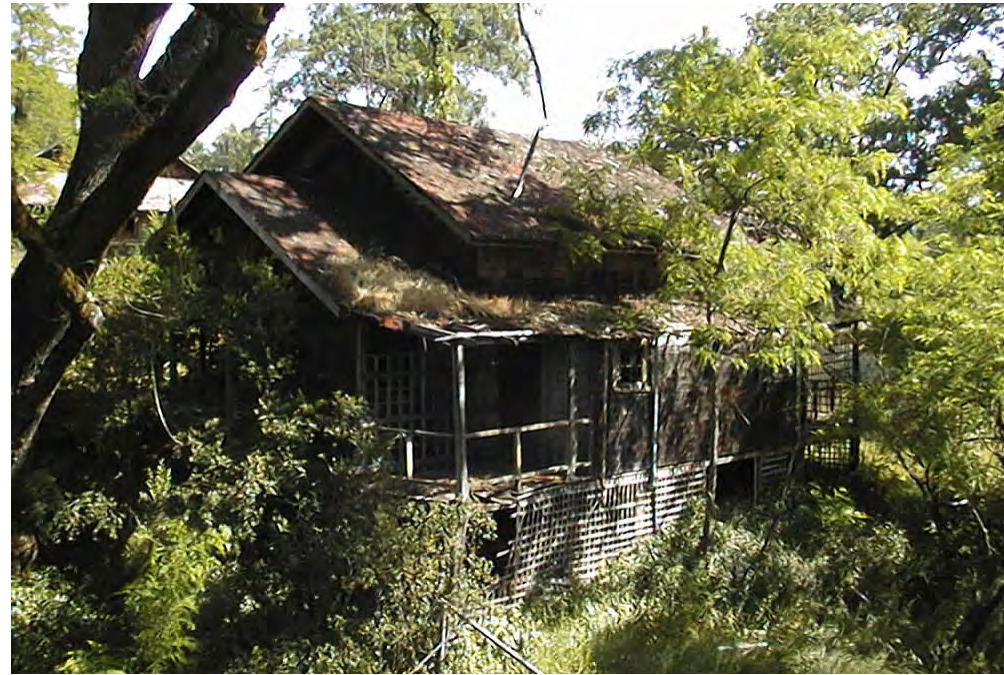
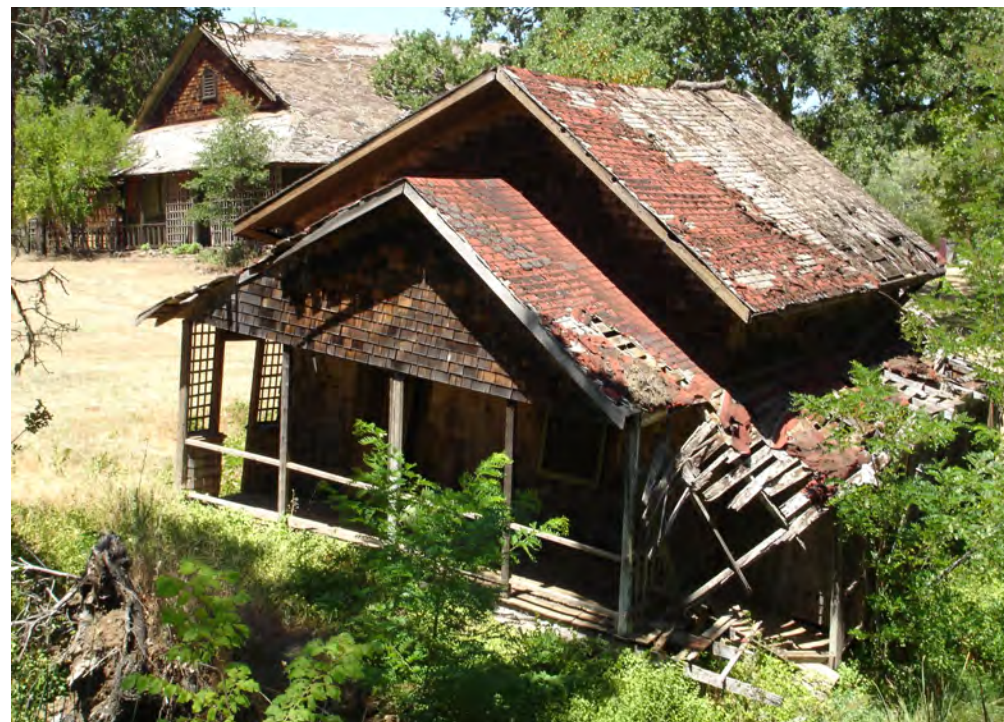
Top - Caroline cottage in 1997, prior to collapse; Bottom - Caroline cottage collapsing into the creek, 2007

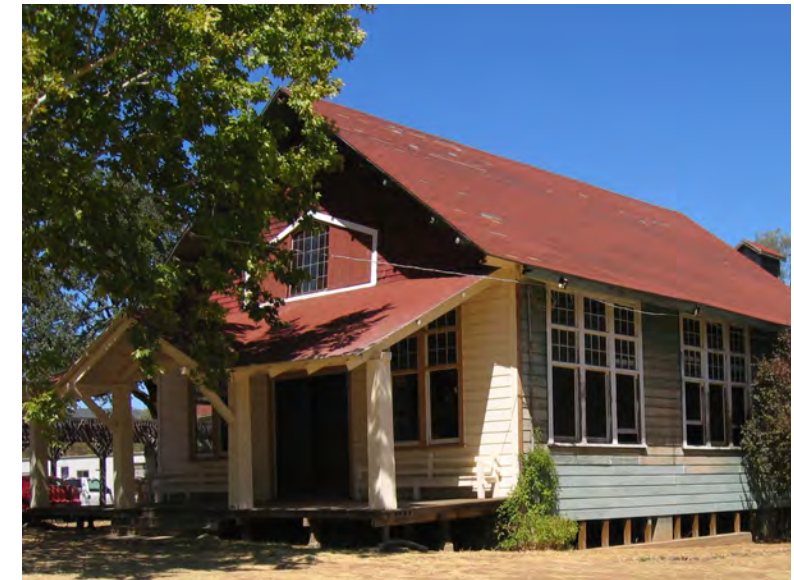
North and west facades of the Dining Hall, which is in good condition

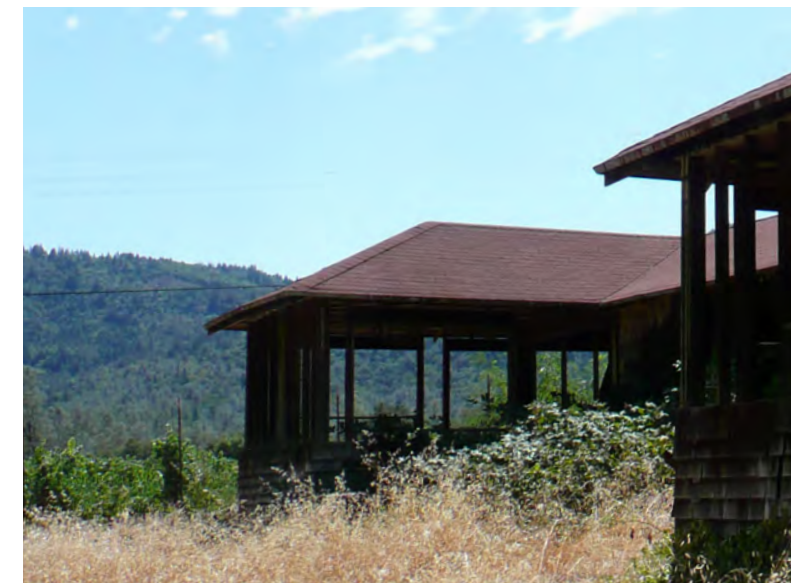
East wings of Munro, which is in very poor condition

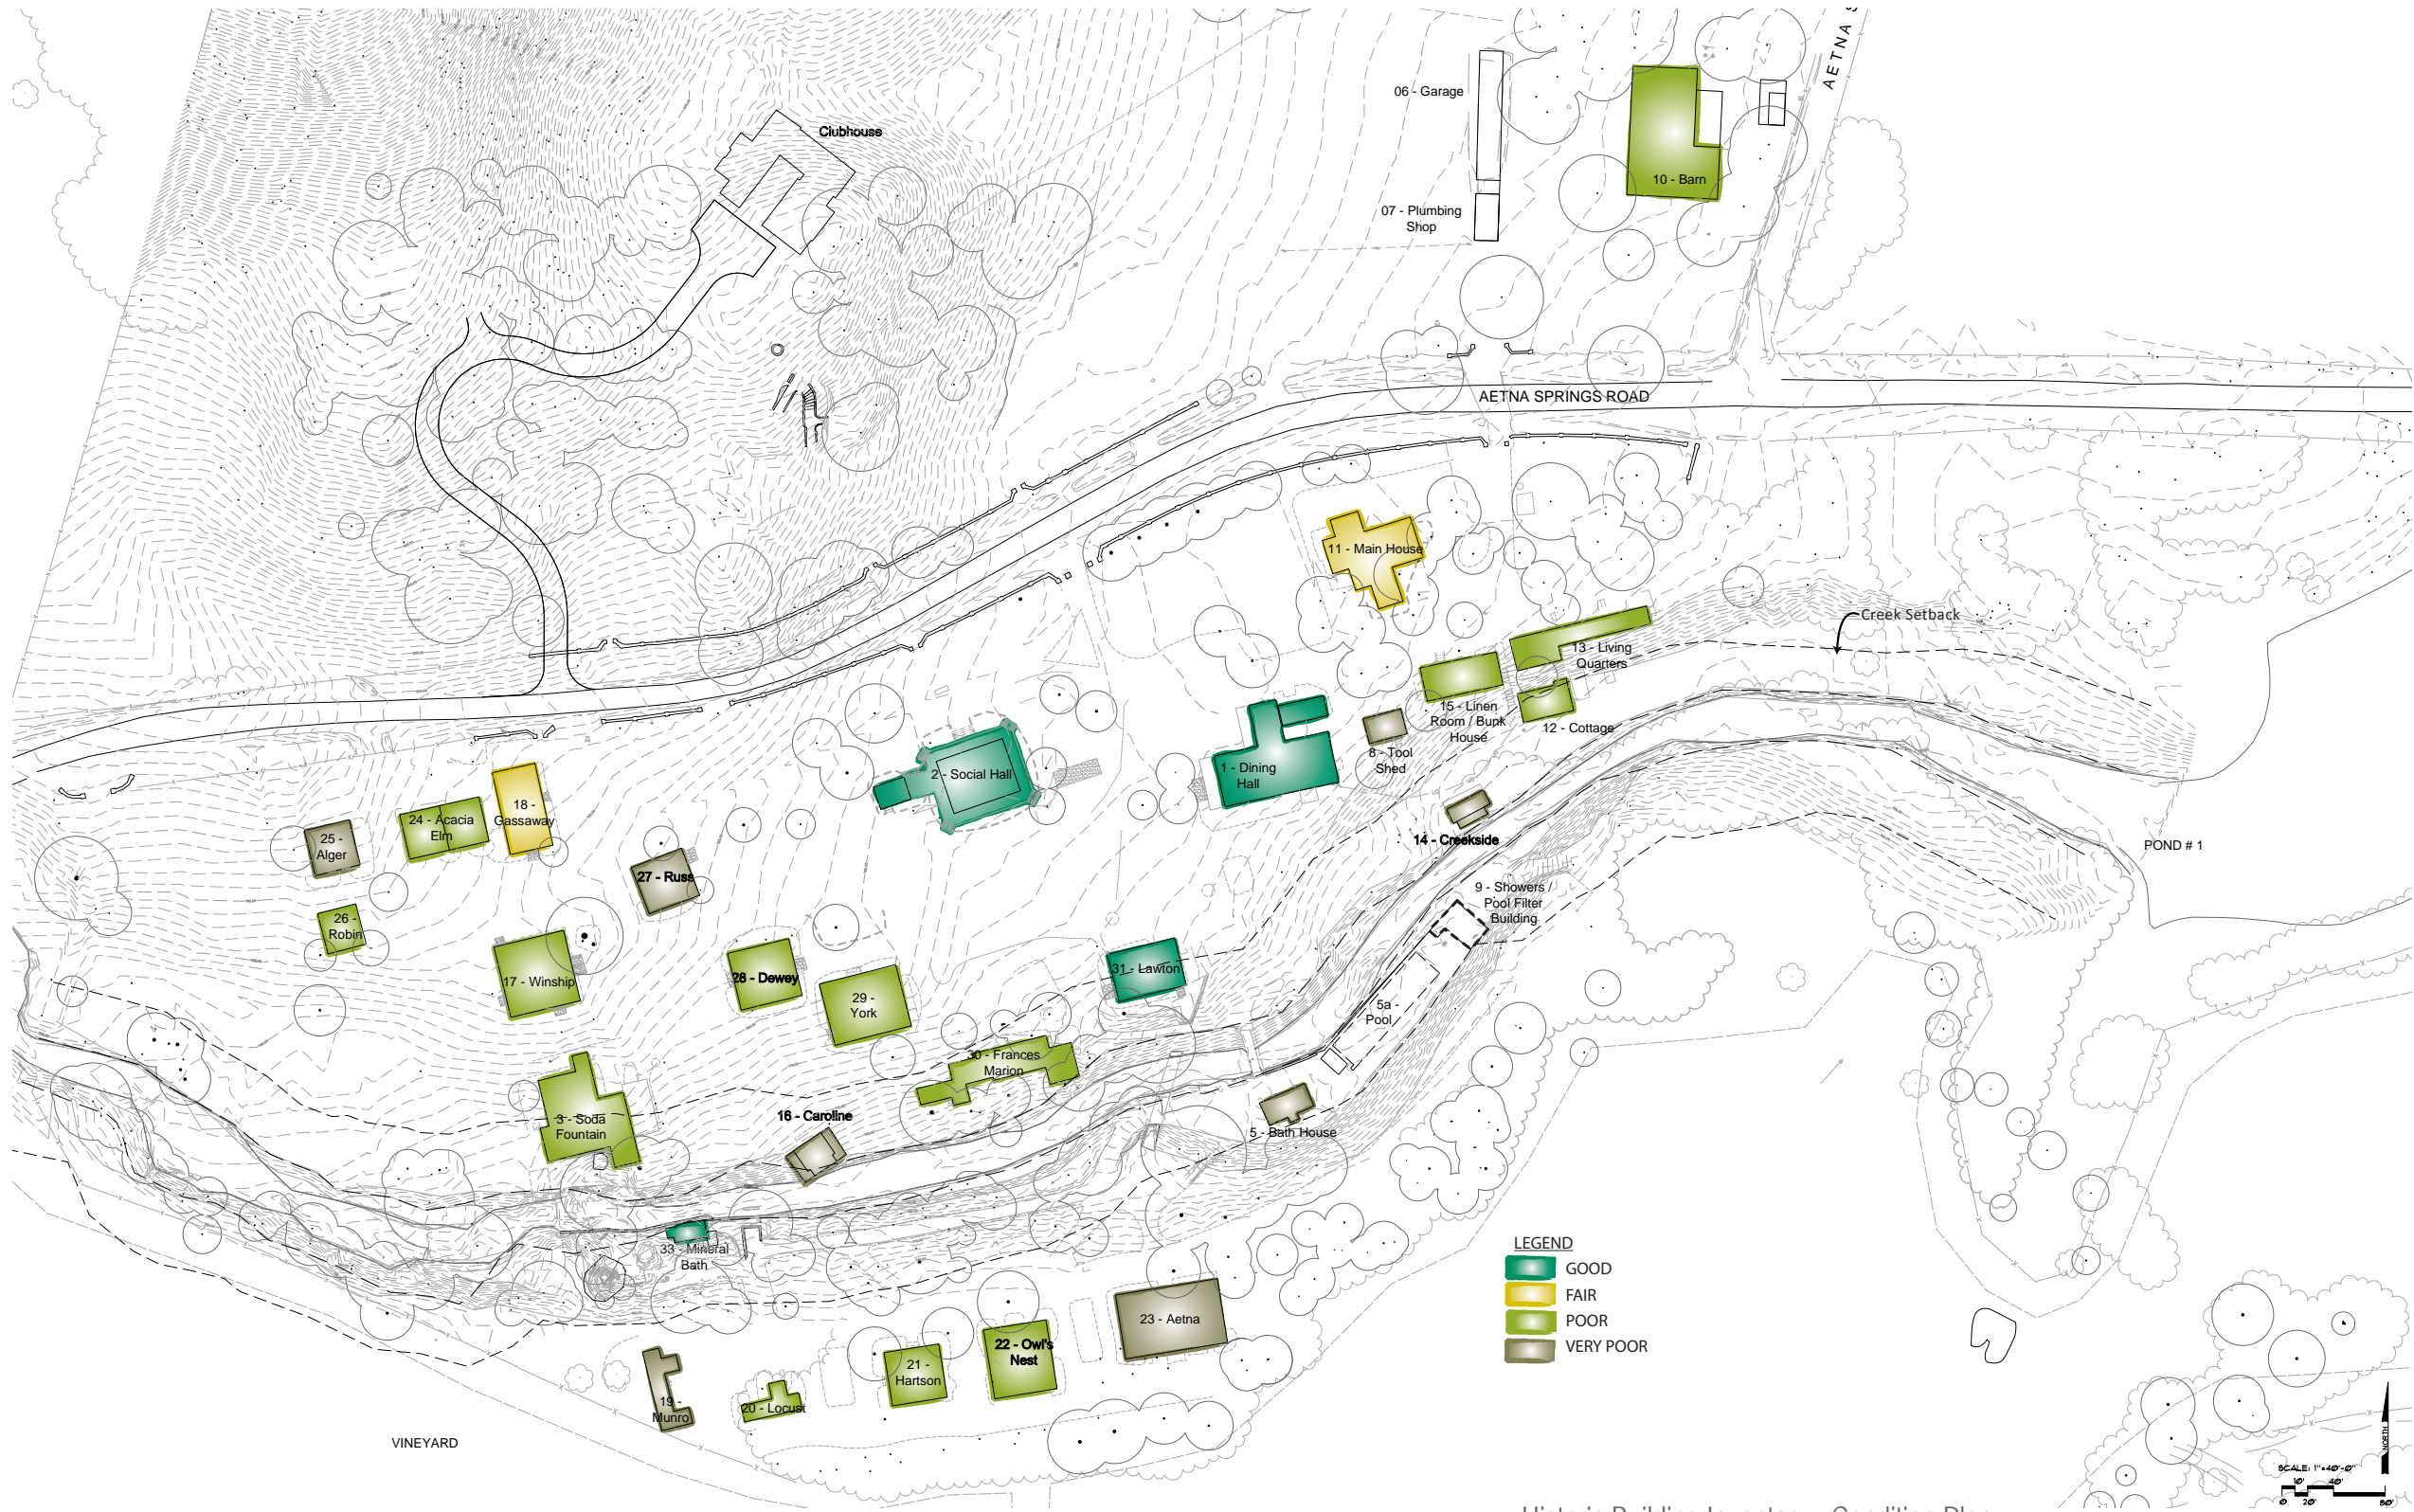
Historic Building Inventory - Condition Plan

Buildings in the Aetna Springs Resort Historic District were surveyed in the summer of 2011 to determine their condition. Most of the buildings have had little to no maintenance for the last twenty to thirty years. They have experienced significant degradation since the writing of the NRN.

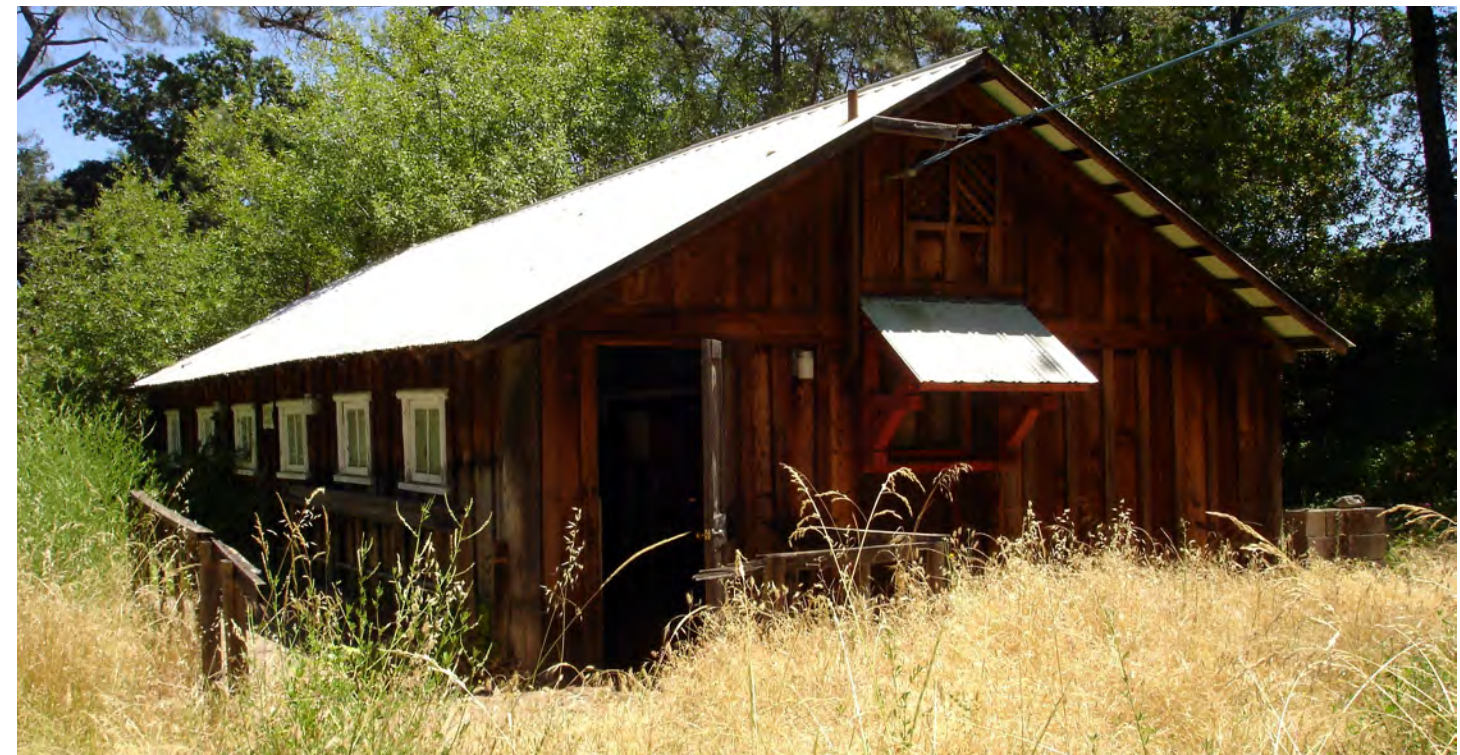
The building is in very poor condition. The interior has been badly damaged by flooding and does not retain its integrity. With the exception of the fiberglass roofing, the exterior appears to retain a majority of its integrity though the wood is quite deteriorated along the base of the

L top - Interior of changing room; M top - Typical window; R top - Ramp to eastern changing room; Bottom - Northwest corner

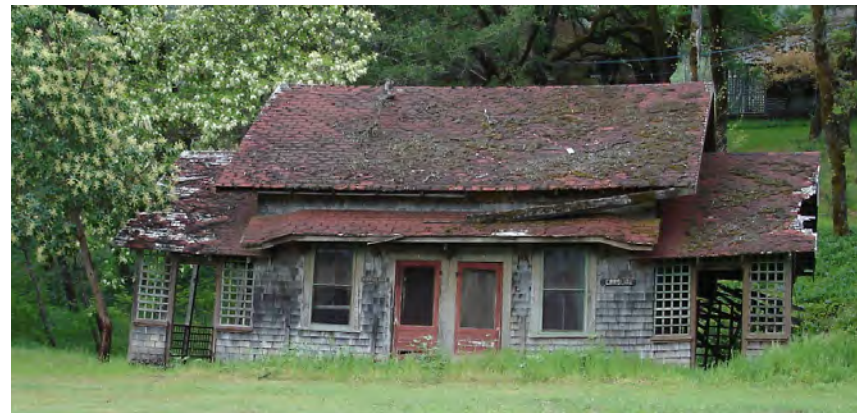
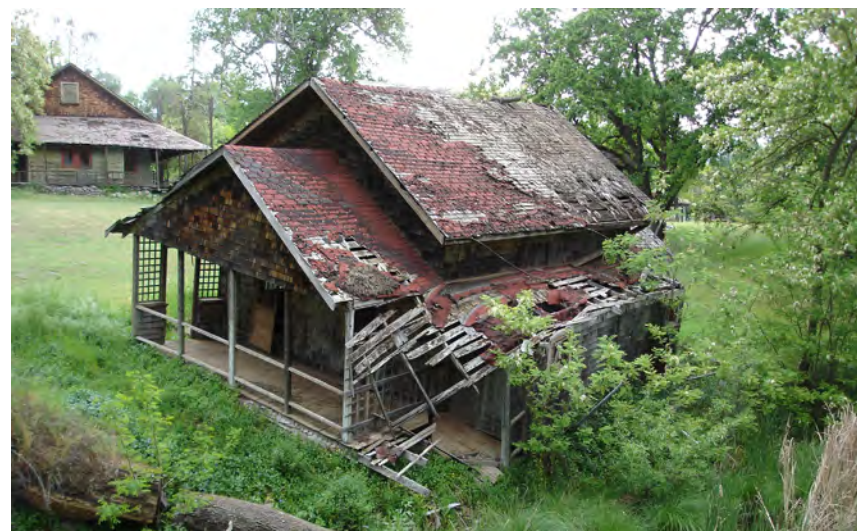
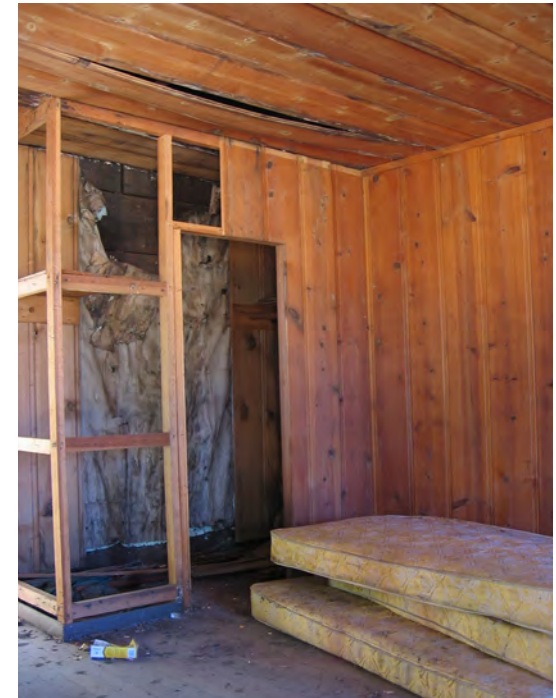
The building is very poor condition. It is heavily deteriorated and has

L top - Name placard; R top - Typical interior; Middle - North facade; L bottom - Southwest corner; R bottom - West facade

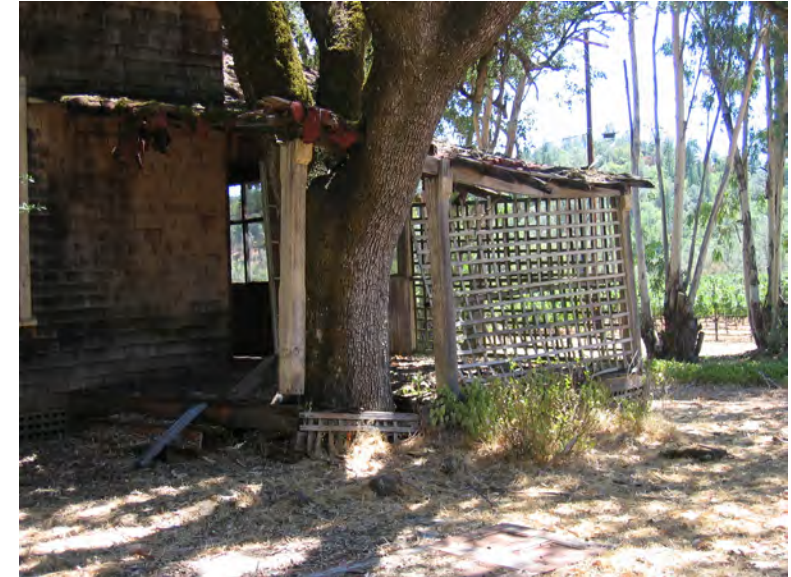
Porch collapsing around existing tree

Rehabilitation of Owl's Nest will continue the existing lodging use. The exterior massing, materials, and features will be retained. Exterior materials will be replaced in kind where deteriorated. Interior finishes and features will generally be replaced in kind or with compatible materials as they are typically missing, severely deteriorated,

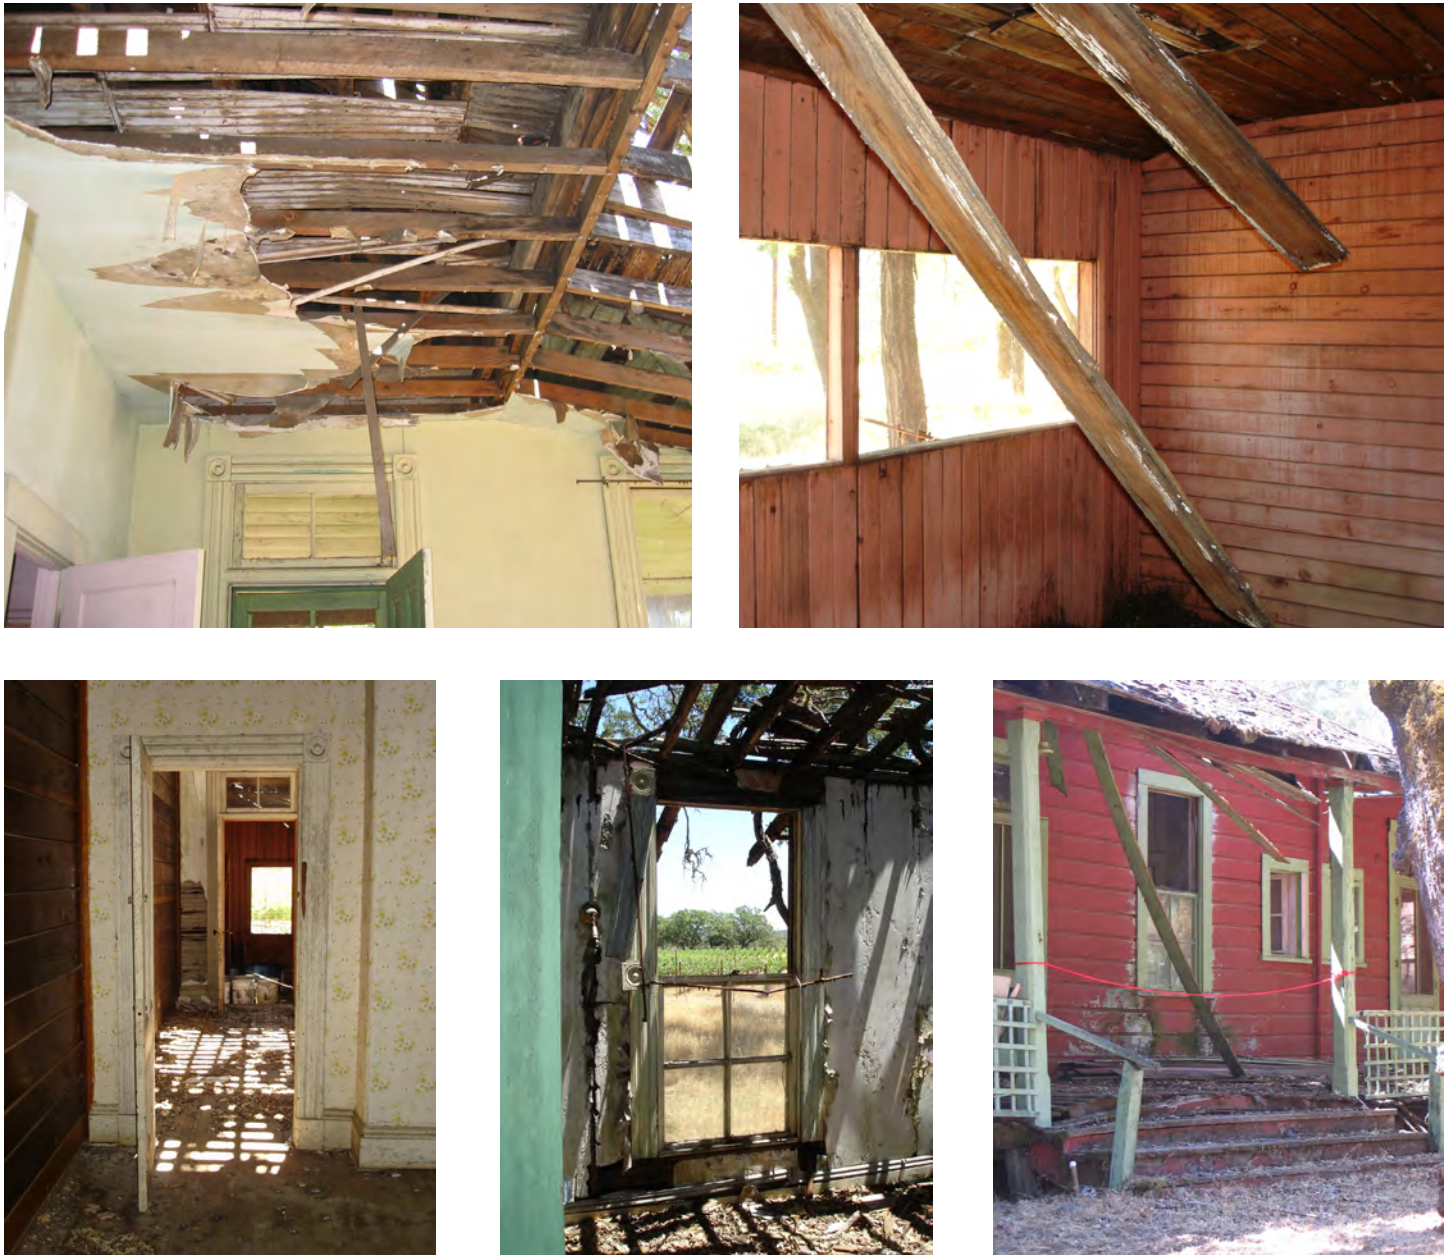
L top - Ceiling of porch enclosure remodel; R top - Non-historic sleeping porch;
L bottom - detail of typical door; M bottom - Deteriorated envelope; R bottom - South porch
