Preliminary Geotechnical Evaluation

Condor Project No. 7464

September 8, 2017

**Subject: Preliminary Geologic Hazards Evaluation
Proposed Winery and Wine Cave – Dry Creek-Mt. Veeder Project
Oakville Winery, LLC, Napa County, California
APN 027-310-039**

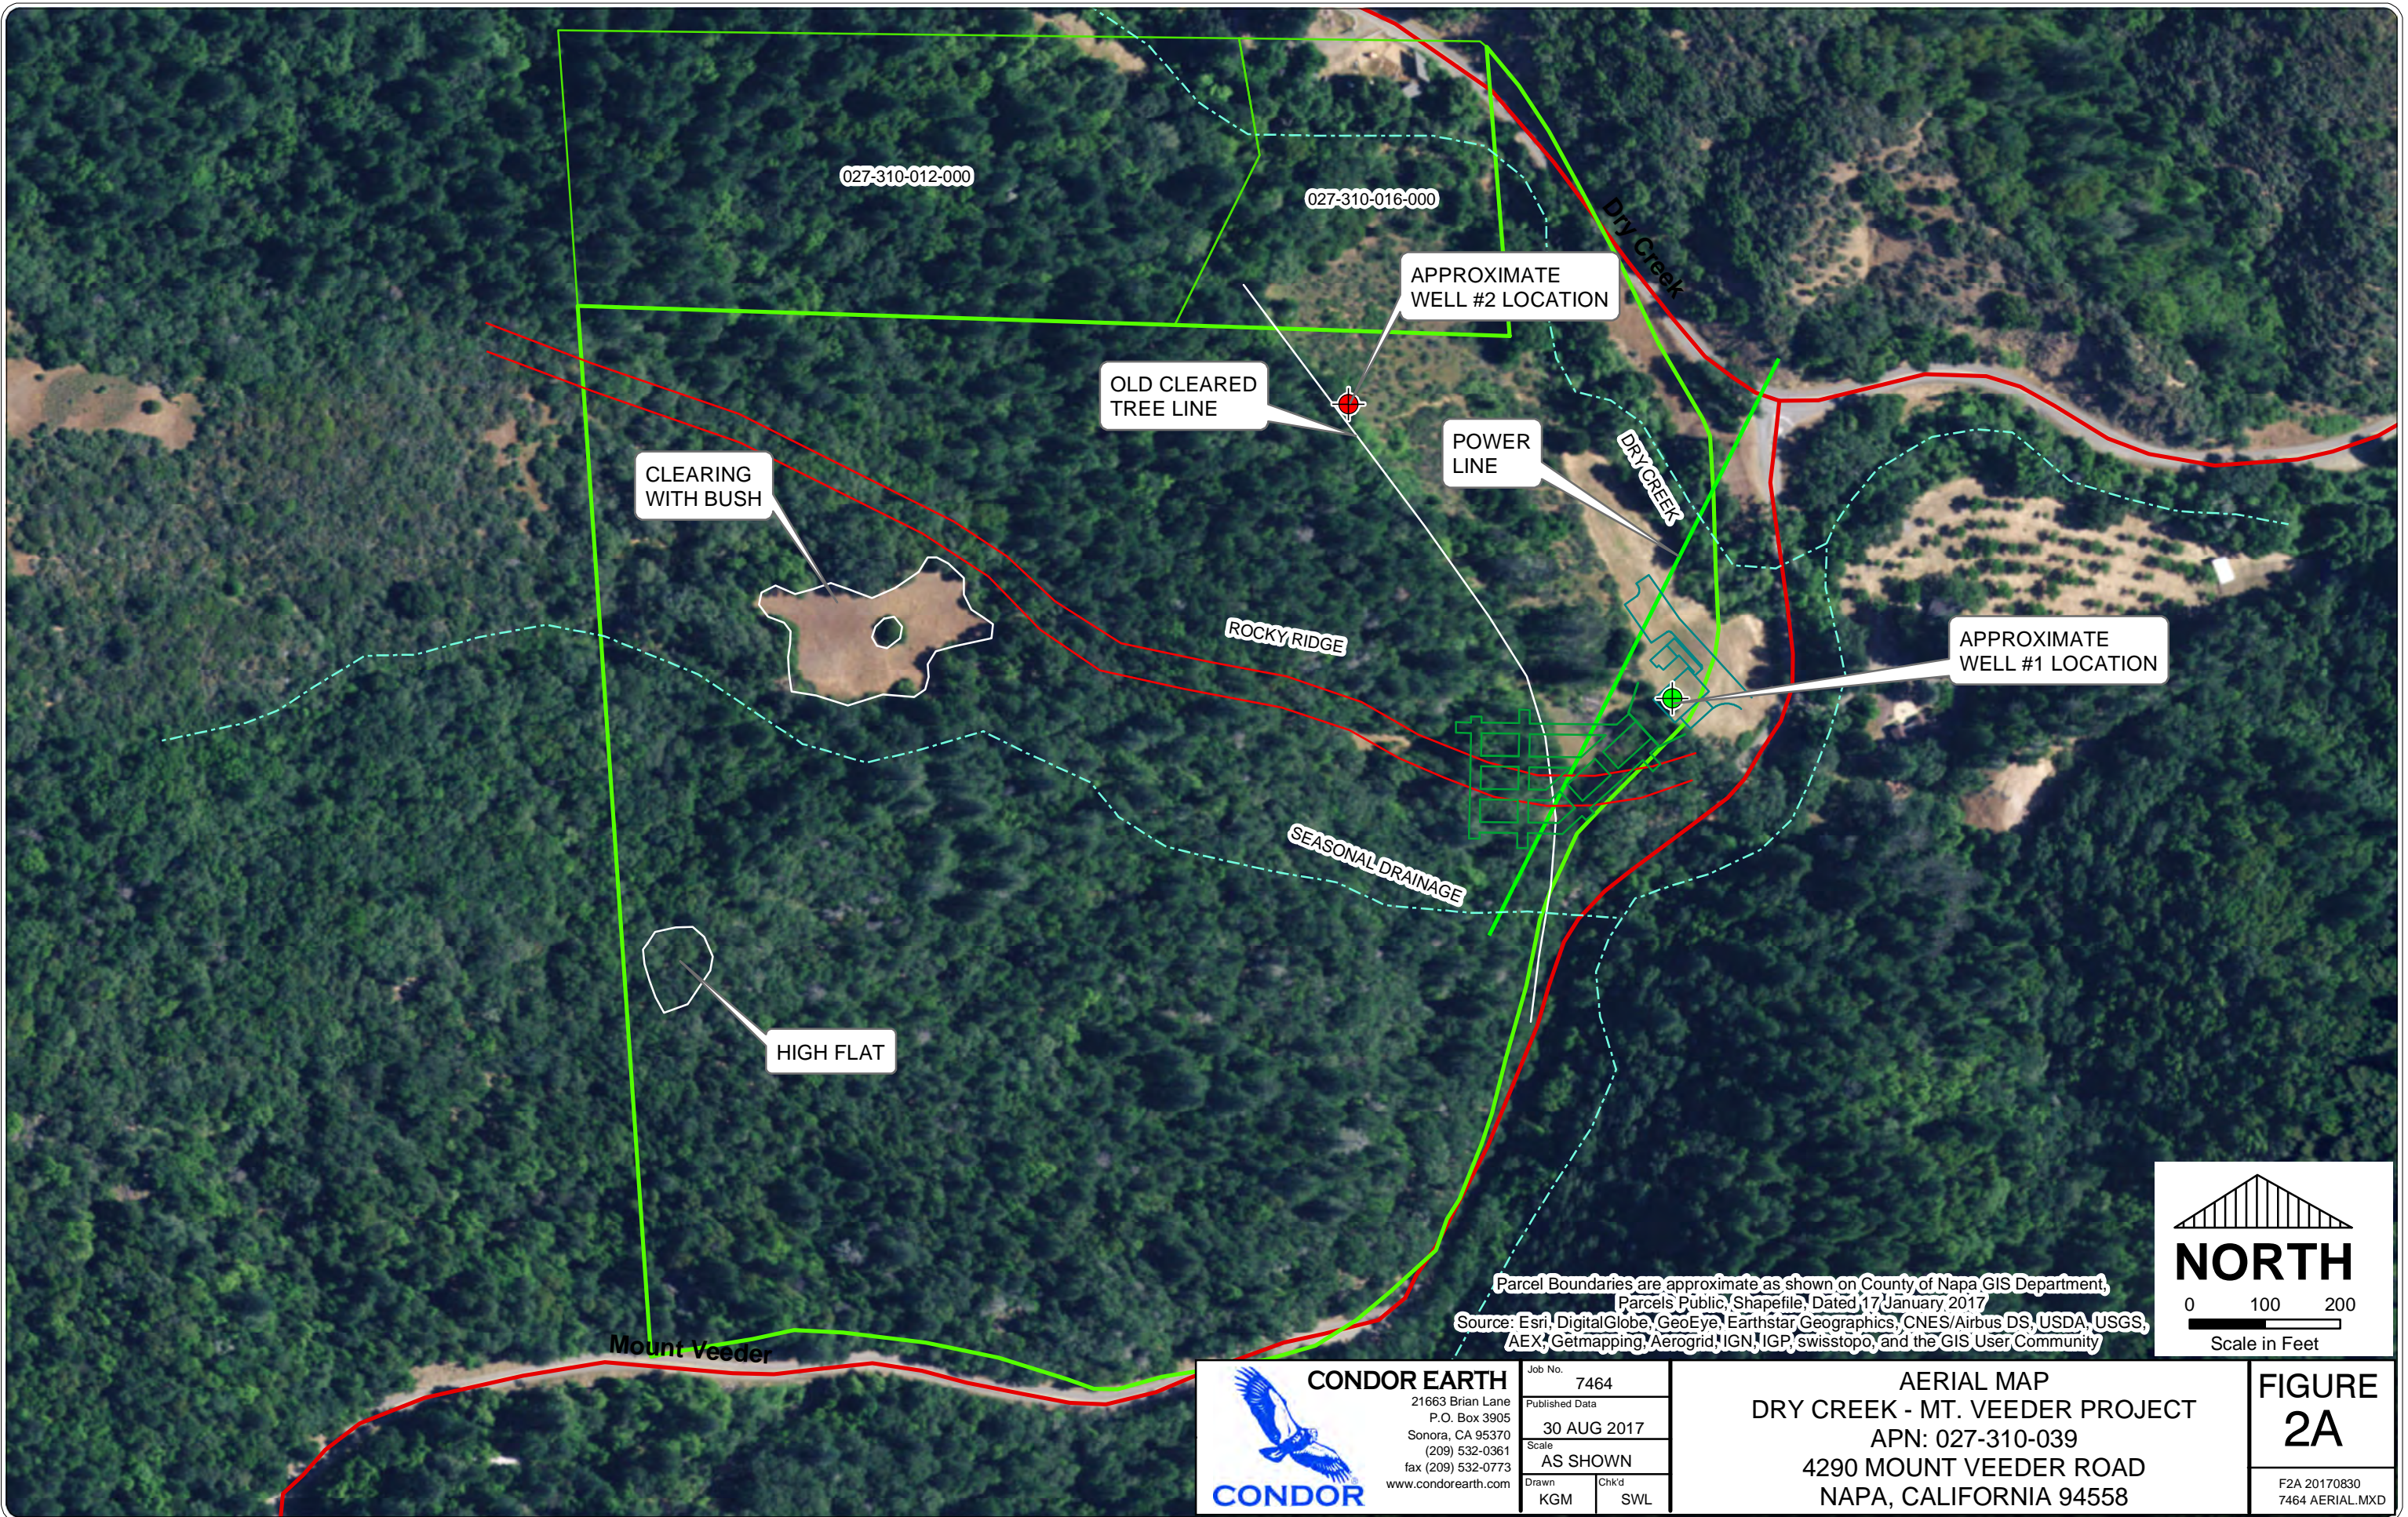
parcel along an approximate east-west line into northern and southern sections. A “high flat” occurs near the west parcel boundary in the southern sections of the parcel (Figures 2A and 2B). Other than the wells and power lines mentioned above, no other permanent improvements were observed on the parcel.

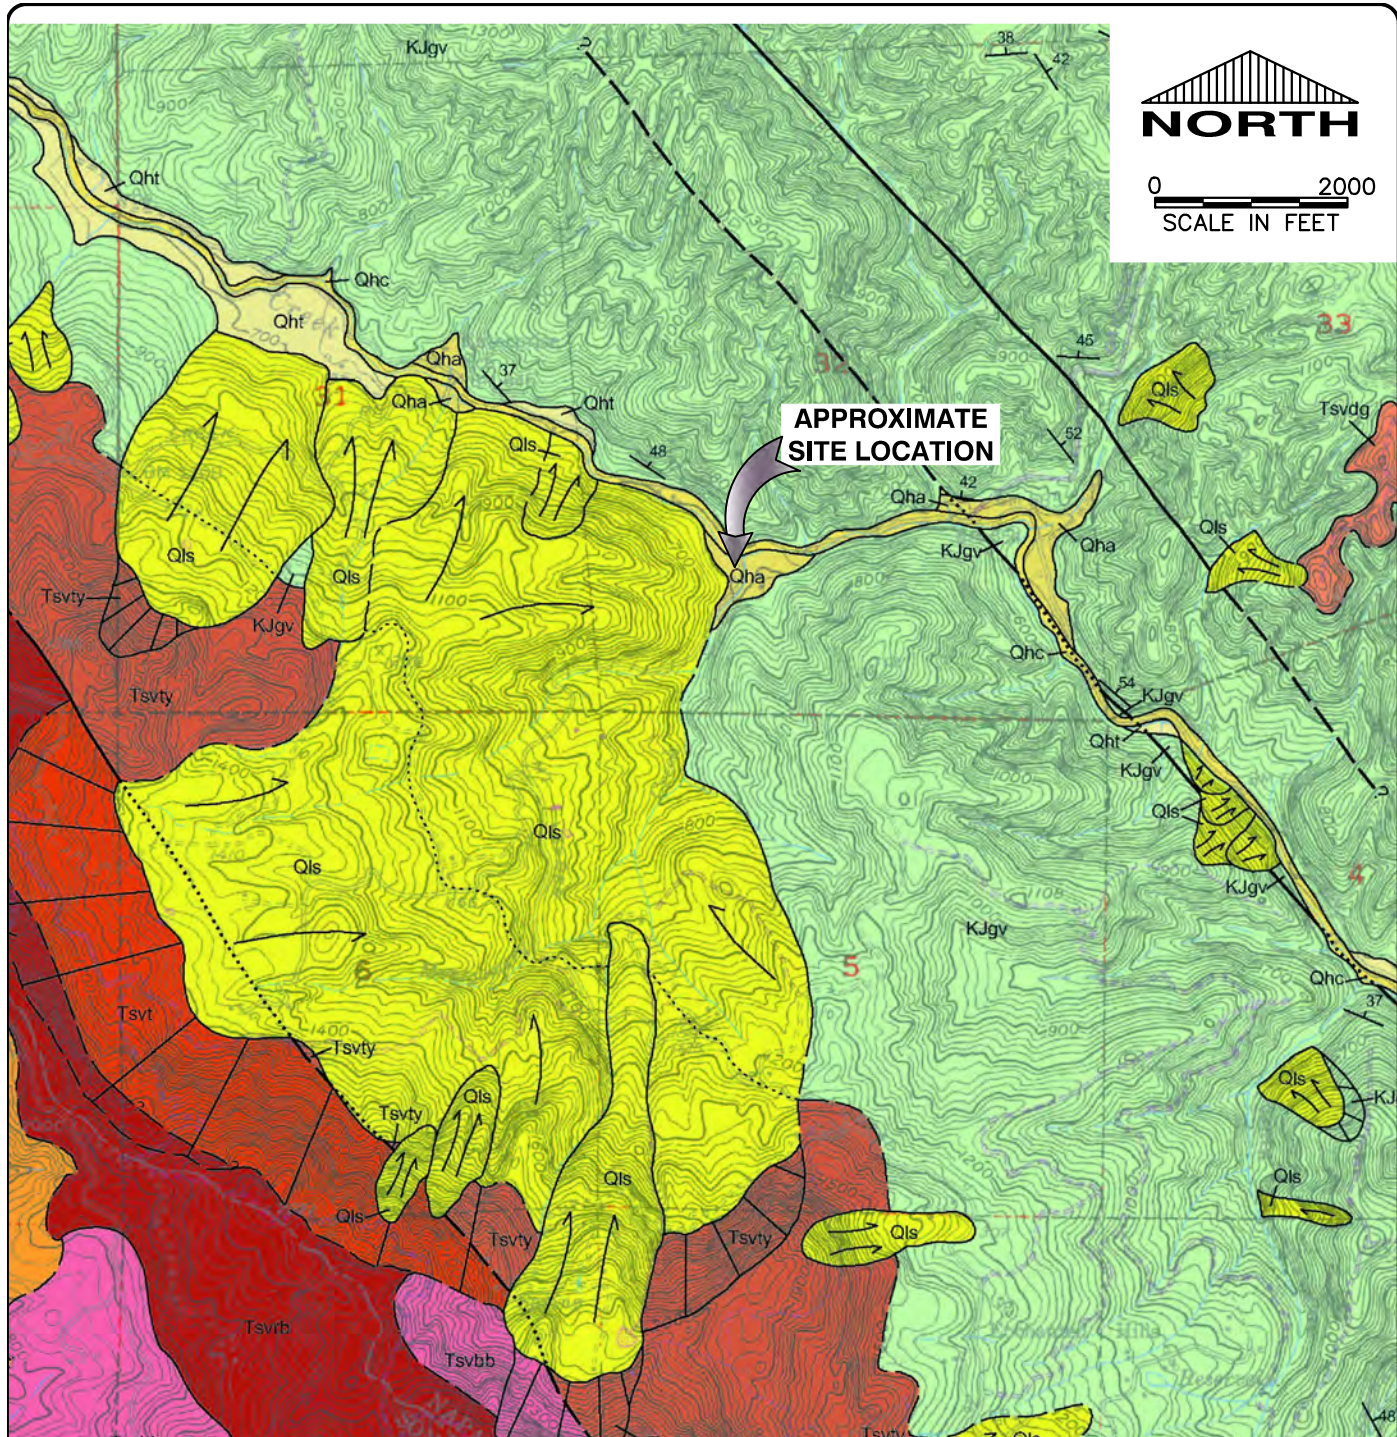
FIGURE
3A

The site geology appears to be challenging for development of site improvements in many areas of the parcel, but one area has good potential. We reviewed two published geologic maps that cover the parcel area, which are shown on Figures 3A and 3B. Figure 3A suggests that the entire parcel, except for a small portion of the lower flat, is underlain by a massive landslide. Figure 3B shows an alternate geologic interpretation, suggesting that the parcel is underlain by in-place rock of the Great Valley Sequence (shale and sandstone). Figure 4 illustrates that no mapped potentially active faults traverse the site. Figure 5A suggests that the nearby massive landslides do not underlie the parcel, but that smaller landslide deposits are present in the vicinity of the old cleared tree area. Other common geologic hazards such as seismically induced or regional settlement, soils expansion/collapse, soil corrosivity, naturally occurring asbestos and radon, solution cavities, volcanism, tsunamis and floods do not appear to significantly affect this site, based on our site and literature review.

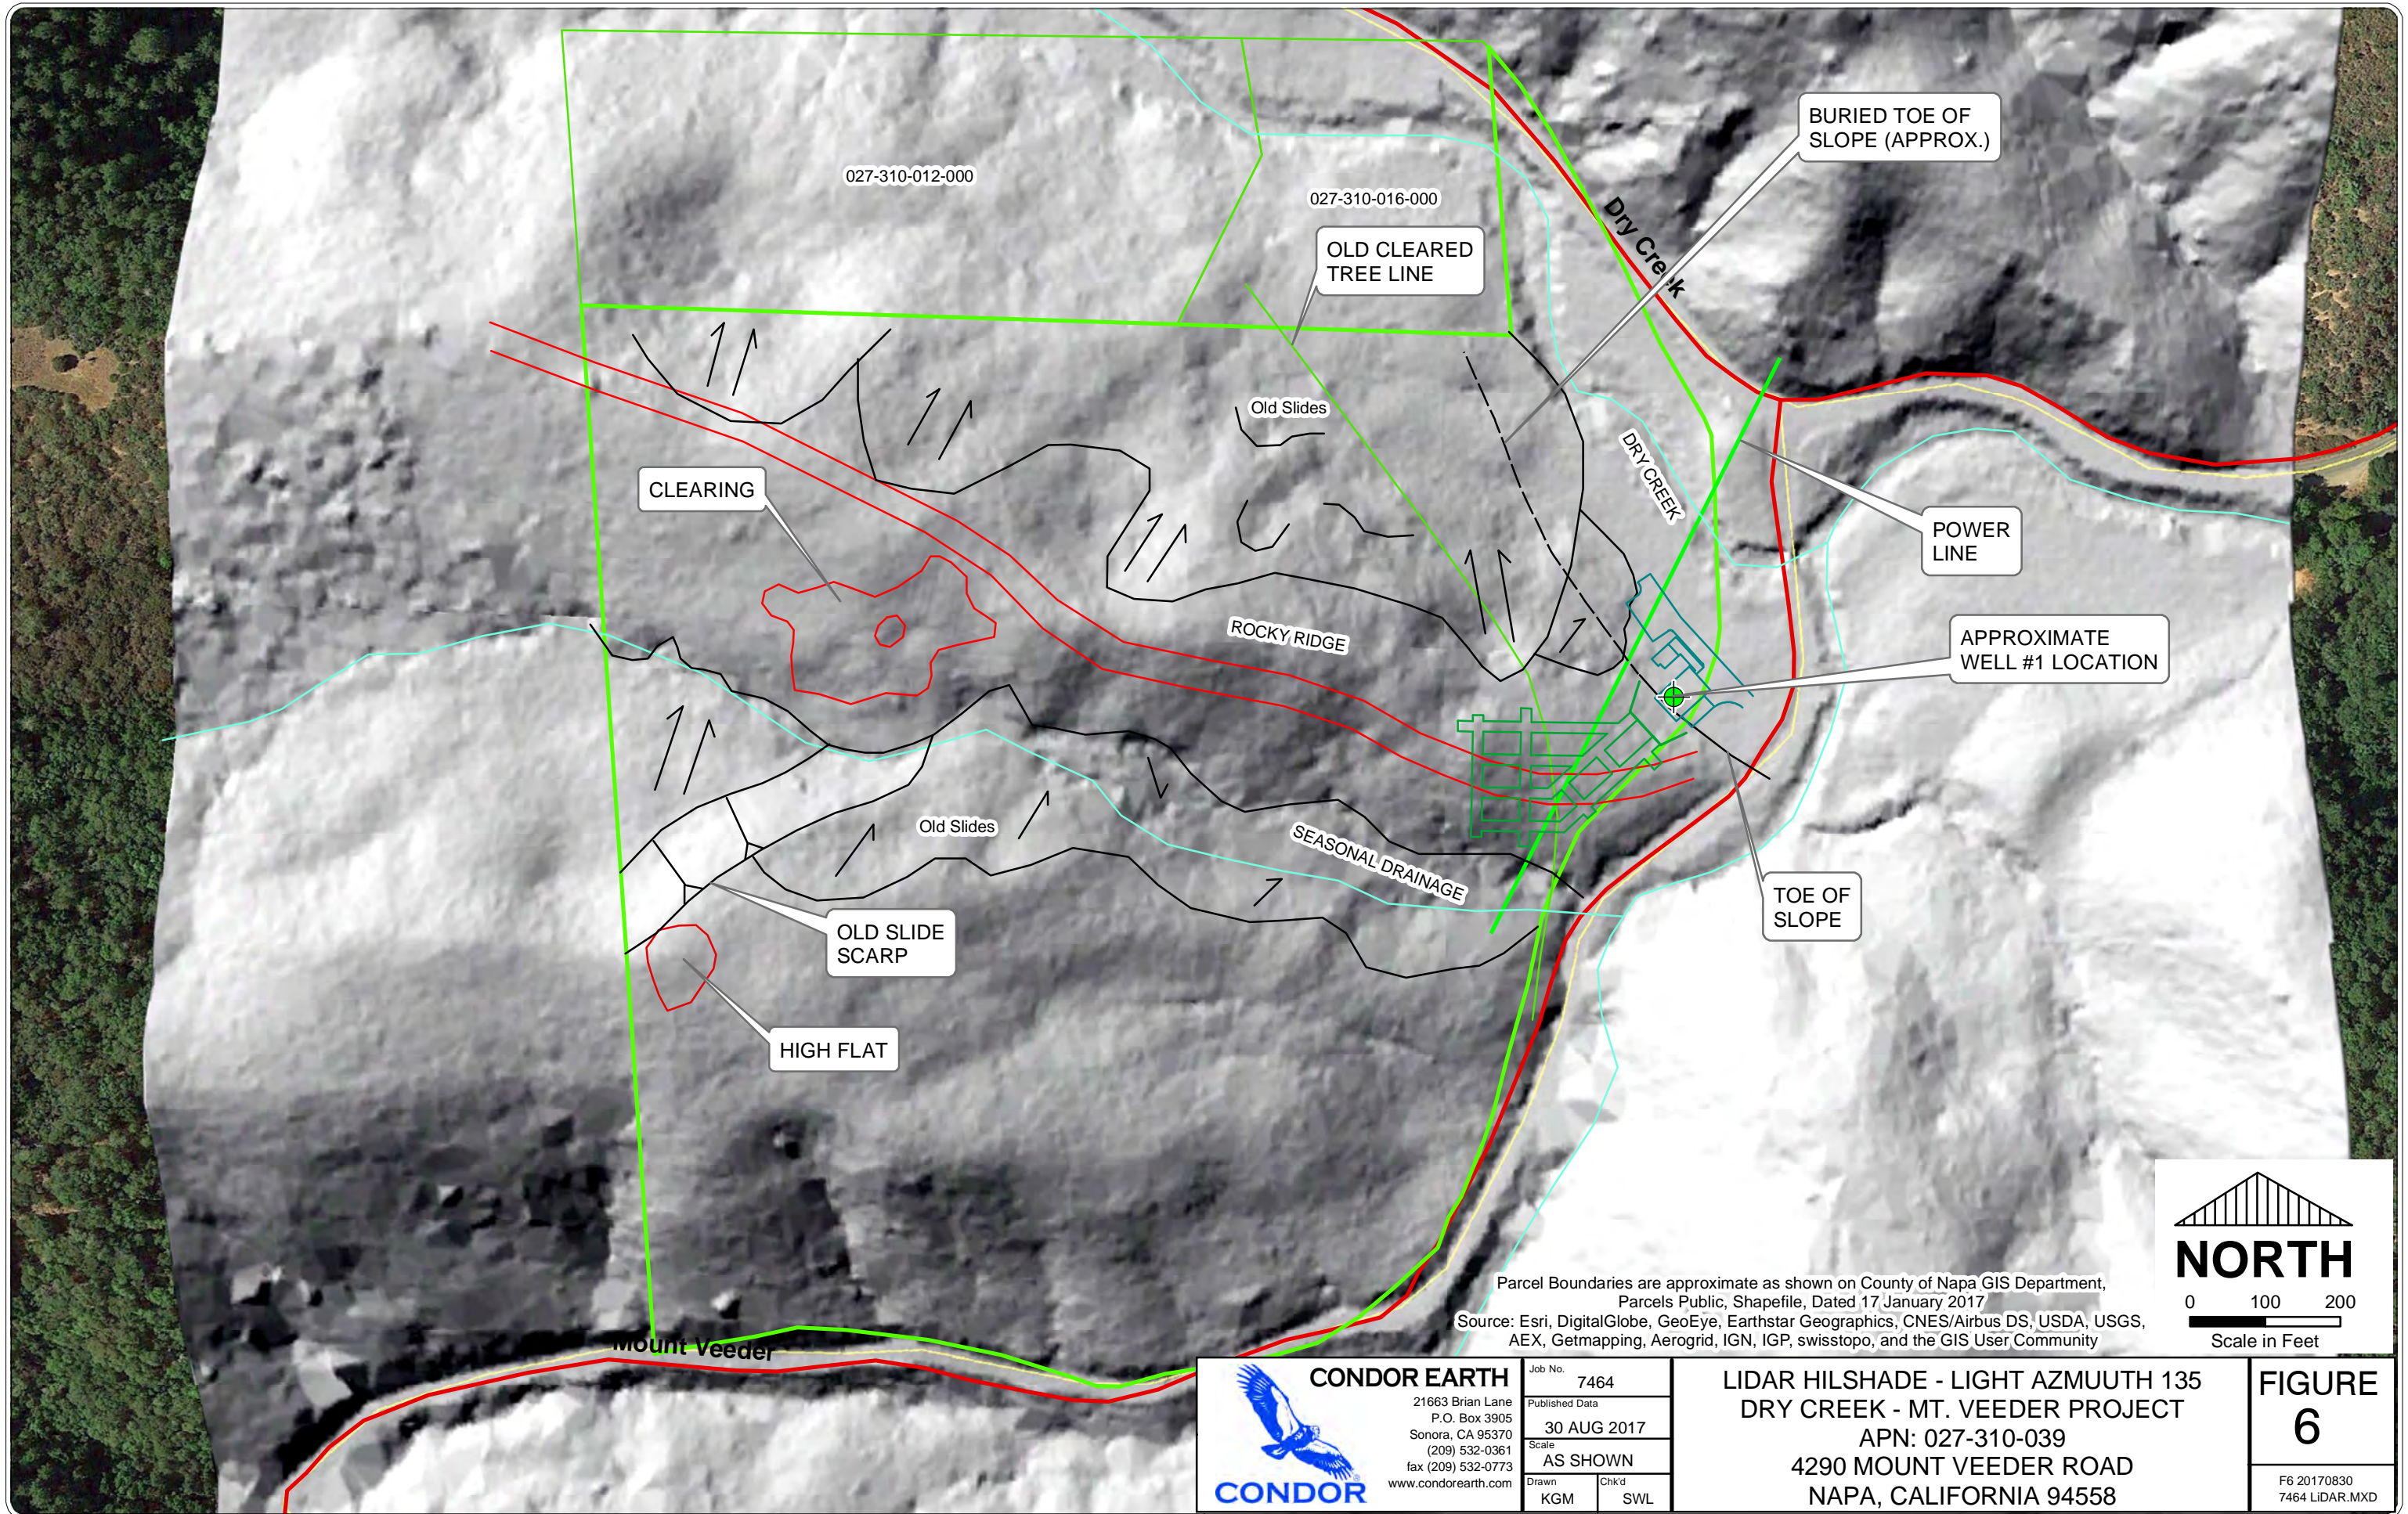
Condor’s preliminary evaluation of the site included studying aerial imagery including stereo-paired air photos (1:7200 scale BW dated 1988 and 1:12000 scale CIR dated 2000), LiDAR Hillshade (recent) and Google Earth (recent), and our on site reconnaissance. The information shown on Figures 6 and 7 illustrate the results of our preliminary landslide evaluation, which is described below.

It appears that the parcel is most likely not underlain by a massive landslide deposit. We observed a continuous outcropping of a resistant sandstone bed that forms the spine of the prominent ridge, labeled “rocky ridge” on Figure 6. The presence of this continuous sandstone bed suggests that the ground is in-place (landslide deposits from the mostly shale Great Valley Sequence would be expected to be broken-up). In addition, our aerial imagery interpretation (Figure 7) suggests that the published landslide mapping (Figure 5A) is more accurate than Figure 3A. However, our observations of hummocky ground on site, coupled with our study of the aerial imagery, suggest that numerous smaller but not-recent landslides are present along the north flank of the rocky ridge and along the parcel-central seasonal drainage. Areas near the toe of slope adjacent to Well #1 and lower flat, near the “clearing with bush,” and near the “upper flat” appear more stable.
