Anthem Winery P14-00320-MOD and Exception to Road and Street Standards,
Variance P14-00321-VAR and Viewshed, and
Agricultural Erosion Control Plan P14-00322-ECPA
Planning Commission Hearing Date (Wednesday, October 3, 2018)

**SUPPLEMENTAL FAULT INVESTIGATION REPORT
ANTHEM WINERY AND VINEYARDS, LLC
3454 REDWOOD ROAD
NAPA, CALIFORNIA**

June 30, 2018

Job No. 1354.100

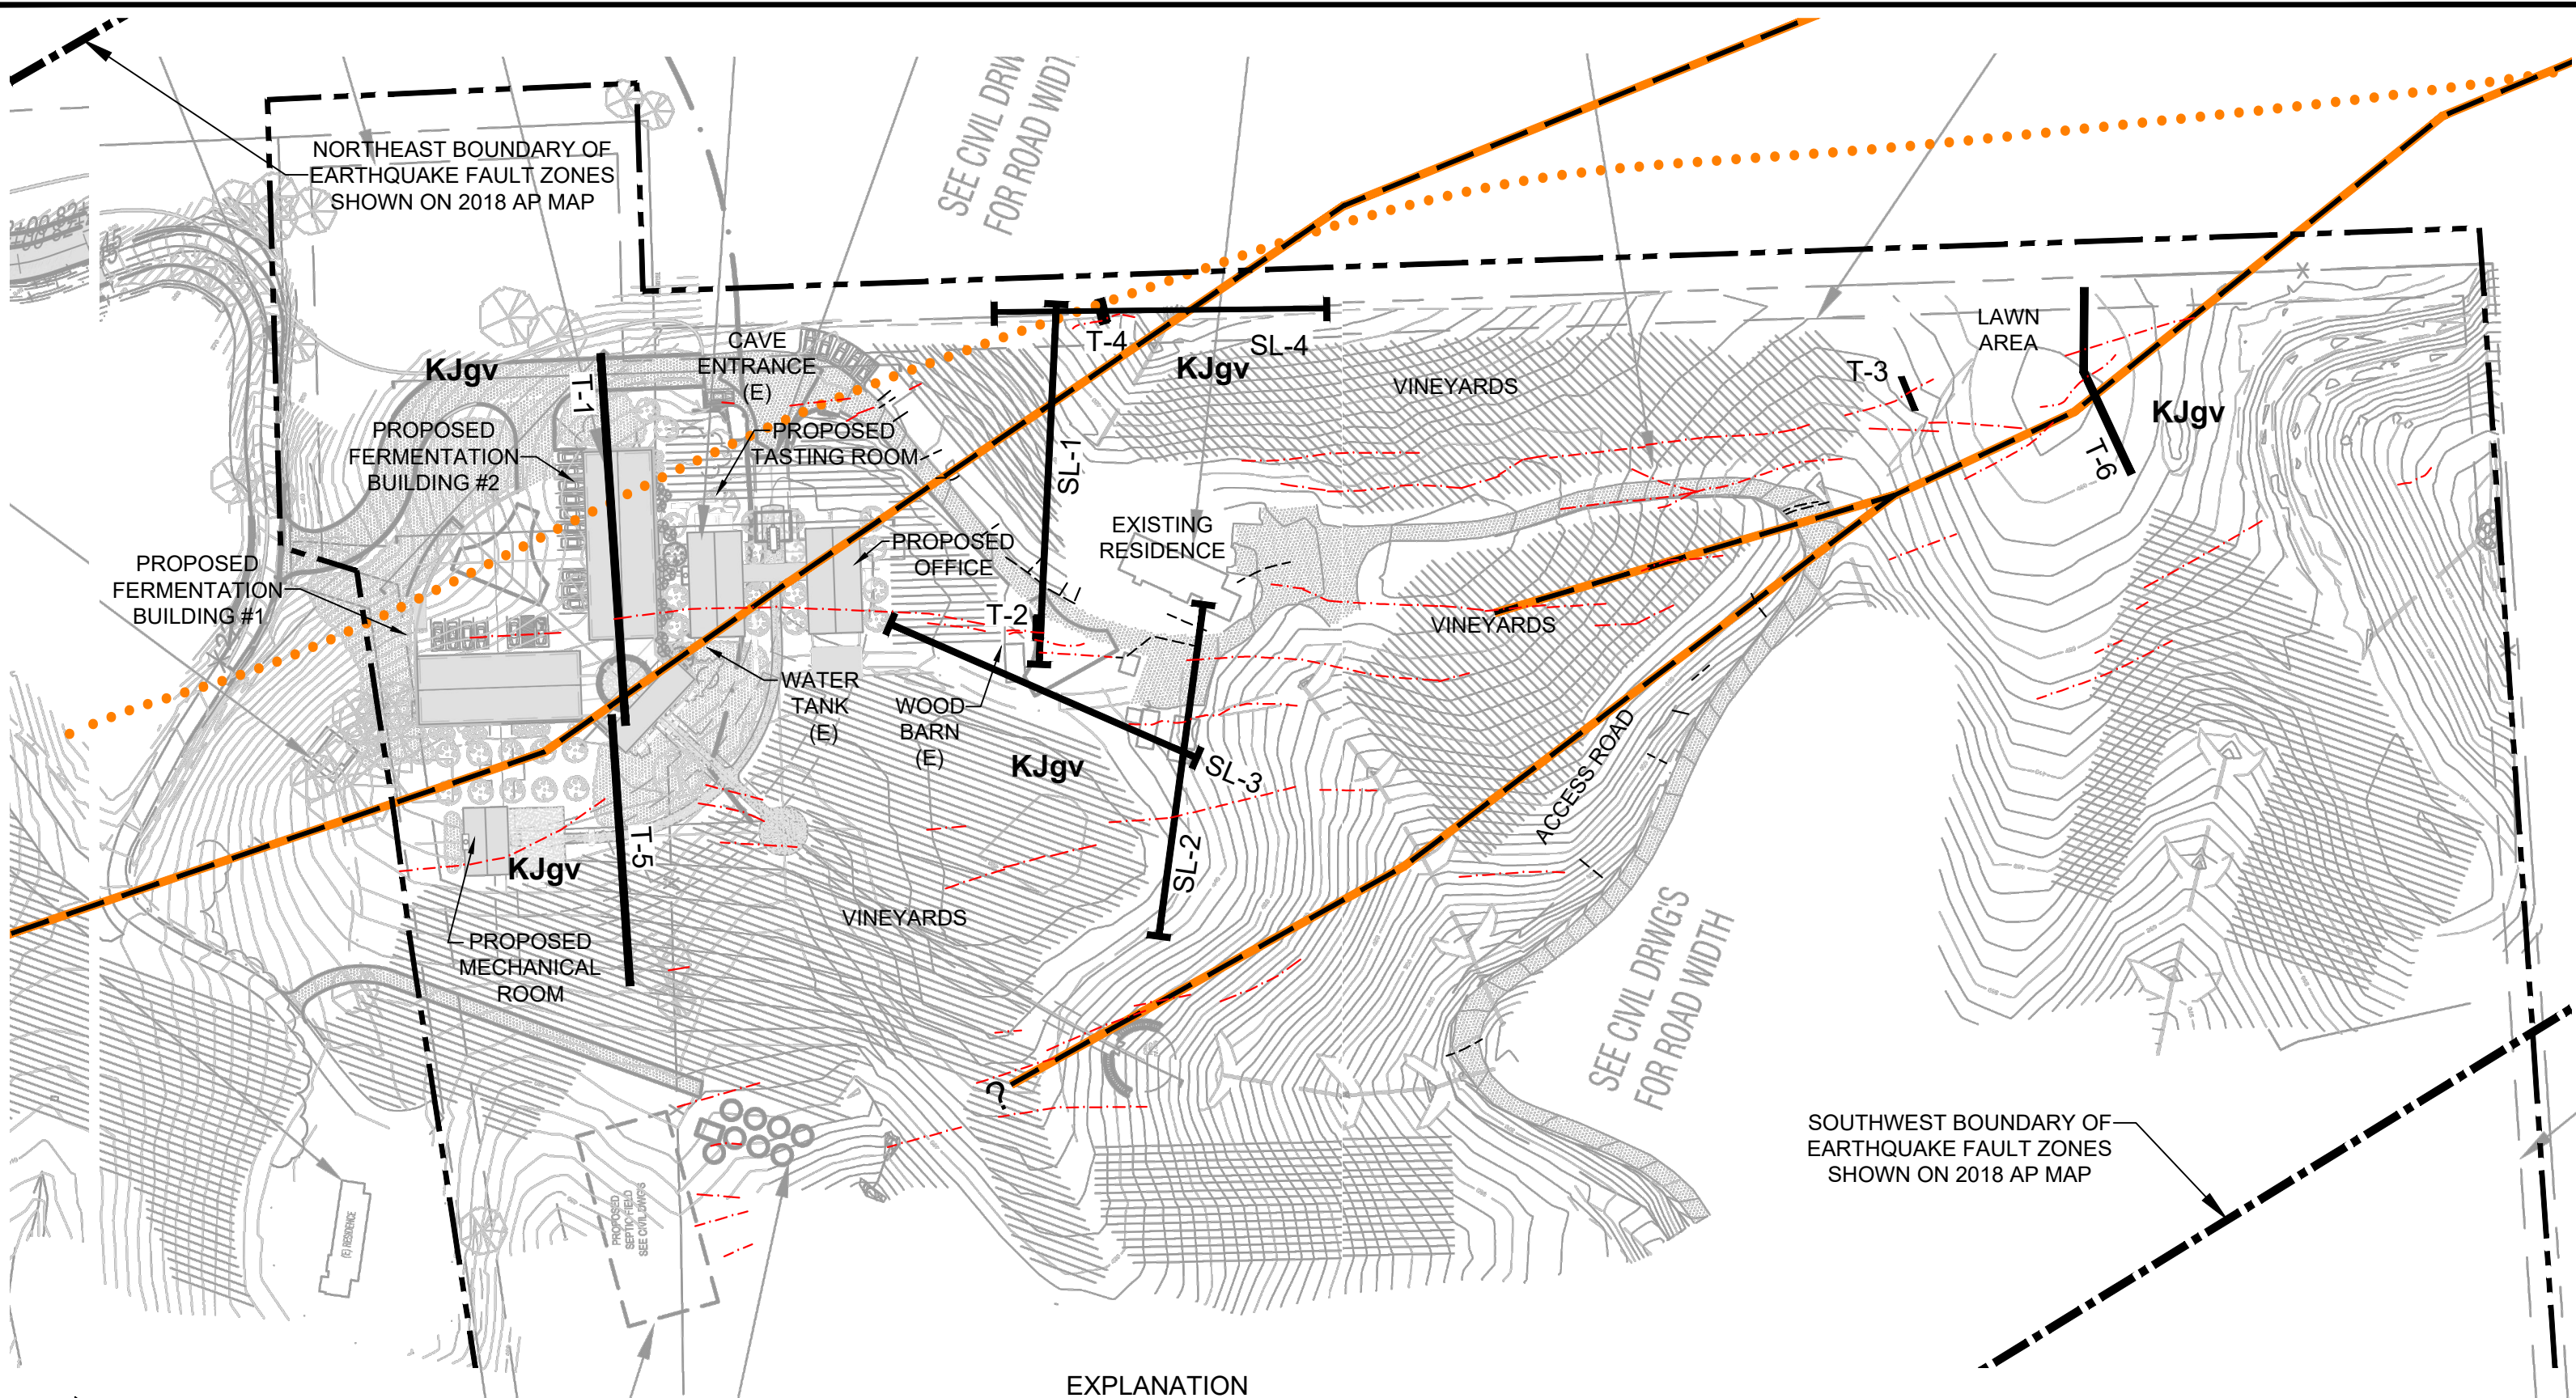
SITE PLAN		
Fault Investigation Report Anthem Winery and Vineyards, LLC 3454 Redwood Road Napa, California		
DATE: 6-30-18	Project No. 1354.100	Figure 3
RYAN GEOLOGICAL CONSULTING, INC. PROVIDING LOGICAL GEOLOGICAL SOLUTIONS

On August 24, 2014, an earthquake measuring M6.0 occurred along the West Napa Fault Zone. The event, known as the “South Napa Earthquake”, provided basis for the new A-P maps. Several sets of ground cracks were observed along the ridgelines between Dry Creek Road and Redwood Road. Some of the ground cracks were noted at the site as shown on the Site Plan, Figure 3.

Earthquake epicenters for the main event and associated aftershocks were located on the “Western Strand” defined in the EERI report. There were no epicenters plotted on the “Eastern Strand”. North of Alston Park, the eastern strand continues with the designation “*probable tectonic rupture from UAVSAR^[8] lineament, unverified by field teams*”. The inferred northern end of the eastern strand projects through the hills near the eastern site boundary. The approximate location of the unverified UAVSAR lineament projected through the property is also shown on the Site Plan, Figure 3.

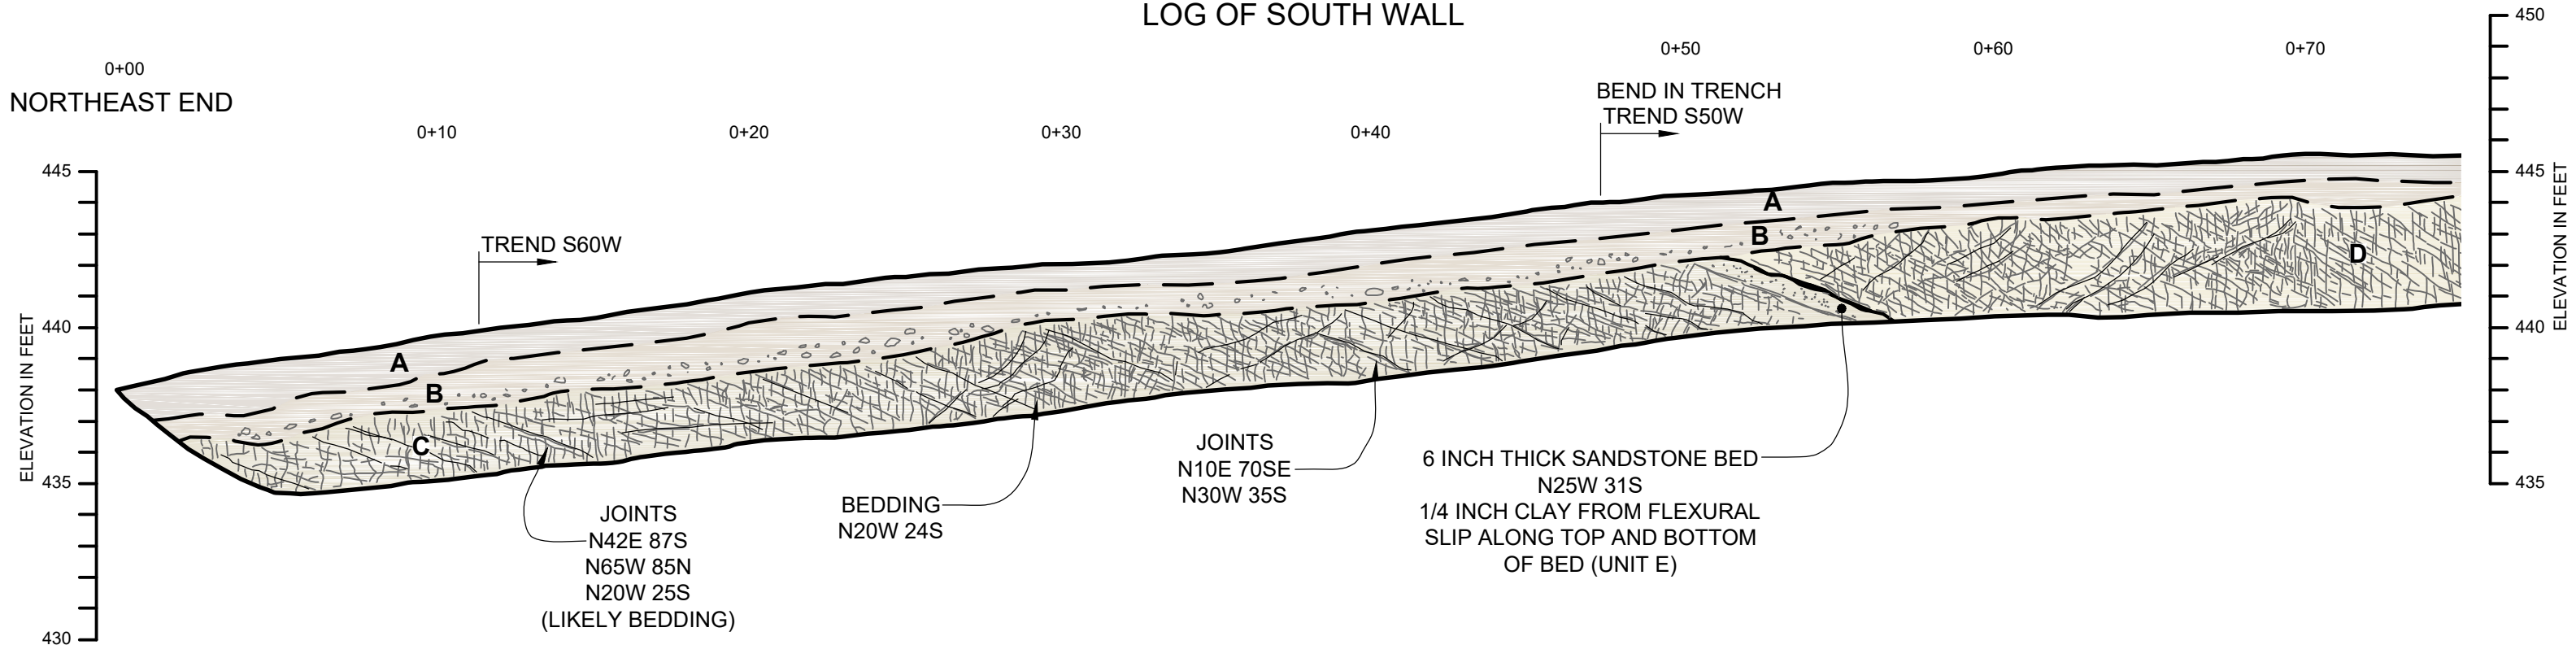
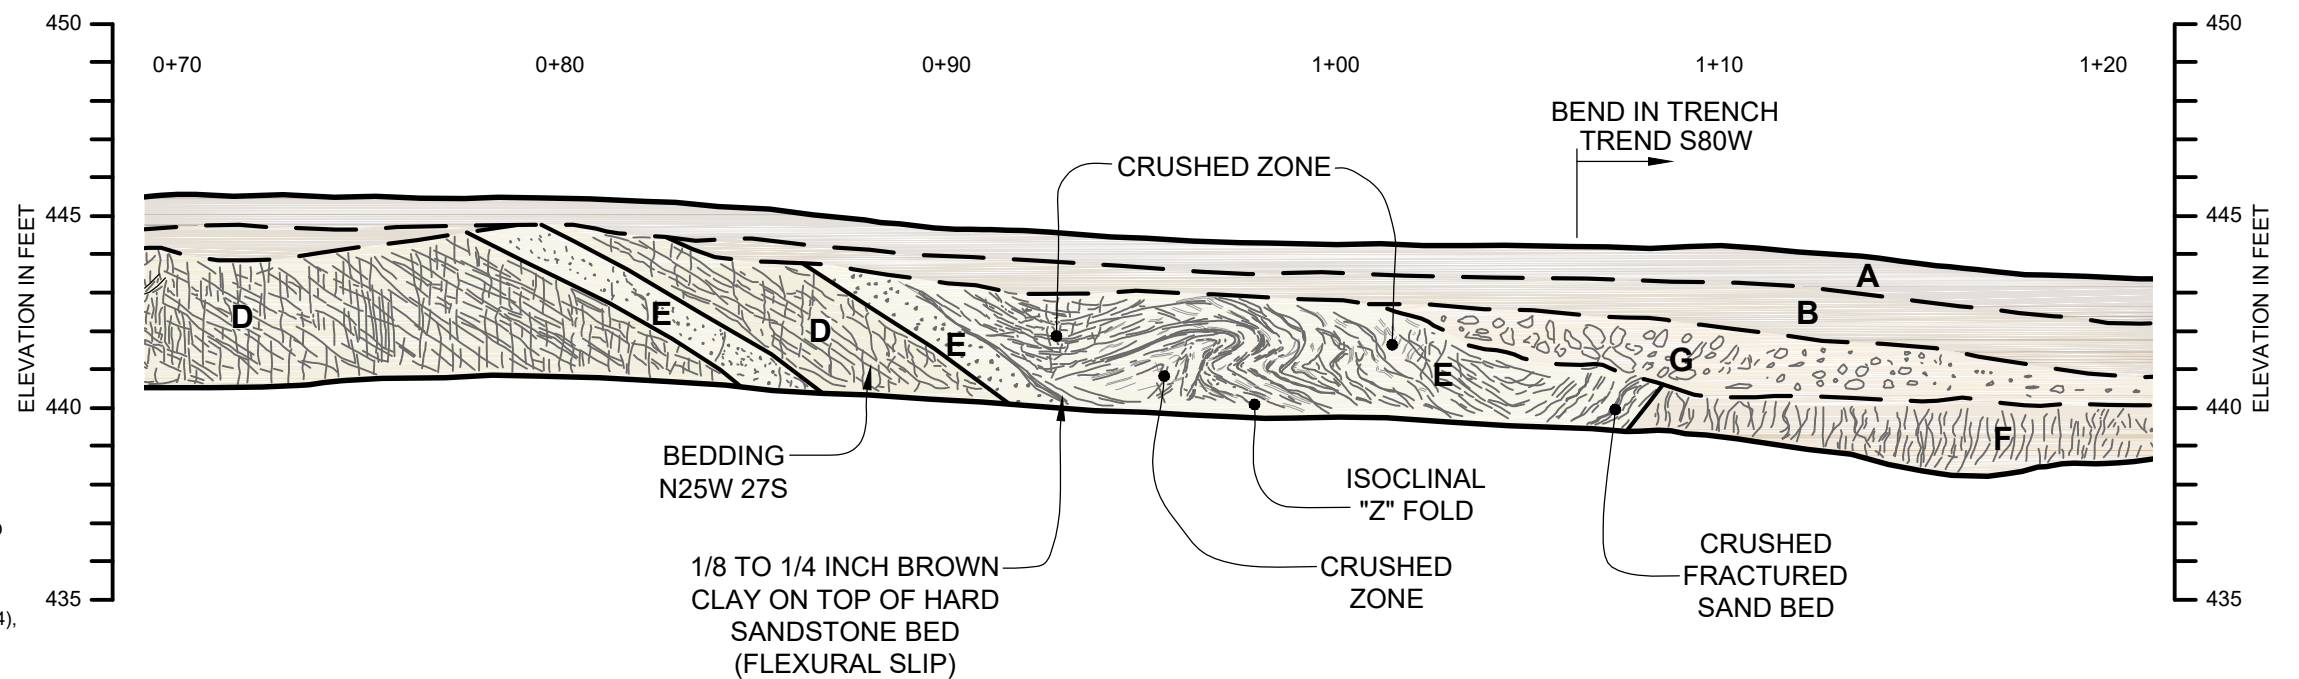
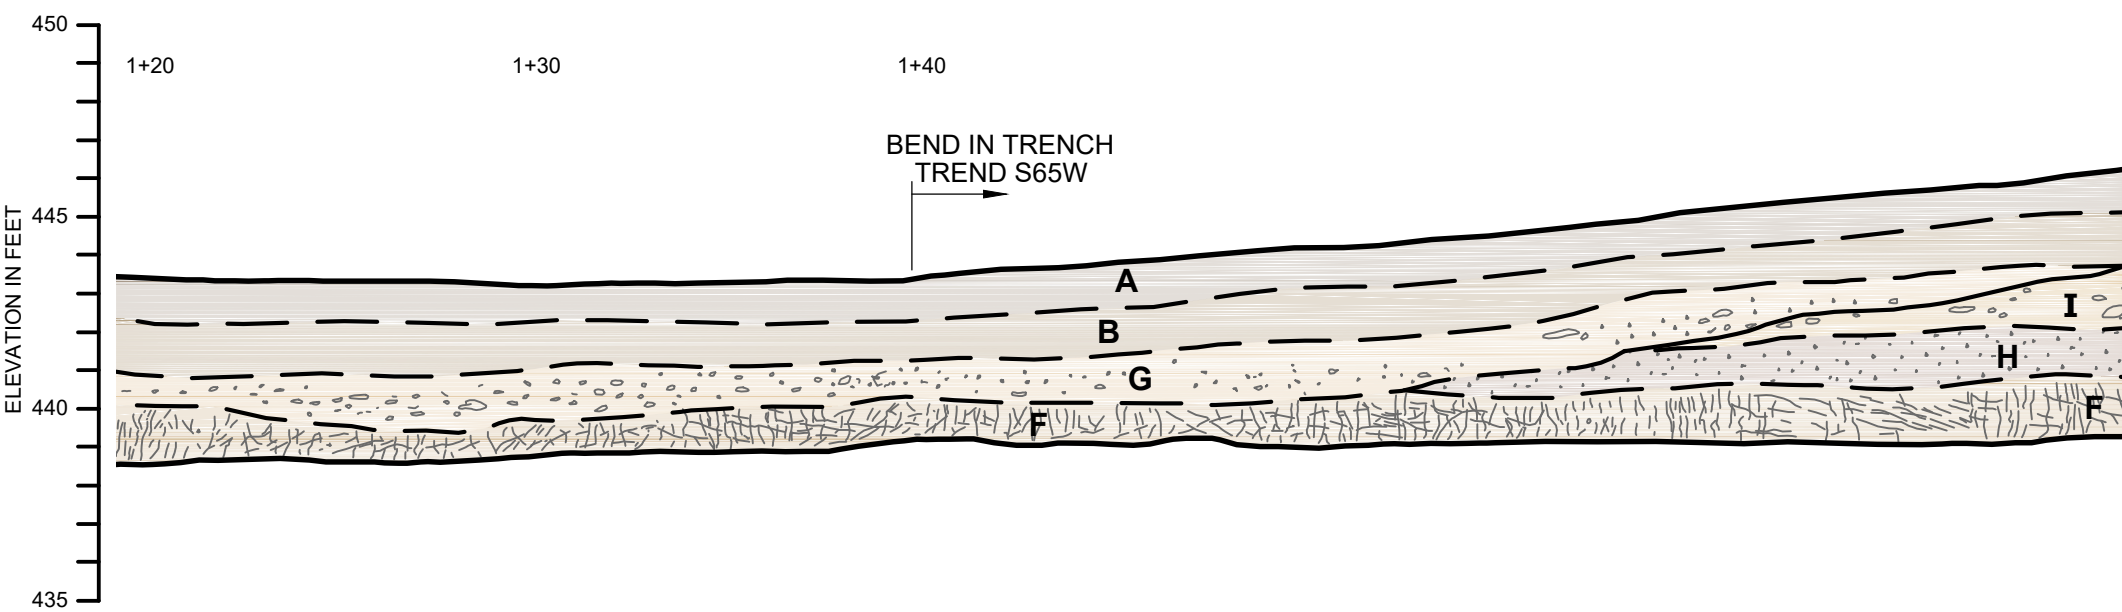
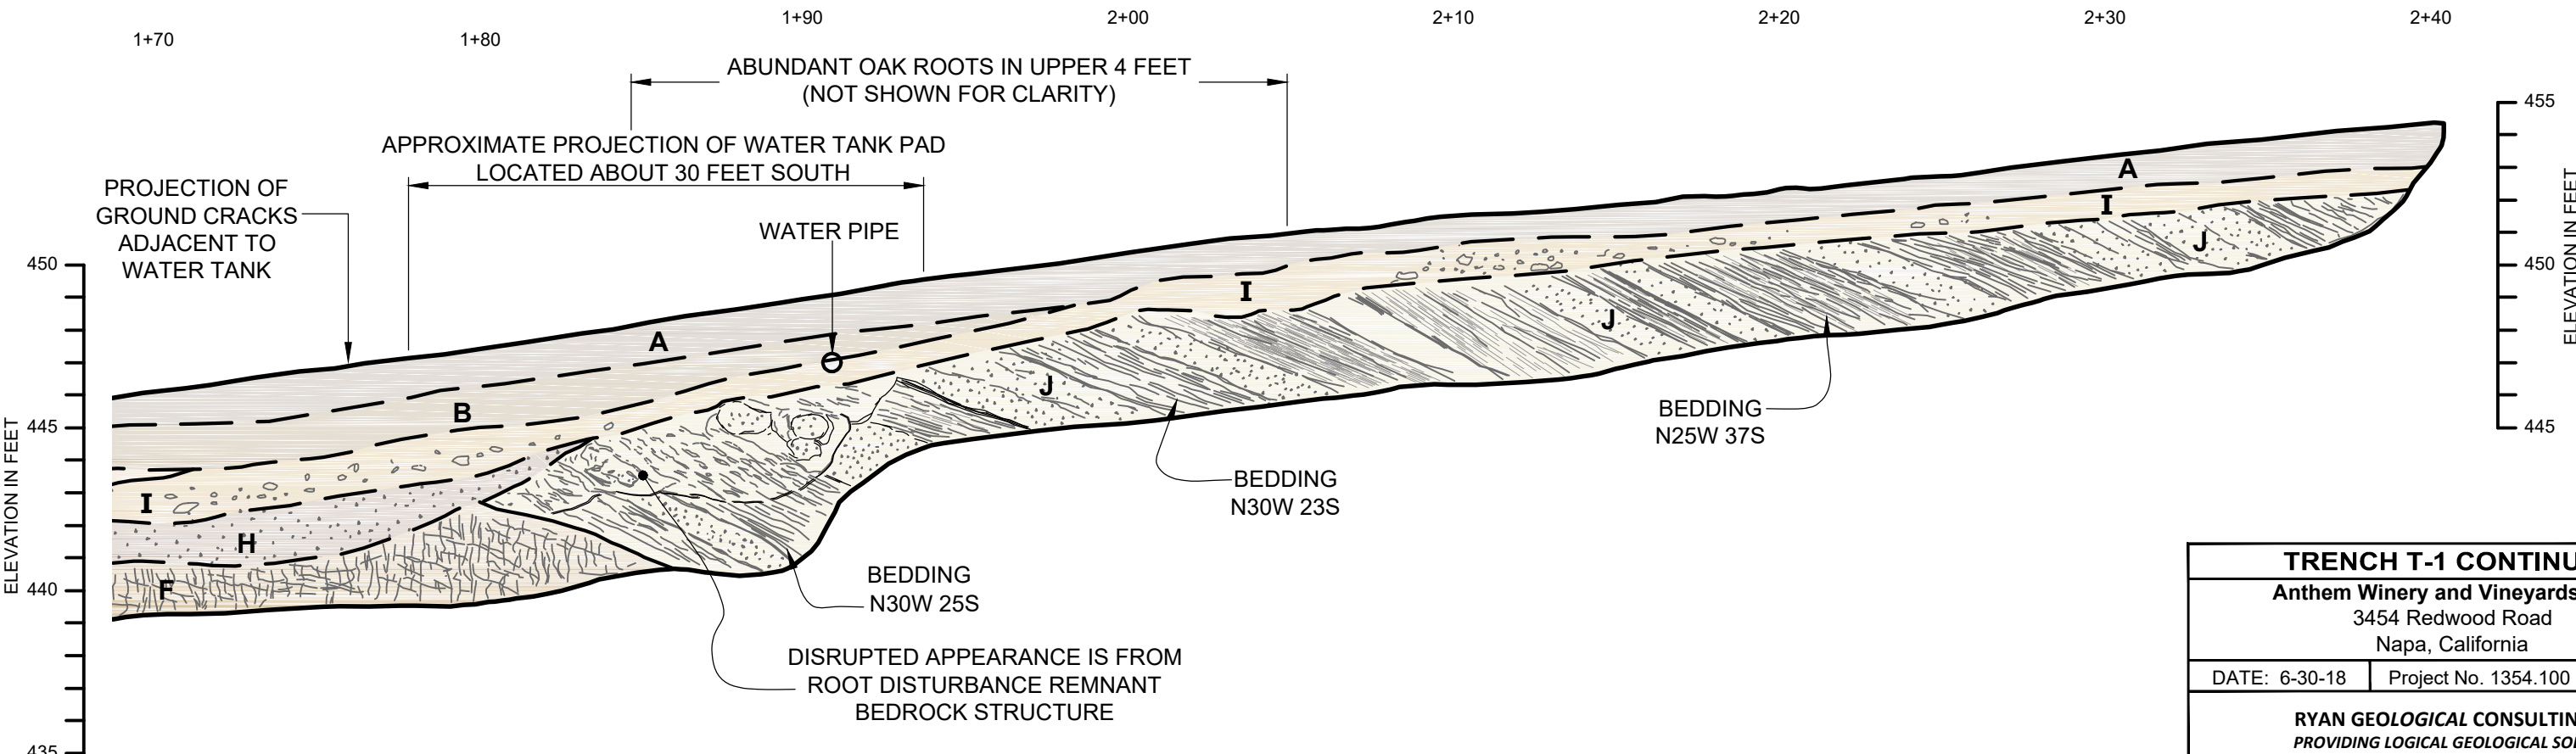
TRENCH T-1 (2014)

Trench T-1 was located in the northern portion of the site. The trench was about 240-feet-long and up to about 8-feet-deep. The trench was positioned to cross the projection of surface cracks that trend towards the proposed fermentation buildings and to shadow the buildings. The UAVSAR lineament projects through the center of the trench as shown on the Figure 3. The eastern inferred fault shown on the 2018 A-P map crosses the west end of the trench.

Minor surface cracks were noted on the north side of the water tank prior to trenching but were not detected in the trench walls during logging. We did encounter trench backfill for a waterline at station 1+90 that connects the two water tanks. The water line trench backfill coincides with the location of the crack between the water tanks that was noted prior to trenching. Below a typical soil cover of about 18- to 24-inches thick, continuously structured sedimentary bedrock units of the Great Valley Sequence were exposed for the entire length of the trench. The bedrock units were found thinly bedded oriented¹⁰ between N20W and N30W dipping to the southwest at inclinations between 23 and 37 degrees. Indications of faulting were not observed in the bedrock. Flexural slip and tight internal folding was observed at Station 0+95.

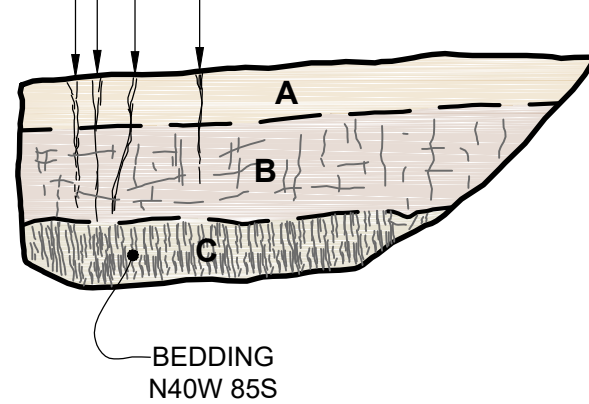
TRENCH T-2(2014) LOG OF SOUTH WALL

Trench T-2 was located across the major set of ground cracks located along the ridgeline. This set of ground cracks trend from the driveway, through the shed and water tank, and towards the western fermentation building. The trench was positioned on the south side of the shed and was excavated about 15-feet-long and 5-feet-deep. At that location, the trench crossed a set of surface cracks that were dilated up to 2-inches wide. The dilation of the cracks appeared to be somewhat exacerbated by the presence of 18-inches of artificial fill at the ground surface. All surface cracks diminished at the base of the blocky residual soils overlying claystone bedrock. Below the cracks, the claystone was near vertically bedded with a strike of N40W. Indications of faulting were not encountered.

SURFACE CRACKS FROM
AUGUST 24, 2014 MAGNITUDE
6.0 EARTHQUAKE
(UP TO 2 INCHES WIDE)

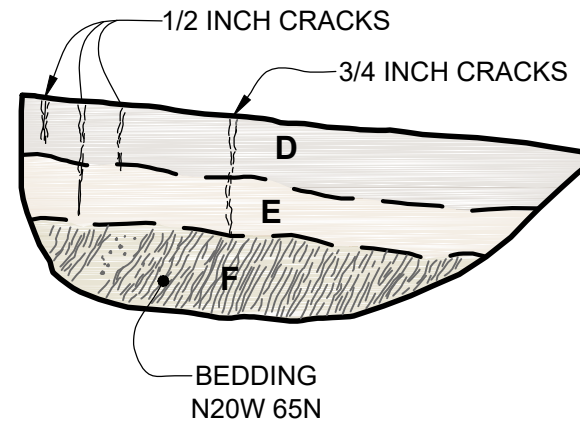
TRENCH T-3 (2014) LOG OF SOUTH WALL

Trench T-3 was located in the southern portion of the property where the major set of cracks along the ridgeline enters the property. Surface cracks between ½ and ¾ inch wide were observed extending down to near the base of the residual soils but not into the underlying steeply dipping claystone bedrock, similar to the conditions in Trench T-2. Bedrock structure was oriented striking N20W dipping 65 degrees to the north. Indications of faulting were not observed.

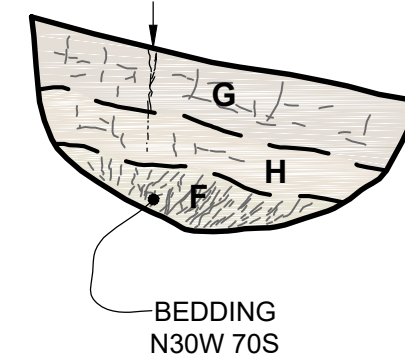
TRENCH T-4 (2014) LOG OF SOUTH WALL

Trench T-4 was located along the eastern property boundary across a surface crack that may correlate with the UAVSAR lineament. At that location the surface crack was about ½ inch wide and extended to a depth of about 1½ to 2 feet at most. The underlying claystone bedrock was found oriented striking N30W dipping 70 degrees southwest. Indications of faulting were not encountered.

1/2 INCH CRACK
EXTENDS 1-1/2 TO 2
INCHES DEEP ONLY

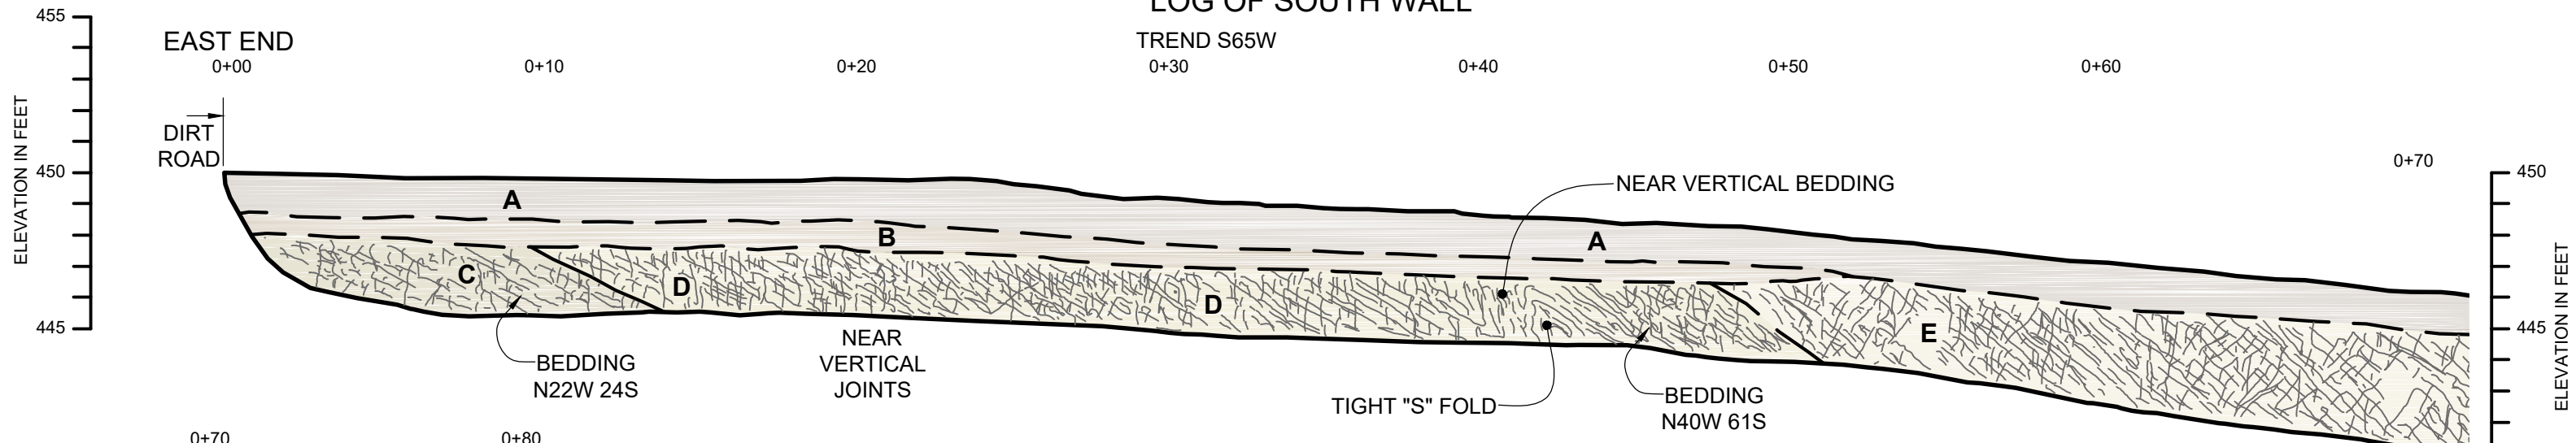
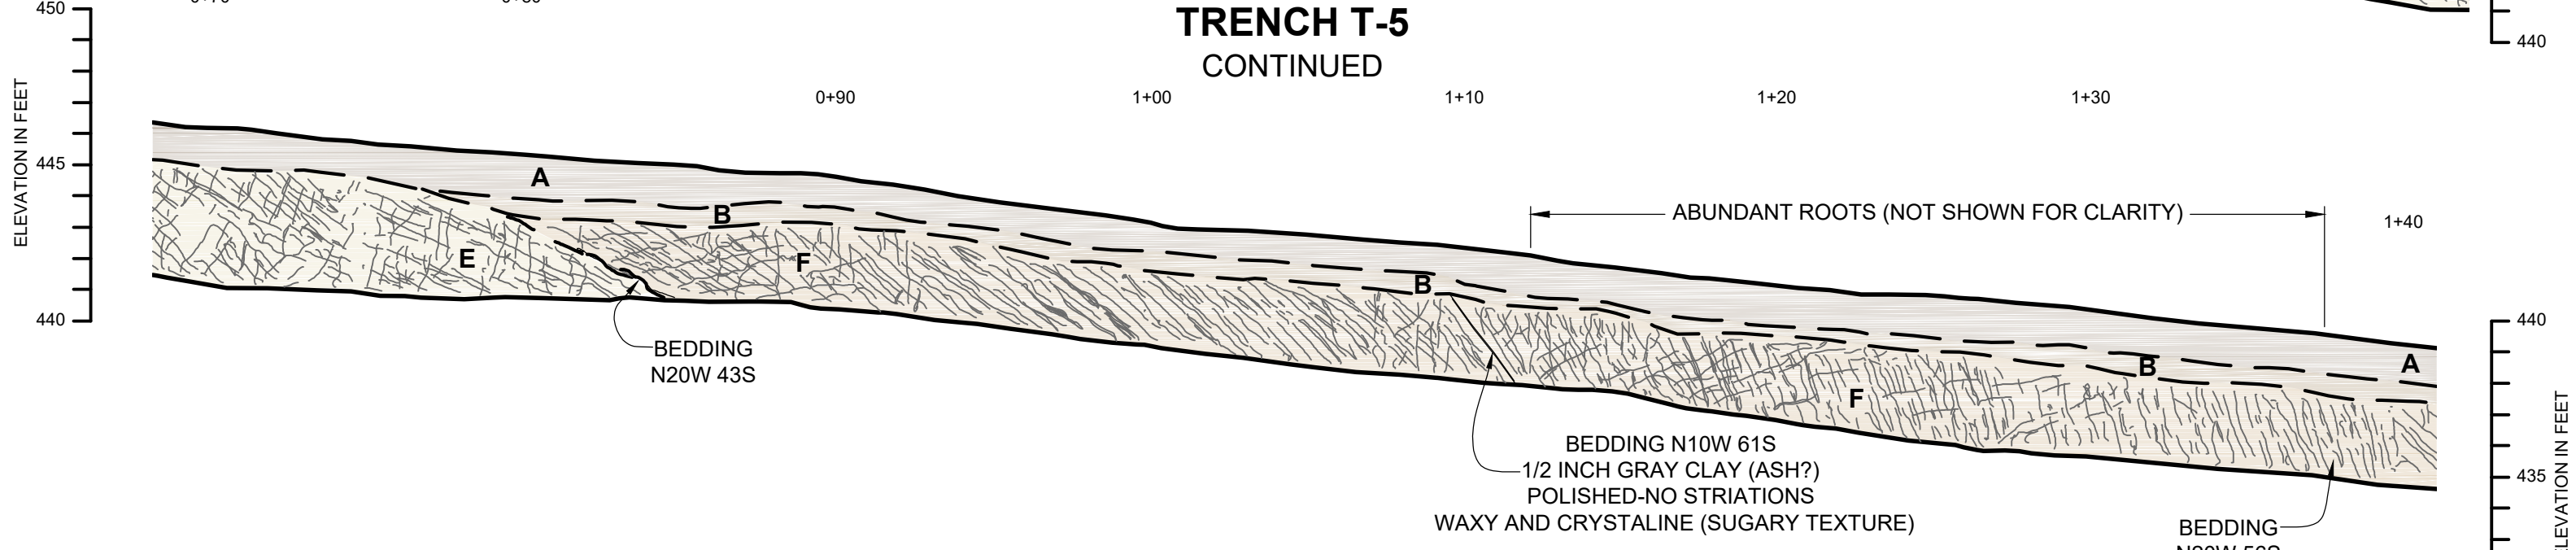
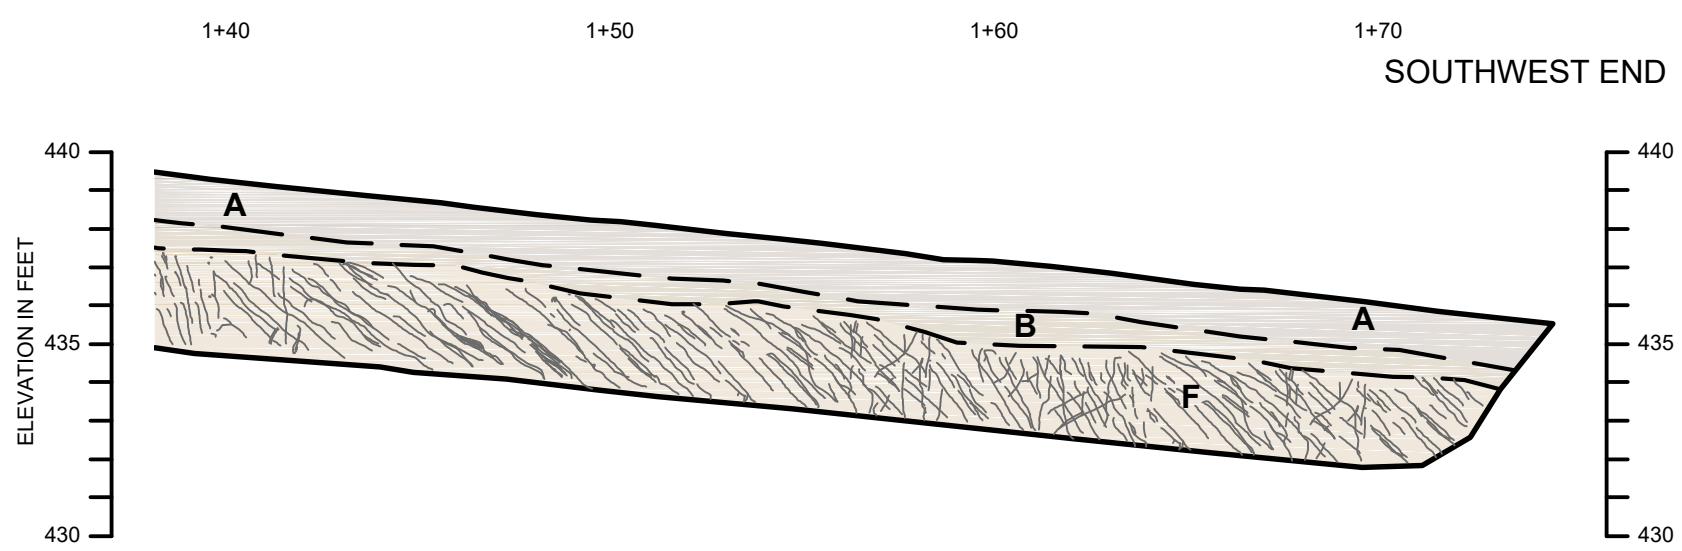
TRENCH T-5 LOG OF SOUTH WALL

Trench T-5 was excavated in the northern portion of the property to extend coverage of T-1 based on the location of the eastern inferred fault shown on the 2018 A-P map. We observed indications of our previous trench T-1 based on a small rut (settled trench backfill) in the field. The trench was about 175-

feet-long and up to about 6-feet-deep. The east end of T-5 was positioned to overlap with the west end of T-1. The findings of T-5 were generally an extension of the continuously structured bedrock encountered in T-1. Bedrock structure was oriented between about N20W and N40W with variable dips between about 25 and 61 degrees to the southwest. Ground cracks mapped in 2014 would cross the trench however they were not visible at the time of this investigation. Indications of faulting were not encountered.

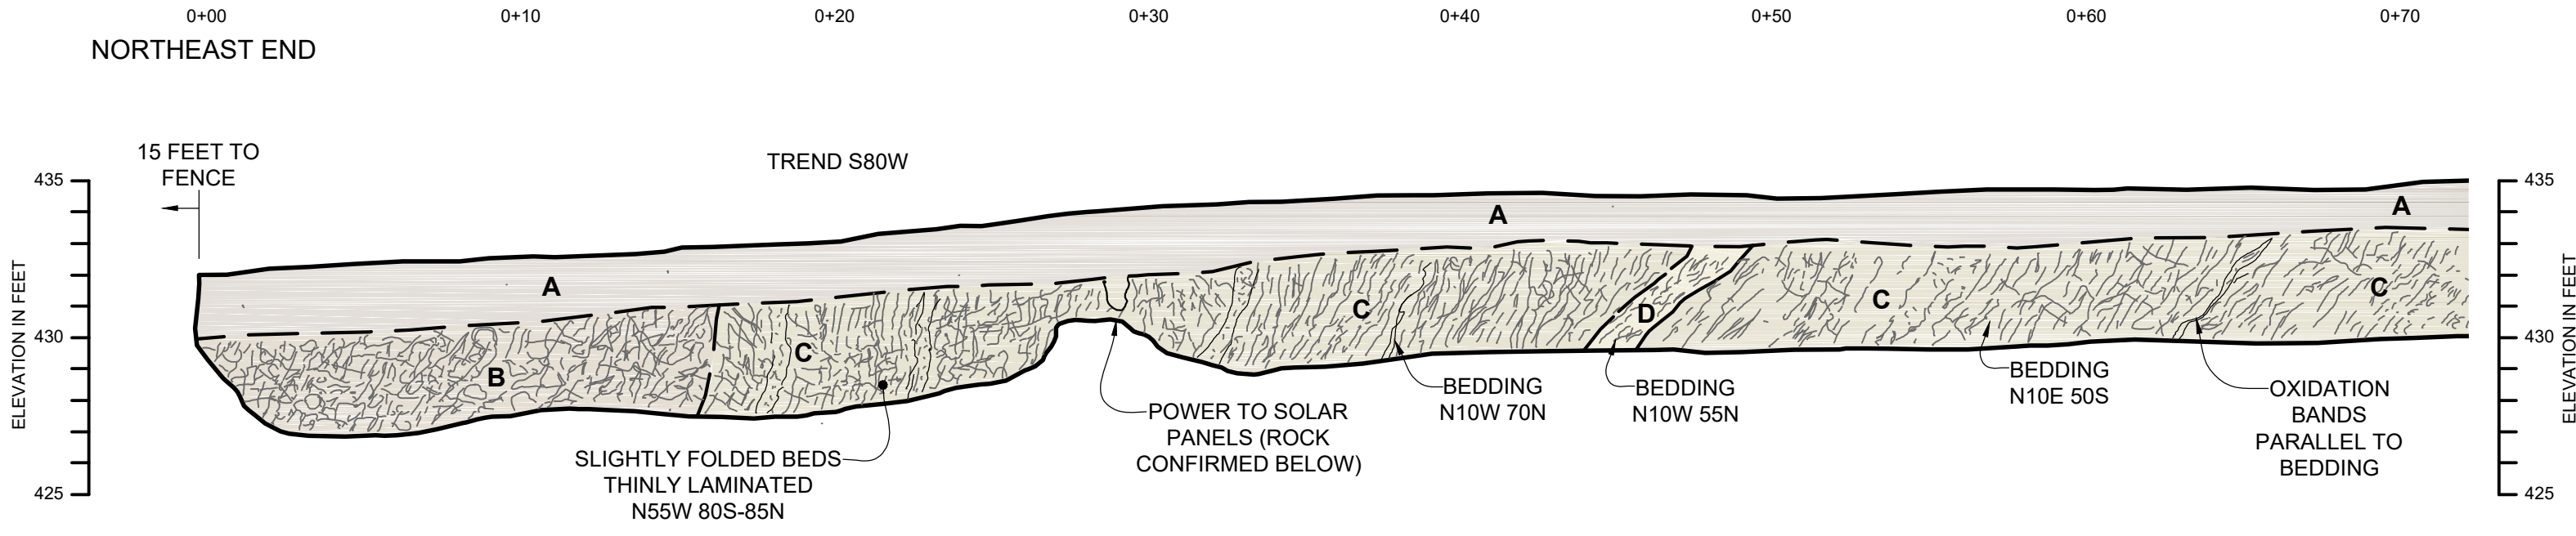
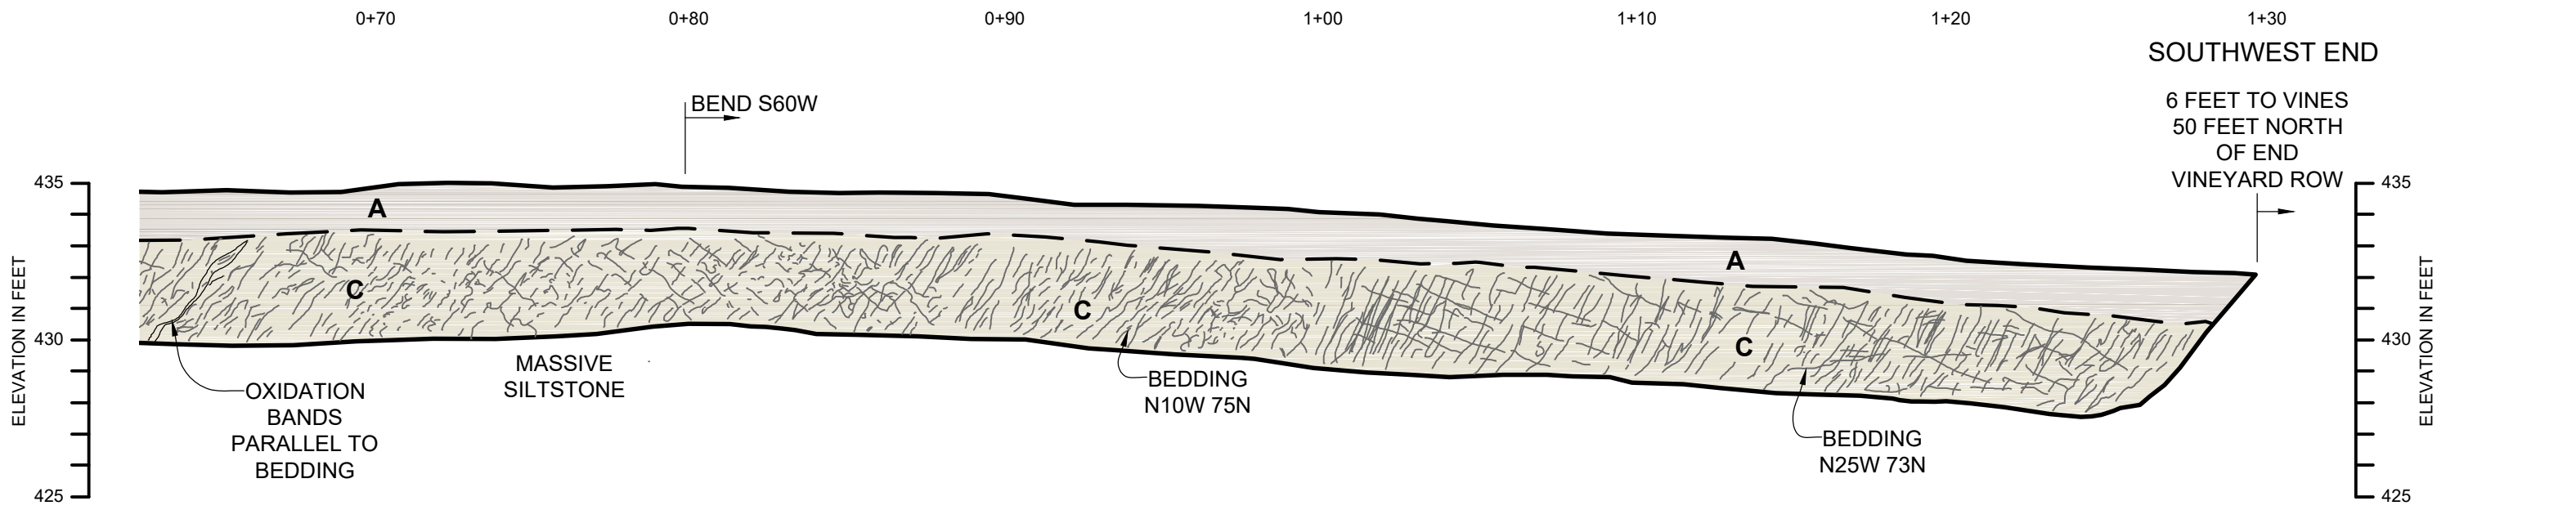
TRENCH T-6

Trench T-6 was excavated in the southern portion of the property near the lawn area. The trench was about 130-feet-long and up to about 6-feet-deep. The trench was positioned to cross the western inferred fault shown on the 2018 A-P map. Additionally, ground cracks mapped in 2014 would cross the trench however they were not visible at the time of this investigation. Bedrock structure was oriented between about N10W and N55W with variable dips between about 50 and 70 degrees to the northeast. Subtle folding was observed. Indications of faulting were not encountered.
