# CALIFORNIA REGIONAL WATER QUALITY CONTROL BOARD SAN FRANCISCO BAY REGION

## CLEANUP AND ABATEMENT ORDER NO. R2-2019-0014

### CLOVER FLAT LANDFILL CLASS III SOLID WASTE DISPOSAL FACILITY CALISTOGA, NAPA COUNTY

Photo Log from March 26, 2019

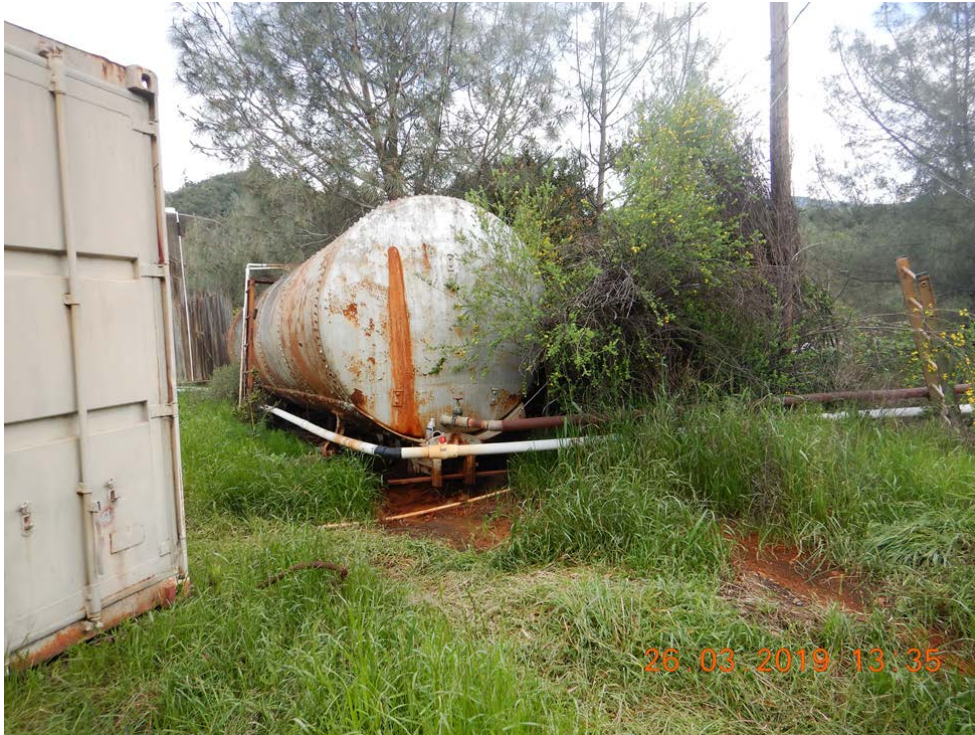
The metal condensate tank is in a similar state of disrepair, with severe rusting around the base of the tank and the surrounding soil, indicating leakage of condensate is ongoing. All tanks are required to have dual containment, adequate storage volume, and an alarm or notification system when the tanks are full. The leachate pump at LEW-2 is also severely rusted and does not work as intended. The water-truck filling station that is connected to the metal tank continuously leaks and needs a shutoff valve installed when trucks are done filling. A concrete pad, with a catchment basin below,

Photo 521- rust staining and leakage from the leachate condensate tank, looking northeast.

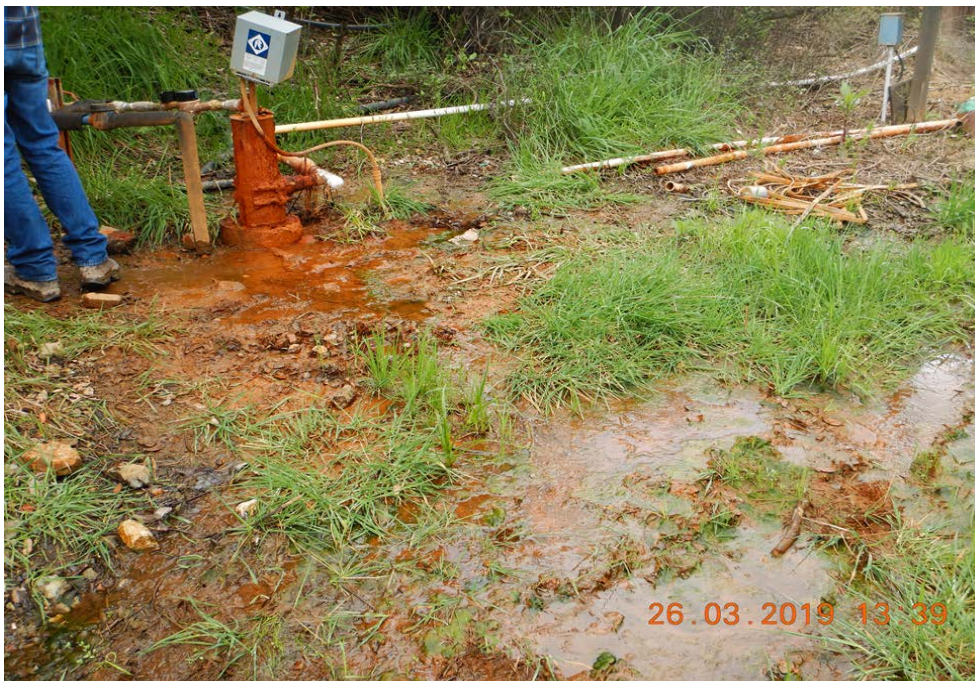
Water Board staff were also informed during the inspection that the leachate pump located near the toe of the landfill (LEW-2; see Figure 12) had been spraying leachate onto the ground instead of pumping it up to the three concrete holding tanks as intended. The location of the leachate pump is approximately 150 feet from the creek, and Water Board staff observed ponded leachate flowing into the creek from LEW-2 (see photo number 535 in the attached photo log), which was in severe disrepair and completely rusted. During the time that the three concrete leachate tanks were full (approximately two weeks), leachate was being routed into the metal condensate storage tank and mixed with landfill gas condensate. This mixture of leachate and condensate was being used as dust control at the landfill as recently as Monday, March 25, 2019 (despite the fact that a significant amount of rain, 0.65 inches, fell in Calistoga on that day, according to records of the National Weather Service).

Photo 535- ponded leachate around the rusted LEW2 wellhead, looking northwest.

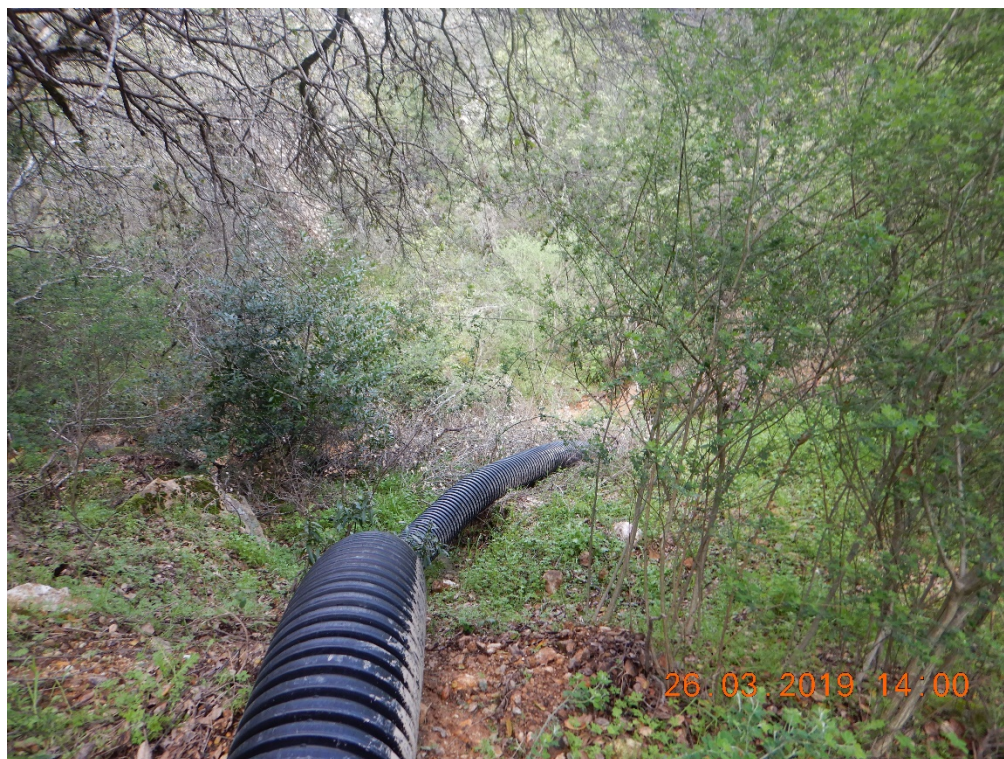
Water Board staff observed ponded leachate and stormwater on the landfill bench between covered waste slopes, as well as a new pipeline that ran from the active area of the landfill directly into the creek (see photo number 575 in the attached photo log). The landfill's personnel informed staff that this pipe was transporting stormwater from the active disposal area directly to the creek to prevent additional erosion on the hillside (see photo number 615 in attached photo log). Upon inspection of the active waste disposal area, staff observed the leachate seeps mixing with stormwater and flowing into drop inlets (see photo number 684 in attached photo log). The drop inlets collected leachate and stormwater runoff and transported it into the pipe running down the hillside and into the creek.

Photo 575- pipeline from the landfill into the creek, looking east.

- a. The pipeline that was draining the leachate and stormwater mixture from the active disposal area had been removed from the creek. The drop inlet that was collecting this water was blocked, and a sump was installed to capture the mixture and route it to a temporary storage tank.
- b. The black oily water that was observed around the LCS area was being partially captured by a sump and routed to the leachate tanks. This sump was not entirely effective at keeping this black oily water from entering the creek, as it was

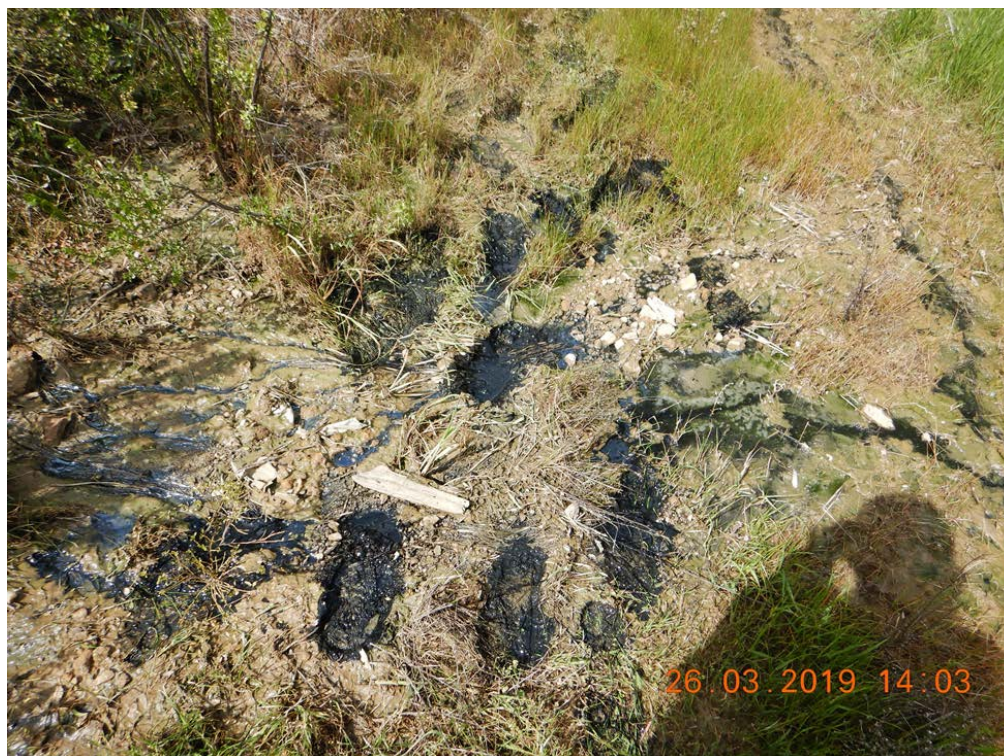
Water Board staff also observed severe erosion and rilling on the bench/access road leading to the leachate pump, as well as black oily water actively running down the hill into the creek from the lower leachate collection system (LCS) (see photo number 589 in the attached photo log, as well as Figure 12 for the locations of the leachate pumps.)

- a. *“Visible, floating, suspended, or deposited oil or other products of petroleum origin.”* The black oily substance that we observed in the pooled water on the banks of the creek had a distinct petroleum sheen.

Photo 589- black, oily-looking material flowing toward the creek, looking northeast.

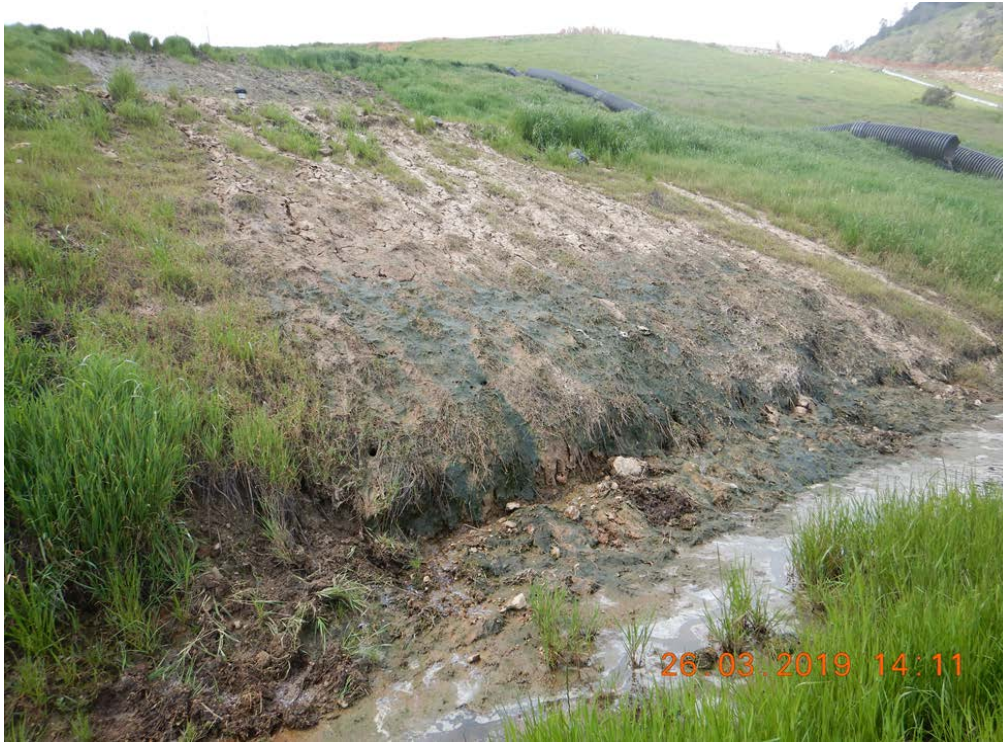
Photo 615- erosion from stormwater and leachate overflow, leachate ponding on the bench, looking northwest.

A work plan, acceptable to the Executive Officer, shall be submitted to propose repair and replacement of the final cap on the side slopes of Modules 1 and 2B, where severe erosion from stormwater and leachate runoff and seepage is evident and ongoing. The work plan shall also propose trenching to determine the thickness of the cap and the location of refuse on the lower southeast portion of Module 1. It is unclear where the limit of waste mass is in this Module, and if the original final cap has been compromised by the dense foliage growing in this area.

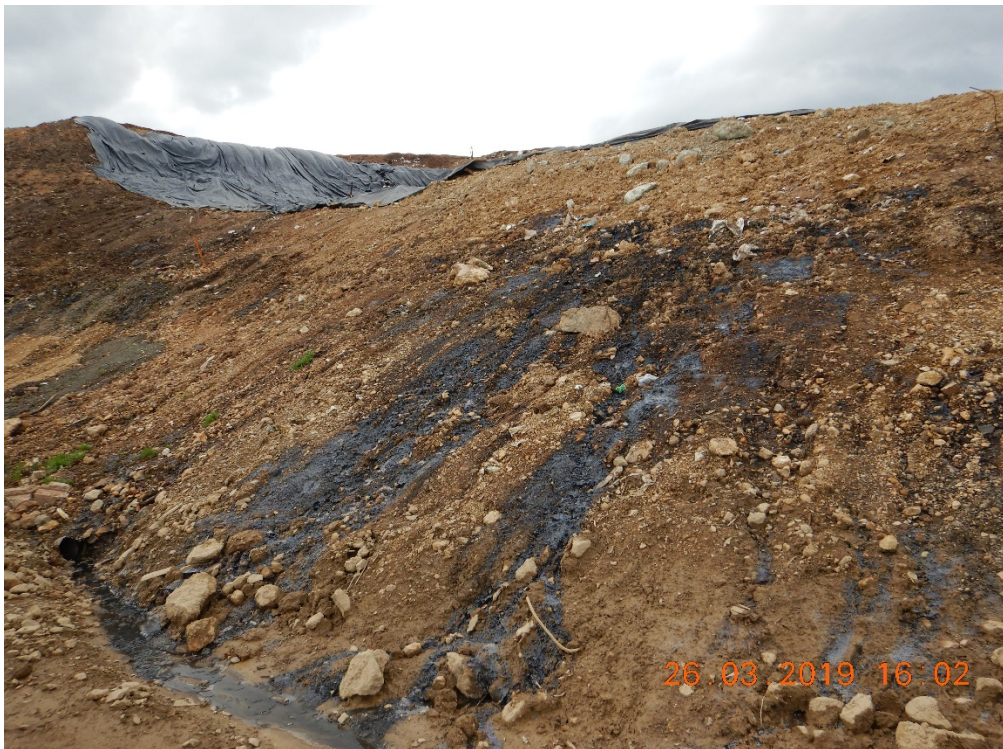
Photo 684- active leachate seeps draining into the drop inlet, looking northwest

The Dischargers shall immediately implement corrective actions to terminate leachate seeps and to prevent additional commingling of leachate with stormwater. The Dischargers shall perform all necessary maintenance to ensure that leachate is properly conveyed to the leachate collection and recovery system, does not leave containment areas, and does not pond within the base of Module 5.
