66-inch Trunk Sewer

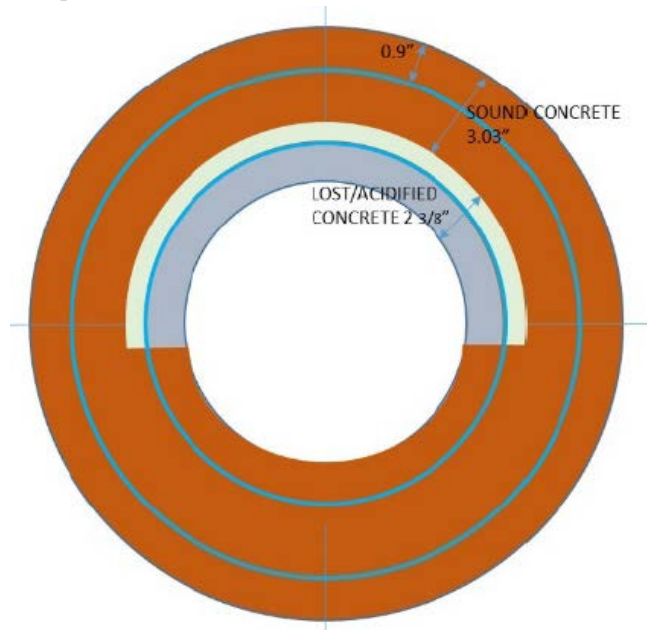
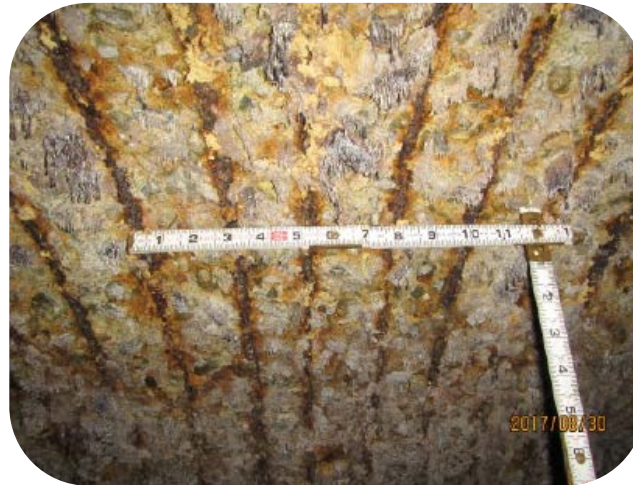
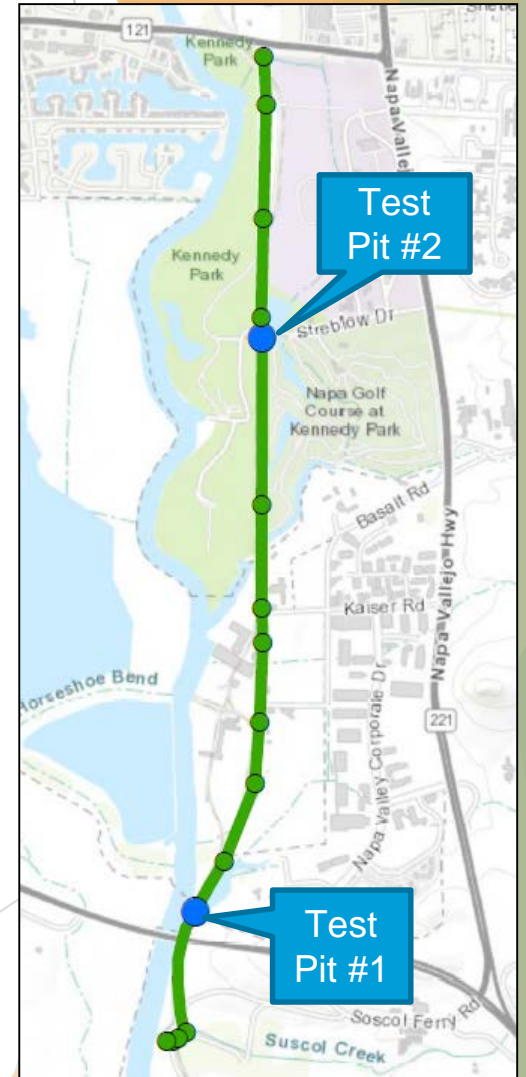
2017 Condition Assessment

- ▶ Pipe interior has advanced deterioration
 - ▶ Concrete wall loss
 - ▶ Exposed rebar
- ▶ Pipe exterior is structurally sound

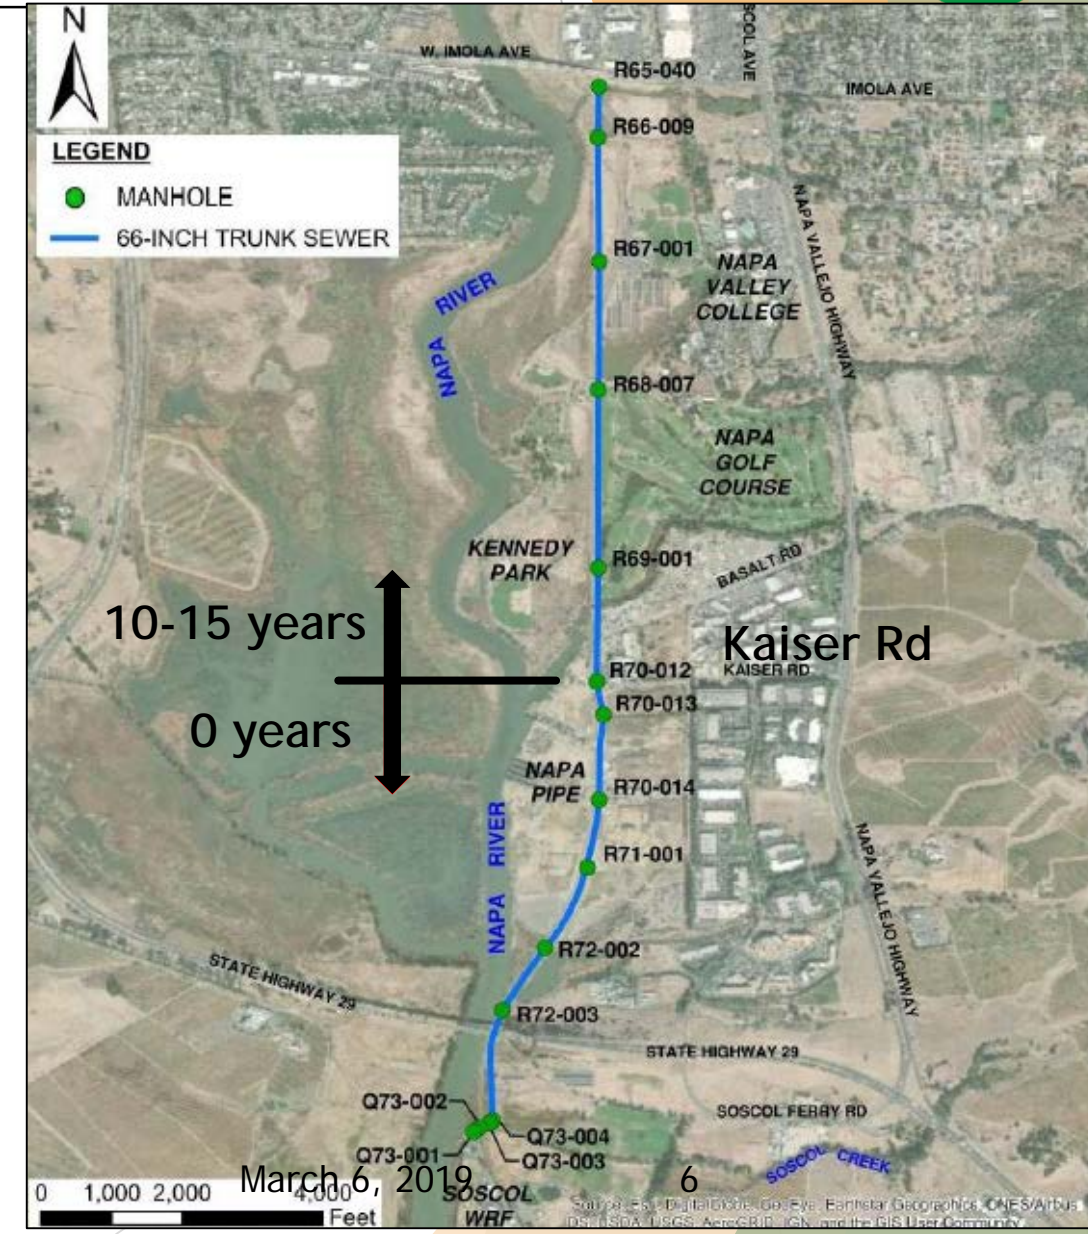
2018 Condition Assessment

- ▶ Pipe from Imola to Kaiser Road is deteriorated (about 10-15 years remaining life)
- ▶ Pipe from Kaiser Road to IPS is severely deteriorated (needs to be scheduled for repair ASAP)

- ▶ Complete the CSMP
- ▶ Rehabilitate the 66-inch trunk with CIPP
 - ▶ Downstream portion in 2021 (Kaiser to treatment plant)
 - ▶ Upstream portion in about 10 years (Imola to Kaiser)
 - ▶ Budget for this scenario in the 10-year CIP
- ▶ Staff recommends including the 66" trunk in the strategic plan due to its criticality and budget impact
