RE: Preliminary Geotechnical Investigation  
Fisher Tentative Parcel Map  
APN's 050-010-24,30,31  
Napa, California

Project Number: 5514.01.01.2

PRELIMINARY GEOTECHNICAL STUDY

FISHER PARCEL SPLIT - II  
APN'S 050-010-24, -30 AND -31  
2435 PARTRICK ROAD  
NAPA, CALIFORNIA

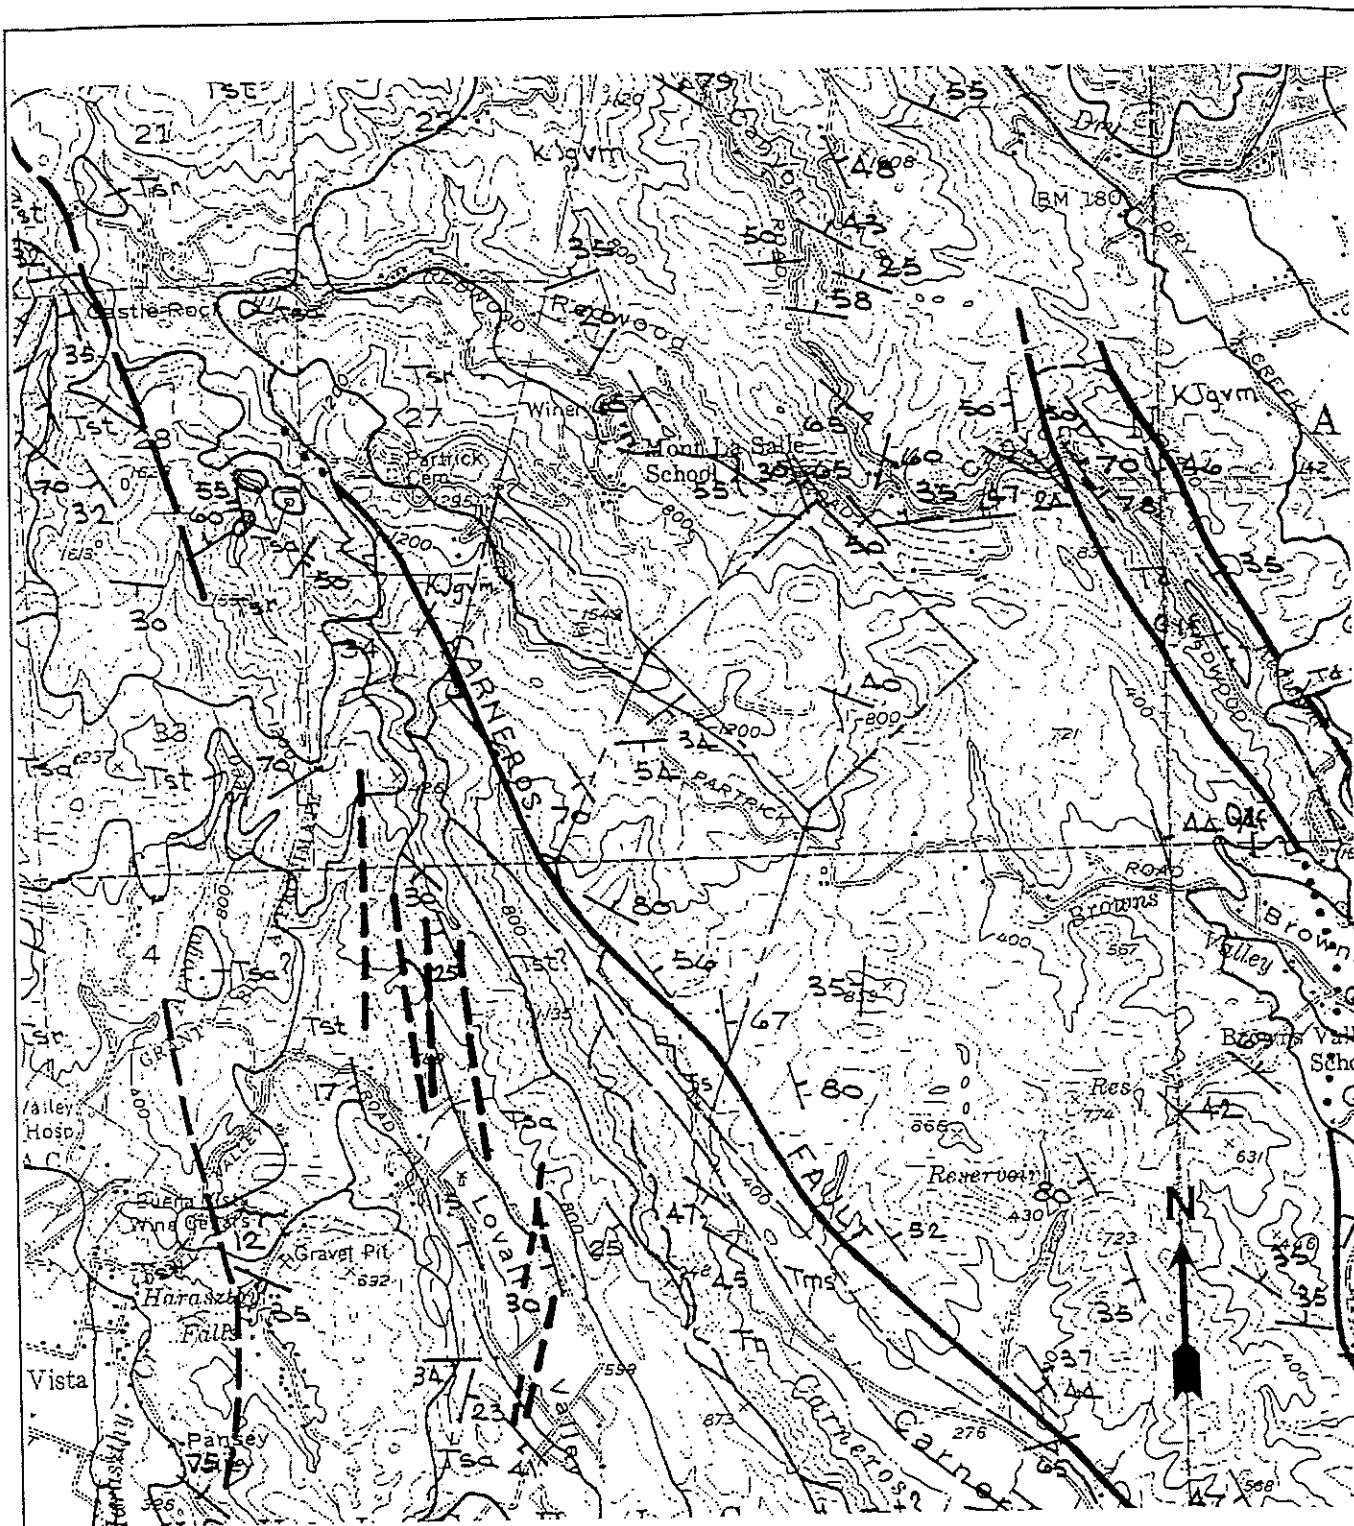
GEOLOGIC MAP

The U.S. Geological Survey maps reviewed, Fox et al. (1973), indicate that, in general, the north and northeastern portions of the property are underlain by predominantly late Miocene-early Pliocene Sonoma Volcanics rhyolite bedrock. Sedimentary rocks of the Jurassic-Cretaceous Great Valley Sequence underlie the southwestern through southeastern and far northeastern portions of the property. The sediments generally comprise mudstone, siltstone and minor thin-bedded sandstone. The Great Valley sediments comprise the majority of slide-prone materials on the property.

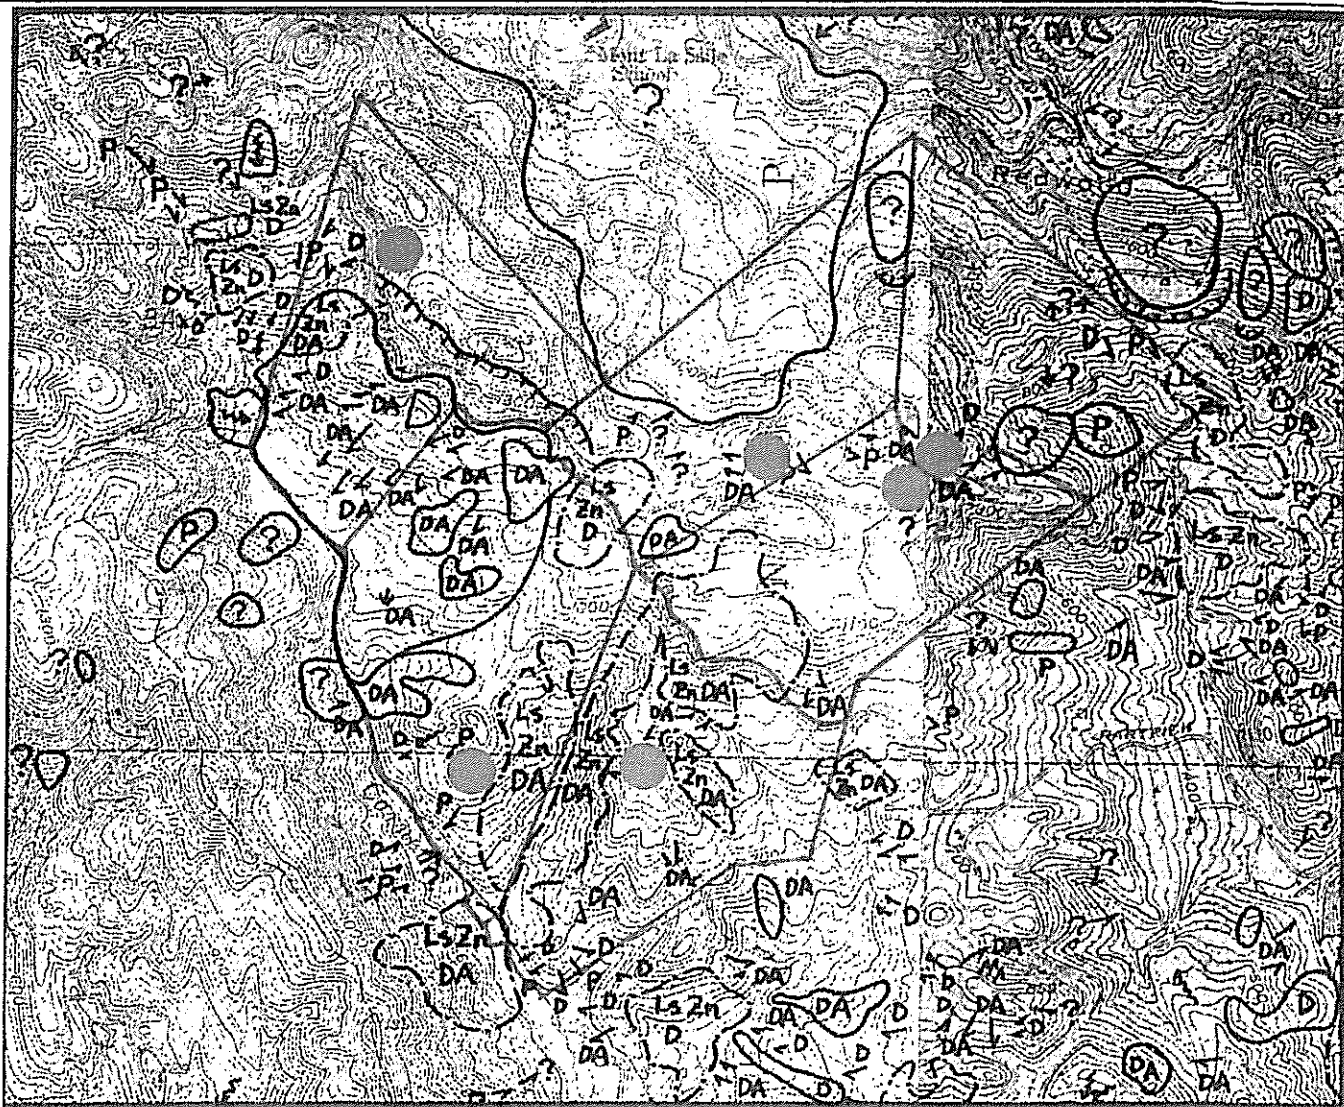
The subject property is underlain by relatively stable-appearing terrain flanked by numerous and abundant landslides and landslide zones of varying size, complexity and activity. Proposed building envelopes relative to mapped landslides are shown on Plate 4. The building envelopes are generally situated on less sloping portions of the property such as knolltops, ridges and saddle areas. The terrain within the proposed building envelopes is generally sloping at gradients of 5:1 and flatter with locally steeper areas.

In general, the portions of the property on the southwesterly side of Partrick Road are underlain by very large landslide complexes. Younger active landslides are visible on the surface of the larger slides and interspersed around the property. On the northeastern side of Partrick Road, the landslides are smaller except for two larger landslides: one is on the southwestern portion of Parcel 2 that extends across Partrick Road and onto Parcel 6; and the other on the northwestern side of Parcel 1 that extends under Mont La Salle School.

The surface soils on the sloping portions of the property are undergoing erosion, sloughing and a gradual downhill movement commonly known as creep. Soil creep is typically manifested by hummocky and irregular topography and downhill-leaning trees at their bases. Soil creep is inherent to hillsides in the area and its force is directly proportional to slope inclination, the soils plasticity, water content and expansion potential.

Area of suspected soil creep; the shallow and gradual downhill movement of soil and loose rock material. Undulating arrows indicate general direction of creep and are centered over the location of creep area

Severe ground shaking could induce new slope failures or renewed landslide activity. Therefore, setbacks from steep slopes and landslides should be established and strictly adhered to. The project structural designer will need to consider seismic shaking forces in the design of structural elements for the future residences. We judge the likelihood of earthquake induced hazards, such as liquefaction and densification within the preselected building areas, is low given the presence of bedrock and absence of loosely consolidated liquefiable sediments.

settlement causes cracks in slabs and structural distress in the form of cracked plaster, and sticky doors and windows. Therefore, it will be necessary to obtain fill and foundation support below the creeping soils. In sloping areas underlain by creep-prone soils that are not remediated by grading, the foundations should be designed to resist stresses imposed by the creeping soils.
