PRELIMINARY GEOTECHNICAL STUDY REPORT

PALISADES WINERY
CALISTOGA, CALIFORNIA

6439.01.01.2

December 29, 2008

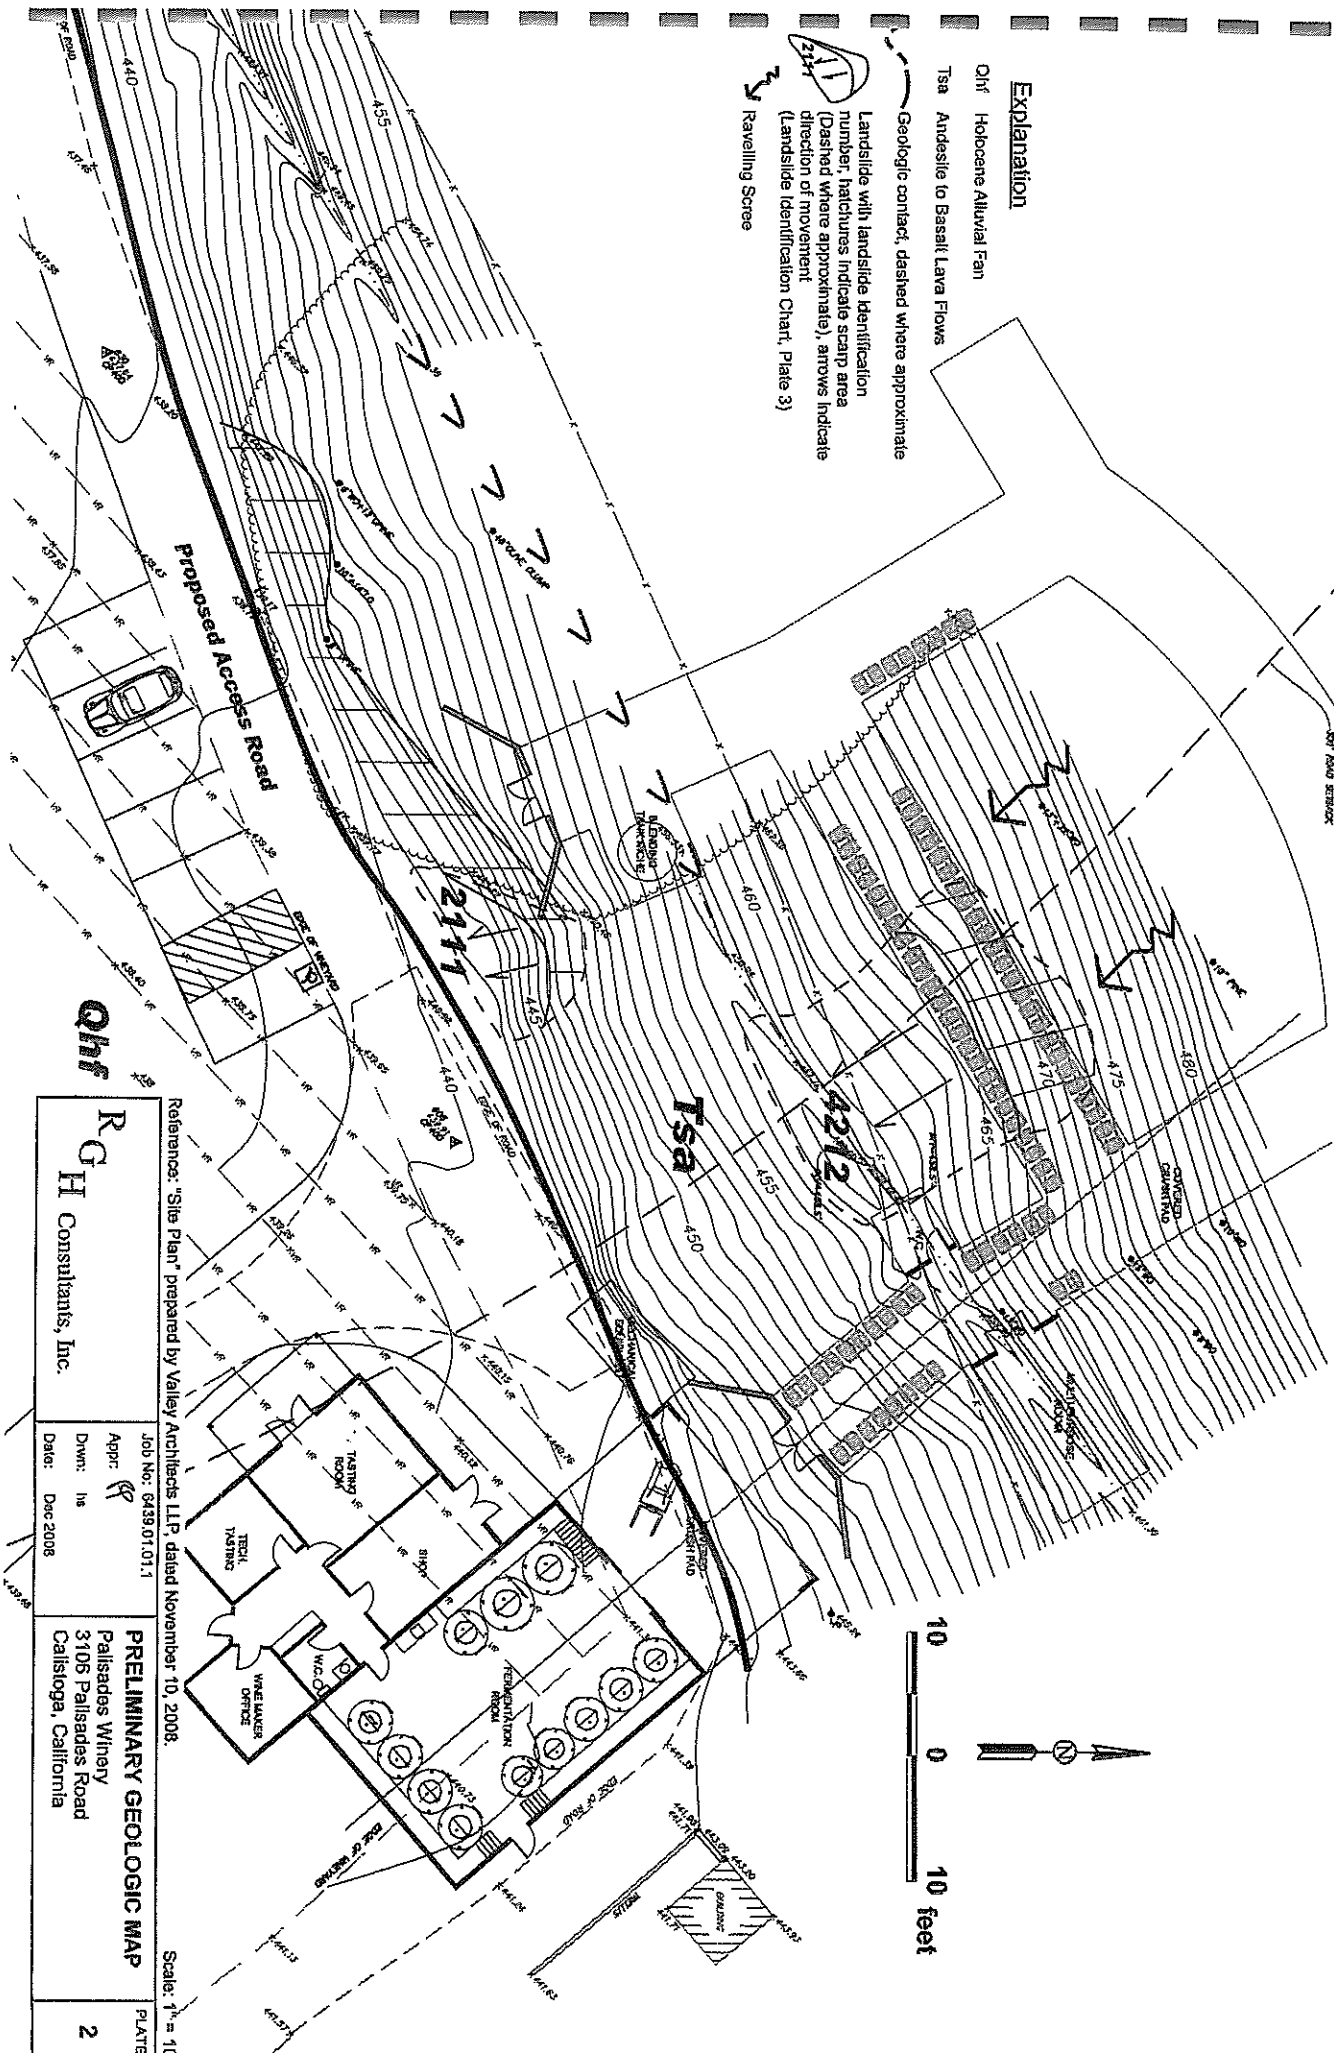
PRELIMINARY GEOLOGIC MAP
Palladas Wherry
3106 Palladas Road
Calistoga, California

Published landslide maps (Dwyer, 1976) indicate a queried landslide is located in a south facing swale situated northeast of the site. No evidence of large-scale active or dormant landslide features were observed in this swale. However, small active surficial failures were observed at the upper portion of the swale. We also observed shallow active and dormant landslides adjacent to and uphill of the planned building site. These include an active translational landslide that is approximately 10 feet long, 15 feet wide and less than 5 feet deep which is located uphill of the proposed parking area in the vicinity of the western portal to the planned cave. A dormant translational landslide approximately 25 feet long, 20 feet wide and less than 5 feet deep is located approximately 20 feet west, laterally from the eastern portal to the planned cave. Additionally, a ravelling scree field (slope wash) is located upslope of the building site. These landslides are presented on Plate 2, Appendix A.

As previously discussed, landslide features were observed at the project site. The observed landslide features are mapped on Plate 2. Proposed grading, structures and utilities should avoid or be set back from these areas unless remedial work is performed to stabilize the slopes. Remedial work could include removing the landslide debris and constructing a buttress. The final geotechnical study should address these issues in detail. Published landslide maps show queried large scale slope instability located to the northeast of the site, however our field observations did not identify this feature as a landslide.

The proposed roadway alignment and parking areas do not traverse across or extend over mapped or observed unstable areas. However, we observed areas of instability directly upslope from the planned paved areas (Plate 2). We judge, on a preliminary basis that, it is geotechnically feasible to construct the driveway and parking areas as shown. Final roadway and parking area design should include a site-specific study of the alignment, particularly areas of inherent weakness such as steep slopes, swales, ravines, and the instability observed directly upslope of the planned paved areas. In general, new paved areas

The proposed building envelopes must be located outside unstable areas and steep slopes in order to reduce the risks associated with slope instability. The location of the building envelop in relation to such areas is shown on Plate 2. Initially, a structural setback of approximately 50-feet from unrepaired, unstable areas and breaks in slope of 2:1 or steeper should be established. A site-specific study should finalize recommended structural setbacks.
