Geological Study

August 10, 2015

Geologic Assessment of Slope Stability

3646 SMR Vineyard Winery 3646 Spring Mountain Road Saint Helena, CA 94574

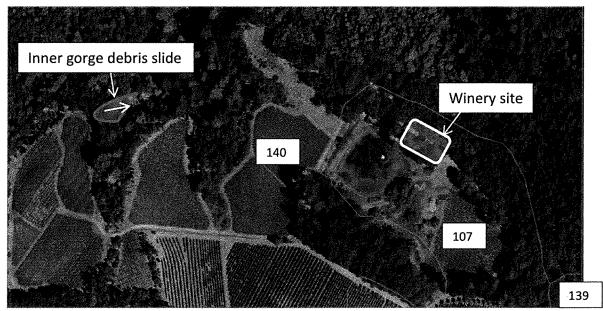
Figure 2. Distribution of soil types on project parcel. The approximate location of the proposed winery site is shown; a more detailed footprint for the winery site and access driveway are shown in Appendix A. An inner gorge debris slide observed in the field is also located. North to top of page; no scale provided with this image. Refer to Appendix A for scale.

The aerial photographs and field reconnaissance identified instability in the inner gorge at the location shown in Figure 2. A head scarp about 10 to 12 feet high was found about 30 to 50 feet beyond the northern tip of the western-most vineyard block at an elevation of about 1550 feet (see topographic map, Appendix A). At the base of this scarp there is a block of down-dropped soil and mature forest vegetation about 30 to 50 feet wide and about 150 to 200 feet long with some "jackstrawed" douglas-fir trees about 15 inches diameter. I believe that this largely un-deformed block of soil dropped in response to a debris slide on the very steep slope of the inner gorge below, which I could not readily observe. The toe of the debris slide approximately 100 feet below the head scarp appears to lie adjacent to the steep intermittent or ephemeral stream channel draining from south to north across the parcel. The toe of the debris slide is bare soil, and this area appears to remain unstable. The uppermost extension of this debris slide scarp does not appear to have moved in recent years, but remains well defined.

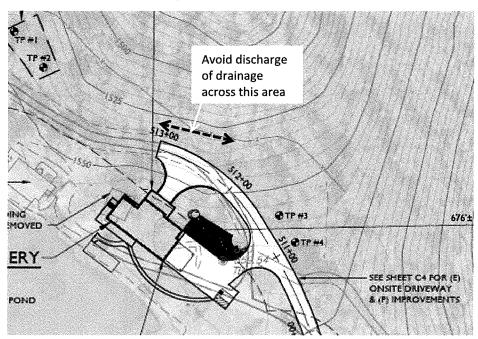
A 100 ft-wide portion of the slope immediately to the north of the proposed winery (Figure 3) should be considered to have some potential for erosion and small scale instability if subjected to increased runoff and concentrated drainage. During development of the site, permanent drainage measures should be implemented to prevent increased or concentrated runoff to this portion of relatively steep and convergent slope. The slopes to the west and east of this location have planar shapes that will not concentrate water, and are more suitable to receive drainage. Nevertheless, concentrated runoff from paved areas, including the driveway and winery roofs, should not be concentrated for discharge on these slopes. Flow spreaders should be employed if storm runoff is to be discharged on these slopes. Where possible, drainage should be routed to the south of the winery building and driveway.

Figure 3. Recommended drainage management at winery site.

Based on the foregoing assessment of site conditions, the proposed winery development is not expected to cause any significant decrease in slope stability nor any increase in erosion. There is one erosion hazard area across the slope immediately north of the proposed winery site where drainage should not be directed. The absence of previous landslides at the winery site, and the gentle to moderate slope at the proposed winery indicate that there is no significant slope stability hazard associated with this project. The winery site is unaffected by, and cannot affect, the debris slide observed on the steep slopes of the inner gorge area over 800 feet west of the winery site.
