### NOTICE OF NONCOMPLIANCE

**RE: Pope Creek Quarry: CA Mine ID #91-28-0007  
Surface Mining Permit #97420-SMP (APN 018-080-023)**

To:	File #P10-00385	From:	Donald Barrella Conservation Division
Date:	February 24, 2011	Re:	Pope Creek Quarry, Mine ID#91-28-0007 APN 018-080-023 Supplement to the 2009-2010 Annual SMARA Inspection Report

Date: February 24, 2011	Re: Pope Creek Quarry, Mine ID#91-28-0007 APN 018-080-023 Photo Supplement 09/10 Inspection Report
-------------------------	--

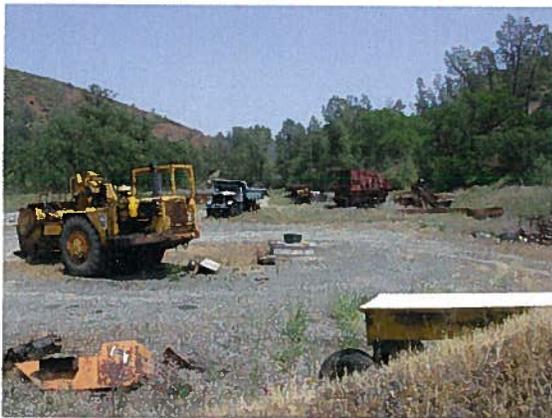
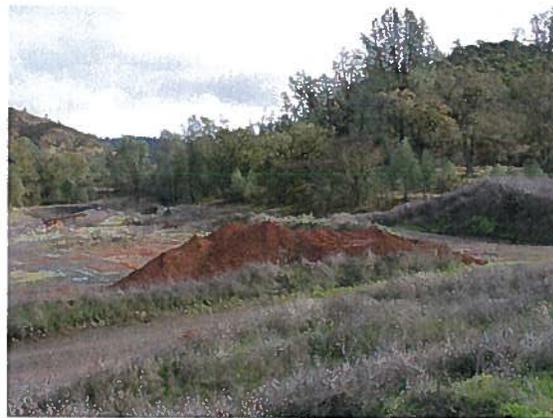
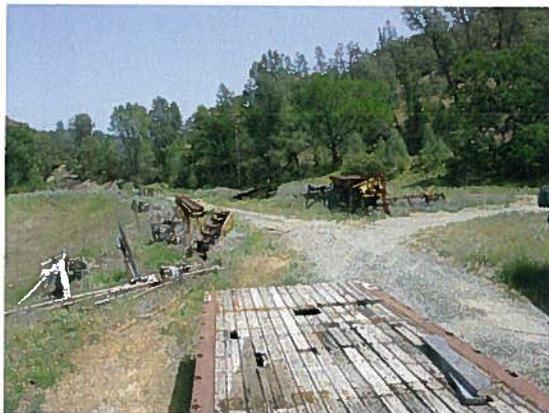
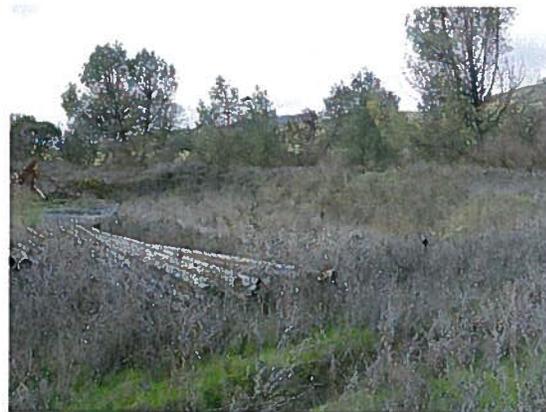
Eastern Portion

- Within the eastern portion of this area, several pieces of large equipment (scraper, dump trucks, flat bed trailer) and other miscellaneous debris (equipment parts, axels, hopper, water tank, conveyor arms, and other metal scrap) have been removed (see attached photos).
- Within the eastern portion of this area, there still remains a conveyor arm, several metal pipes, a couple miscellaneous pieces of metal scrap, and a concrete pad that need to be removed.
- Within the western portion of this area, several pieces non-mining related debris (car, van, pickup truck, tires, pallets, boats, snow mobile trailer, fire wood, bricks) and some miscellaneous scrap have been removed (see attached photos).
- Within the western portion of this area, there still remains several large pieces of equipment, scrap and debris (scrapers, dump truck, cube van, large trailers, drill rig, earth movers),

- It appears that a few pieces of equipment may have been moved from the eastern portion of the site to the western; however overall there is less equipment, scrap and debris at the Batch/Wash Plant area than in the previous inspection.

- Efforts to remove equipment, structures, scrap, and debris will need to continue and all such materials need to be removed within 3 months (i.e. by **May 31, 2011**).

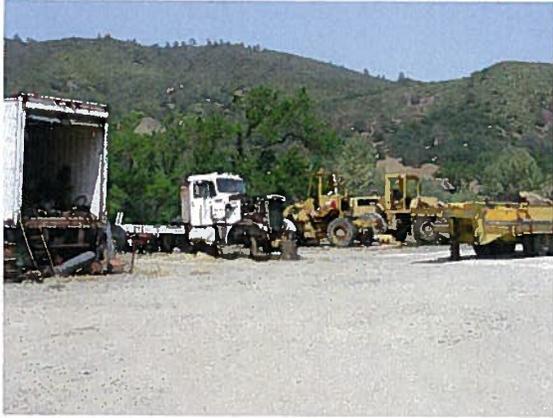
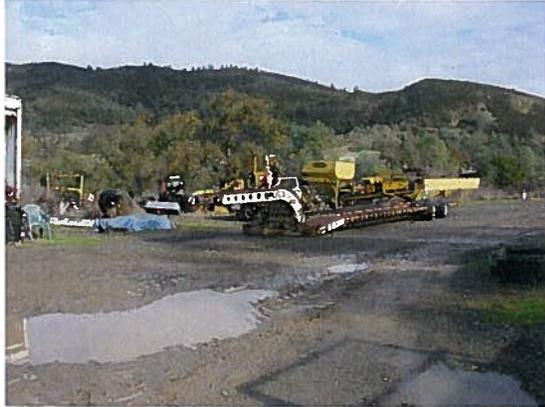
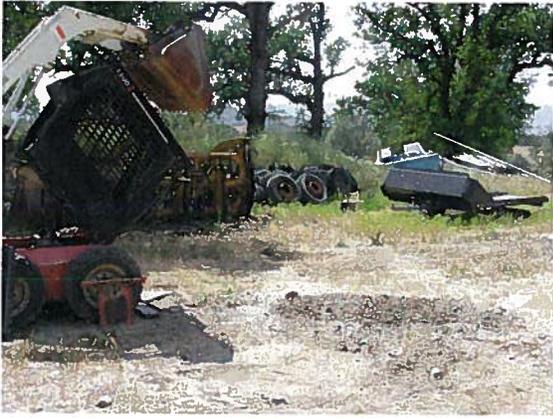
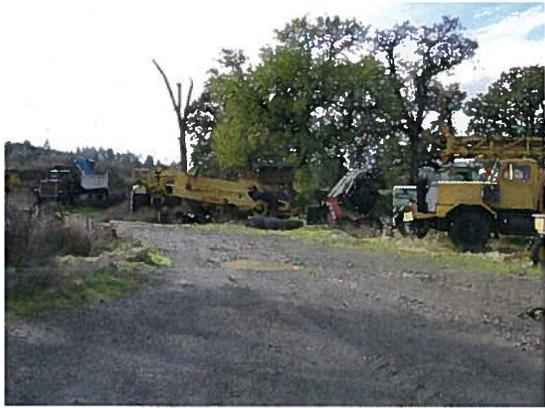
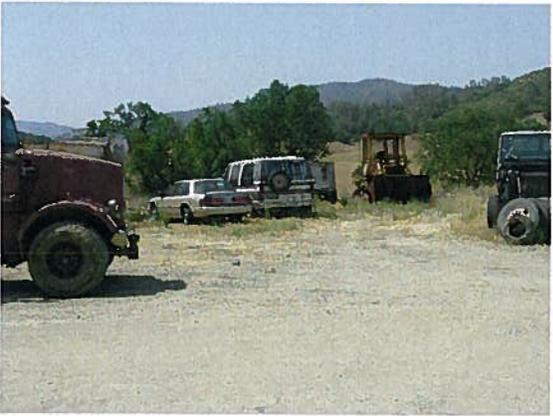
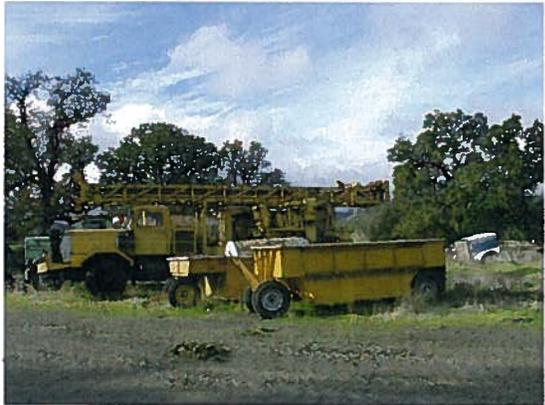
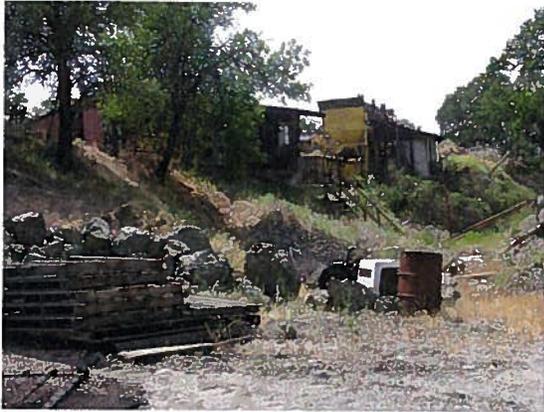
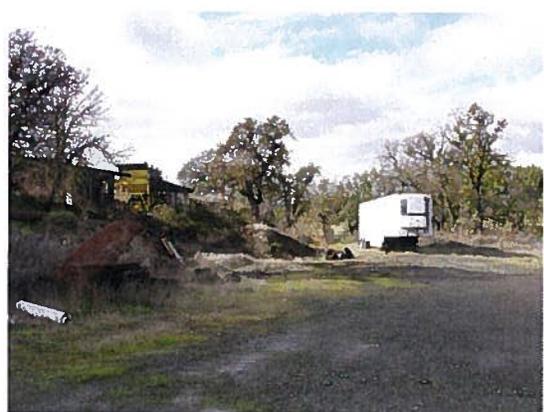
Western Portion

structures (batch plant, shop, shed) and miscellaneous pieces of scrap and other debris, that need to be removed.

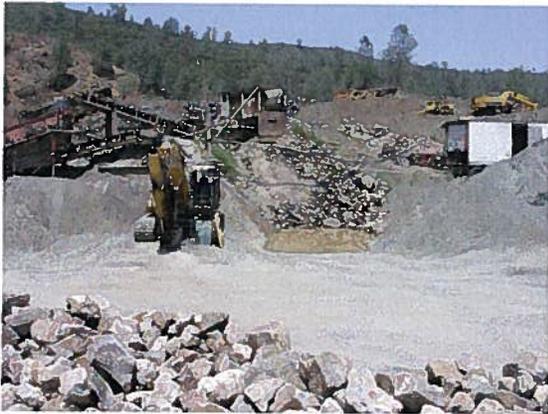
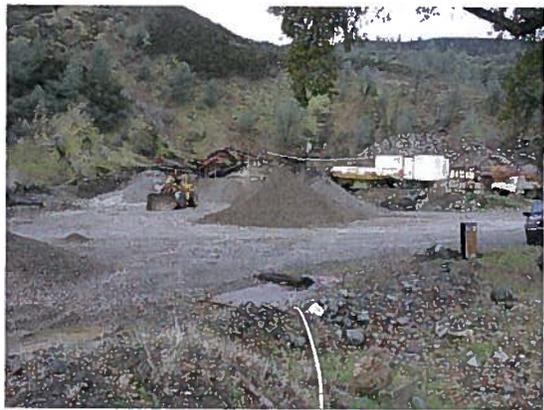
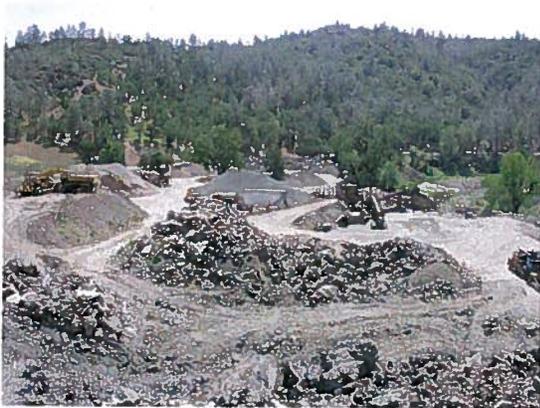
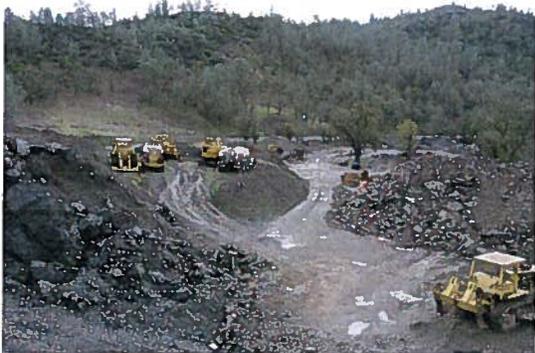
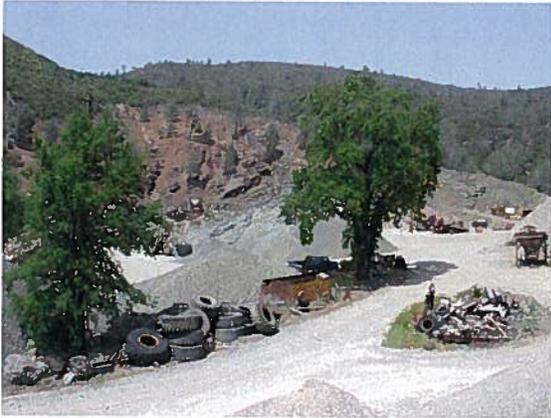
Rock Quarry Area:

- There has been some limited removal of scrap and other debris from this area (tires, hopper, and miscellaneous scrap). It appears that some pieces of equipment (tanker trailers) have been moved to this area from the Batch/Wash Plant area.
- Generally, non-operational large equipment and scrap has not been removed from this area on a regular basis (see attached photos) – equipment, scrap and debris not associated with the operation needs to be removed within 3 months (i.e. by **May 31, 2011**).

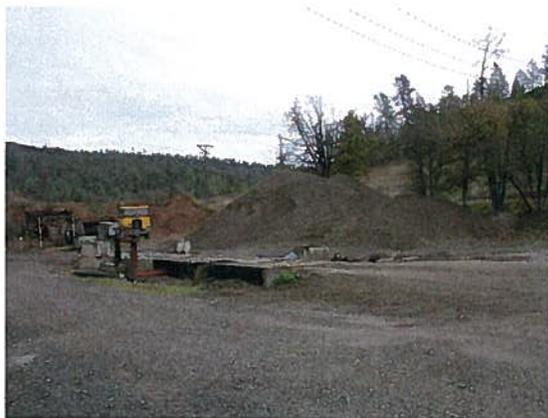
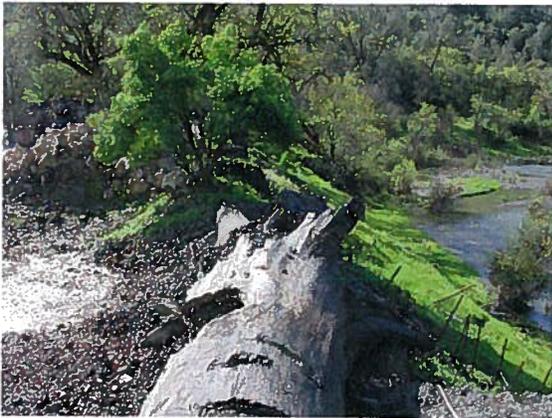
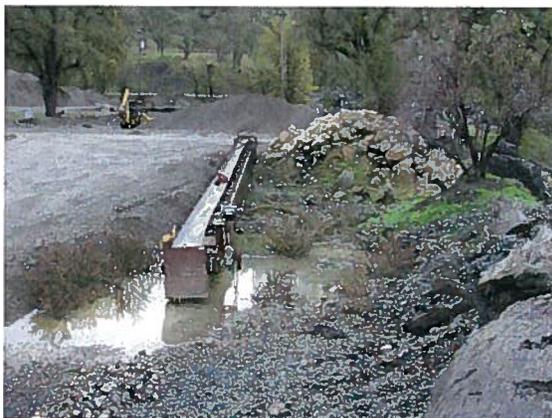
Discharge and Runoff – Hard Rock Quarry area:  
March 30, 2010

The runoff basin/area located within the southwestern portion of the Hard Rock Quarry (i.e. southwest of the quarry pit and crushing plant) was inspected on March 30, 2010 (a day after a rain events) and on December 3, 2011 (after several days of rain). The basin appears to have adequate capacity at the current level of filling and no evidence was discovered that indicated this basin had overtopped and discharged into Pope Creek (see attached photos). However, a large conveyer arm has recently been placed within this area. This piece of equipment shall be removed from this area within 30 days (i.e. by **March 28, 2011**) so that it does not interfere with the functioning of the basin or adversely affect water quality.

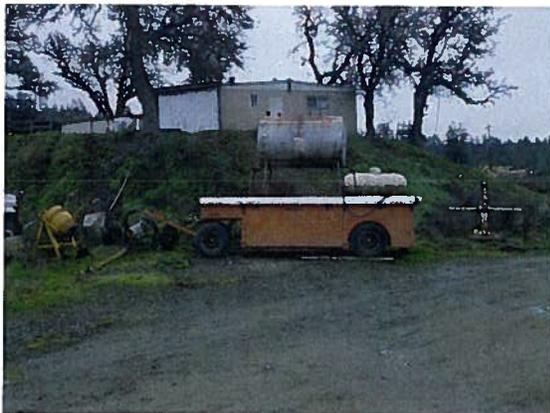
Fuel Tank Containment –Batch/Wash Plant area:

The 550 gallon above ground fuel storage tank has been placed within a containment unit (i.e. grape gondola) with an anticipated capacity of 1,500 gallons (see photo). This containment approach should be considered a temporary measure and the operator will need to work with the County Department of Environmental Management (DEM) to properly maintain and contain the fuel tank. The operator has a permit from the DEM to store hazardous material; CDP will request that DEM inspect the site within the next 6 months to ensure compliance with that permit and State laws pertaining to petroleum storage.
