# WATER AVAILABILITY ANALYSIS

KENZO ESTATE  
3200 MONTICELLO ROAD  
NAPA, CALIFORNIA

August 31, 2015  
Project #4112041.0

## ANNUAL GROUNDWATER RECHARGE RATE

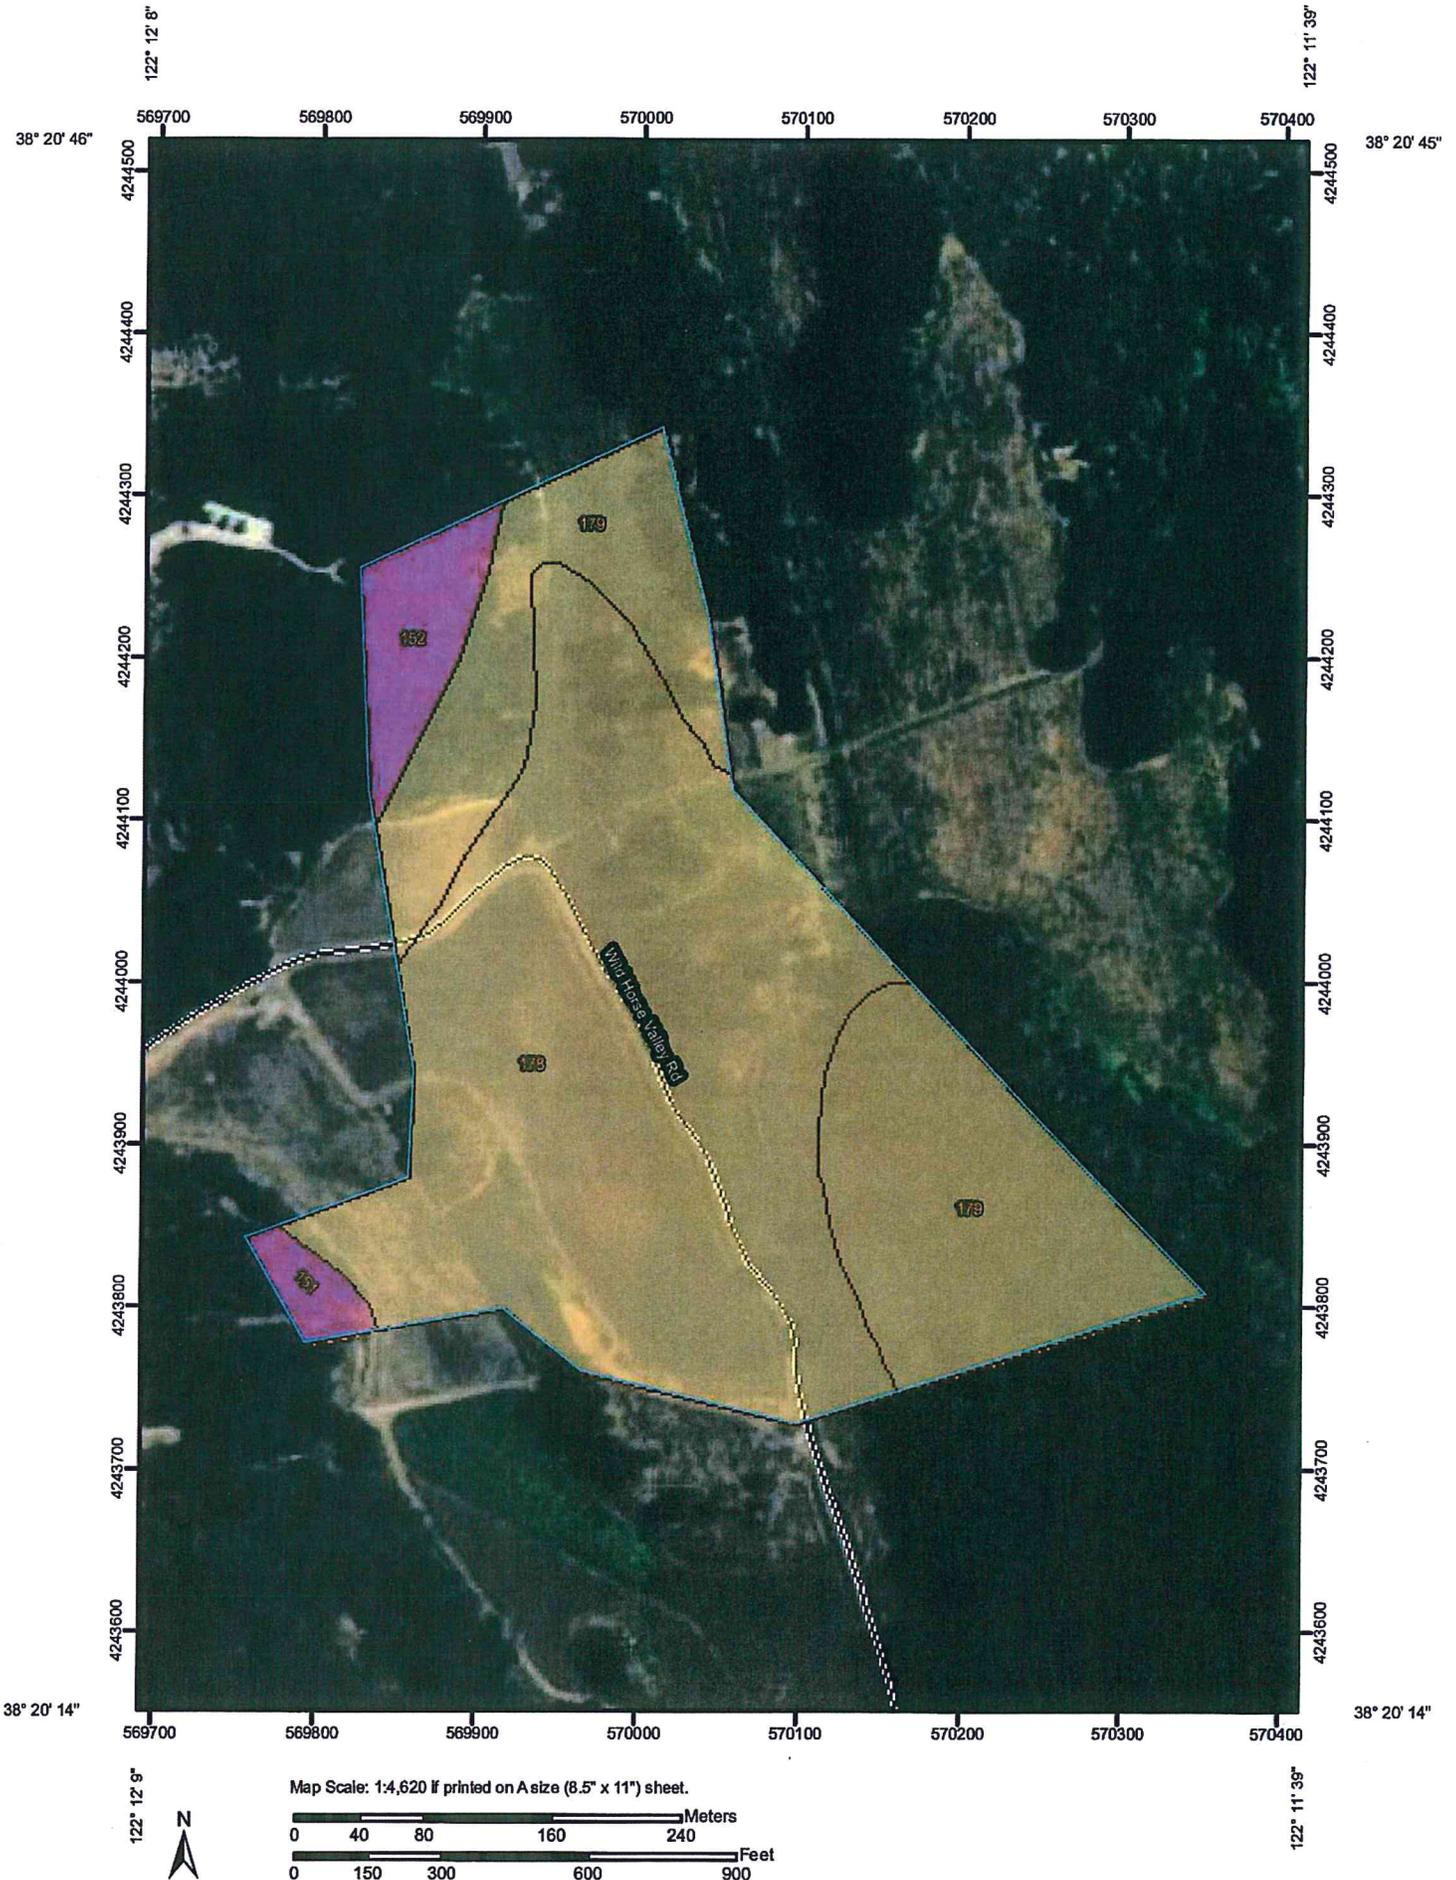
Hydrologic Soil Group—Napa County, California  
(Kenzo Estate Winery)

## Hydrologic Soil Group

Hydrologic soil groups are based on estimates of runoff potential. Soils are assigned to one of four groups according to the rate of water infiltration when the soils are not protected by vegetation, are thoroughly wet, and receive precipitation from long-duration storms.
