Cultural Resource-Historical Evaluation

**Cultural Resource Evaluation for
5537 Solano Avenue
Napa County, CA**

By
Juliana Inman Architect
May 25, 2015
Revised May 6, 2016

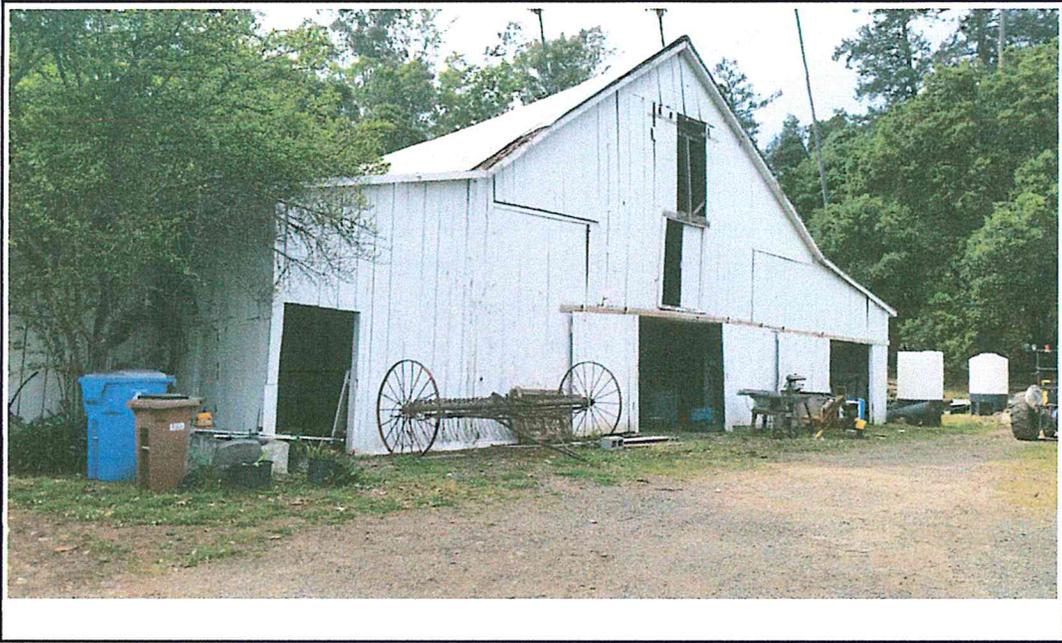
Figure 3. Front of the barn (north) showing double sliding doors and hayloft doors above.

This reviewer recommends replacing the barn doors with wood barn doors similar to the original doors.

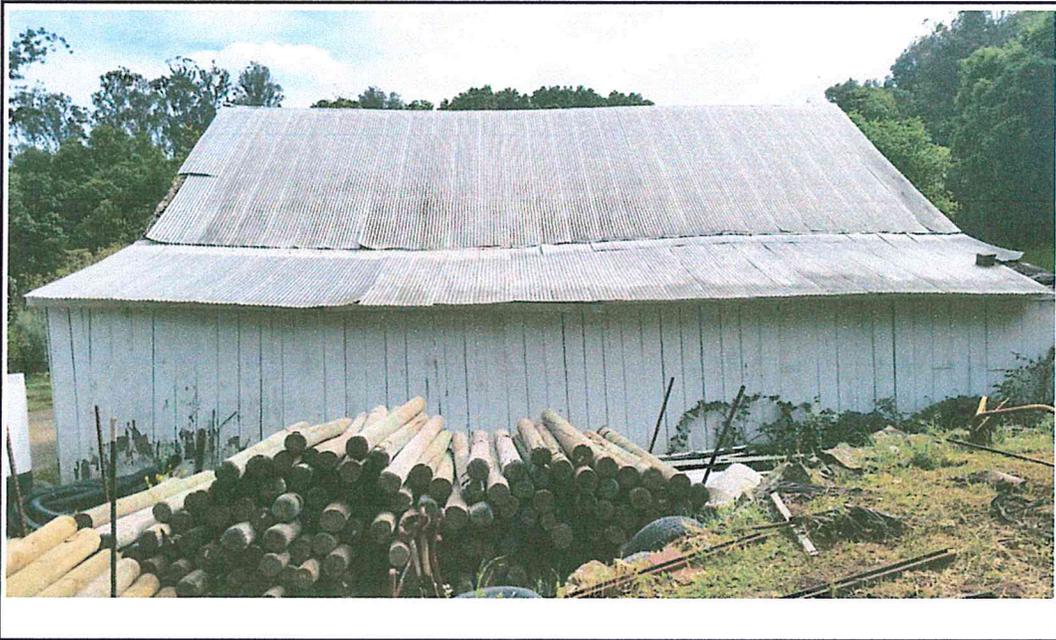
Figure 4. West side of the barn showing metal roof and slope up to the upper driveway.

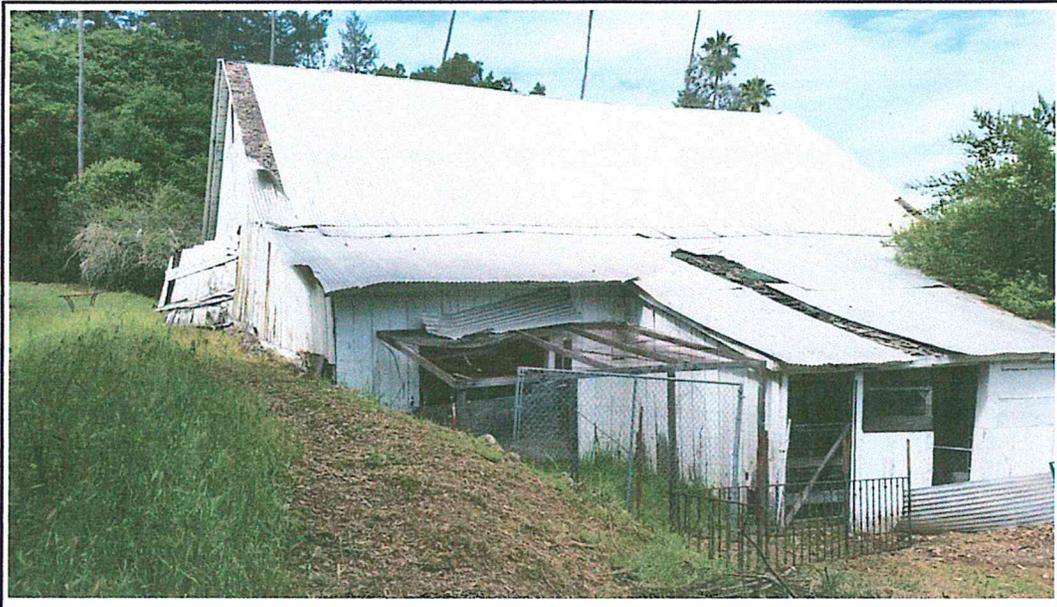
Figure 5. Oblique rear view showing the east side with animal pens, original wood shingles and upper drive on the south.

Existing alterations that have become part of the historic fabric of the building will remain. Inappropriate and poor quality additions will be removed. The “critter pens” infested with wood destroying pests will be removed and not replaced.

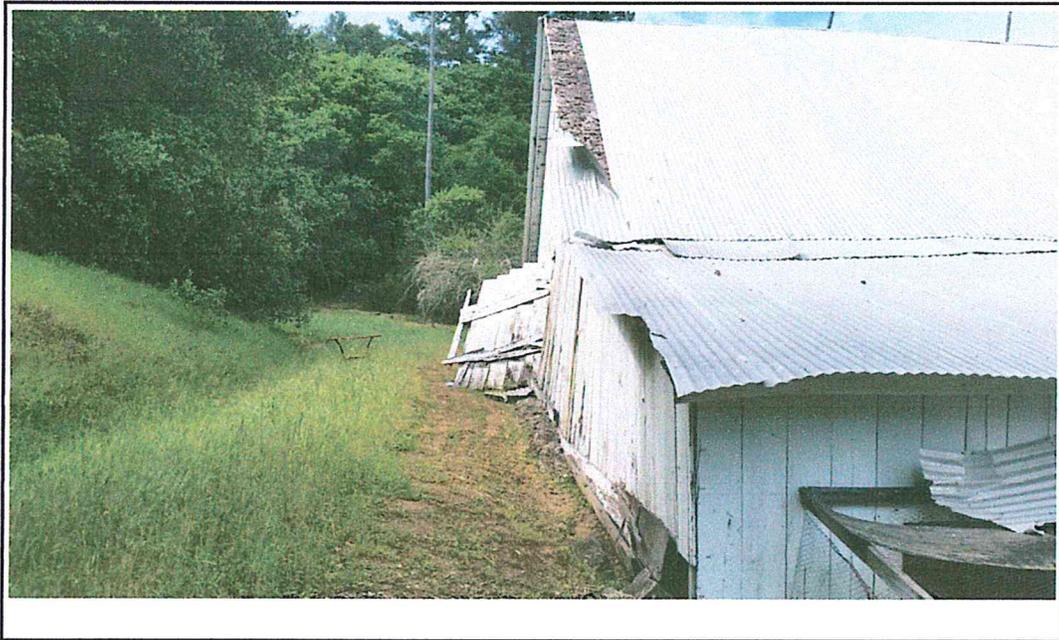
Figure 6. Rear view showing drive at upper level of the “bank barn.”

Reconstruction of the roadway continues the historic access to the upper level of the barn and makes possible rehabilitation and continued use of the building. Construction of the crush pad could be removed in future without damage to the historic barn.

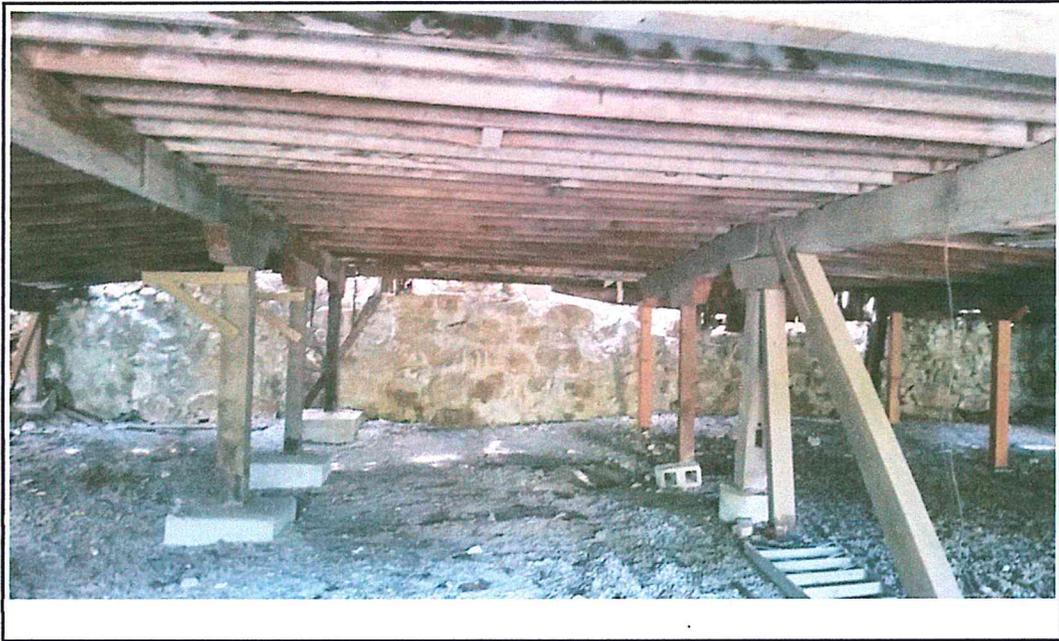
Figure 7. Interior showing failed stone retaining wall at lower level.

The condition of the upper drive stone retaining wall and the south wall of the bank barn is in poor structural condition. Part of the stone wall has collapsed, and the barn has shifted toward the north as a result. Efforts have been made to stabilize the structure, but the building needs repair and retrofitting to survive.

4. Materials: The original material remains throughout most of the building. The condition of the building is fair to poor due to the structural failure of the original stone retaining wall and subsequent shifting of the wood framed barn structure. There is also extensive structural pest damage on the east, south and west sides of the building.

Replacement of historic materials will be done where original material has been broken, lost or weathered to an extent making repair infeasible. Replacement features will match the old in design, color, texture, visual qualities, and material. The failed stone retaining wall will be rebuilt to current road and building standards to provide continued access to the upper level of the barn. The barn has been moved approximately 12-18 inches off its original location by pressure from the collapsed retaining wall. Removal and replacement of the road and retaining wall will allow restoration of the barn and moving the barn back into its original position. **First plans reviewed for the project showed this roadway removed. The road to the upper level access has been restored to the plan and meets the Secretary of the Interior Standard.**

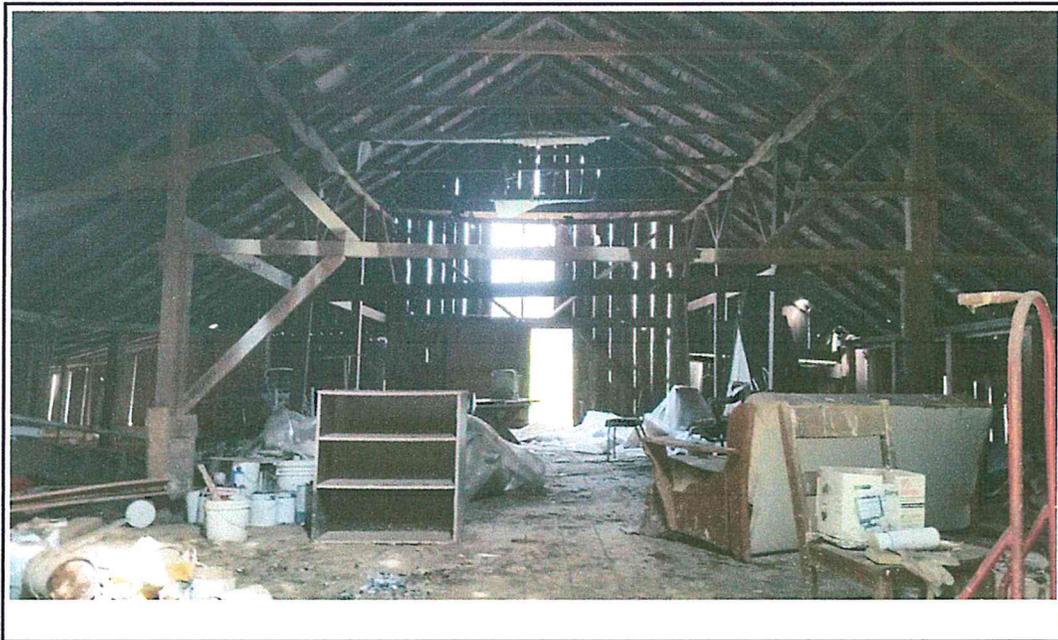
Figure 8. Interior from upper bank drive doors, showing framing.
