Water Availability Analysis

MEMORANDUM

Re: Results of Napa County Tier 1 Water Availability Analysis
for Existing Behrens Family Winery
4078 Spring Mountain Road
Vicinity St. Helena, Napa County, California

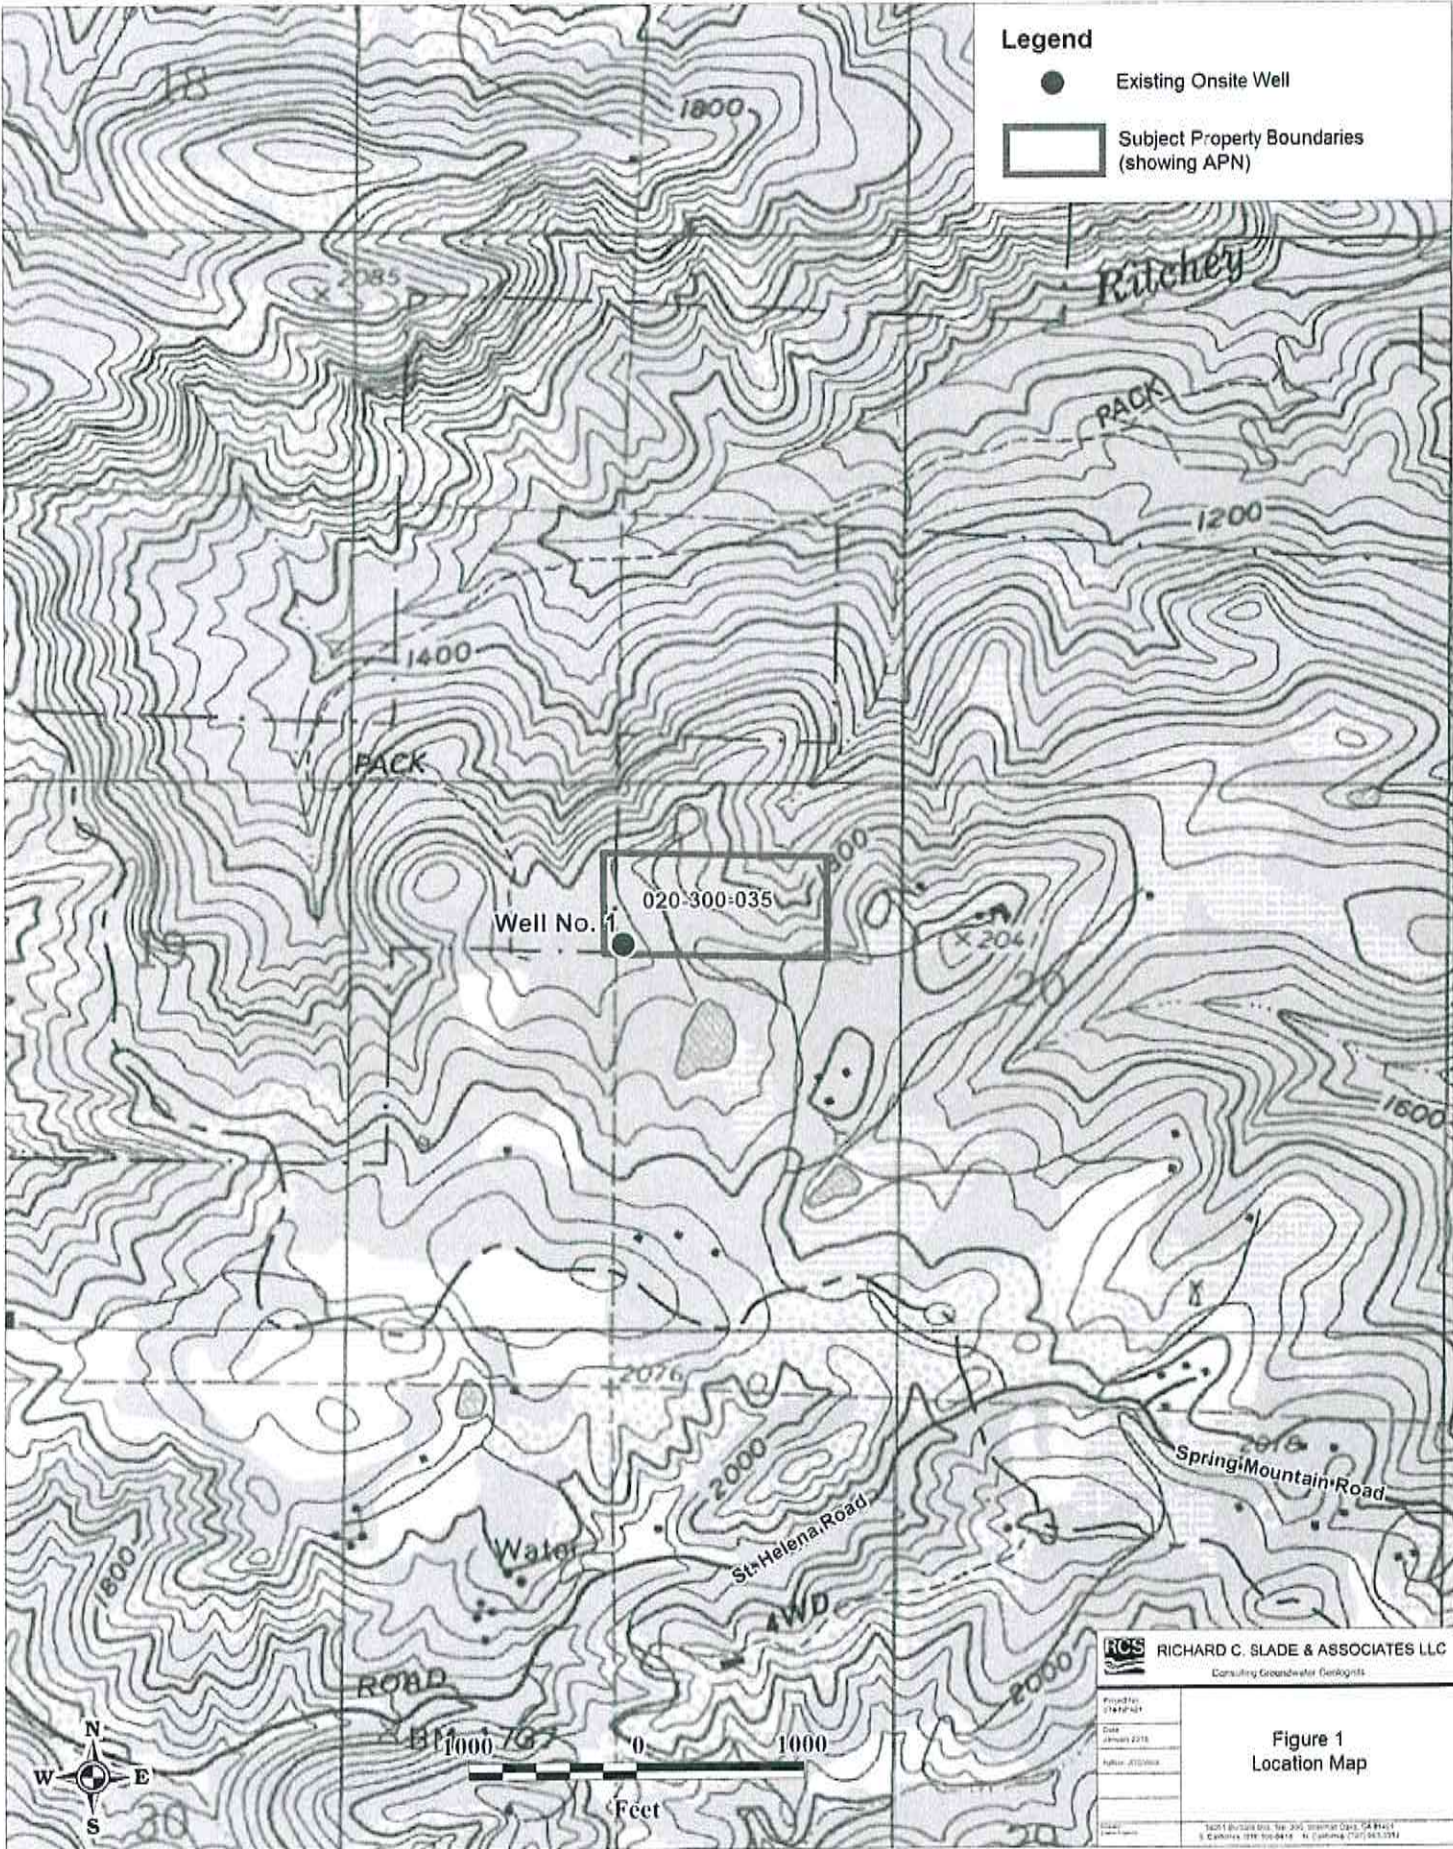
Figure 1
 Location Map

- Existing Onsite Well
- ▭ Subject Property Boundaries (showing APN)

Scale: 1 inch = 1000 feet
 North Arrow: True North
 UTM Zone 10N
 Datum: NAD 83
 Contour Interval: 20 feet

From our field reconnaissance visits at the subject property on July 21, 2015, the following key items were noted and/or observed (refer to Figures 1 and 2):

- c. One water well (known herein as "Well No. 1") was observed to exist on the subject property, the location of which is shown on Figures 1 and 2. At the time of our July 21, 2015 site visit, this active well was not pumping.
- d. The offsite areas surrounding the subject property consist primarily of existing vineyards and/or wooded hillsides.
- e. A minor unnamed swale exists in the southwestern portion of the subject property near Well No. 1; at the time of the site visit, this swale was observed by the RCS geologist to have a small amount of flow in it. Reportedly, there is some seasonal flow from an offsite spring that may have been the source for the water in the swale. No other information (including its exact location) is known about this offsite spring.

As mentioned above, one water well is located in the southwestern corner of the subject property (see Figures 1 and 2; the well is shown as Well No.1 thereon). A California Department of Water Resources (DWR) well completion report (also known as a driller's log) was available for the existing well and was provided to RCS by Mike Muelrath of Applied Civil Engineering (ACE), the project Engineer. The driller's log lists the well name as "#1".

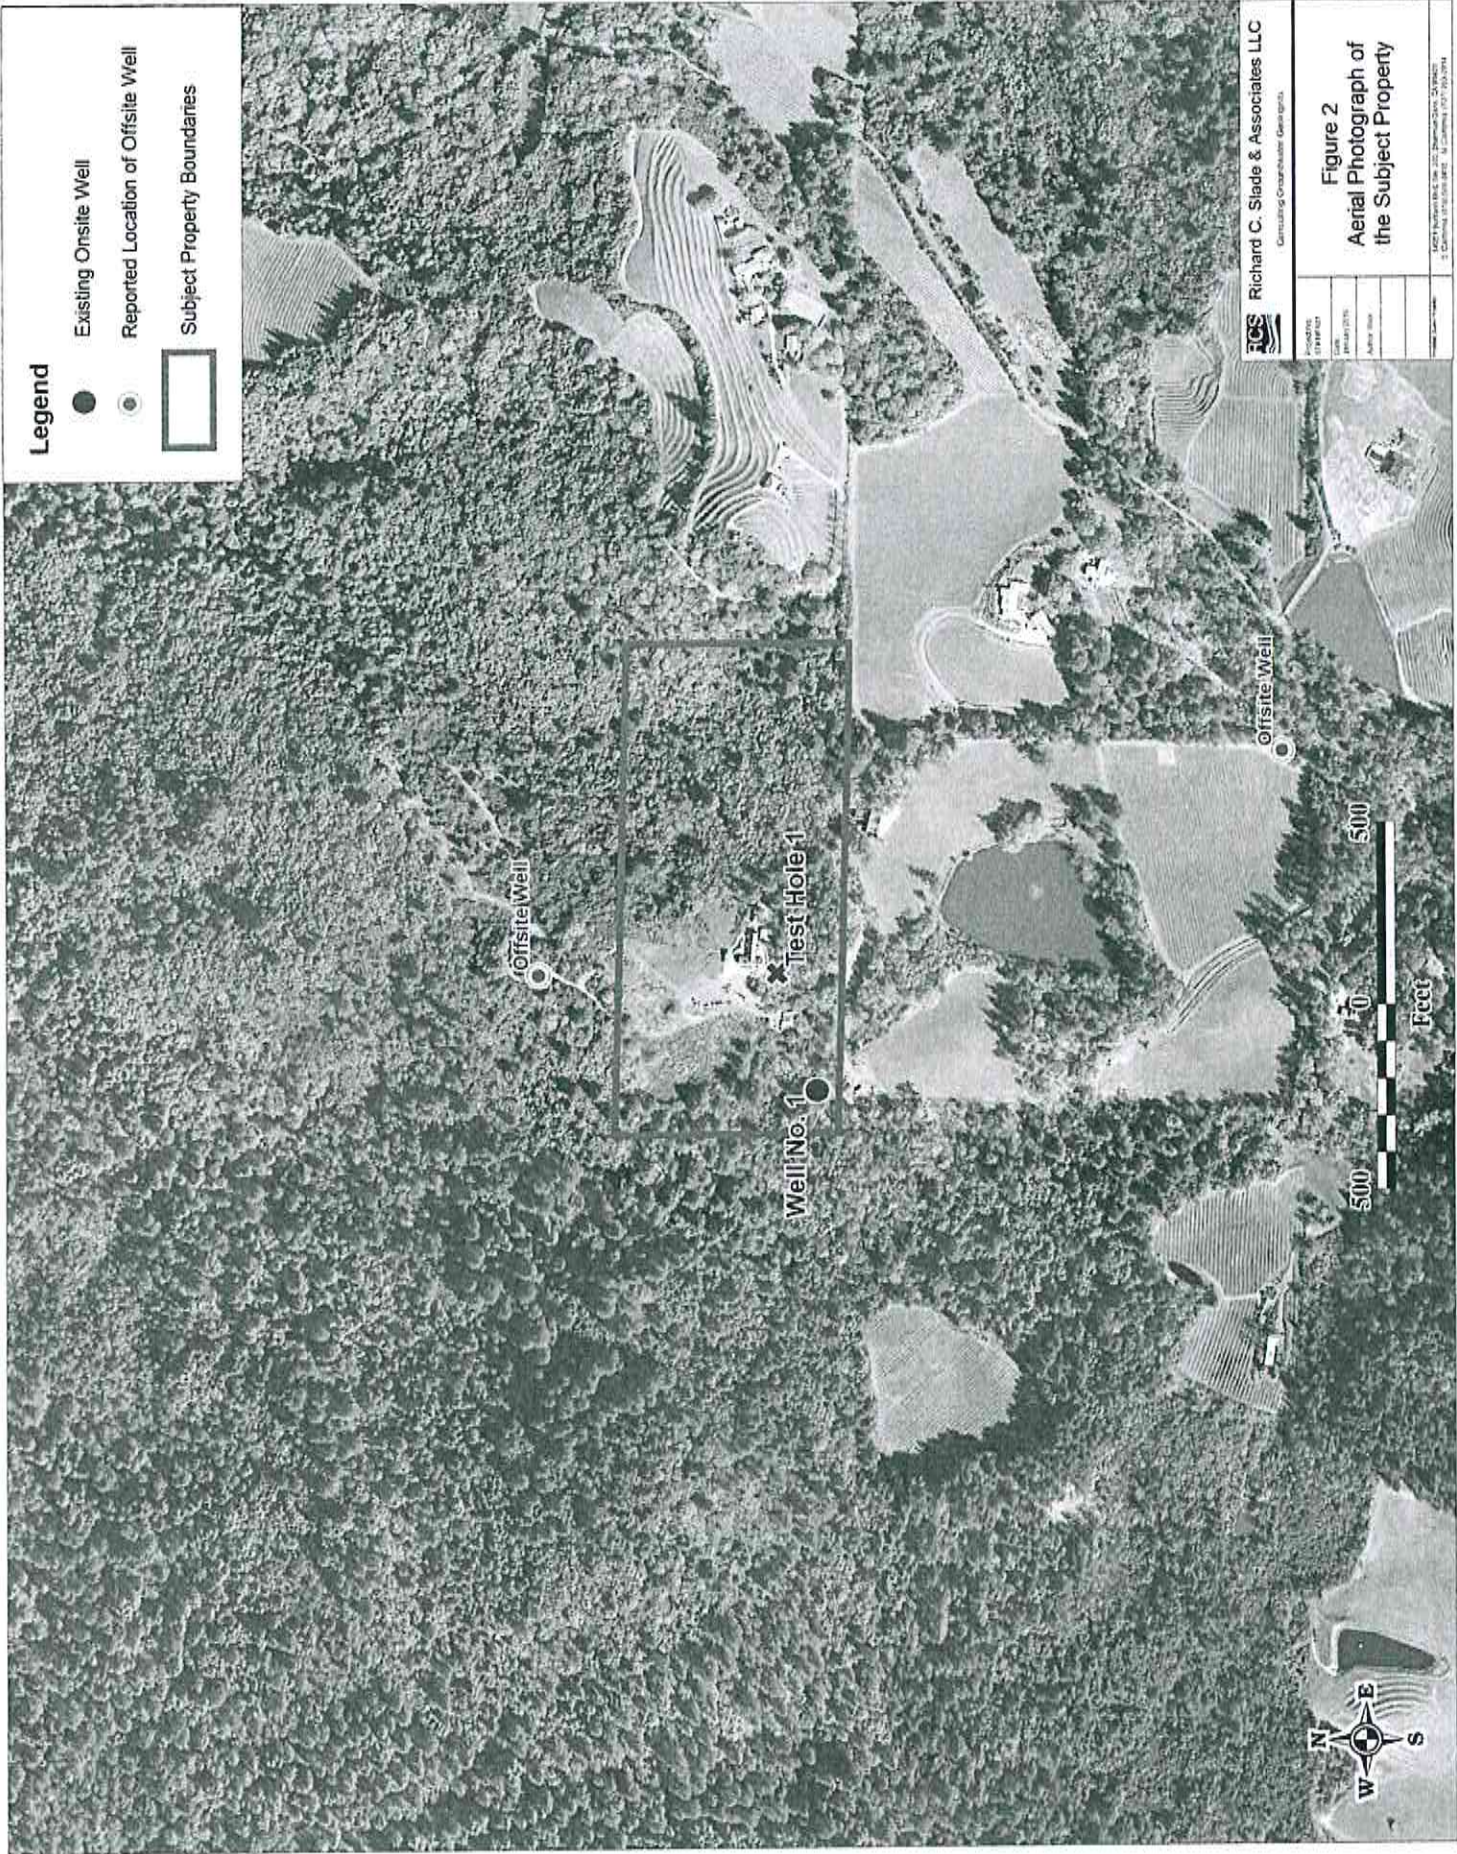
- Existing Onsite Well
- ⊙ Reported Location of Offsite Well
- ▭ Subject Property Boundaries

- f. No offsite wells were directly observed during the site visit. However, the reported locations of two neighboring offsite wells were provided to RCS via email from Mr. Sean Behrens, of Behrens Family Winery; the reported locations of these wells are shown on Figure 2. These two offsite wells lie approximately 820 ft northeast, and 1,520 ft southwest, respectively, from existing onsite Well No. 1. No construction information or pumping data were provided for either of these offsite wells owned by others.
