Historic Evaluation

Regusci Winery, Major Modification to Use Permit P16-00307
& Request for Exception to Road and Street Standards
Planning Commission Hearing Date, November 15, 2017

Re: Historic Assessment for the Regusci Winery, 5584 Silverado Trail, Napa, CA
APN. 039-030-023-000

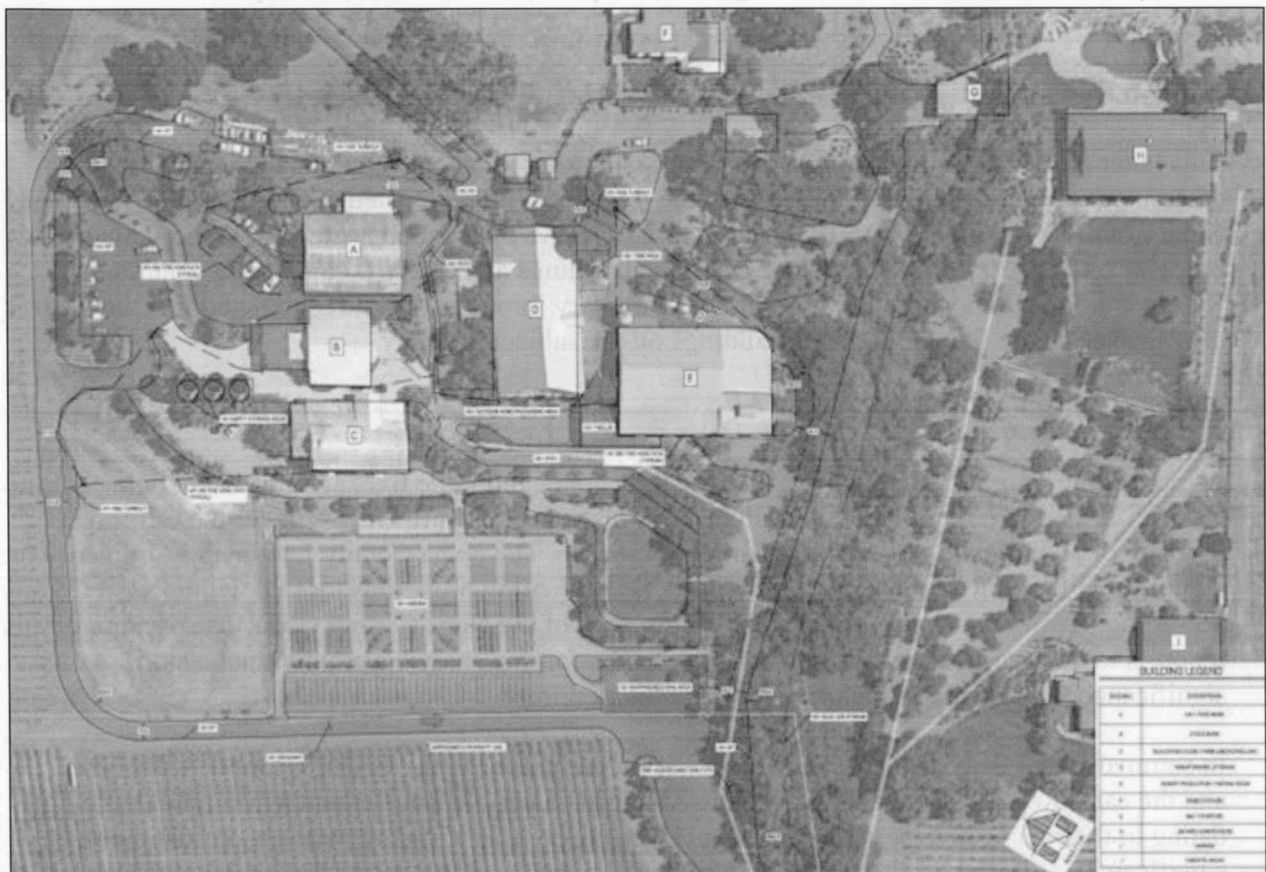
Figure 1. Regusci Winery site plan. Buildings evaluated for this study include Buildings A through E.

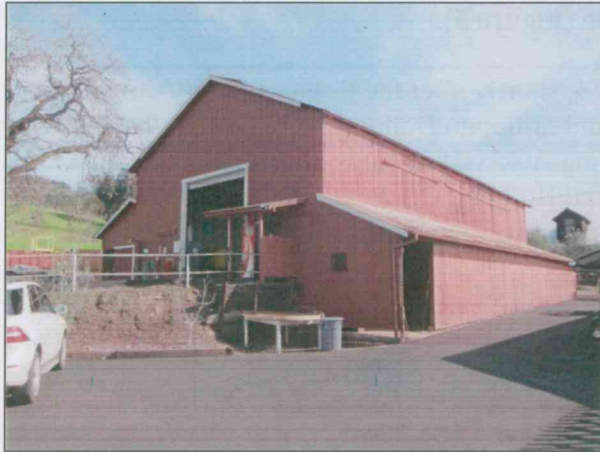
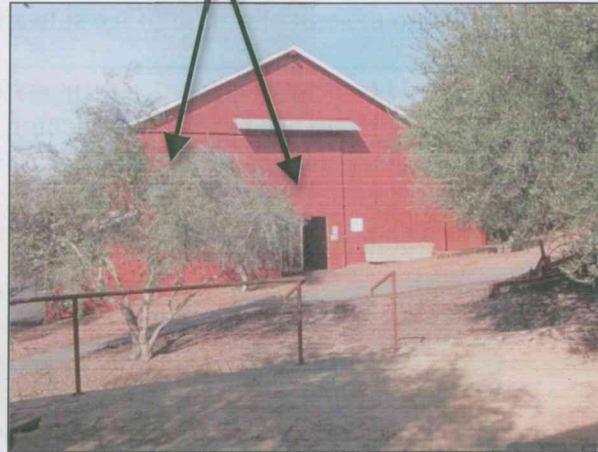
The Hay/Feed Barn is a center-bay/side-aisle barn with a central, gable-roofed mass, flanked by shed-roofed side aisles (**Figures 2 through 5**). Constructed circa-1933 after the James G. Regusci family acquired the property, the structure served as animal and feed storage when the property operated the slaughterhouse. Since closure of the slaughterhouse in 1974, the barn is currently used for farm equipment storage and maintenance.

Figures 2 and 3. Left image shows the north elevation and gable roof/side aisle design. Right image shows the south elevation with corrugated shed roof and replacement T1-11 plywood siding (arrows).

The Hay/Feed Barn has undergone various alterations. Exterior, vertical-board wood siding has been replaced in selective locations, particularly on the south elevation, where T1-11 plywood has been installed on the barn door and adjacent south elevation wall (**Figure 3**). On the north elevation, the center-bay entrance door has been replaced with a steel roll-up door; and a small shed-roof supported on squared columns has been installed. A new opening has been installed in the side aisle near the north elevation's gable end (**Figure 4**). A shed-roofed, storage structure has been installed onto the east elevation of the side aisle (**Figure 5**).

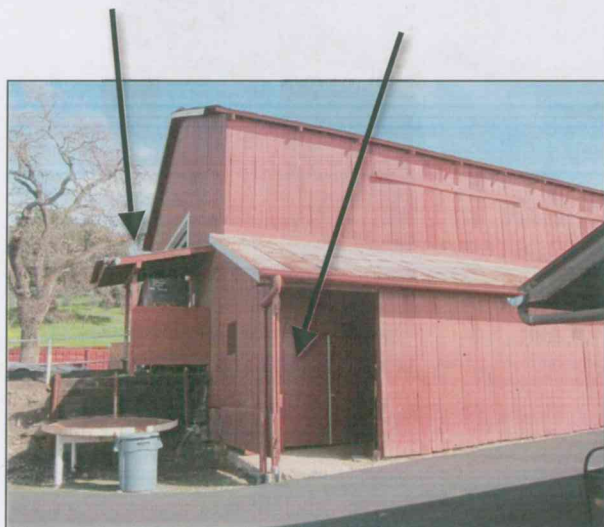
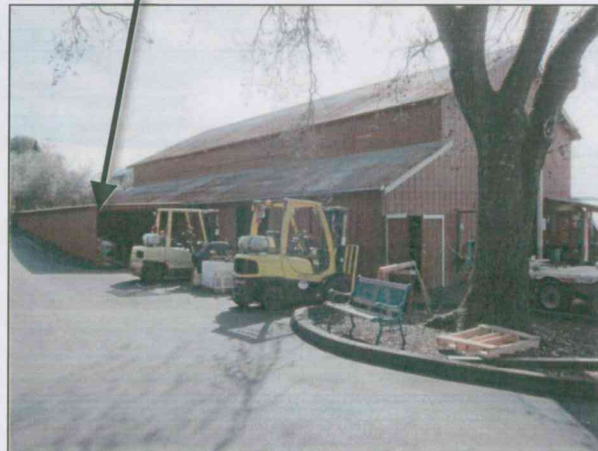
Figures 4 and 5. Left image shows the north and partial west elevations. A small shed-roofed porch has been placed onto the north elevation to shelter equipment (left arrow). A new opening has been installed in the side aisle near the north shed end (right arrow). Right image shows the north and east elevations, with the addition of an open structure to the east of the side aisle (arrow).

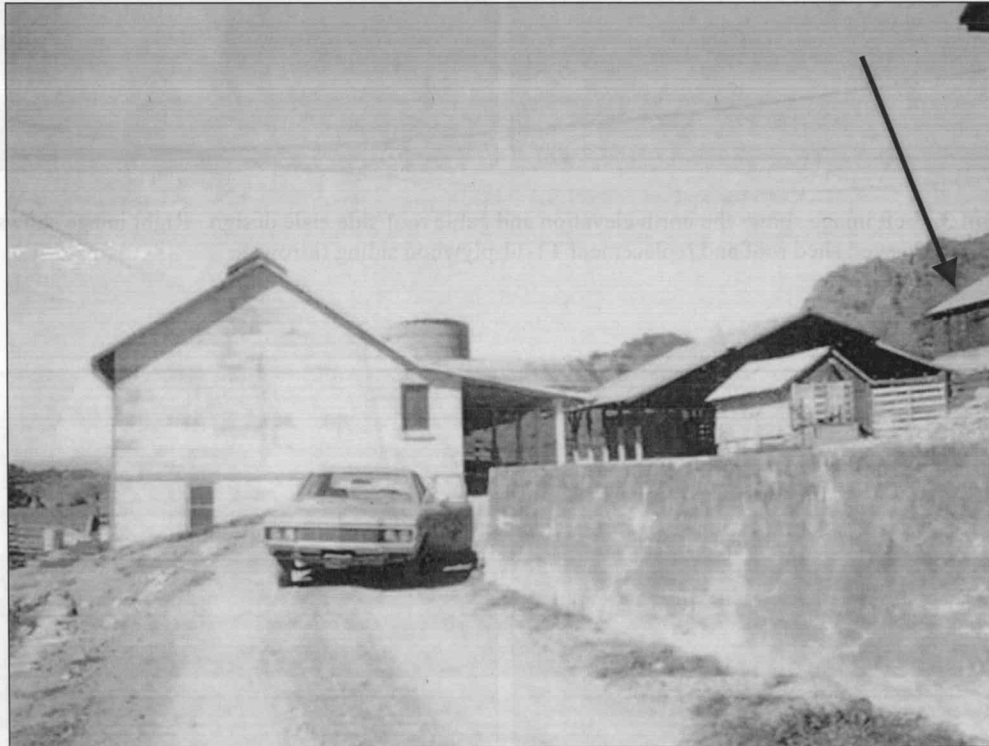
Buildings A, B and C were all constructed circa-1933, shortly after the Regusci family purchased the property and began to use the site for ranching and farming. Building A, B and C all served the new slaughterhouse operations for the ranch. Building A served as feed and animal storage; Building B was originally the animal holding pen; and Building C was the slaughterhouse. A circa-1960 Assessor's photograph shows the three buildings in configuration (**Figure 6**).¹

Figure 6. Circa-1960 view of the slaughterhouse operations taken from the south. The Slaughterhouse (Building C) is at the left; the Former Stock Barn (Building B) immediately to the right; and the Hay/Feed Barn (Building A) to the far right of the image (arrow).

As seen on the circa-1960 photograph (**Figure 6 – previous page**), the Stock Barn originally was an open structure with a corrugated metal roof and served as the holding area for the animals, before they entered the slaughterhouse.

The Former Slaughterhouse has undergone numerous alterations for conversion to offices and a caretaker's dwelling. As seen on **Figure 6**, the building was constructed of plain concrete block walls with few window openings. Numerous windows have been inserted onto the south and west elevations subsequent to the building's original construction (**Figures 9 and 10**).

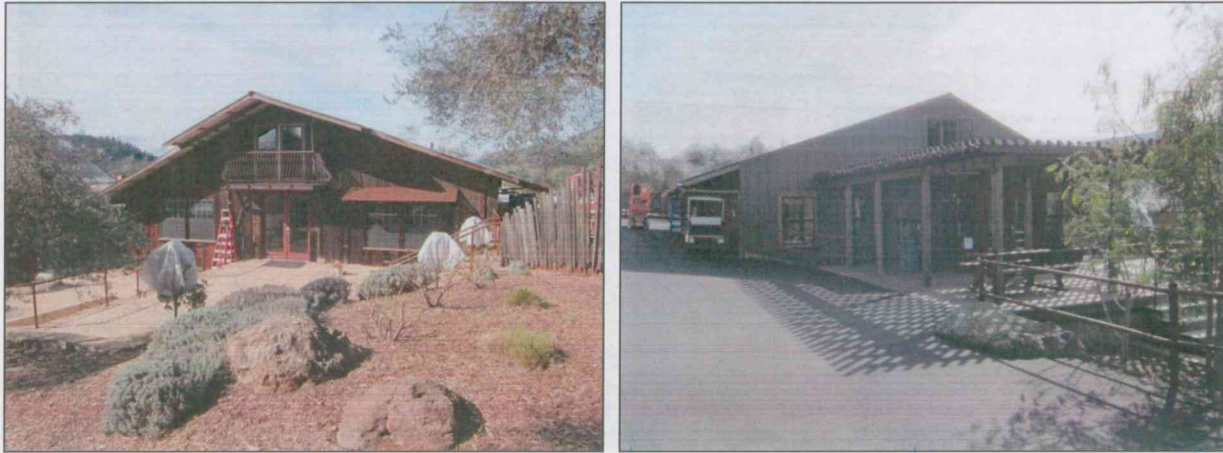
Figures 7 and 8. Left image shows the south elevation of the now enclosed Stock Barn. The building was converted to offices for the present Regusci winery operations. Right image shows the north elevation with outdoor covered patio.

As offices for the present Regusci Vineyard management operations, the formerly open Stock Barn structure has been highly altered, with the entire structure enclosed with wood framing, new windows and entrances, to serve as offices for the present Regusci Winery (**Figures 7 and 8**). With the exception of the roofline and original structural plan, the present structure does not resemble the original physical configuration of the former Stock Barn.

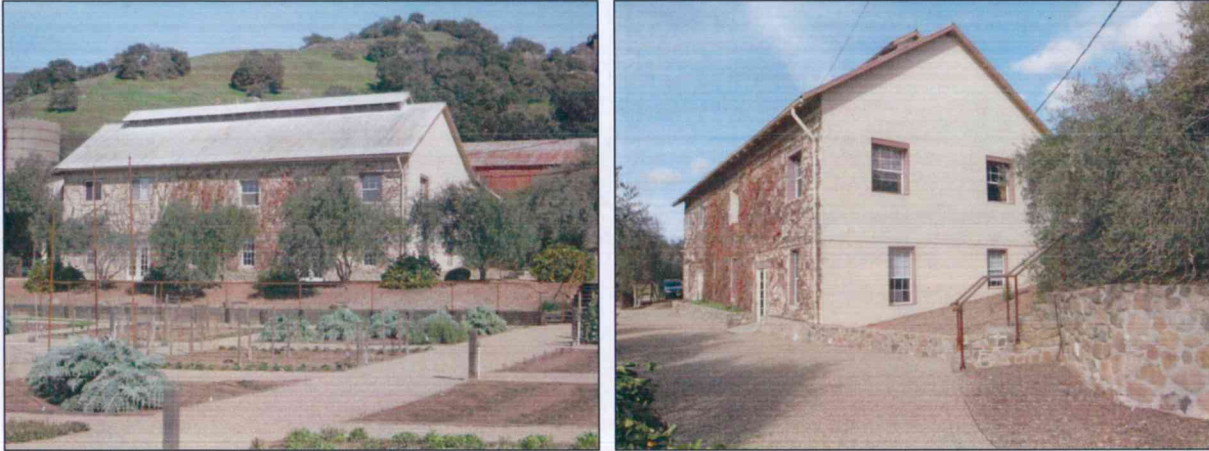
The former Slaughterhouse is a concrete-block building with a corrugated gable monitor roof (Figure 9). Following the end of slaughterhouse operations in 1974, the building was converted into offices and a caretaker's dwelling on the northeast side of the building.

Figures 9 and 10. Left image shows the west elevation with corrugated monitor roof and windows inserted in the building wall. Right image shows the south and west elevations, with windows and doors inserted into the building walls. Compare this image to the historic view of the south elevation, shown on Figure 6.

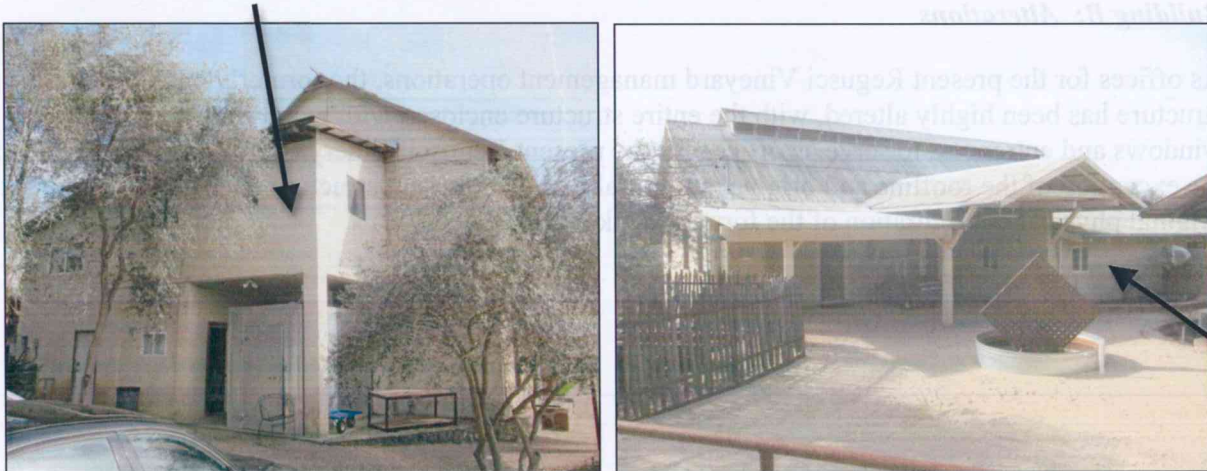
Figures 11 and 12. Left image shows large addition installed onto the north elevation (arrow). Right image shows the east elevation with the caretaker's dwelling at the far right of the image (arrow).

The north elevation originally featured an open, wood-framed structure that has been subsequently framed and covered with stucco, with newer window insertions (**Figure 11**). Additions to the east elevation include various shed roofs, including the shed roof sheltering the caretaker's dwelling at the building's northeast corner (**Figure 12**).

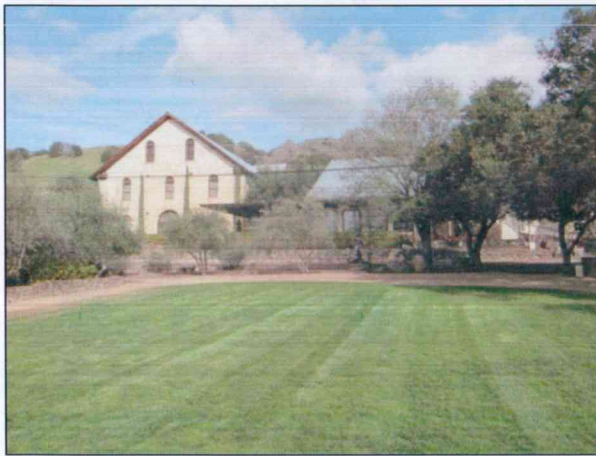
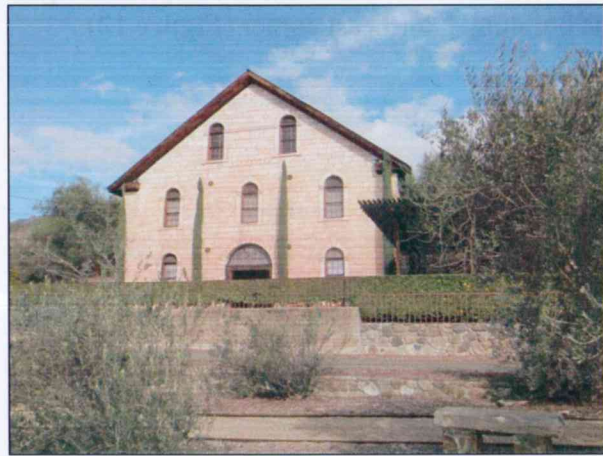
The circa-1878 Grigsby Winery building is a three-story stone building that dominates the farm site (**Figure 13**). The large, stone gable end facing Silverado Trail (west elevation) consists of a symmetrical composition with arched windows flanking a central arched entrance on the ground floor. The second and third floors also contain arched windows (**Figure 14**). The building is constructed into the hillside, to allow easy access to the building from the north elevation, which features a large set of double doors (**Figure 15**). Both the side elevations contain gable-roofed dormers, framed in wood and containing a single window (**Figure 16**).

Figures 13 and 14. Left image shows the west elevation taken from the lawn. Right image shows the west elevation's composition of arched windows flanking an arched central entrance.

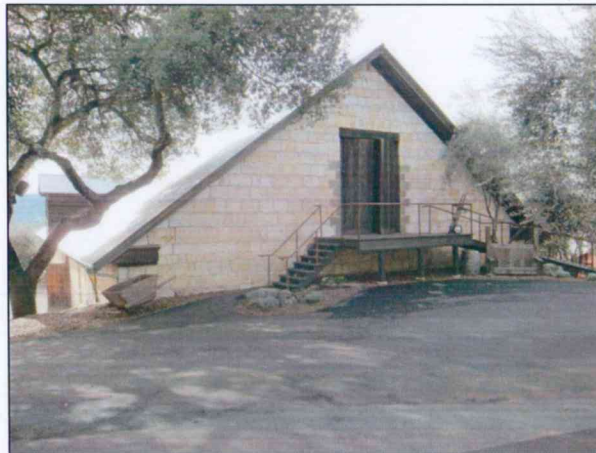
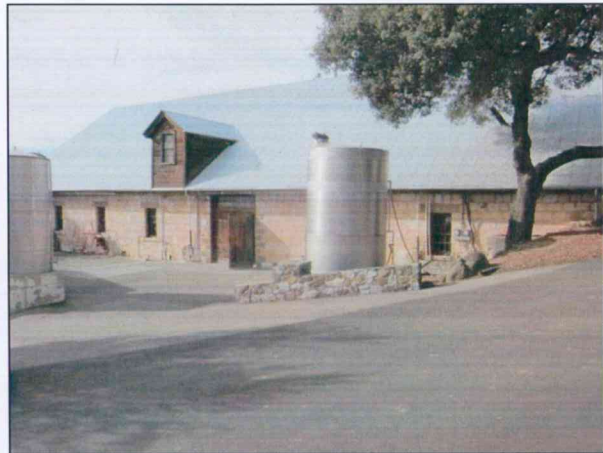
Figures 15 and 16. Left image shows the east elevation built into the hillside. The double doors access the building's third floor. Right image shows the south elevation, punctuated by a series of multiple-pane windows, with a gable-roofed dormer containing a single window.

The building is largely unaltered, with the primary changes being the addition of a shed roof sheltering building infrastructure on the north elevation and new entry stairs and deck to the east elevation (**Figure 15**). A circa-1930s fixed glass tympanum has been installed over the main entrance on the west elevation (**Figure 17**). Original wood sash windows remain; however windows contain various cracked, broken or missing panes at various locations.

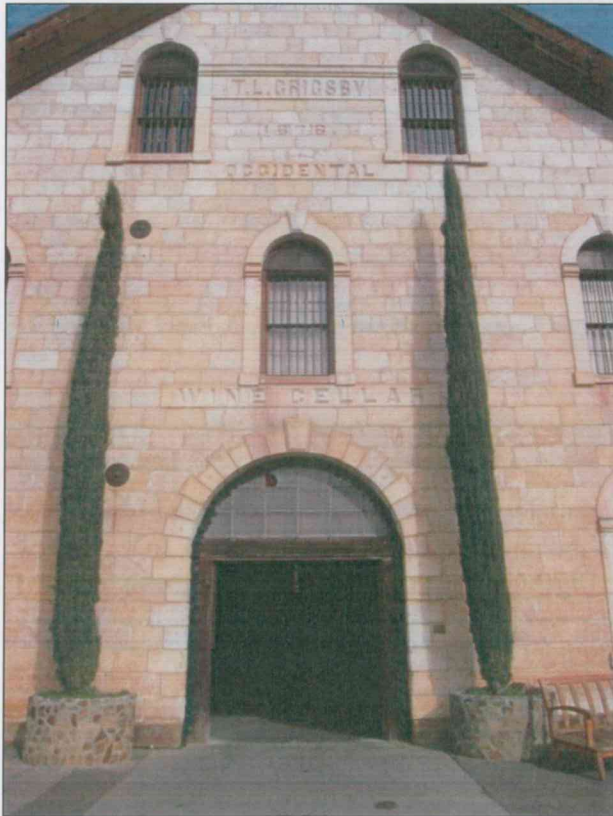
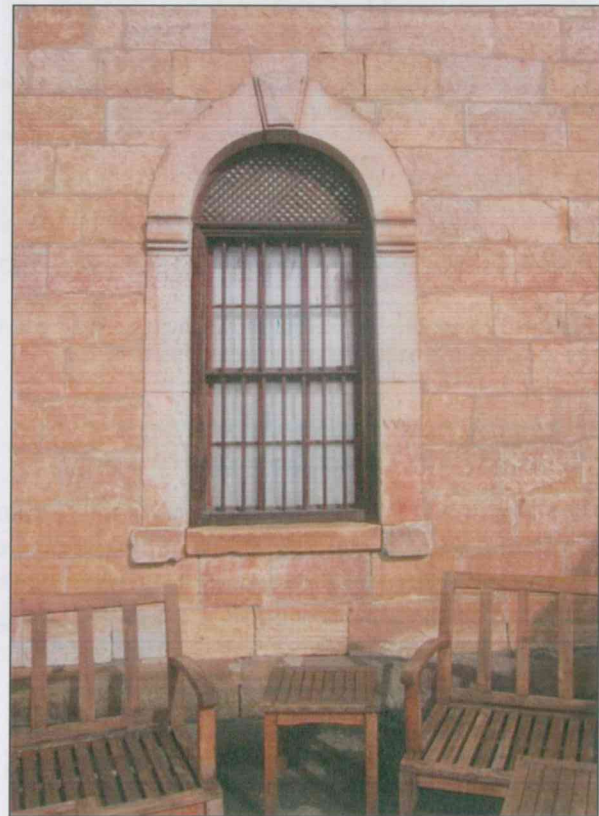
The building is constructed of lava stone, a locally quarried igneous rock. The composition is a hybrid Greek Revival/Romanesque Style, with roof cornice returns, arched windows that contain mult-light Greek Revival-style wood sash windows and framed by Romanesque stone surrounds with decorative keystones. The building features the carved stone inscription, “T.L. Grigsby/1878/Occidental/Wine Cellar.” The arched entrance is surrounded by quoins with a keystone (**Figure 17**). Windows also contain steel bars to prevent entry and theft (**Figure 18**).

Figures 17 and 18. Left image shows the front (west) elevation of the lava stone, circa 1878 Grigsby Winery building, with a handsome arched entrance surrounded by stone quoins and a keystone. Note the fixed-glass windows inserted in the arch's tympanum, likely done after the property changed ownership in the 1930s. Arched windows mimic the entrance and are placed symmetrically on the composition. Right image shows an arched window detail, with stone surround and keystone. Each window contains 6-over-6, wood sash windows in the Greek Revival style. The windows also contain steel bars for security.

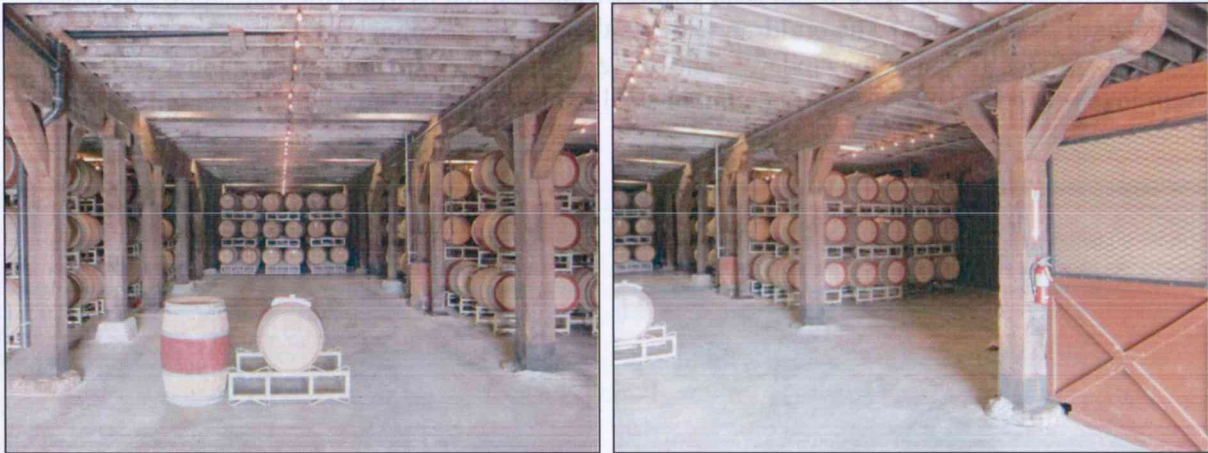
The building interior contains large timber vertical supports, capped with rounded column capitals and diagonal bracing. The columns support a series of Douglas fir floor joists. The floor is concrete slab for easy cleaning and maintenance (**Figures 19 and 20**).

Figures 19 and 20. Left image shows the ground floor interior looking east from just inside the entrance. Right image details the timber supports of the ground floor interior.

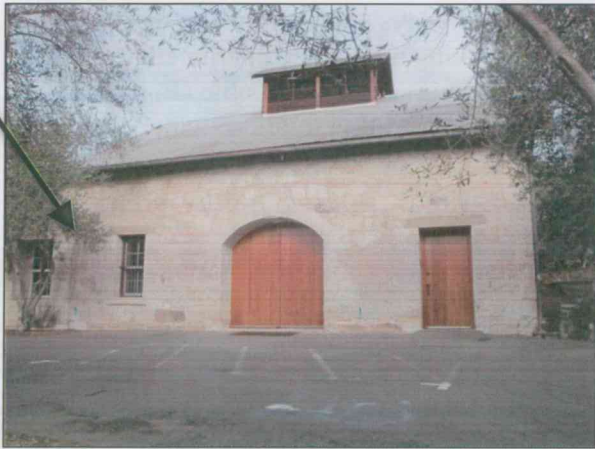
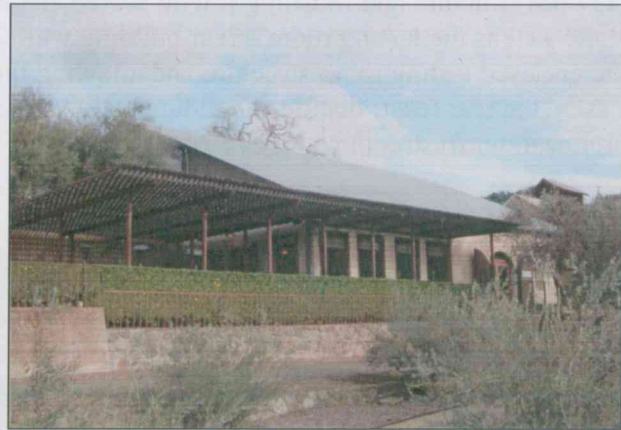
The present Winery Production/Tasting Room includes the circa-1878 Distillery as part of the composition. Also constructed of lava stone, the distillery mimics the winery building's composition with an arched entrance (Figure 21). In 1996, a tasting room was constructed adjacent and immediately north of the distillery, by enclosing the circa-1940 wood-framed structure (Figure 25 – next page) and finishing it with stucco scored to mimic the original lava stone (Figure 22). An outdoor patio seating area was constructed north of the tasting room, adjacent to the circa-1878 lava stone wall that connects the winery and distillery buildings (Figures 22 and 23).

Figures 21 and 22. Left image shows the west elevation of the circa-1878 Distillery, also composed of lava stone and containing a central arched entrance and roof dormer. The enclosed structure that is now the tasting room was constructed against the distillery wall (arrow). Right image shows the enclosed, circa-1940 wood structure that now serves as the tasting room. Compare this image to the historical image in Figure 25 – next page.

The circa-1878 distillery building is largely unaltered on its primary (west) elevation. The enclosed tasting room was constructed against the north distillery building wall and uses a scored stucco wall finish that mimics the lava stone of the distillery (**Figure 21**).

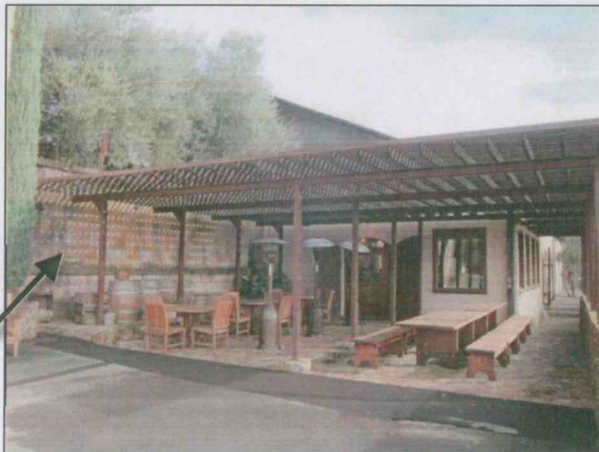
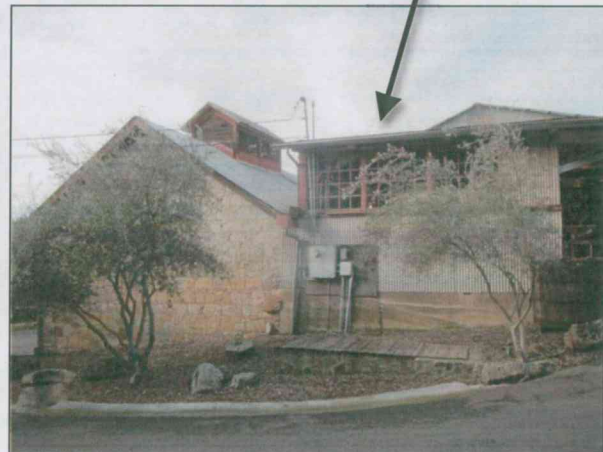
Figures 23 and 24. Left image shows the north elevation of the enclosed tasting room, with outdoor patio area. Note the lava stone wall at the left of the image. This wall was constructed in 1878, along with the winery and distillery buildings and connects the entire composition (arrow). Right image shows the south elevation of the distillery, with large addition constructed to the east (arrow).

The circa-1878 composition consisted of the winery building and distillery connected by a lava stone wall. Following purchase of the property by the Regusci family in 1932, James G. Regusci constructed a roof structure to the north of the distillery in 1942. This structure appears below in a circa-1940s photograph of the buildings (**Figure 25**). The tasting room was created by enclosing the open structure and finishing it with scored stucco to resemble lava stone and using the 1878 stone wall as the tasting room's rear building wall. A patio seating area was constructed north of the enclosed tasting room structure and allowing the original stone wall to be visible (**Figure 23**). Lastly, the rear (east) distillery building wall has received a large addition to house winery production infrastructure (**Figure 24**).

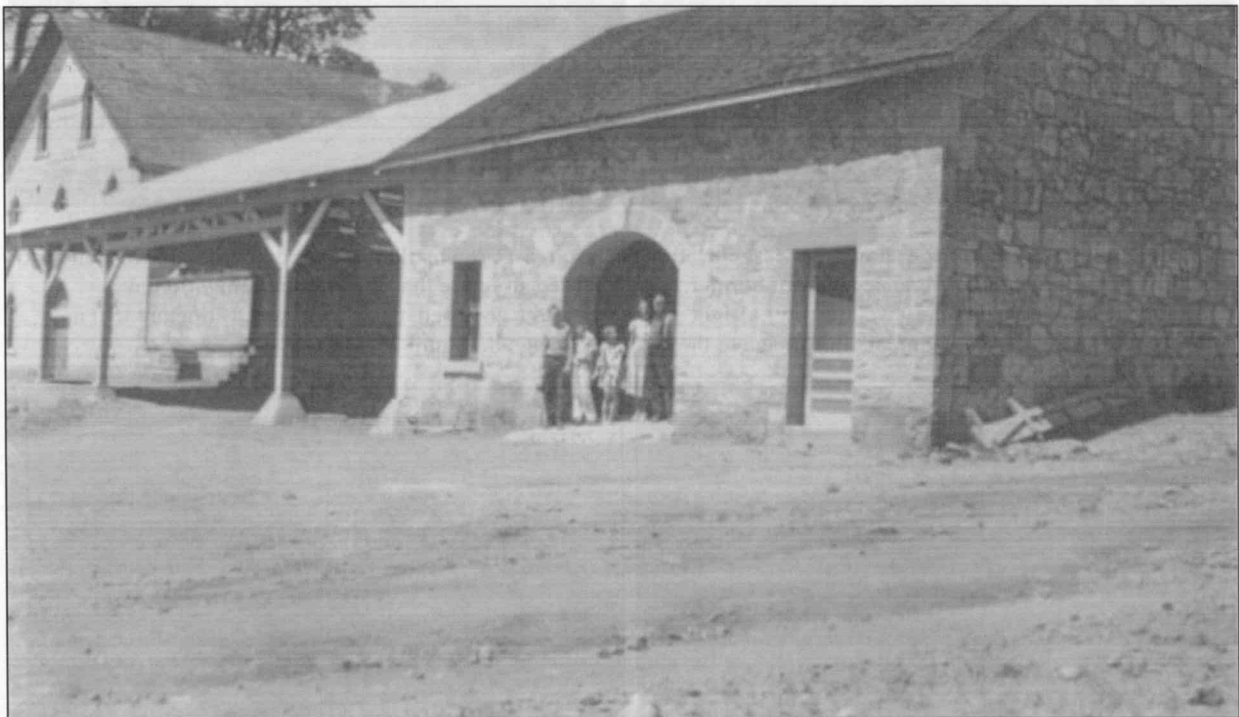
Figure 25. View of circa-1940s open structure between the Winery Building and the Distillery. This structure was enclosed in 1996 to create the present tasting room (*Courtesy: James Regusci Family*)

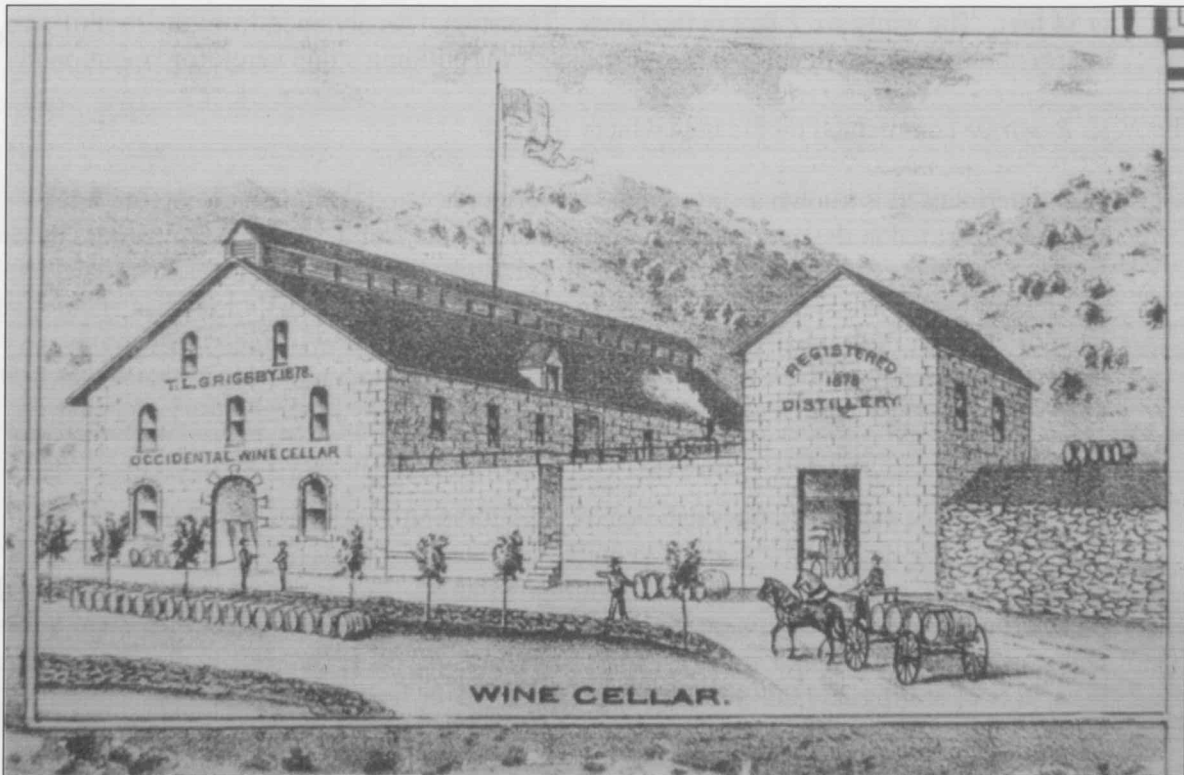
Figure 26. Detail of circa-1878 drawing of Grigsby Winery. Please note that the Grigsby Winery as constructed differs significantly from this illustration, which was common for these publications.

While the illustration shown on **Figure 26** shows the essential composition of winery and distillery connected by a stone wall, the building orientation and details, as constructed, differ significantly. The winery building does not have a monitor roof as shown in the image; nor does the connecting wall have a central staircase. The staircase is located at the south end of the wall adjacent to the distillery. The distillery shown in the circa-1878 drawing orients the gable end facing west, as in the winery building. However, this was not how the distillery was constructed, which was to orient the gable roof direction opposite what is shown in the drawing. Also, the drawing does not show the central roof dormer that presently exists on the distillery building (**Figure 21**).

The above, circa-1878 illustration taken from Illustrations of Napa County California with Historical Sketch (Figure 26) demonstrates the significance of the Napa Valley wine industry before the combined effects of a national financial panic and the Phylloxera pest infestation of the 1870s/1880s sent the wine industry into significant collapse. These effects placed a huge toll on T.L. Grigsby’s financial holdings, as he was heavily invested in his Occidental Winery. Grigsby also made a catastrophic mistake when he organized the San Francisco, Clear Lake and Humboldt Co. Railroad in 1887.¹⁵ The line would run from Napa City, through the then-fertile Napa Valley wine region north to Clear Lake, and along the Eel River in Humboldt County. The railroad was described in 1887 in the journal *Railway World*, but the railroad was never constructed.¹⁶ The combined effects of the Phylloxera pest infestation’s destruction of the vineyards, the Financial Panic of the 1870s-1880s and the failed railroad venture led to the financial ruin of Terrell L. Grigsby, who died in Napa in 1892. The Grigsby property was sold by Terrell’s heirs in 1932 to James G. and Livia Regusci.
