## Biological Assessment

Cardey Residence Driveway Repair Use Permit Exception to  
the Conservation Regulations, #P18-00116-UP &  
Request for Exception to Road and Street Standards  
Planning Commission Hearing June 20, 2018

RE: Biological Assessment at 1100 McCormick Lane, Napa County  
Driveway Repair and Improvement Plan

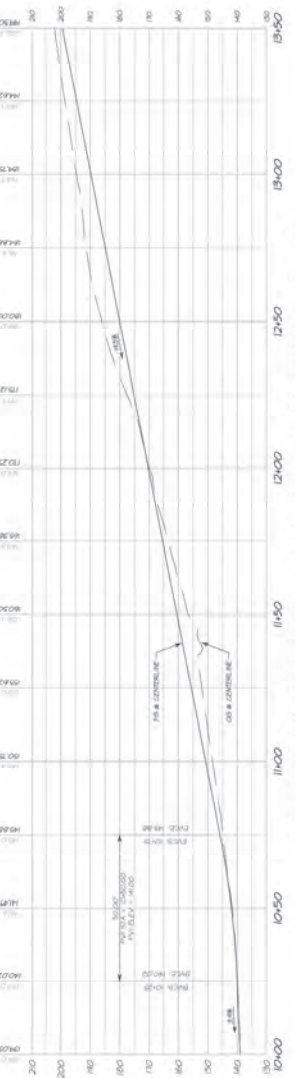
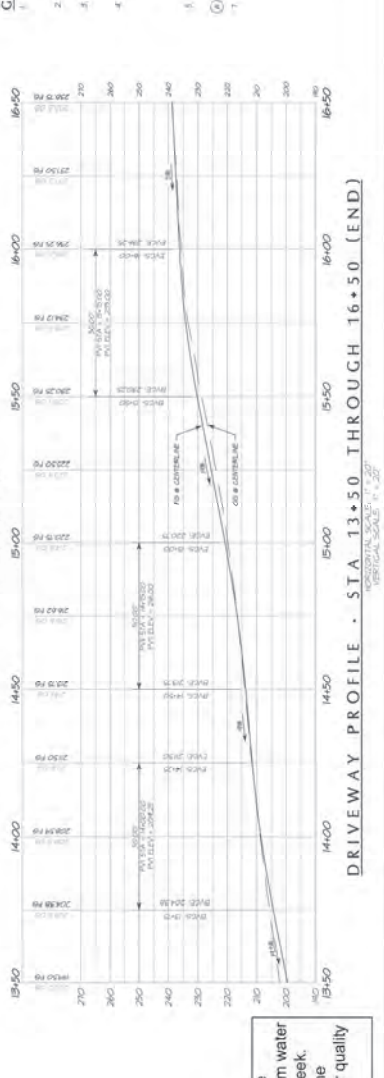
**GRADING & LAYOUT PLAN**  
 SCALE: 1" = 20'

Figure 2b. Plans showing how the driveway will be repaired and other improvements, such as the storm water collection system and delivery to Browns Valley Creek. The drainage system will detain sudden runoff to the creek, reduce sediment in runoff, and protect water quality in the creek.

The proposed project is the repair and improvement of a driveway destroyed by a landslide that provides access to an existing residence (Figures 2a, 2b, and 2c). The repair and improvement of the driveway will include realignment to avoid the landslide area and place the driveway on stable ground. The improved driveway will be straightened and go directly uphill after crossing the bridge which will avoid the landslide area. Because of the uphill gradient, the driveway will need to be excavated in places and filled in places in order to reduce the gradient. Existing underground utilities, which include electric, communication, and water lines, will be relocated within the new driveway.

The stormwater runoff system will be improved as part of the project. Two culverts in the upper driveway section pre-existing the landslide will be removed and the temporary plastic culvert that was installed after the landslide occurred will also be removed. The system will include rock-lined roadside ditches and new 12-inch diameter culvert at the upper end of the driveway. A stormwater detention basin will be installed with a 36-inch diameter overflow riser connected to an 18-inch diameter underground pipe leading downhill to the existing 24-inch diameter culvert that outfalls to the creek. Storm drain inlets will be installed at appropriate locations along the driveway, also connected to the 18-inch pipe to periodically collect runoff and pipe it down slope. The 24-inch culvert will be extended downslope on the creek bank to bring the outfall closer to the creek and allow installation of a flow energy dissipator made of rock. This dissipator will be installed above the ordinary high water elevation of the creek at approximately the 130 feet amsl level and will be approximately 40 feet from the flowline of the creek. Finally, an existing 12-inch diameter culvert and storm drain inlet at the bottom of the driveway will remain, however a flow energy rock dissipator will be installed as part of the driveway improvement because one is not present now.

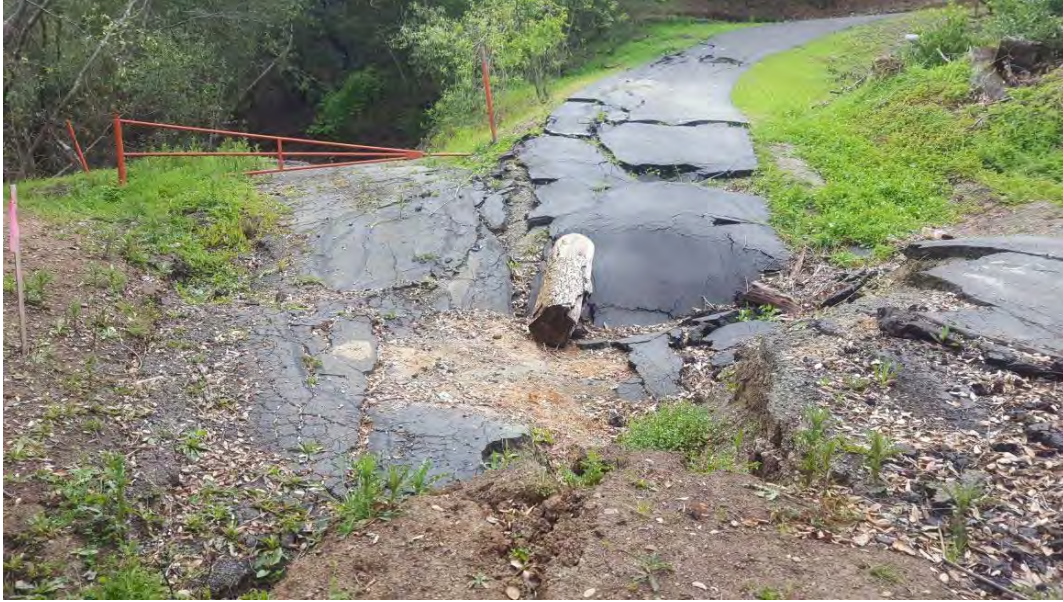
Above: View of the existing conditions at the Project Area showing the extent of damage to the existing driveway from the landslide.

The existing driveway begins just south of the McCormick Lane bridge crossing Browns Valley Creek. The original driveway made a gradual curve to the east and back to the west while ascending a hill and continuing more or less due south to the northwest corner of the main property area. The landslide affected the lower part of the driveway, including a portion shared with the neighboring property, that veers eastward to the Moose Lodge. The slide moved northward toward the creek and caused breaks in the asphalt driveway and dislodged several large diameter trees. Some of the trees, although dislodged, were still living at the time of the site visit, but their long-term prognosis for continuing survival is unknown. Most of the vegetation that existed prior to the landslide had been removed from the landslide area after the slide occurred in order to expose the landslide conditions and allow observation and testing to determine how to repair or re-establish the driveway.

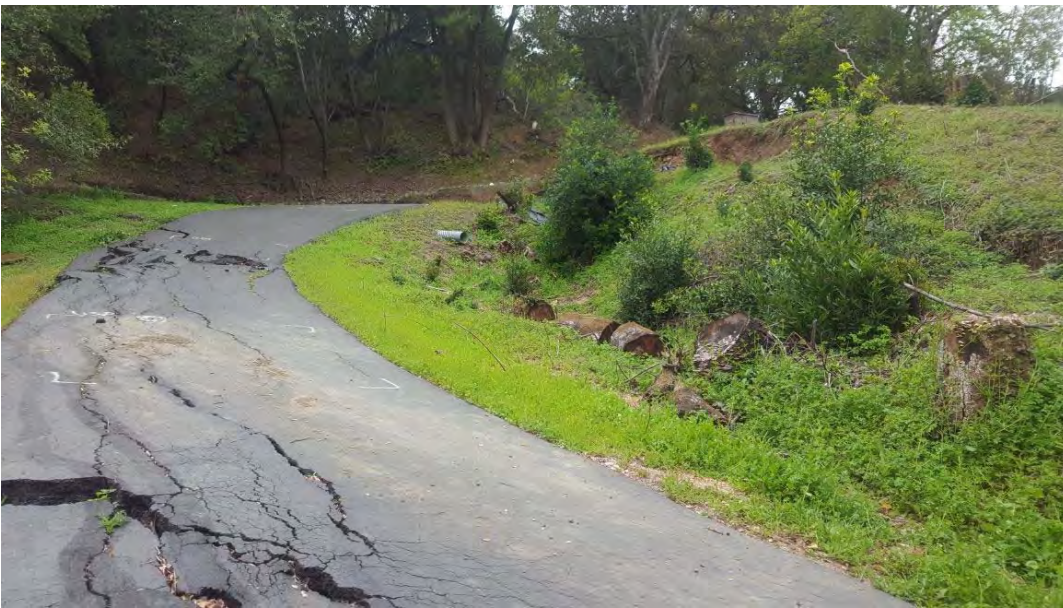
Below: Vegetation was cleared on and adjacent to the landslide in order to investigate the extent of the landslide and determine repairs.

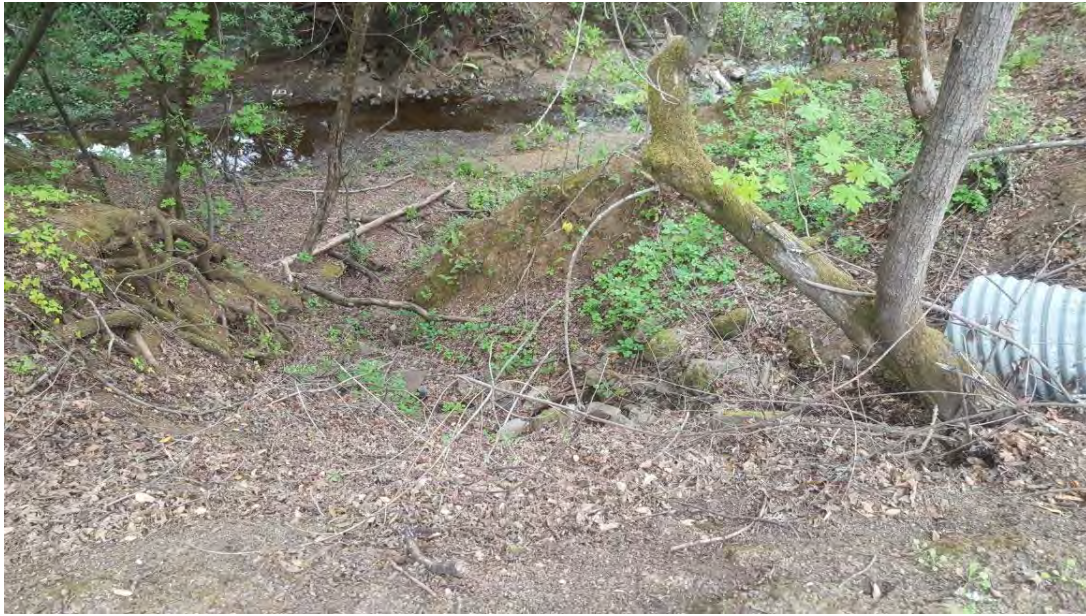
Above: The existing 24-inch culvert outfall on the banks of Browns Valley Creek. The culvert will be extended down the bank and a rock energy dissipator will be installed.

The landslide disrupted the existing storm runoff drainage system that had been in place. Runoff from upslope flowed in a series of rock-lined roadside ditches and culverts crossing the driveway, culminating at a 24-inch diameter metal culvert outfall on the upper bank of Browns Valley Creek. A temporary plastic culvert (15-inch diameter) was installed above the landslide area after the slide occurred in order to divert water away from the slide area. The storm runoff system will be redesigned as part of the driveway improvements.

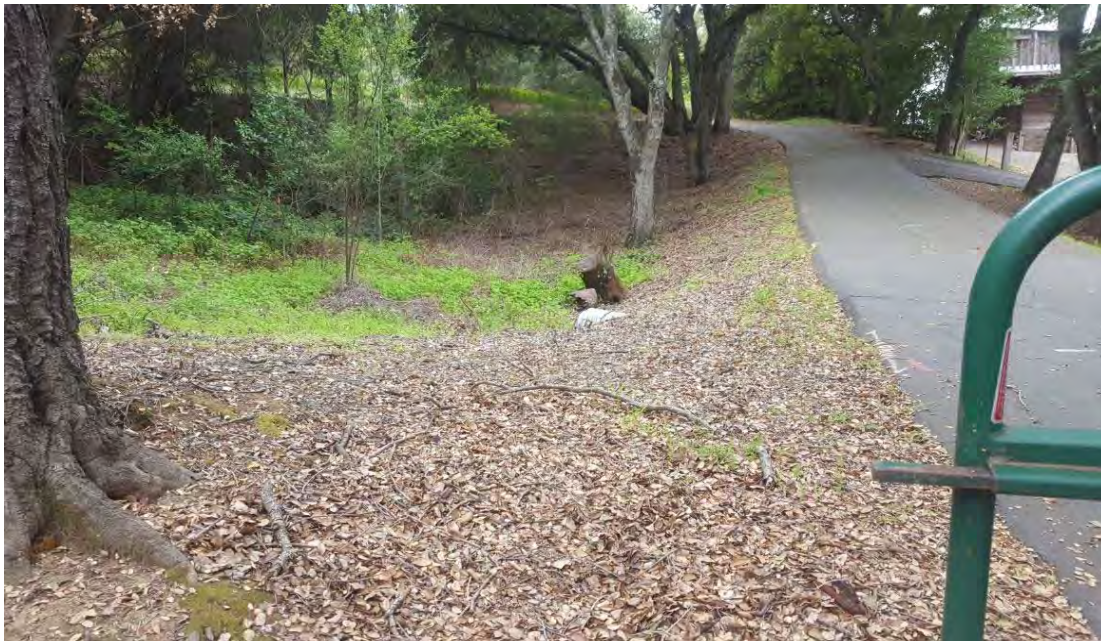
Below: A new feature of the storm drain system will be a detention basin installed to the left of the driveway in an existing depression. Detention will slow runoff to the creek and allow ground infiltration extending base flow in the creek.

The storm water system of the improved driveway will also help to protect water quality in Browns Valley Creek. The new detention basin near the upslope end of the driveway will detain water and slow the runoff into the creek. In addition, the detention basin will allow some infiltration of water into the ground and will likely contribute to lengthening base flow period in the creek. The rocked ditches and storm drain inlets along the driveway, and installation of rock energy dissipators at the two culvert outfalls near the bottom of the driveway, will also contribute to reducing erosion and sediment in runoff.
