Water Availability Analysis and Water use Calculations

Anthem Winery P14-00320-MOD and Exception to Road and Street Standards,
Variance P14-00321-VAR and Viewshed, and
Agricultural Erosion Control Plan P14-00322-ECPA
Planning Commission Hearing Date (Wednesday, October 3, 2018)

Re: Results of Aquifer Testing of Project Wells and
Napa County Tier 1 Water Availability Analysis
For Proposed Anthem Winery
3454 Redwood Road and 3123 Dry Creek Road
Mt. Veeder Area, Napa County, California

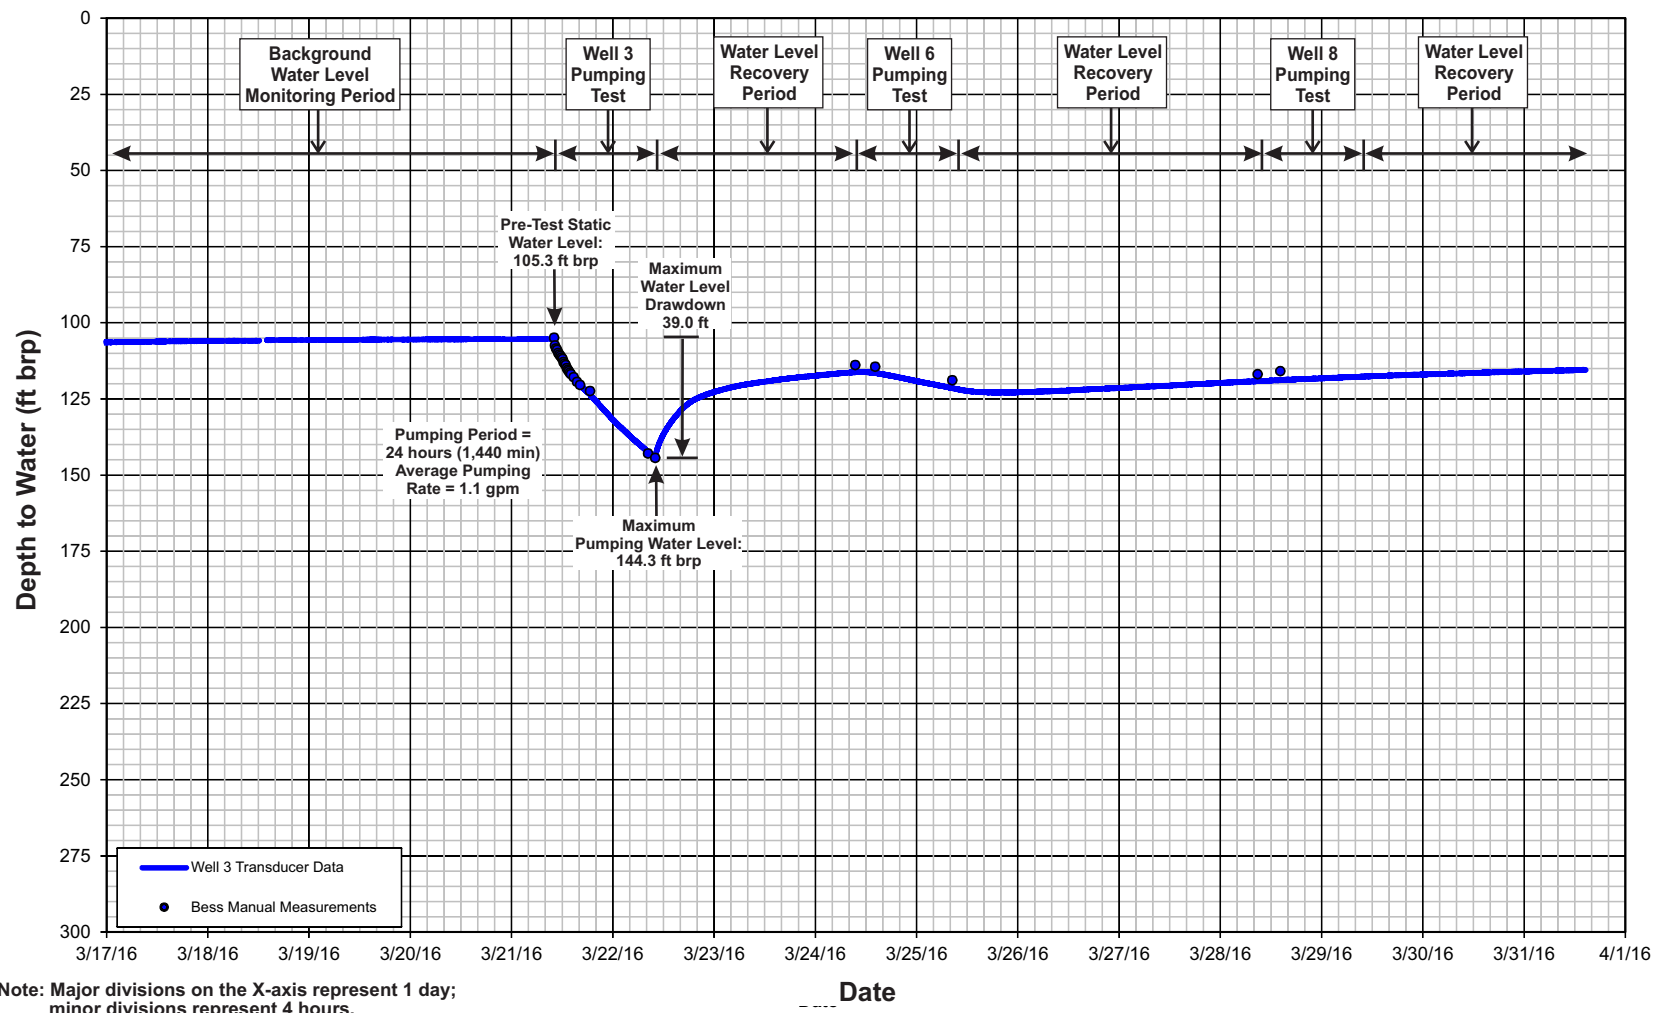
FIGURE 4A
WATER LEVELS DURING AQUIFER TEST
WELL 3
PROPOSED ANTHEM WINERY

- drawdown impact was detected in the transducer for Well 2 while performing the 24-hour constant rate test at Well 8.
- Well 3 – Transducer data for Well 3 (Figure 4A) show that water levels increased approximately 1.5 ft over the entire 24-hour pumping period in Well 8. Therefore, no definitive water level drawdown impact was observed in Well 3 during the 24-hour constant rate pumping test at Well 8. Well 3 water levels may have still been recovering from its pumping test between March 21 and 22, 2016, and/or from the water level drawdown impacts induced by the pumping test at Well 6 between March 24 and 25, 2016.

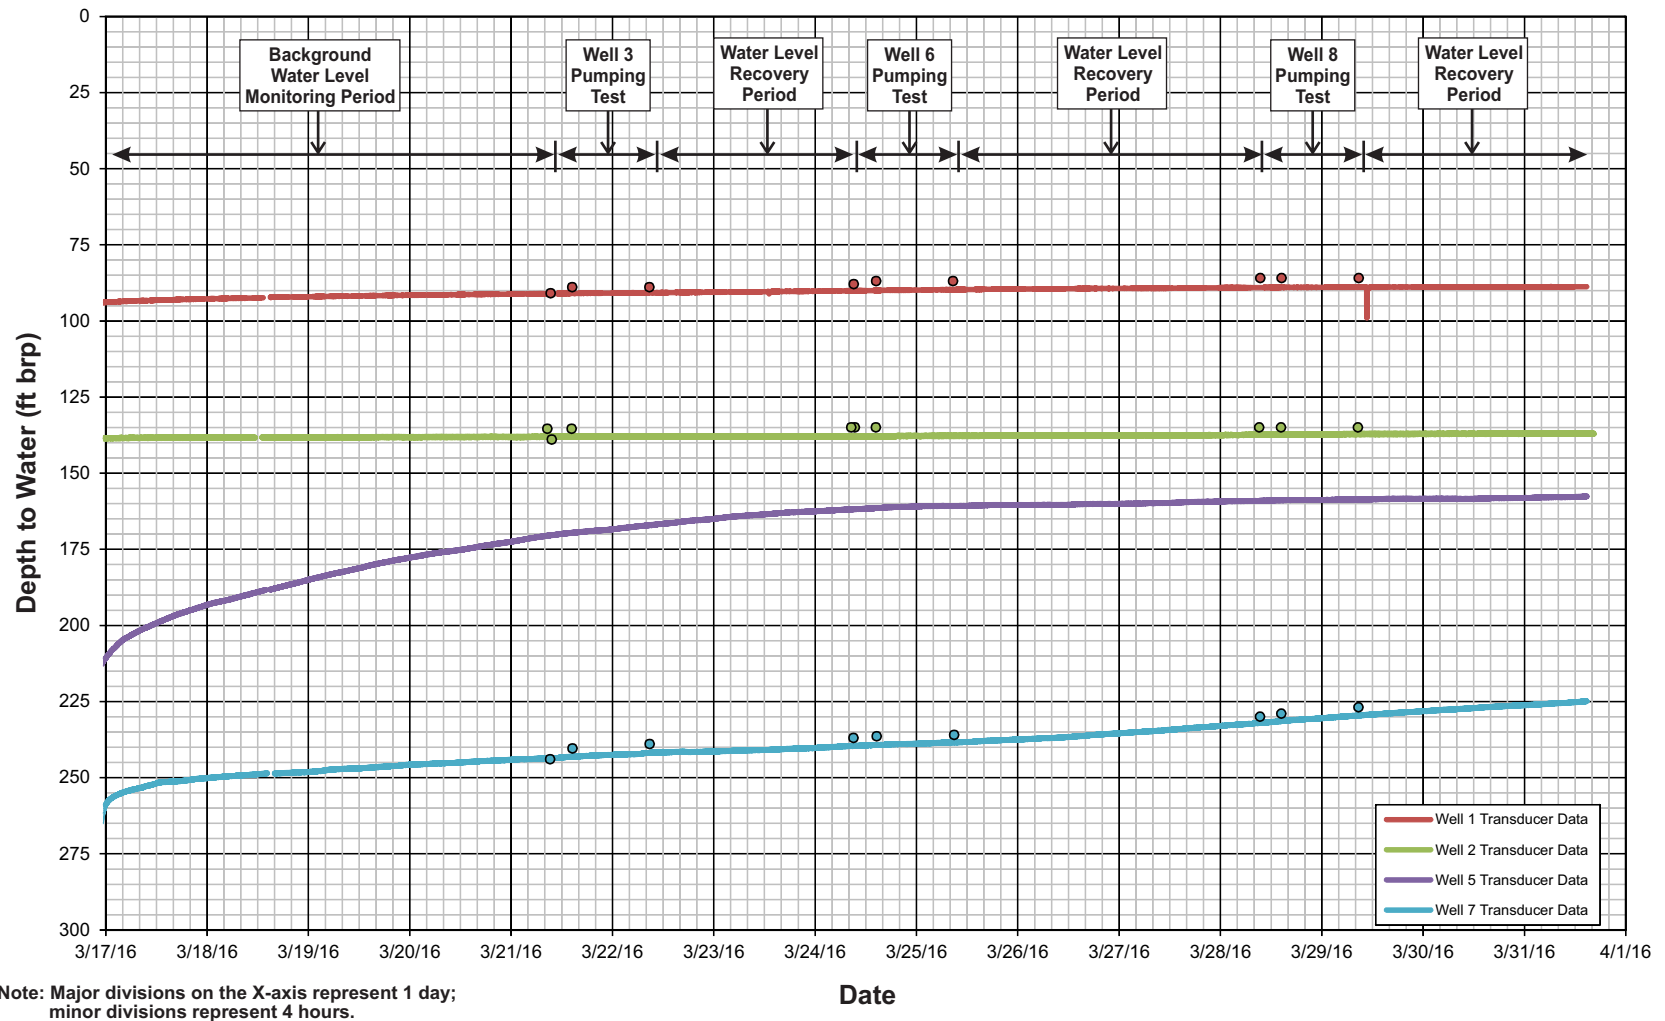
- Well 1 – Water levels recorded by the transducer in Well 1 (Figure 4D) showed no definitive water level drawdown impact during the 24-hour constant rate pumping test at Well 3. That is, water levels in Well 1 were observed to actually have slightly increased by roughly 0.3 ft during the 24-hour testing period at Well 3. In the 48-hour water level recovery period, water levels in Well 3 continued to increase by another 0.6 ft, prior to the commencement of the test at Well 6.

- Well 5 – Transducer data for Well 5 (Figure 4D) show that water levels increased approximately 3.4 ft over the entire 24-hour testing period of Well 3. Therefore, no definitive water level drawdown impact was observed in Well 5 during the 24-hour constant rate pumping test at Well 3. Well 5 water levels may have still been recovering slowly following the pumping of this well on March 16, 2016.

- Well 5 – Water levels in Well 5 (Figure 4D) appeared to be increasing continuously during the 24-hour constant rate pumping test of Well 6. Transducer data for Well 5 show that water levels increased approximately 1-foot over the entire 24-hour testing period at Well 6. Well 5 water levels appeared to have still been recovering slightly from a short pumping period in this well on March 16, 2016. Thus, no definitive water level drawdown impact was detected in the transducer for Well 5 while performing the 24-constant rate test at Well 6. As is commonly the case in fractured rock systems, the fact that no drawdown interference was recorded suggests that Well 5 is too distant from Well 6 and does not lie in the sphere of pumping influence created by Well 6, or that these wells do not extract groundwater from the same water-bearing fractures.

- Well 1 – Water levels recorded by the transducer in Well 1 (see Figure 4D) showed no definitive water level drawdown impact while performing the 24-hour constant rate pumping test at Well 8. That is, water levels in Well 1 were observed to have slightly increased by roughly 0.1 ft during the 24-hour testing period. Thus, no definitive water level drawdown impact is apparent in the water level data collected in Well 1 while performing the 24-hour constant rate test at Well 8.
- Well 2 – Water levels in Well 2 (Figure 4D) increased approximately 0.1 ft during the entire testing period of Well 8. Thus, no definitive water level

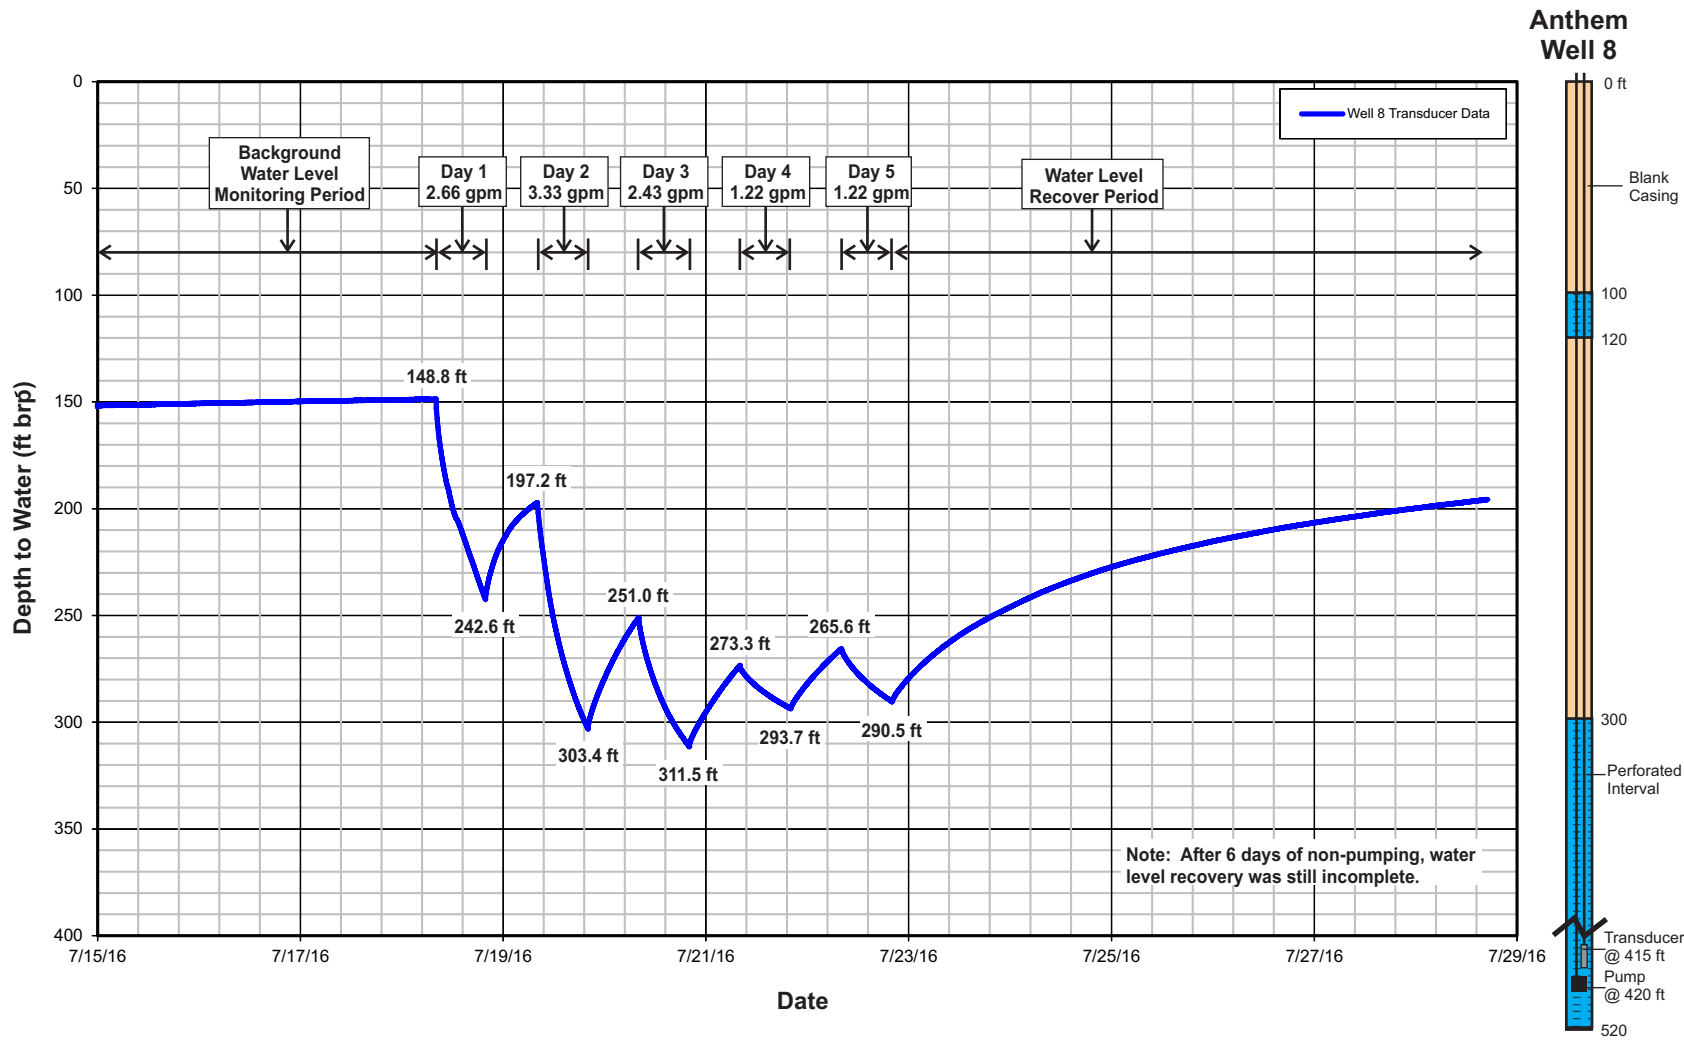
FIGURE 6
WATER LEVELS DURING 5-DAY PUMPING TEST
WELL 8
PROPOSED ANTHEM WINERY

The original results of the constant rate pumping test performed in Well 8 by Bess in late-March 2016 showed that Well 8 likely could not sustain an operational pumping rate of 6.9 gpm. As a result, and following discussions with the property owner, future anticipated groundwater demands for the project were reduced by the owner through the inclusion of process waste water recycling, increased rainwater harvesting, and the planned installation of a higher efficiency irrigation system in the vineyards to be planted. Based on these project changes, RCS recommended performing another pumping test in Well 8 but at lower rates than those used during its prior test in March 2016. Pumping at these lower rates could help determine a more feasible pumping rate for Well 8. RCS recommended performing a constant drawdown-type test (in lieu of a constant rate test) at pumping rates on the order of 3 gpm for Well 8. RCS also recommended performing this pumping test over a 5-day period with alternating 12-hour periods of pumping and non-pumping (i.e., 12 hours pumping followed by 12 hours of water level recovery). These alternating periods of pumping and water level recovery were performed to help “mimic” the proposed future operational pumping of this project well, based on the project water demand data provided by RSA+.
