Re: Phase 1 Environmental Site Assessment  
Vineyard and Access Road  
South of Soscol Ferry Road  
Napa, California

**PHASE 1  
ENVIRONMENTAL SITE  
ASSESSMENT**

**Vineyard and Access Road  
South of Soscol Ferry Road  
Napa, California**

Project 19-4771

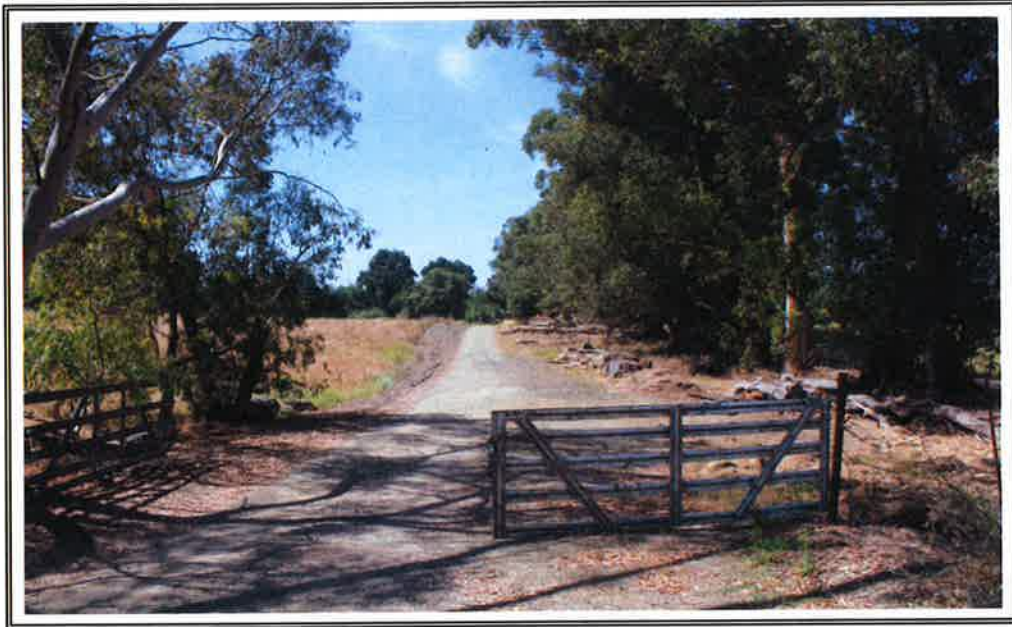
1. View of the Access Road on the Subject Property Looking South From Soscol Ferry Road

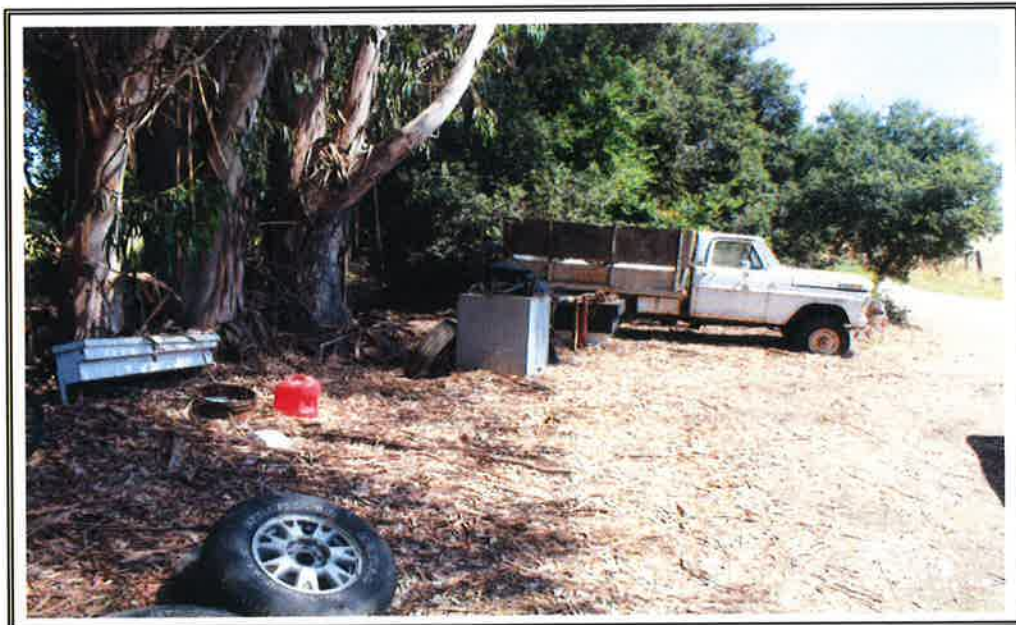
The Subject Property consists of an vineyard and access road. On the day of the inspection, no use of hazardous materials were observed on the site, as can be seen in Photographs 1 - 10 in Appendix C. On the west side of the access road, containers were observed, as can be seen in Photograph 2. They were not labeled, and the contents of these containers could not be determined. There were also bee hives; apparently non-operating vehicles and equipment; and a small wood mill located along the access road. In the covered storage area, two (2) 2.5 gallon containers of hydraulic oil, fuel containers, small containers of oil additives and spray cans of lubricant and paint were observed, as can be seen in Photograph 10. Also observed in this area was a cargo container in which sacks of sulfur and quart containers of fungicide were located. None of the containers were leaking, and no evidence of significant past leaks were observed.

2. View of Containers Observed Along the Access Road Whose Contents Were Not Determined

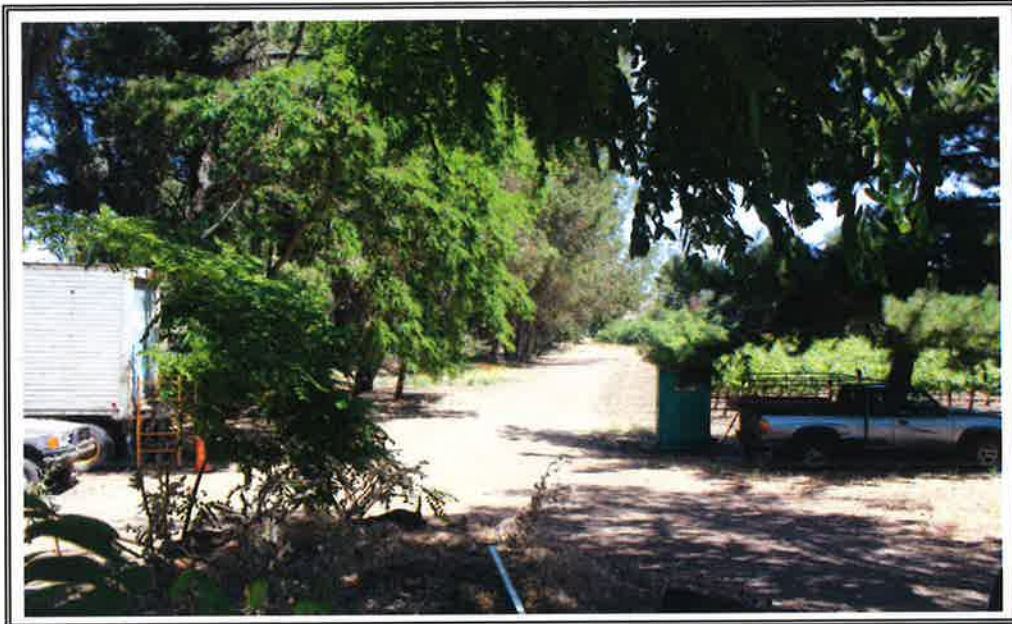
3. View of the Access Road Looking North Showing Trucks and an Outhouse

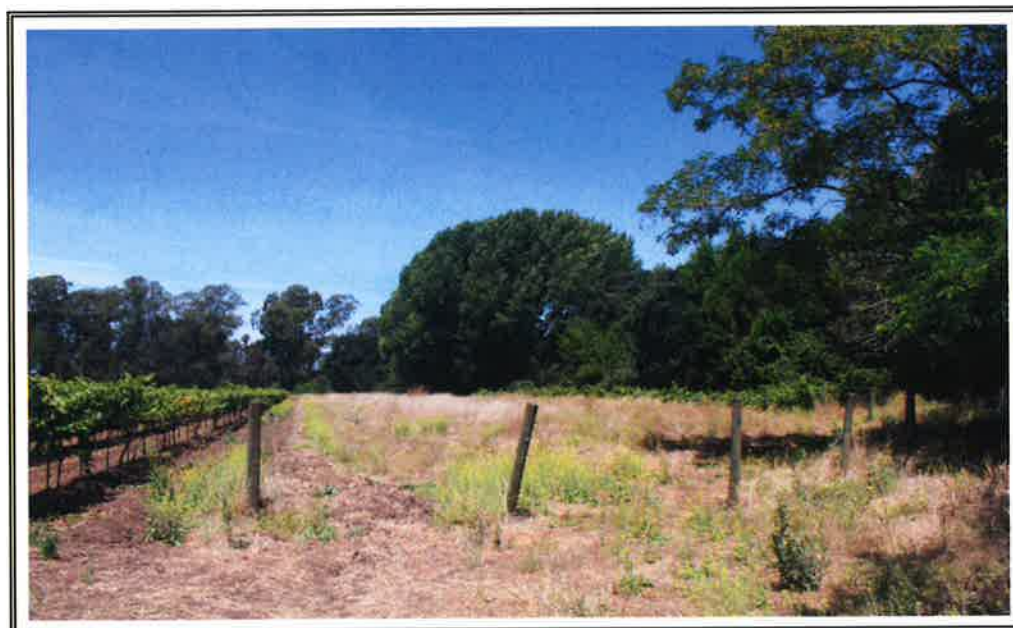
6. View of an Area in the Northwestern Portion of the Subject Property Which  
Had Been Cleared of Vines

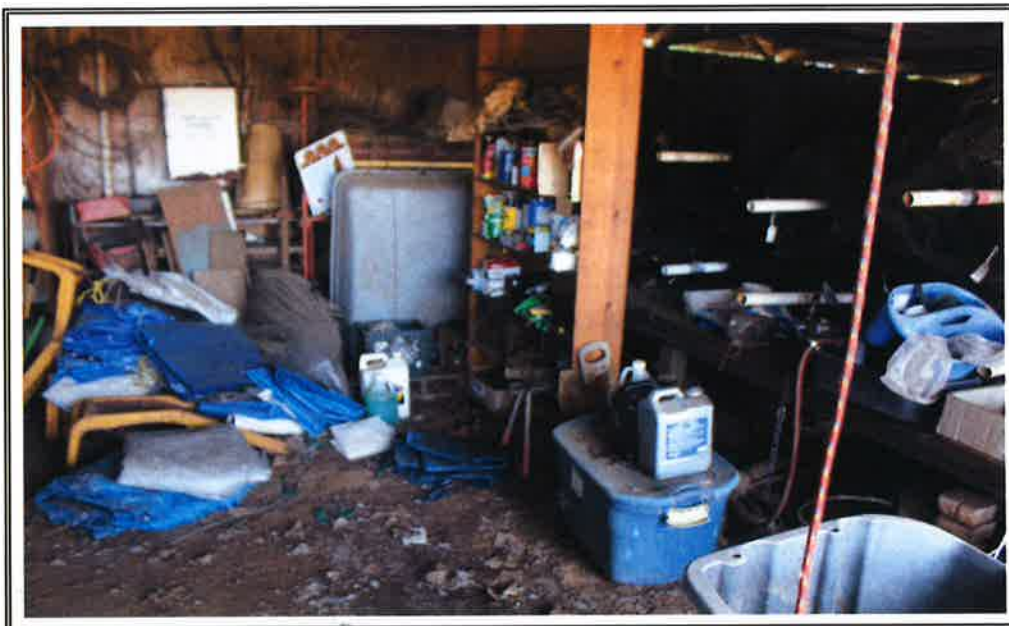
10. View of Containers of Hazardous Materials in the Covered Storage Area in the  
Southwestern Portion of the Subject Property

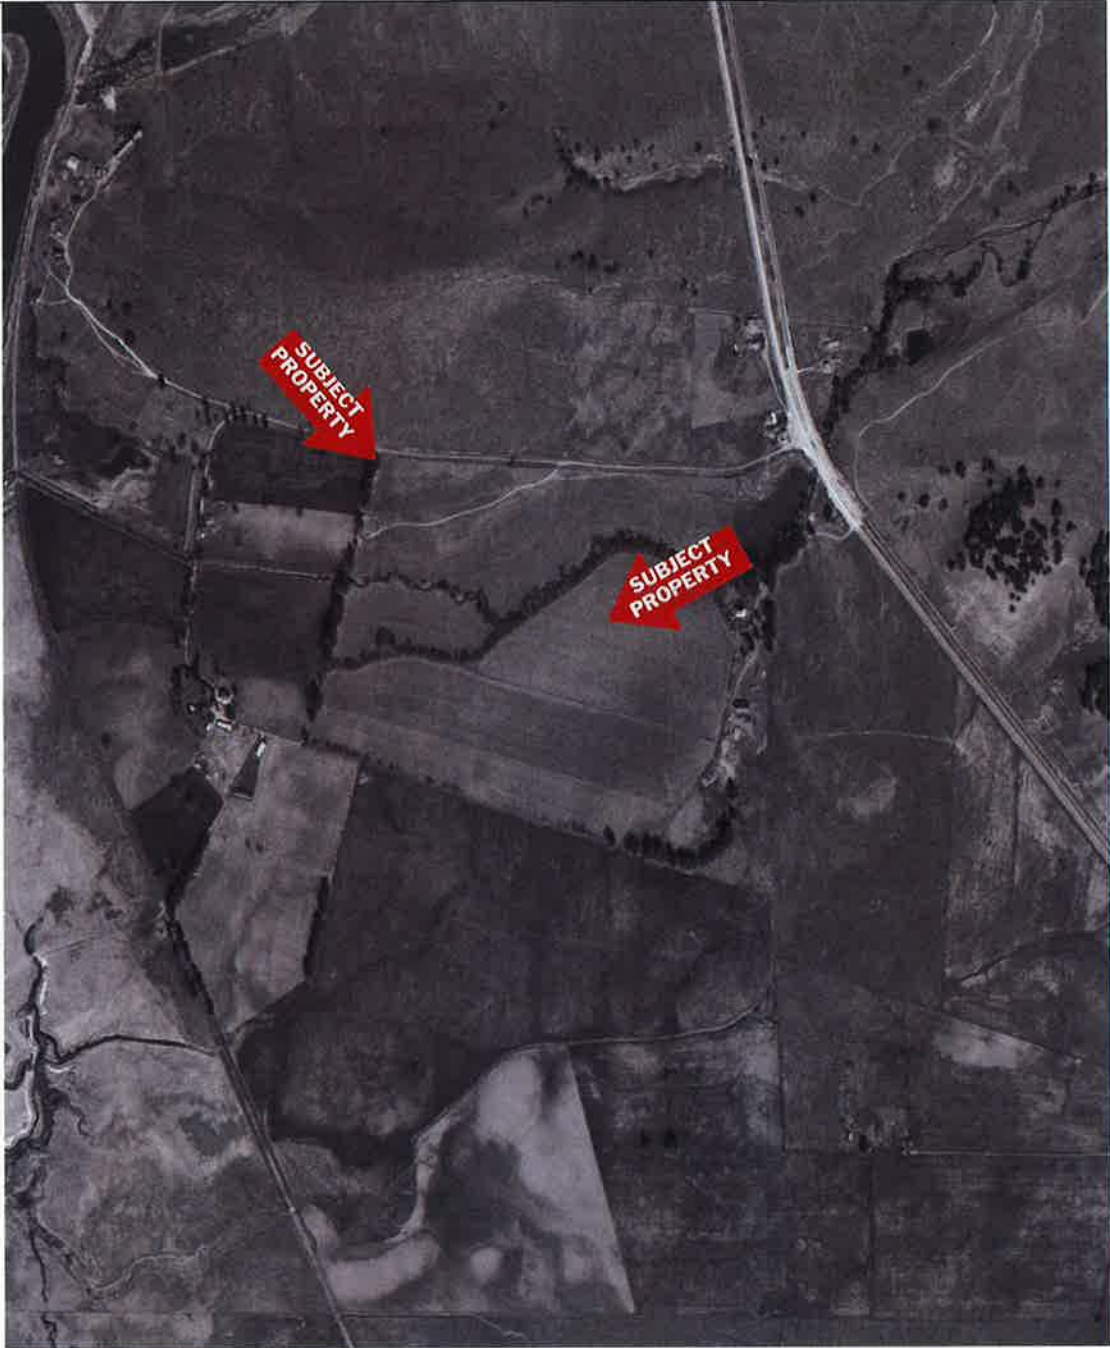
FIGURE:  
C-1

- An aerial photograph taken in **1948** showed the Subject Property and the adjoining property to the south to be undeveloped and possibly used for crop production or pasture land. In the adjoining area to the north was Suscol Creek, and the parcels to the north of the creek were shown to be undeveloped, with no evidence of activity observed. Adjoining to the east was an undeveloped area that was possibly used for crop production or pasture land; as well as structures that appeared to include a residence, a barn and out buildings. Adjoining to the west were undeveloped parcels that were possibly used for crop production or pasture land. Smaller structures that appeared to include residences and storage buildings were shown to the southwest, northeast and northwest. State Highway 12 and Devlin Road had not been built. Railroad tracks were shown to the west. The Napa River was shown to the northwest. Most of the surrounding area was undeveloped. A copy of this aerial photograph can be seen as Figure C-1 in Appendix C.

1948 AERIAL  
PHOTOGRAPH

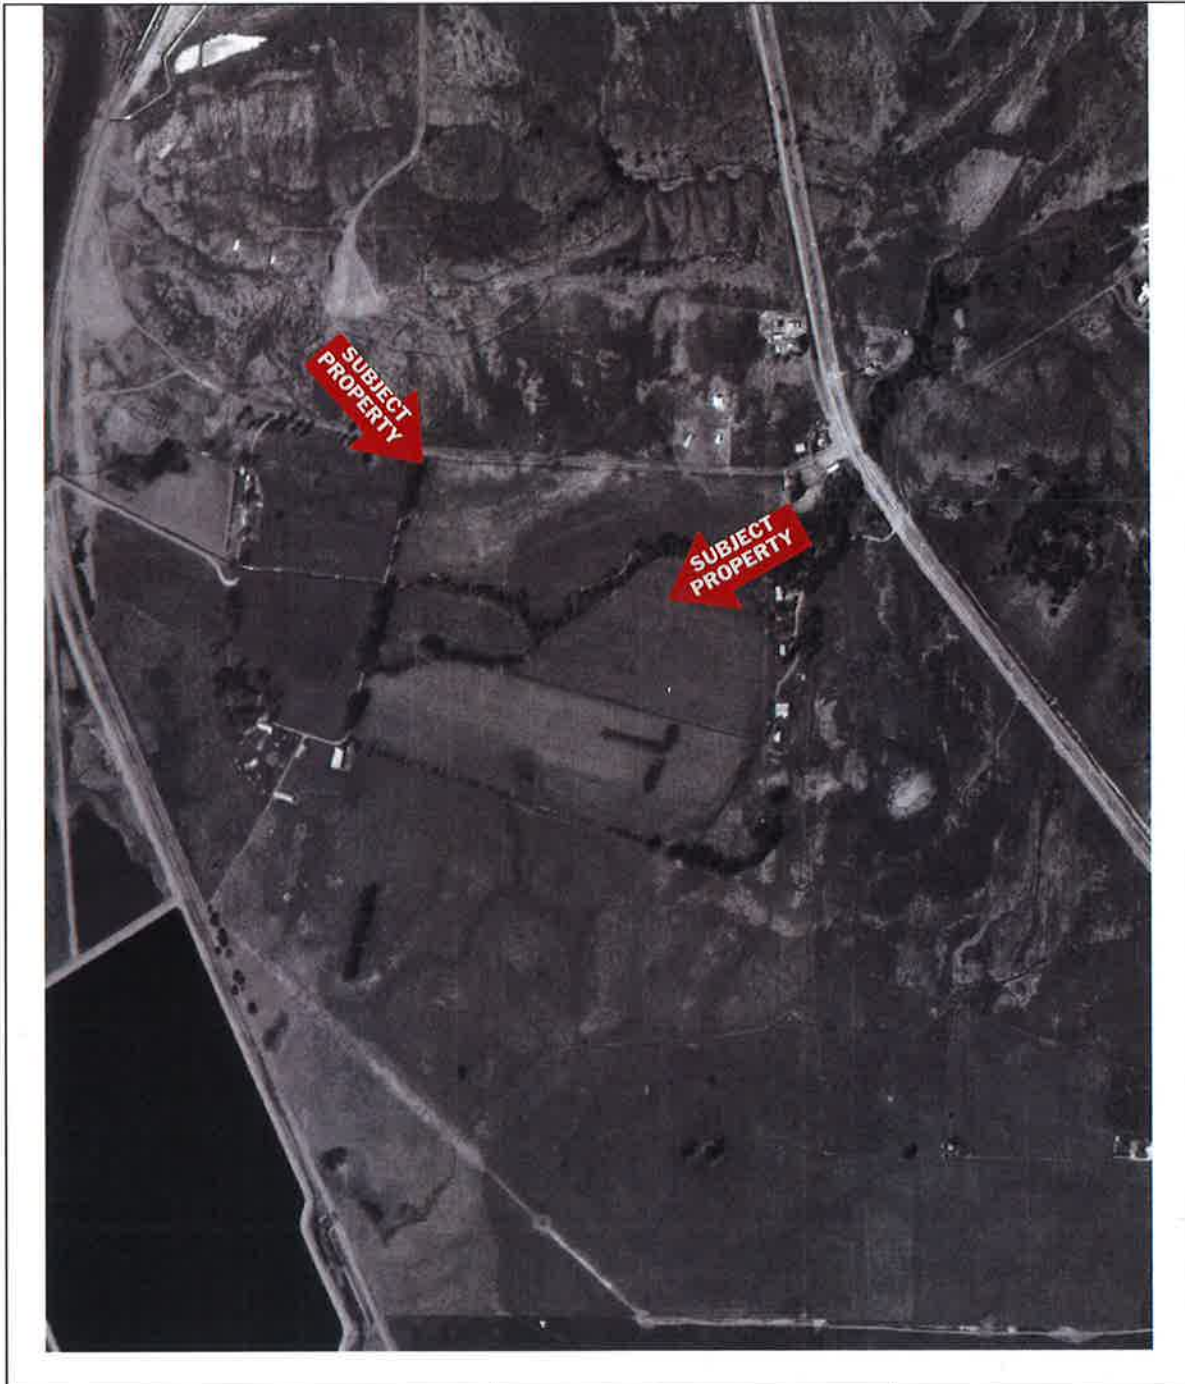
FIGURE:  
C-2

- An aerial photograph taken in **1968** showed the Subject Property and the adjoining property to the south to be undeveloped and possibly used for crop production or pasture land. In the adjoining area to the north was Suscol Creek, and the parcels to the north of the creek were shown to be undeveloped, with no evidence of activity observed. Adjoining to the east was an undeveloped area that was possibly used for crop production or pasture land; as well as structures that appeared to include a residence, a barn and out buildings. Adjoining to the west were undeveloped parcels that were possibly used for crop production or pasture land. Smaller structures that appeared to include residences and storage buildings were shown to the southwest, northeast and northwest. What appeared to be a large pond was shown to the southwest. State Highway 12 and Devlin Road had not been built. Railroad tracks were shown to the west. The Napa River was shown to the northwest. Most of the surrounding area was undeveloped. A copy of this aerial photograph can be seen as Figure C-2 in Appendix C.

1968 AERIAL  
PHOTOGRAPH

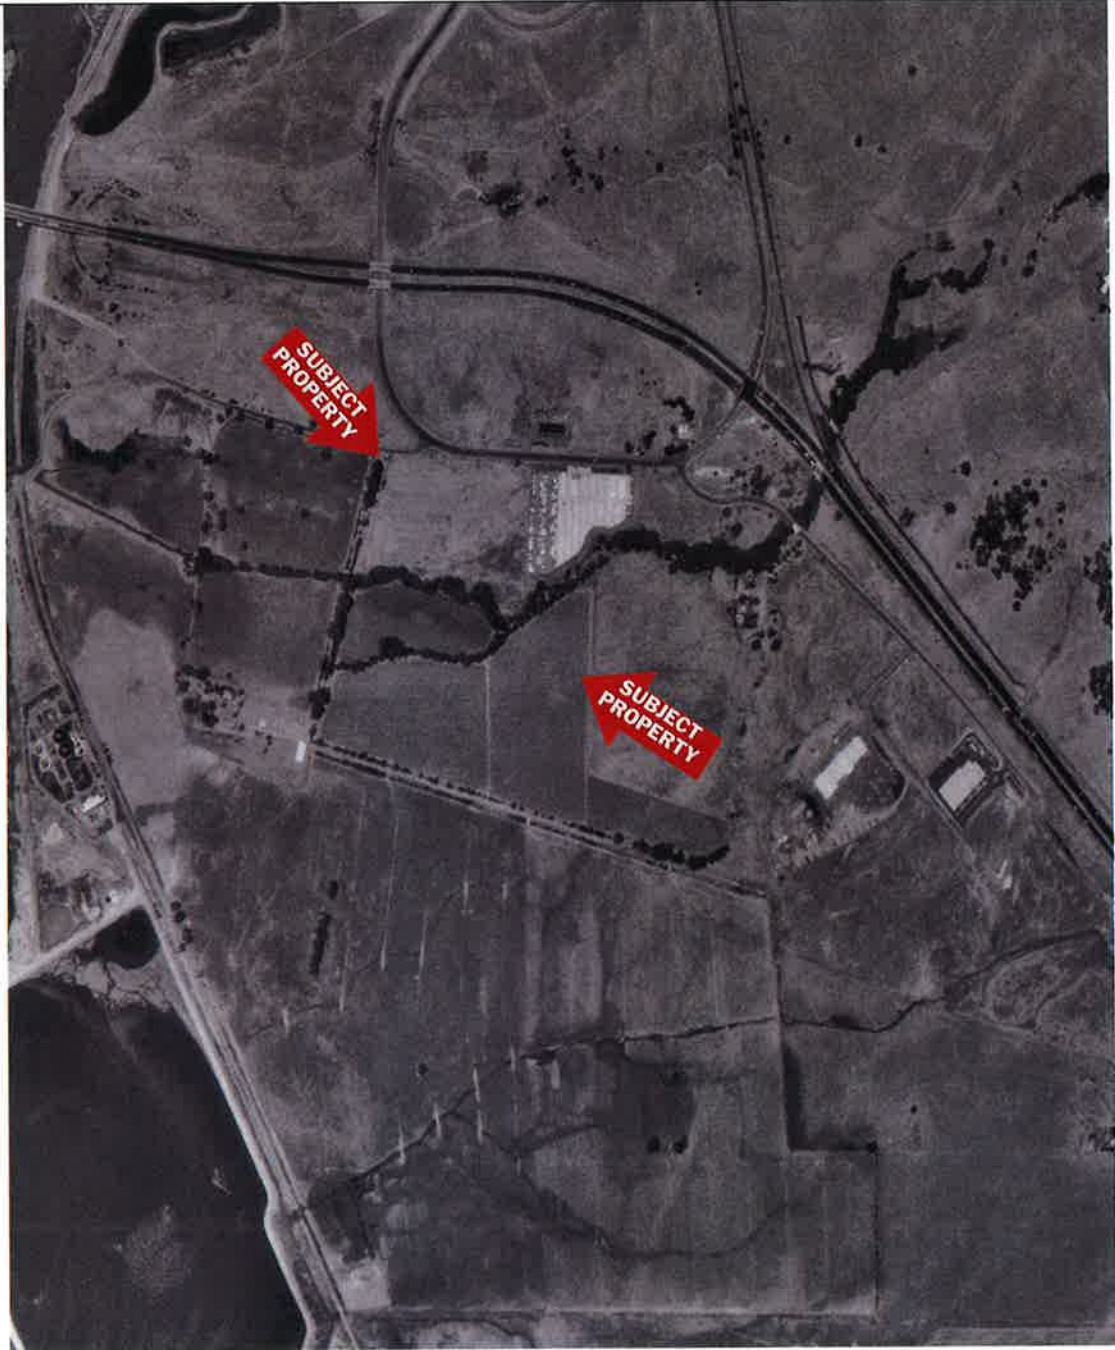
FIGURE:  
C-3

- An aerial photograph taken in **1993** showed the Subject Property and the adjoining property to the south to be undeveloped and possibly used for crop production or pasture land. In the adjoining area to the north was Suscol Creek. Two of the parcels to the north of the creek were shown to be undeveloped, with no evidence of activity observed. The third parcel to the north was shown to be a mini-warehouse and vehicle storage facility. Adjoining to the east was an undeveloped area, as well as structures that appeared to include a residence and out buildings. Adjoining to the west were undeveloped parcels that were possibly used for crop production or pasture land. Smaller structures that appeared to include residences and storage buildings were shown to the southwest, northeast and northwest. A facility observed to the west appeared to be a water treatment plant, and a large pond was shown to the southwest. The streets and highways in the area appeared to be configured as they are currently. A newer structure was shown to the north that appeared to be a multi-tenant industrial building. Larger structures to the southeast appeared to be a contractor's facility and an industrial building. Railroad tracks were shown to the west. The Napa River was shown to the northwest. Most of the surrounding area was undeveloped. A copy of this aerial photograph can be seen as Figure C-3 in Appendix C.

1993 AERIAL  
PHOTOGRAPH

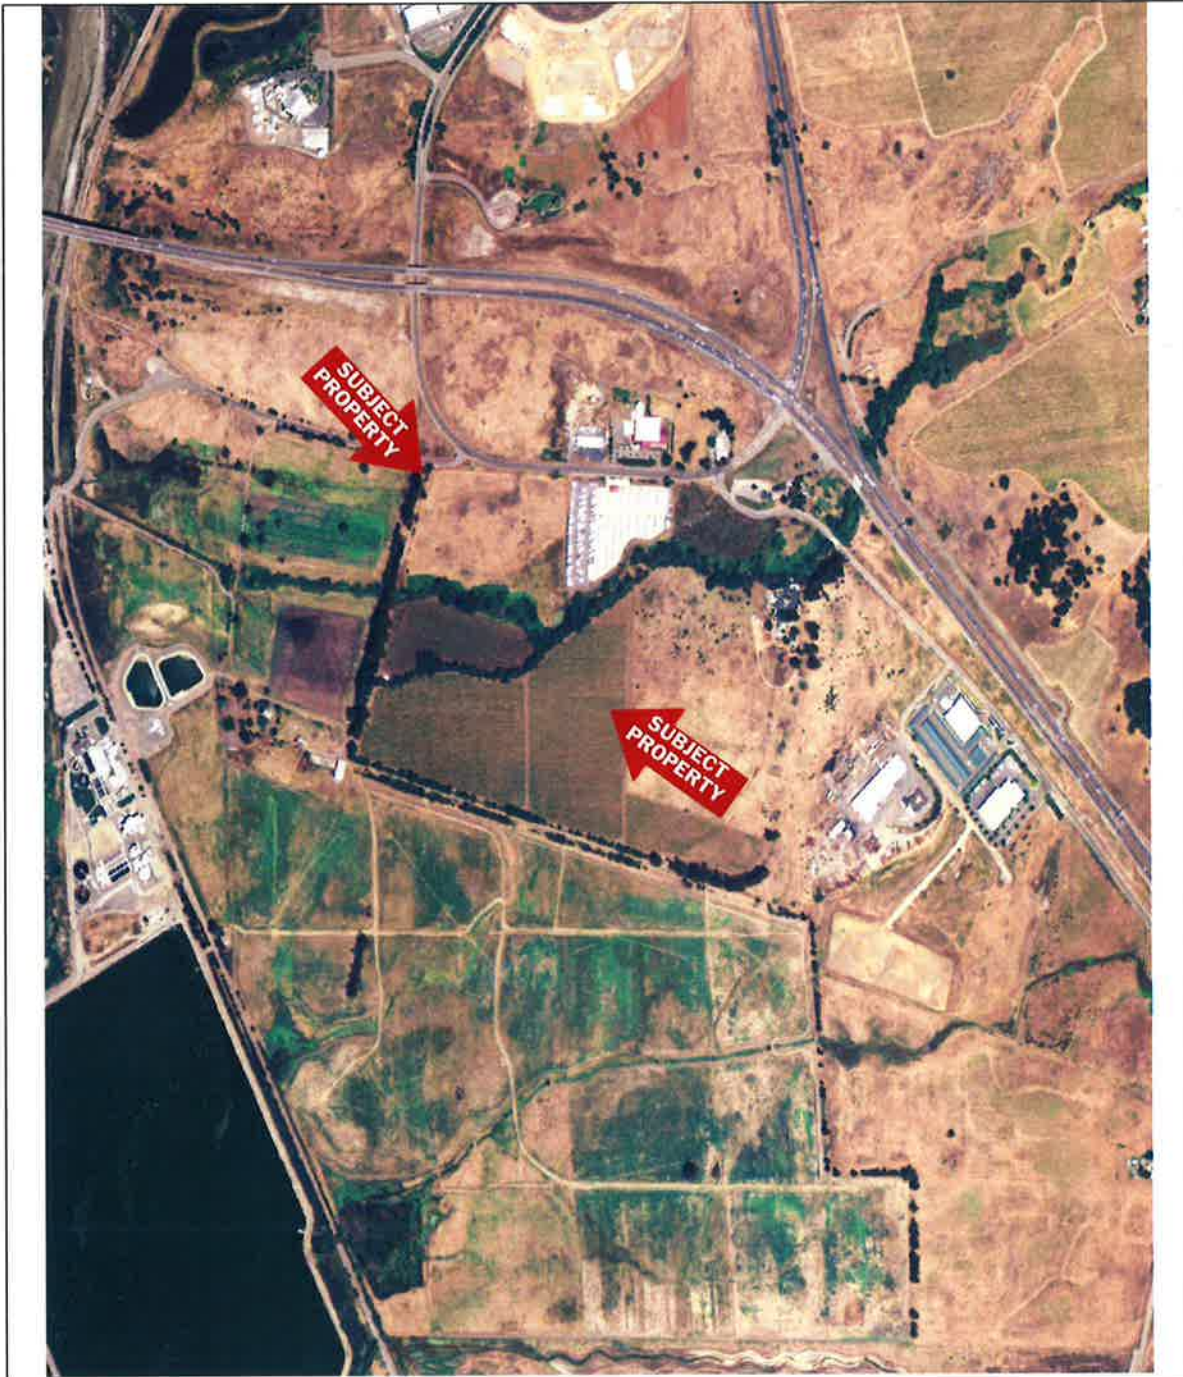
FIGURE:  
C-4

parcels to the north of the creek were shown to be undeveloped, with no evidence of activity observed. The third parcel to the north was shown to be a mini-warehouse and vehicle storage facility. Adjoining to the east was an undeveloped area, as well as structures that appeared to include a residence and a winery. Adjoining to the west were undeveloped parcels that were possibly used for crop production or pasture land. Smaller structures that appeared to include storage buildings and residences were shown to the southwest, northeast and northwest. Smaller ponds and a facility observed to the west appeared to be a water treatment plant, and a large pond was shown to the southwest. An existing and a newer industrial building were shown to the north. A larger structure and yard area to the southeast appeared to be a contractor's facility. Two structures that appeared to be industrial in use were also shown to the southeast. A newer facility which included satellite dishes was shown to the northwest. A construction site was shown to the north. Vineyards were shown to the northeast. Railroad tracks were shown to the west. The Napa River was shown to the northwest. Much of the surrounding area was undeveloped. A copy of this aerial photograph can be seen as Figure C-4 in Appendix C.

2005 AERIAL  
PHOTOGRAPH

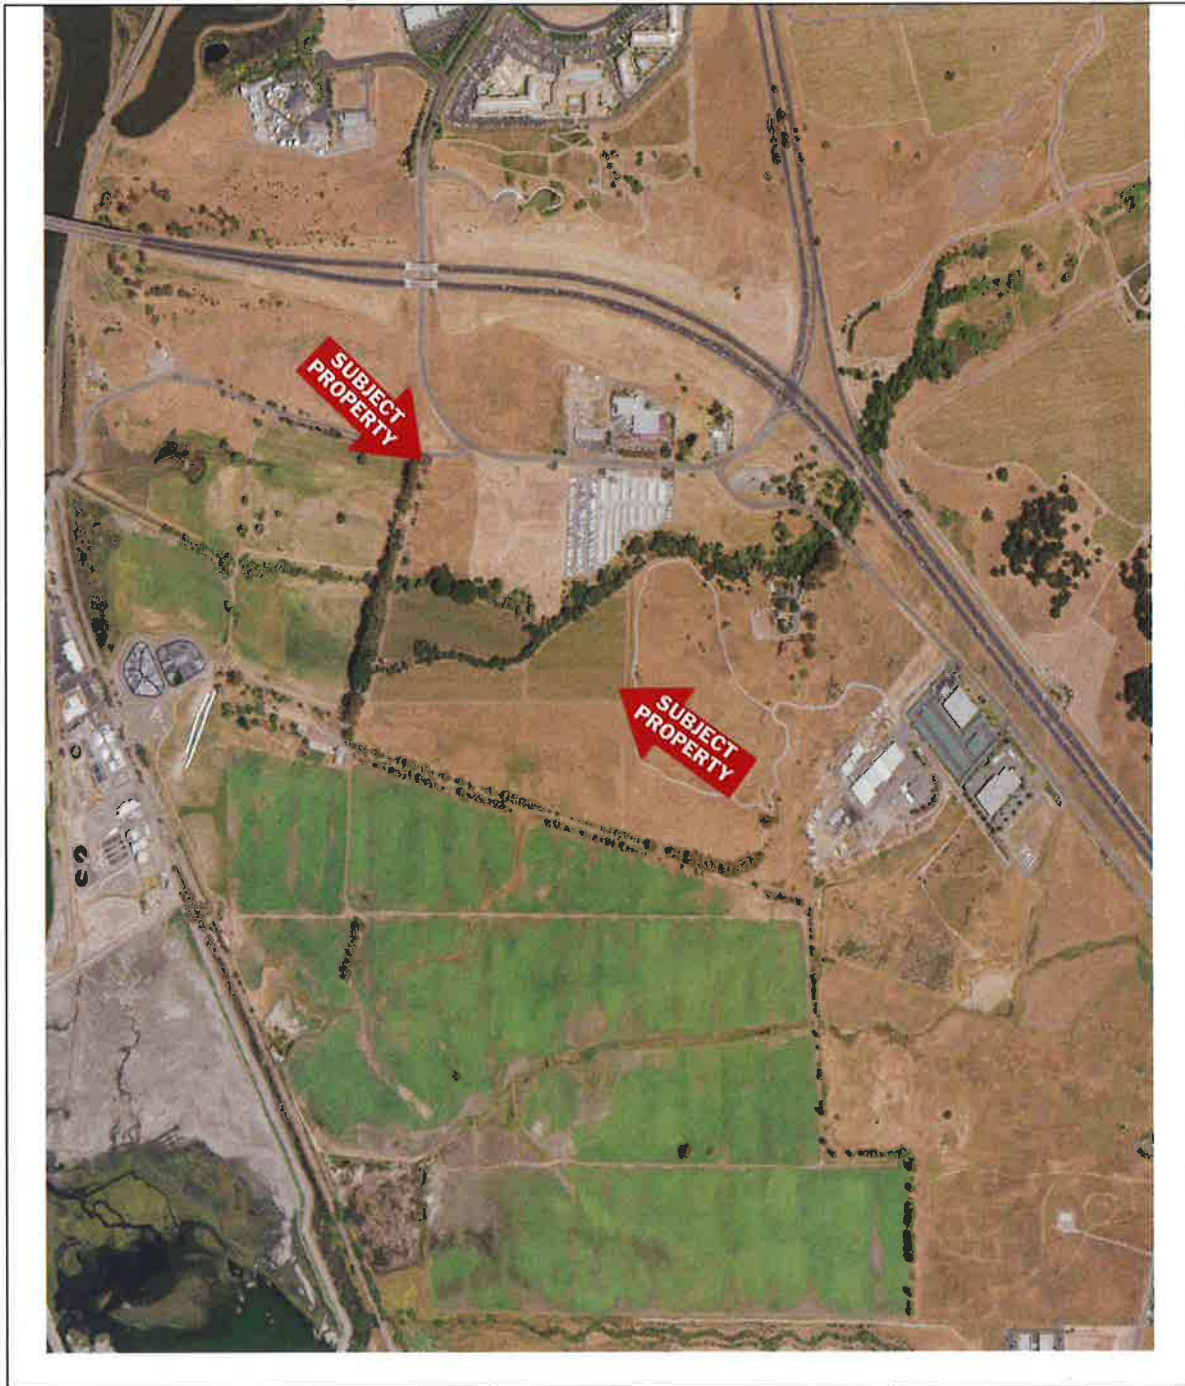
- An aerial photograph taken in **2014** showed the Subject Property to be a vineyard. In the adjoining area to the north was Suscol Creek. Two of the parcels to the north of the creek were shown to be undeveloped, with no evidence of activity observed. The third parcel to the north was shown to be a mini-warehouse and vehicle storage facility. Adjoining to the east was an undeveloped area with a meandering walkway, as well as structures that appeared to include a residence and a winery. The adjoining property to the south was shown to be cleared of vines and undeveloped. Adjoining to the west were undeveloped parcels that were possibly used for crop production or pasture land. Smaller structures that appeared to include storage buildings and residences were shown to the southwest, northeast and northwest. A facility observed to the west appeared to be a water treatment plant, and a pond was shown to the southwest. Industrial buildings were shown to the north. A larger structure and yard area to the southeast appeared to be a contractor's facility. Two structures that appeared to be industrial in use were also shown to the southeast. A facility which included satellite dishes was shown to the northwest. A hotel was shown to the north. Vineyards were shown to the northeast. Railroad tracks were shown to the west. The Napa River was shown to the northwest. Much of the surrounding area was undeveloped. A copy of this aerial photograph can be seen as Figure C-5 in Appendix C.

<p>2014 AERIAL PHOTOGRAPH</p> <p>Subject Property: 22.39 Acres South of Soscol Ferry Rd.; Napa, California</p>	<p>↑ NORTH</p>
<p>JOB NUMBER: 19-4771</p>	<p>Date: 7/16/19</p>	<p>FIGURE: C-5</p>
