# Award Task Order for 66-inch Trunk Sewer Design Services (CIP 19701)

Napa Sanitation District Board of Directors Meeting May 15, 2019

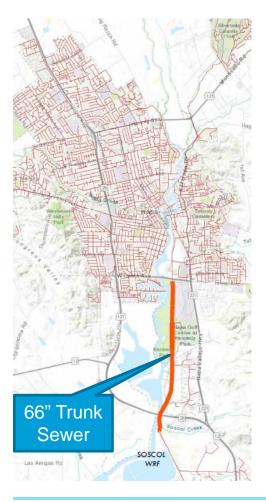
- 15,400 LF (~3mi length)
- 66" RCP unlined
- Criticality
  - Conveys over 90% of flow to treatment plant
  - Extends along east bank of Napa River
  - No redundancy

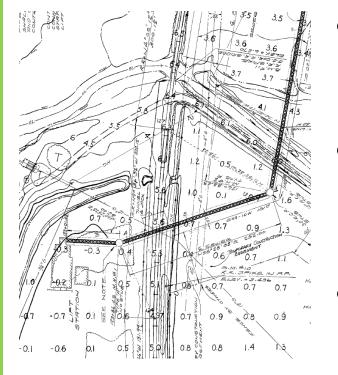
### • Constructed in 1967

- Outfall line from Imola plant to oxidation ponds
- Began conveying untreated sewage in 1998
- Inspection history: 2001, 2012, 2017 (partial)

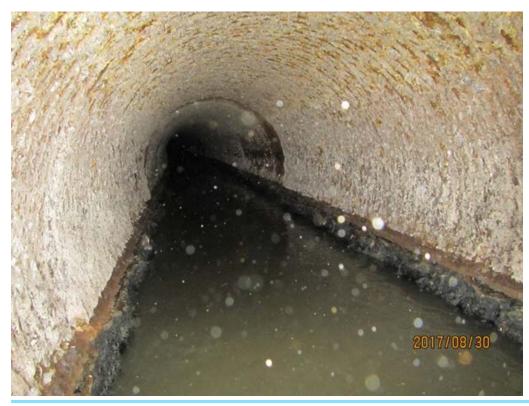
## **Internal Condition**

- Corrosion observed at all entries
- Structural deterioration along lower third
- Loss of concrete hardness and wall thickness

- Significant corrosion throughout entire length
- Severe corrosion (exposed rebar) downstream of Napa Pipe
- Remaining useful life of pipe upstream of Napa Pipe is estimated at 10-15 years
- Average sediment depth of 5-7 inches

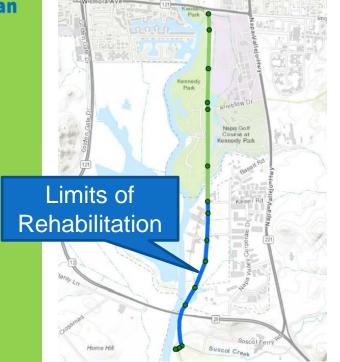
### **Recommended Near-Term Project**

- Structural rehabilitation (CIPP) of downstream ~6500' of trunk main (south of Kaiser Road)
- Manhole construction replacements to facilitate liner installation
