**Plant, Wildlife, and Tree Survey Reports  
For  
Clover Flat Landfill Recycling Facility Expansion**

**July 14, 2010**

Questa Project #1000031

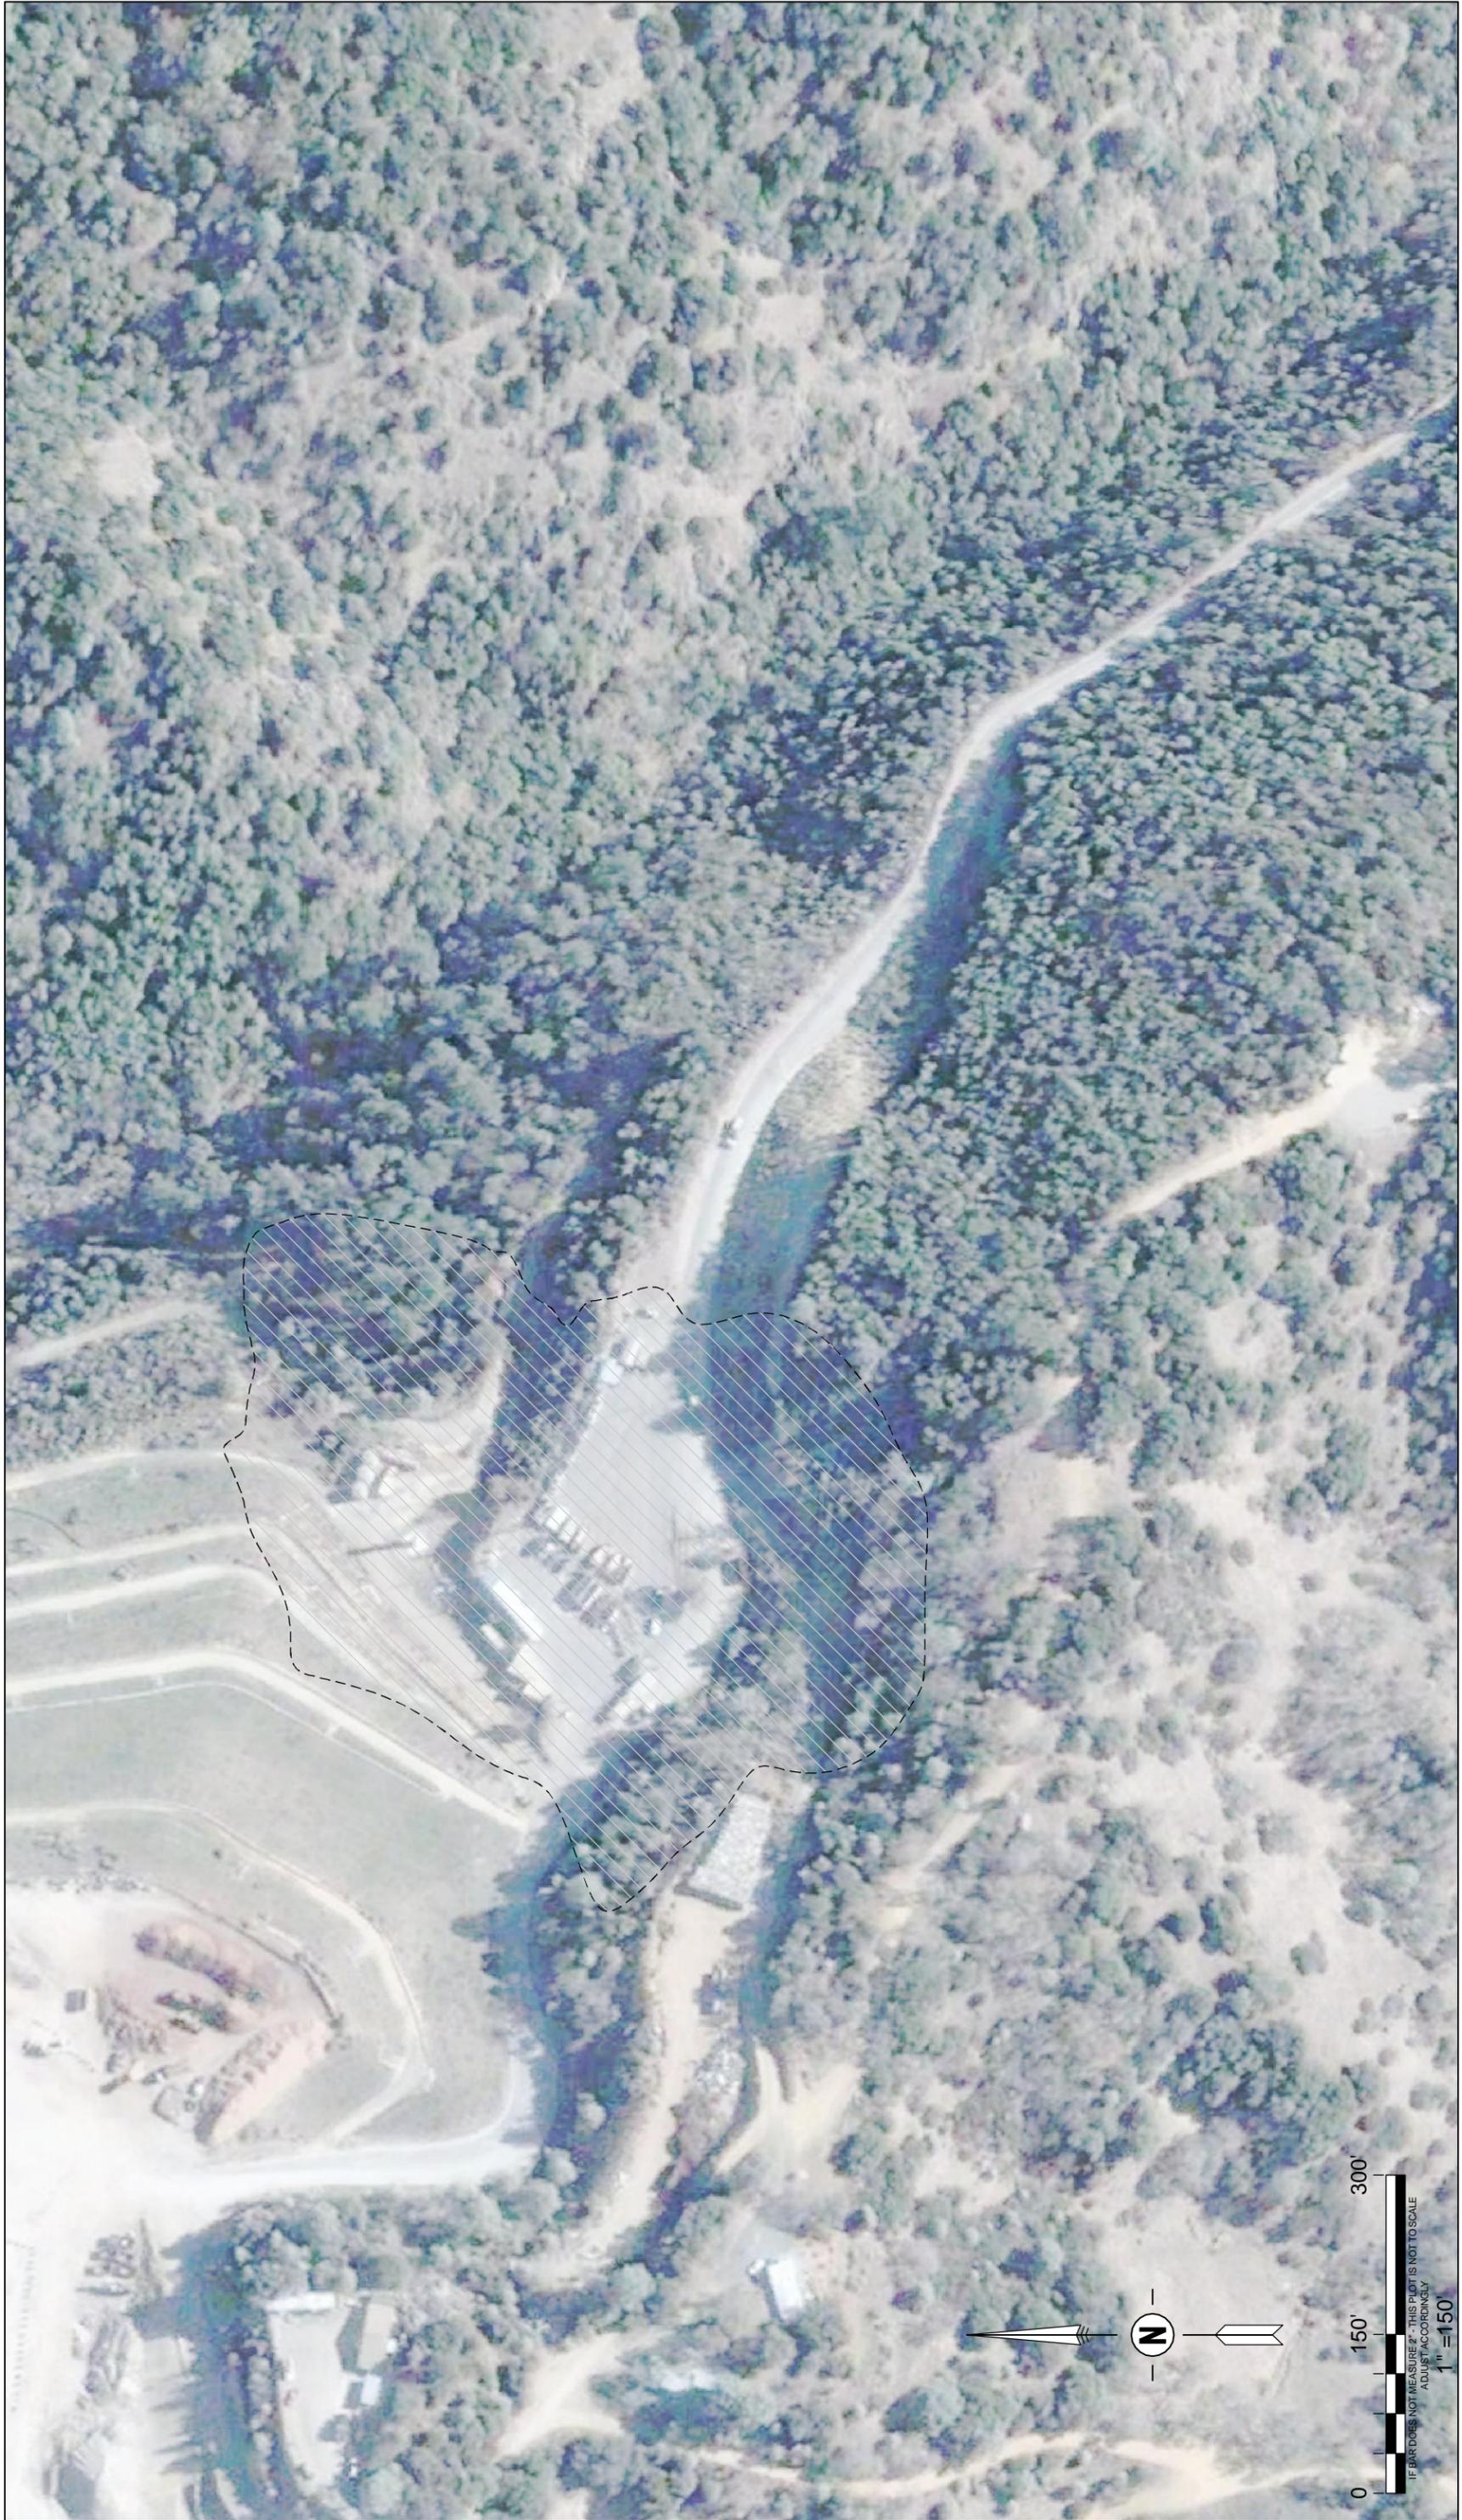
FIGURE  
**3**

**CLOVER FLAT LANDFILL RECYCLING  
FACILITY EXPANSION**

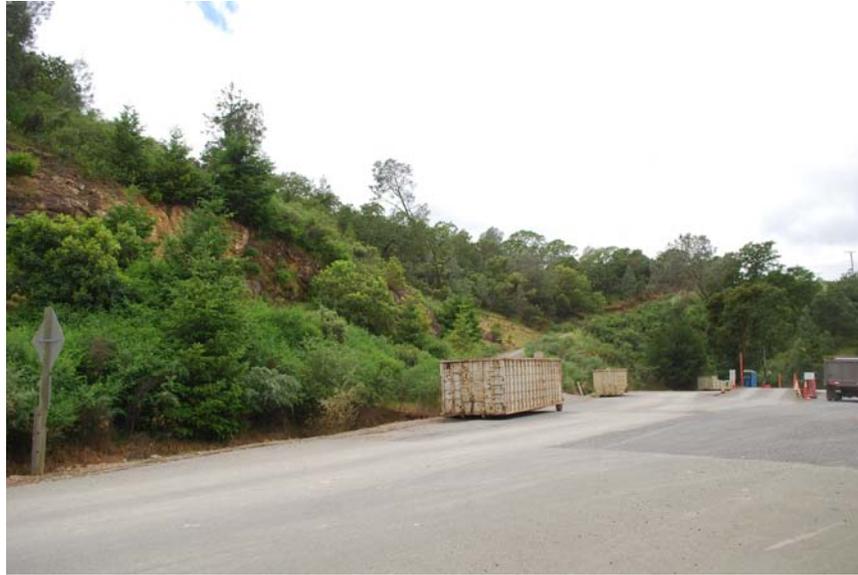
**Photo 1.** View from tank pad looking North East – east ½ of site. Expansion area is left center of photo. Small intermittent drainageway runs diagonally upper left to lower right of photo.

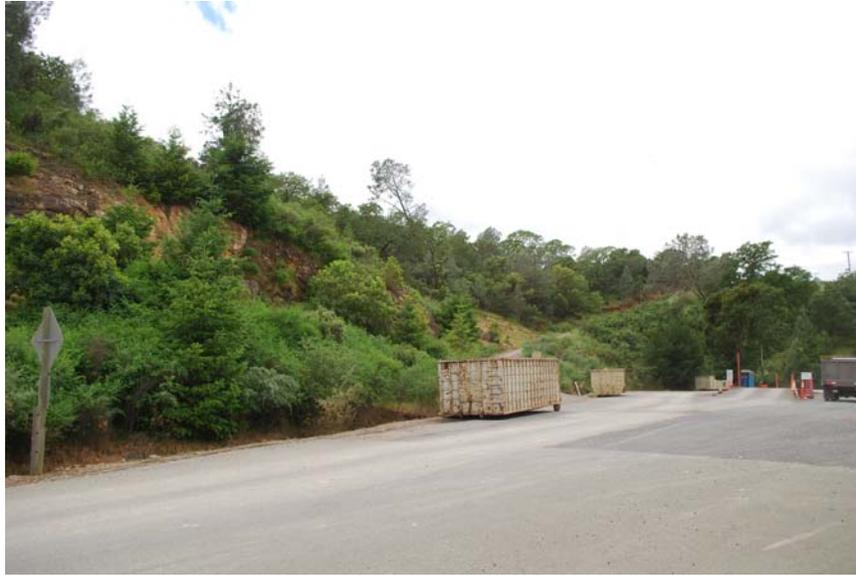
**Photo 3.** View of western expansion area from entry road near scale house. Note dense cover of Foothill pine, coast live oak, toyon and manzanita. Access road to west ½ of expansion site just above dumpster.

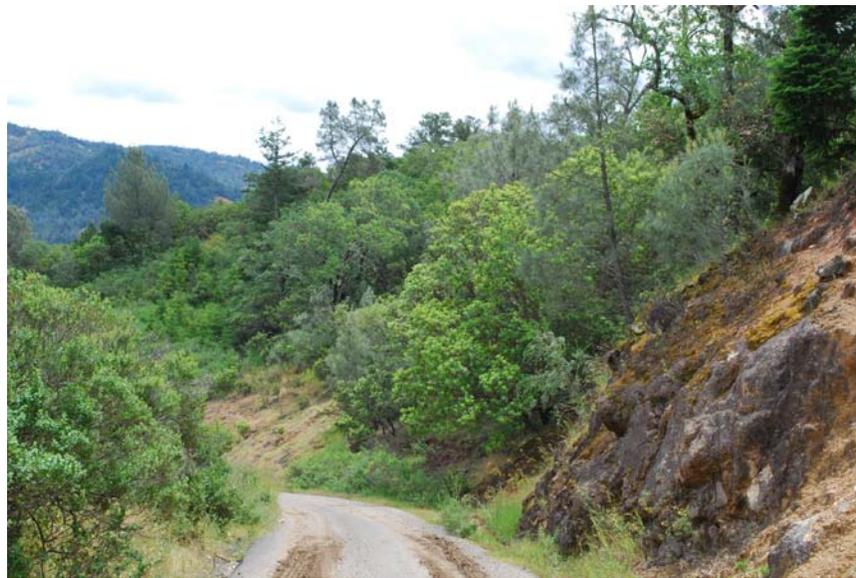
**Photo 4.** View of western expansion area from access road showing dense cover of pines, oak, toyon, manzanita and other shrub species. Not rock out crops lower right and shallow soils exposed in road cut center of photo.

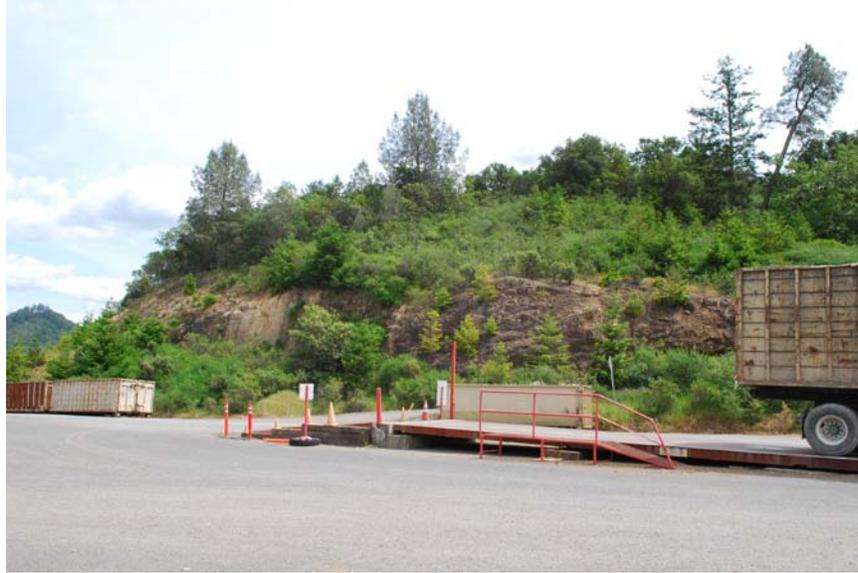
**Photo 5.** View of expansion area from scale. Note dense brush and small oak understory.
