**Historic Resource Report Update  
And CEQA Findings  
19 August 2013  
by Juliana Inman, Architect**

**Theorem Winery (formerly Graeser)  
255 Petrified Forest Rd.  
Calistoga, CA**

**REPORT: HISTORICAL EVALUATION OF THE GRAESER WINERY  
255 PETRIFIED FOREST ROAD  
CALISTOGA, CALIFORNIA**

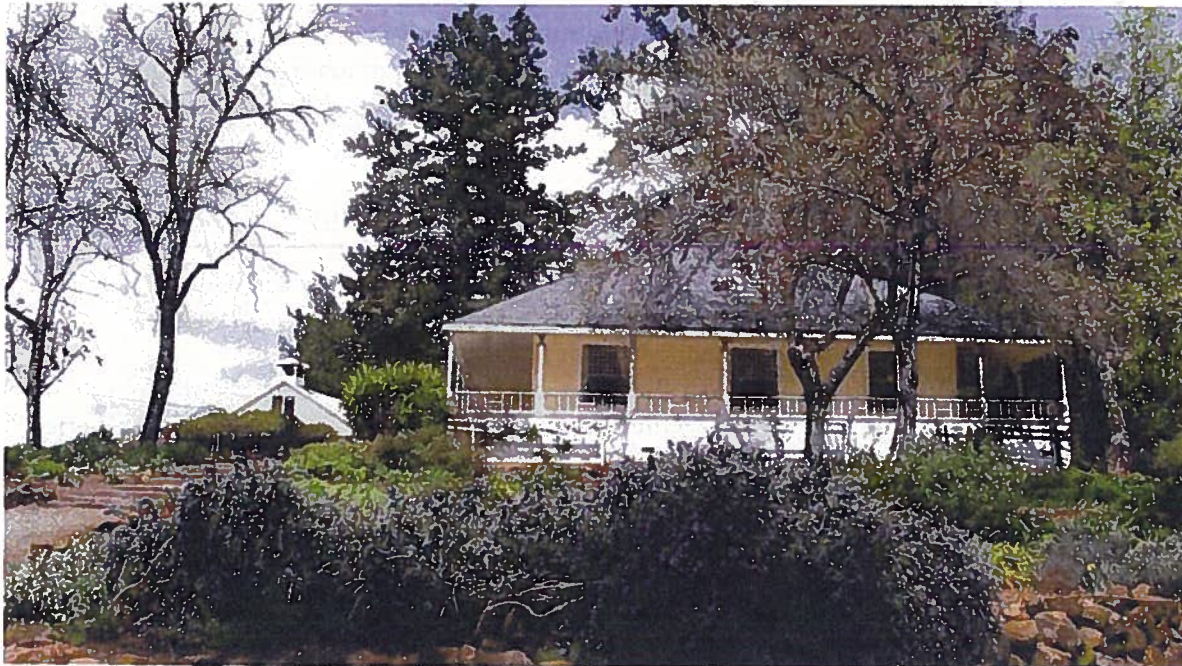
Main House:

The **Main House** was built by the Cole family in about 1889 as a rustic retreat from the fog and their busy lives in San Francisco. This building is an excellent example of a pyramidal Victorian with a high-pitched hipped roof covering the mass of the house and the wrap-around porch. Queen Anne style details are found in the windows, porch railings, columns and doors. Restoration work on the house is currently underway. Inappropriate and non-historic rear and side additions to the house have been removed.

This reviewer recommends restoration of the Main House.

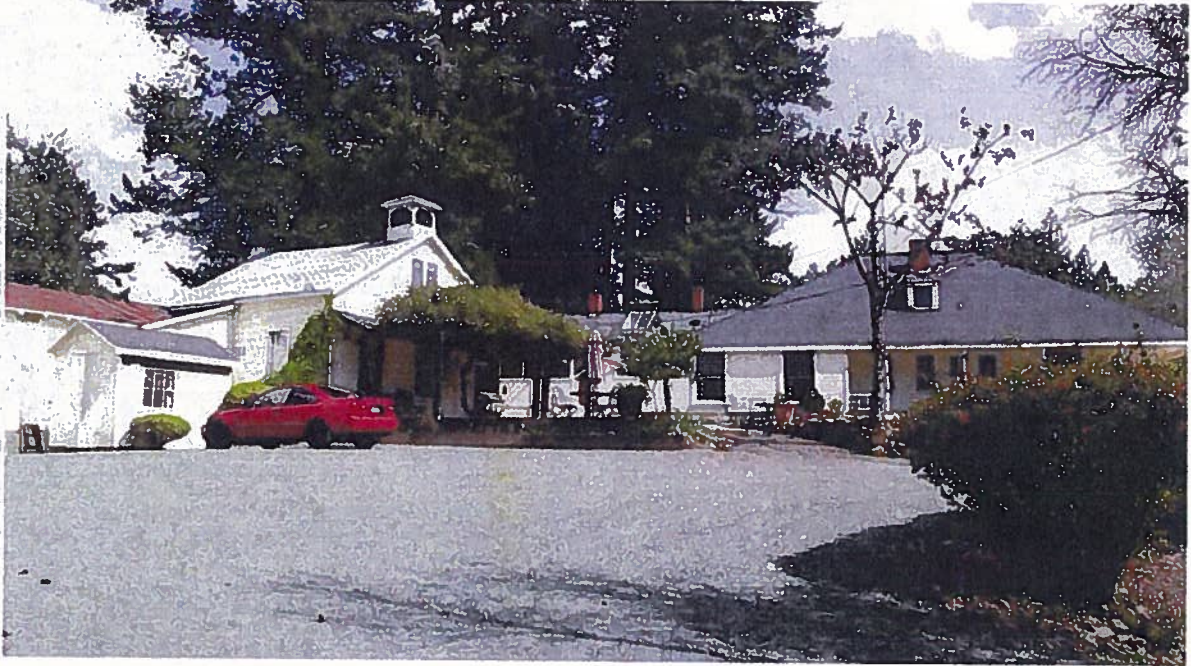
**Original House and Main House:**

The **Original House** on the property was built prior to the ownership of the Coles and displays remnants of its vernacular gable-front cottage style. Estimated to have been built in the late 1870's, this house has been significantly altered. Some alterations may date after the 2005 survey, and one addition on the north of the building has been flagged by Napa County Code Enforcement for having been built without permits and as unsafe for occupancy. The house has been conjoined to the working ranch building known as “The Hatchery”. The “shed-roofed passageway” connecting the Original House to the Hatchery as described by Roland-Nawi has been replaced with a gable-roofed retail space as part of the previous winery occupancy. This second floor addition to the Hatchery building destroyed the integrity of the “Hatchery” below by adding wood columns and foundations throughout the earlier Hatchery building, and compromises the integrity of the Original House. Structural condition and integrity of the Hatchery building will be reviewed in the “Working Ranch” section of this description. The second floor addition to the Hatchery, as well as a shed-roofed bathroom wing addition to the house do not show on the site plan diagram in the Roland-Nawi report and are not included in the

**This review recommends that the second floor front gable window be a 6 over 6 original style window. This reviewer recommends that after demolition of the non-historic pergola and porch additions, that a similar covered porch or pergola feature be restored to this elevation of the Original House.**

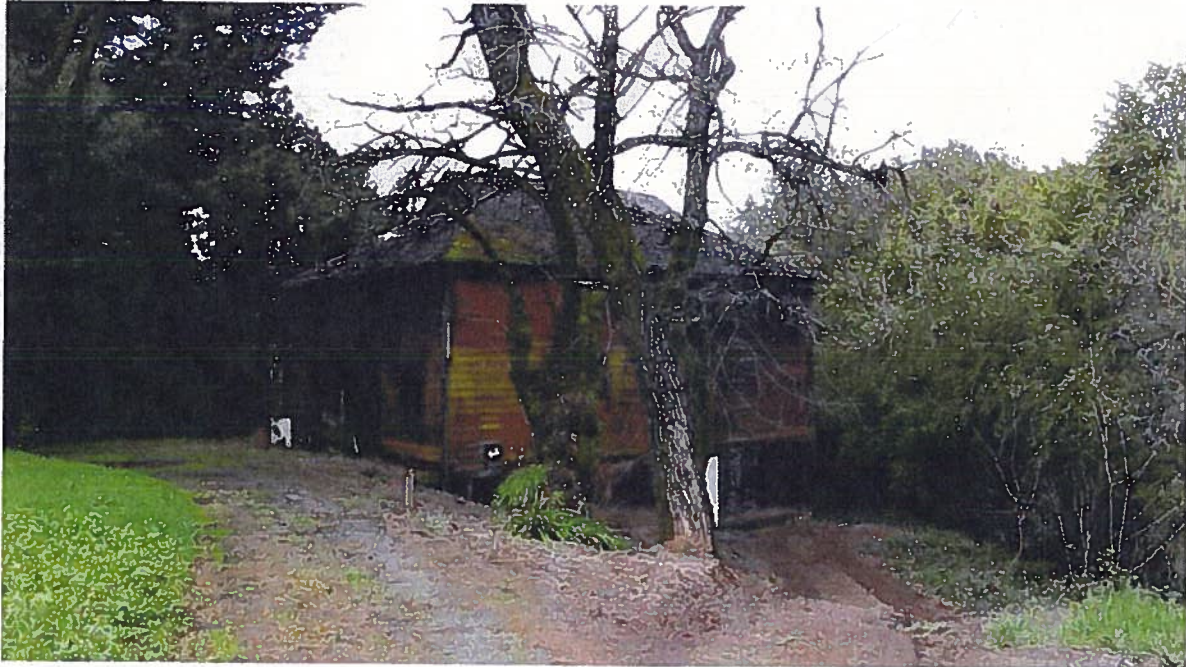
**Barn/carriage house:**

No work on the Barn is proposed at this time. The structure is in very tenuous structural condition, appears to have a foundation failure, and has been strapped with chains and ground anchors to the existing edge of the slope. The building appears to have moved approximately 8 inches off its foundation. If plans are developed for this structure in the future, consideration should be given to returning the Barn to its 1889+/- appearance and removal of the rear addition that steps down the steep slope of the mountain. Please see conclusions on pages 13 and 14 of this report. Include in this report are recommendations for stabilization of the Barn using the Secretary of the Interior's Standards for Restoration.

**Maintain roof covering for the building. Monitor for wood destroying pests. Monitor for movement of the building off of its current foundation.**

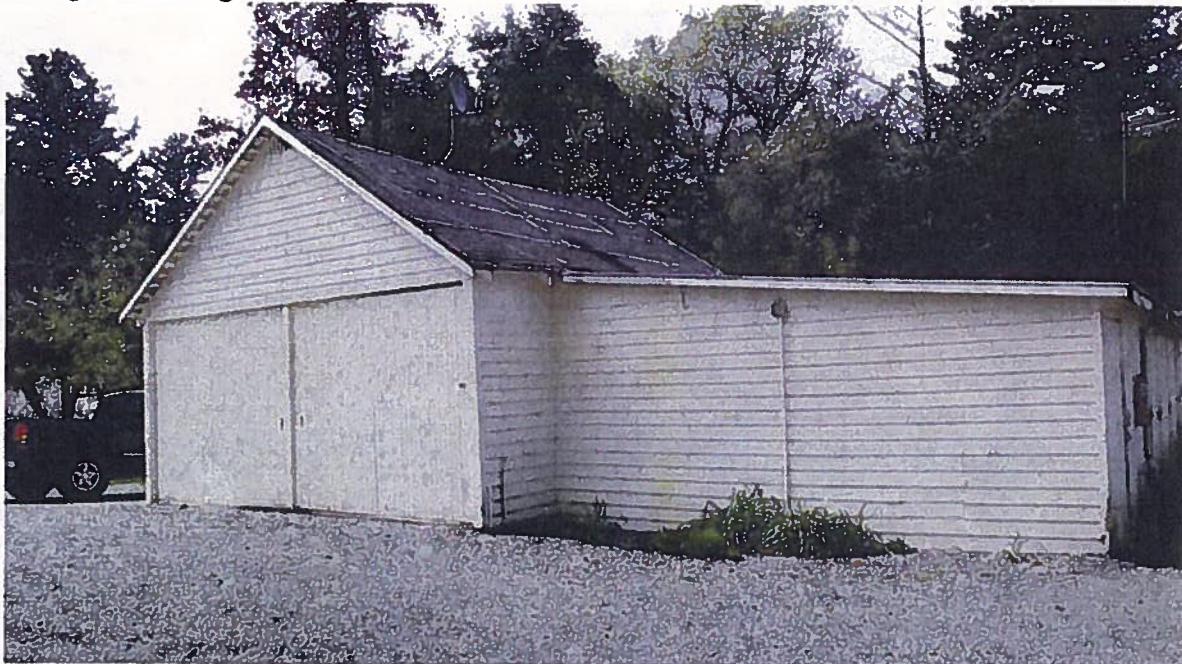
Garage and storage building:

The Garage was built about 1940. It was a two-car gable-roofed structure with horizontal wood siding. Extensive shed-roofed additions were made from previously used building materials from the 1950's through 2011+/- . The previous winery use demolished the structural integrity of the garage by removal of the ceiling joists and collar ties. The Garage was heavily insulated, apparently for wine storage. Removal of the structural system has created a dangerous condition. The side wall of the Garage has been opened up to the shed-roofed additions, and there is no load path for the roof structure. As a result, the Garage roof displays signs of failure in the "sway-backed" appearance of the ridge.

Due to the lack of integrity of this structure and the multiple non-historic additions built after the period of significance, the Garage does not contribute to the district theme of a poultry ranch. This reviewer recommends the demolition of this structure and recycling of its building components.

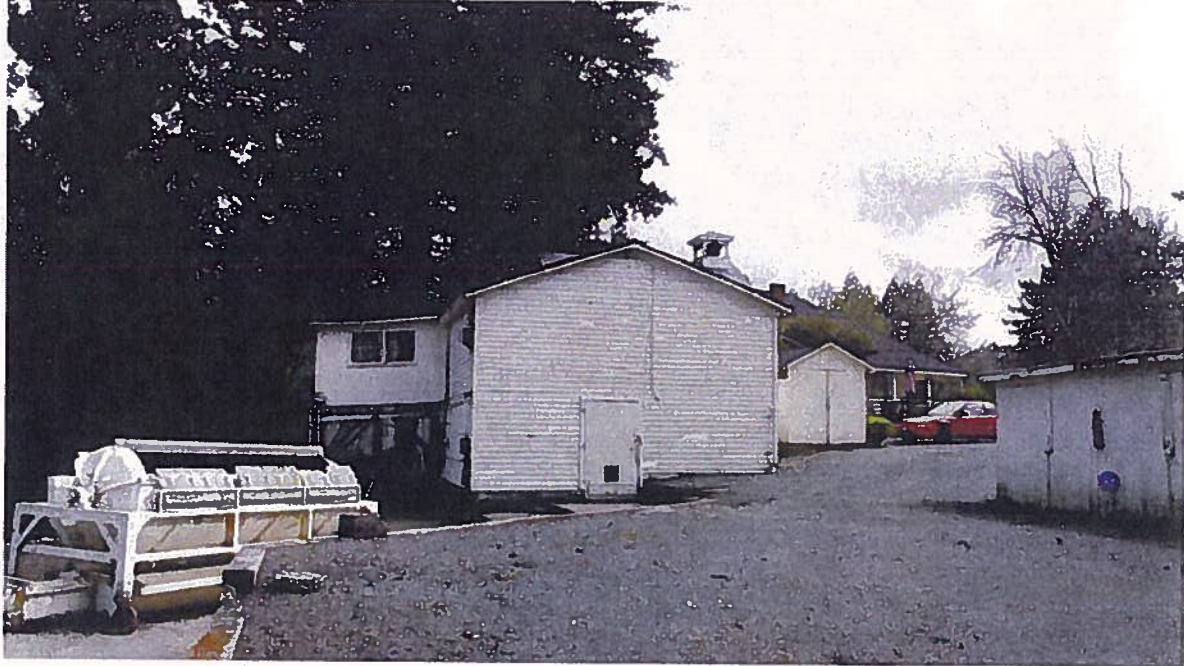
Hatchery Building:

My review demonstrates that the Hatchery has been almost completely removed and replaced by non-historic, makeshift, structurally inadequate, unsafe and common additions that destroy the integrity of the Hatchery and make it a non-contributor to the district. All together, these additions and alterations have effectively demolished the Hatchery.

**The Hatchery** was originally a one-story structure with wood-siding, high pitched gable roof which was connected to the Original House by a shed-roofed passageway. The Hatchery floor was on the same level as the basement level of the Original House. It was not a two-story building. Subsequent alterations (probably after 2005) include adding a second floor to the Hatchery which is supported by new columns and foundations throughout what was previously a high one-story building. New floor joists were added to support the second floor addition in what was previously an open ceiling space. A gable-roofed addition conjoins the Hatchery with the Original House where a shed-roofed passageway once connected the structures, and a shed-roofed bathroom wing was added to the north side of Original House. Openings into the Hatchery were all sealed and covered over to create winery use space. All together, these additions and alterations have effectively demolished the Hatchery.

This reviewer recommends demolition of the Hatchery building and restoration of the residential character of the Original House which will restore integrity of workmanship and materials. The original design will not be completely recovered. Removed building components should be recycled.

Due to the extensive alterations to the Hatchery, the integrity of the building has been lost. Since the Hatchery no longer contributes to the district, I recommend removal of the non-permitted addition, what remains of the Hatchery and removal of other recent additions to the Original House so that the historical appearance of the Original House may be restored.

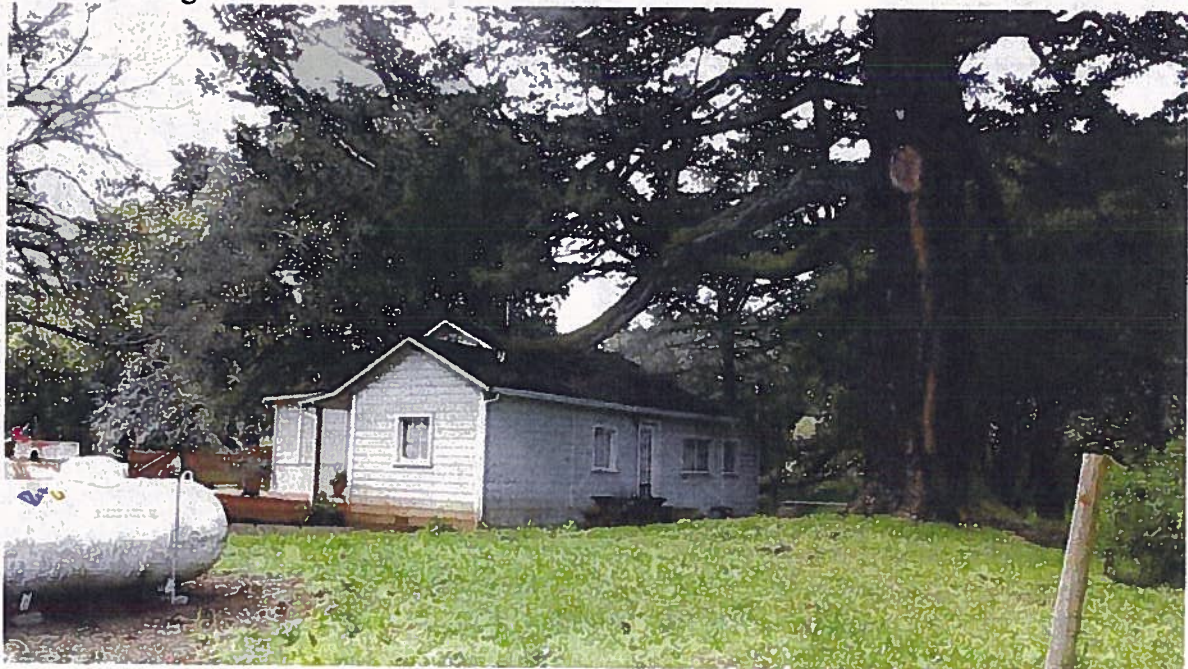
Small dwelling:

The **Small Cottage**, built circa 1920, has been so altered that it does not retain integrity and is noted by Rowland-Nawi as a "non-contributor" to the potential district.

Due to the fact the the building does not retain integrity and does not contribute to the district, this reviewer continues to recommend demolition of this structure and recycling of its components.

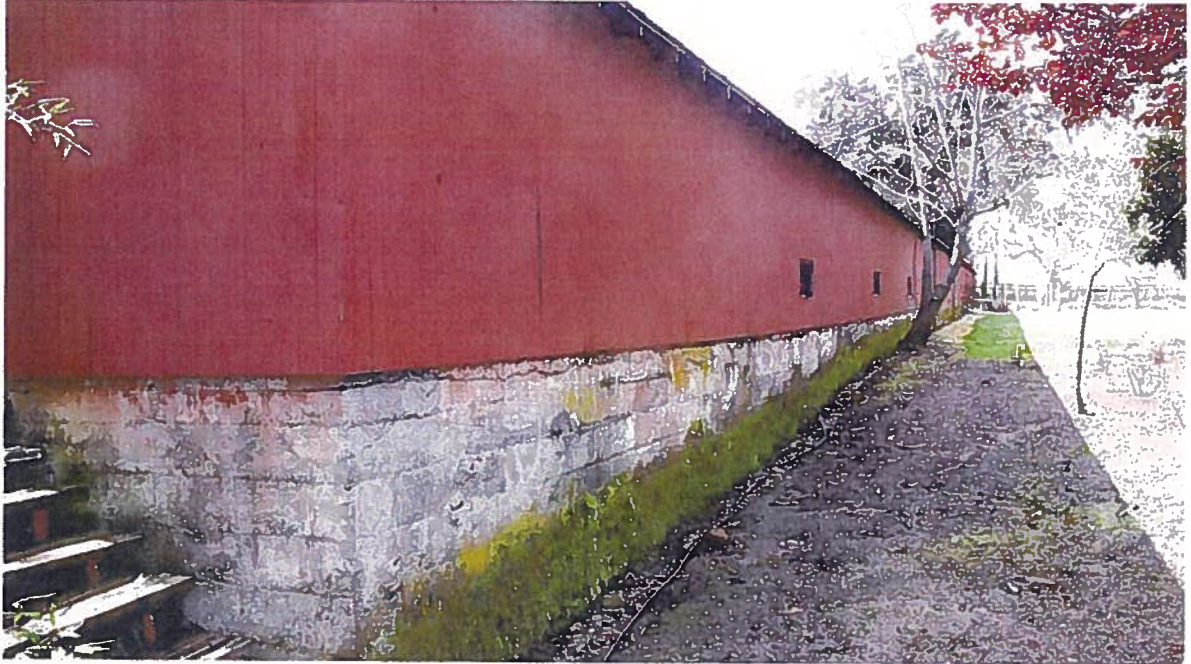
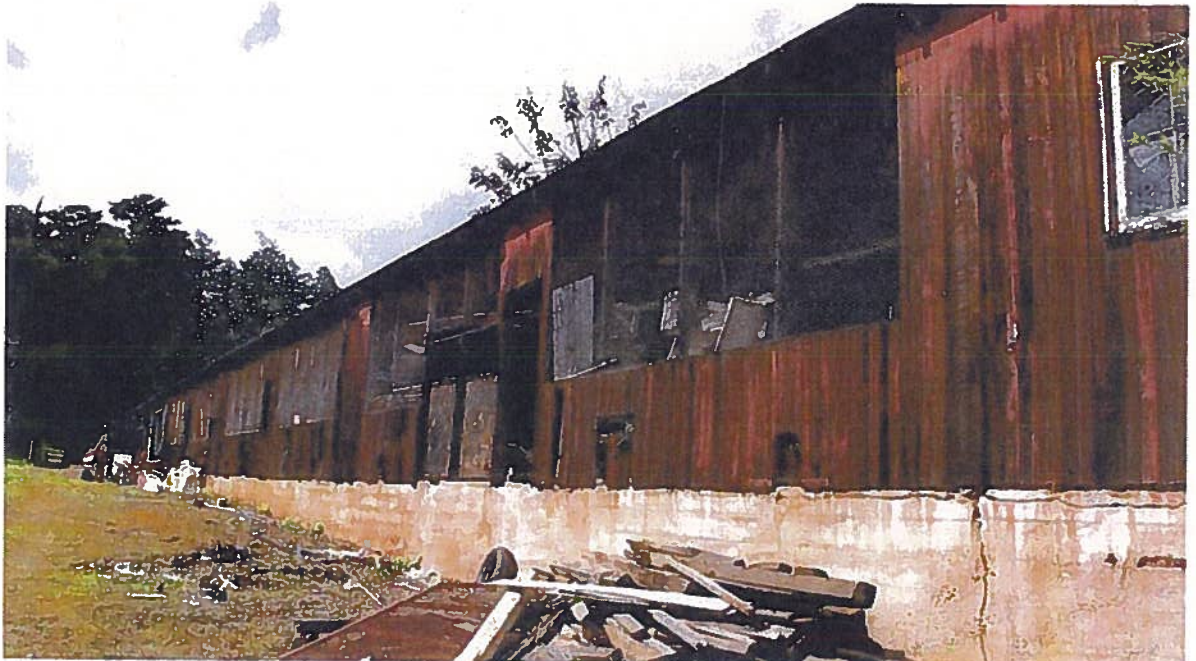
Poultry House:

Proposed rehabilitation of the Poultry House is included in the Secretary of the Interior's Standards review. I noted presence of dry wood termite activity throughout the north wall. There is evident structural failure of the roof system. Plans include maintaining the massing of the building in the landscape while doing structural rehabilitation that returns the building to use. Please see conclusions on pages 13 and 14 of this report.

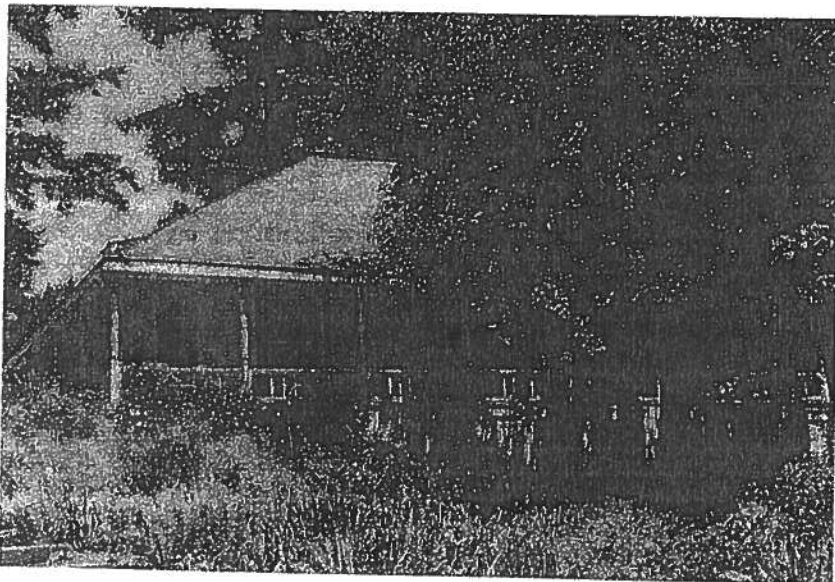
- \*P3b. Resource Attributes: HP/33 HP 2  
\*P4. Resources Present: ☒ Building ☐ Structure ☐ Object ☐ Site ☐ District ☒ Element of District  
P5b. Description of Photo: Front (east) façade, view west

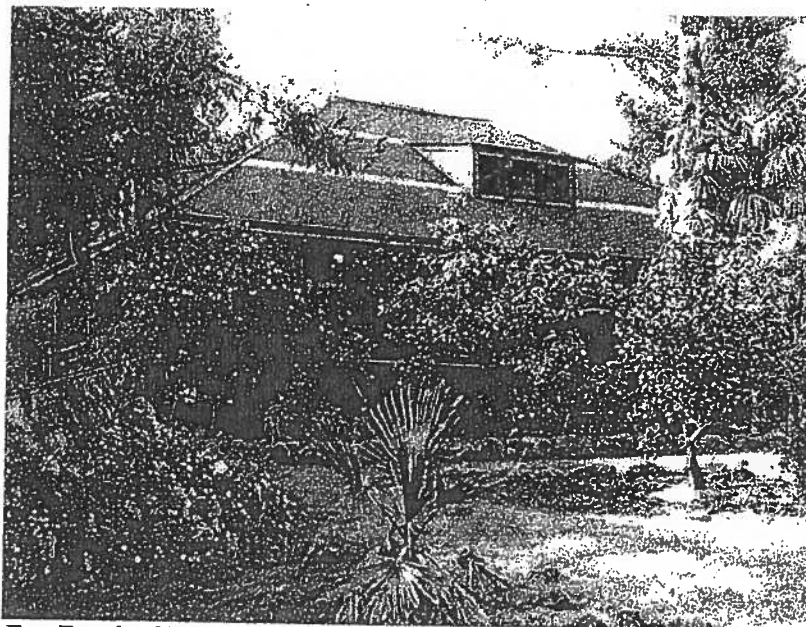
East Façade Circa 1907

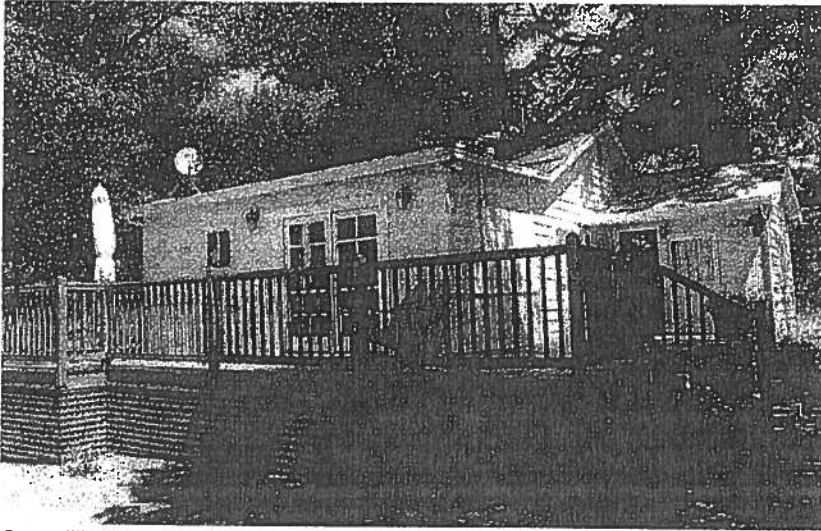
Guest House South façade showing alterations

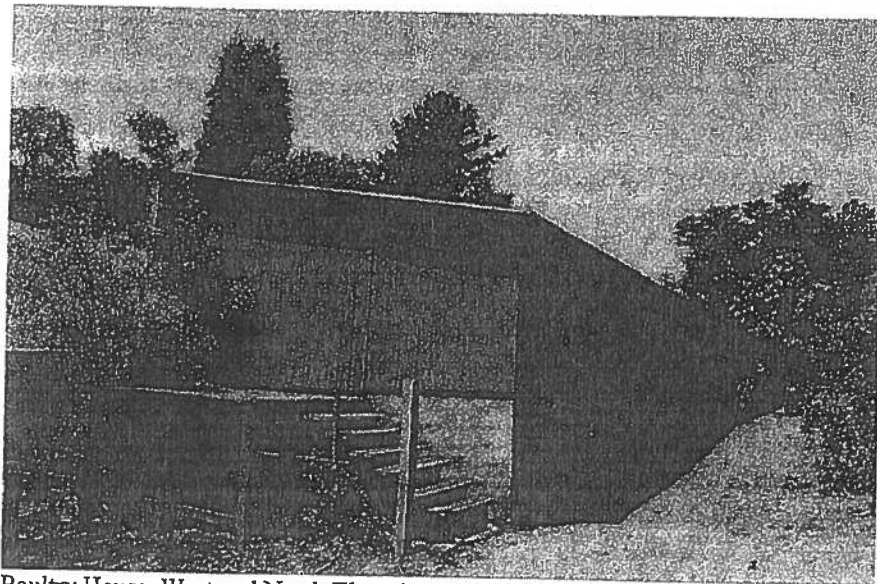
Poultry House West and North Elevations
