**Update:
Historic Resource Report
16 December 2013**

**Seismic Strengthening and Alterations
Louis M. Martini Winery
254 St. Helena Highway
St. Helena, CA 94574
APN 030-020-001**

**Historic Resource Report
And CEQA Findings**

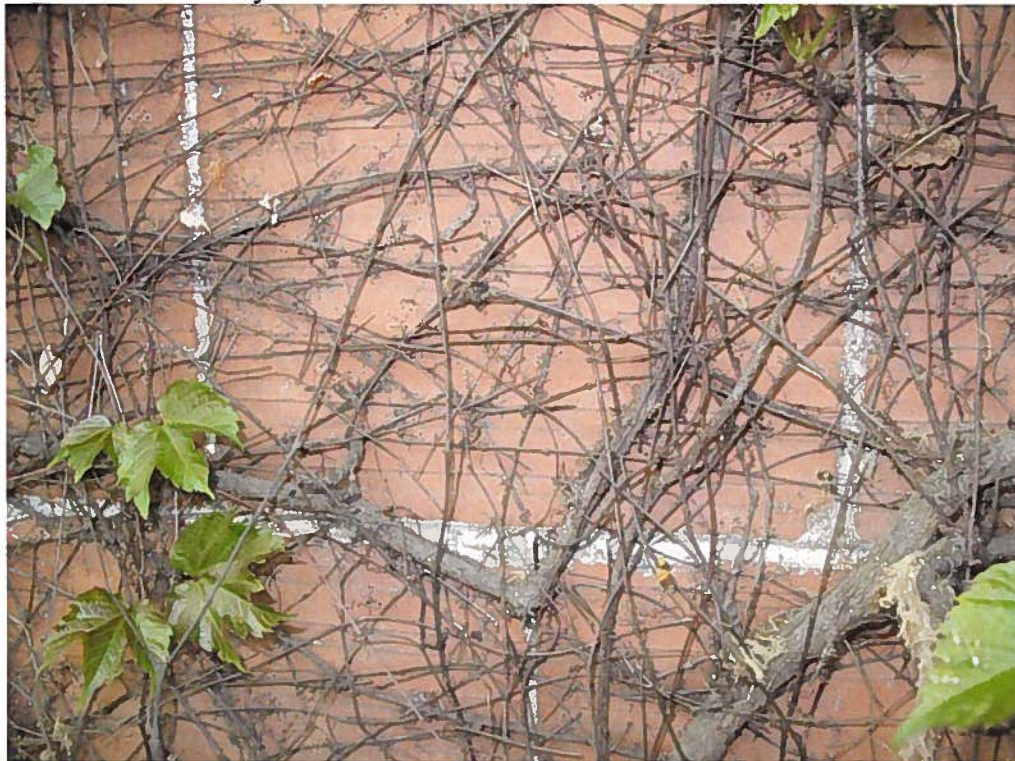
Exterior hollow clay tile detail:

As a part of the seismic rehabilitation of the unreinforced masonry main winery building, the interior wythe of hollow clay tile will be removed. This removal of historic material is unavoidable. The exterior wythe of hollow clay tile will remain as a fully anchored veneer, so the exterior appearance will be minimally altered.

Work in the proposed project meets the Secretary of the Interior's Standards. It is recommended that a large stock of the original hollow clay tiles be salvaged from the interior seismic rehabilitation project and be stored on site for future repair or restoration projects. These salvaged clay tiles should also be used to patch openings in the south and west walls of the main winery building. After evaluation of many alternatives, removal of interior hollow clay tiles is an unavoidable alteration required for the seismic strengthening of the main winery building and the Monte Rosso building.

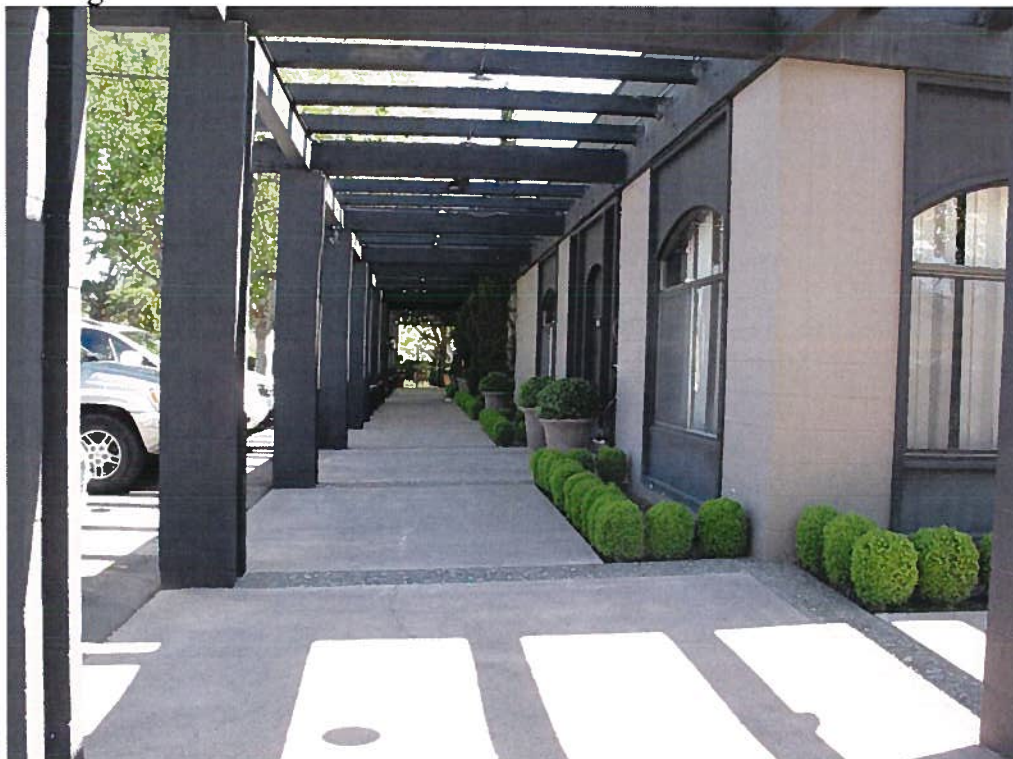
Tasting room addition to be removed:

A non-historic office and tasting room addition on the south and west sides of the main building obscure part of the original winery. This addition, circa 1970, is planned to be demolished. A small, detached hospitality building is planned for the west side of the site in the space now occupied by a parking lot and lawn.

Removal of the non-historic tasting room and office additions will restore the historic appearance of the south west portion of the building. The greatest alteration of the appearance of the main building is the removal of clay tiles in two bays of the front elevation for an enlarged tasting room main entrance. Since this change is reversible if adequate stock of the original tiles is retained, this alteration is acceptable.

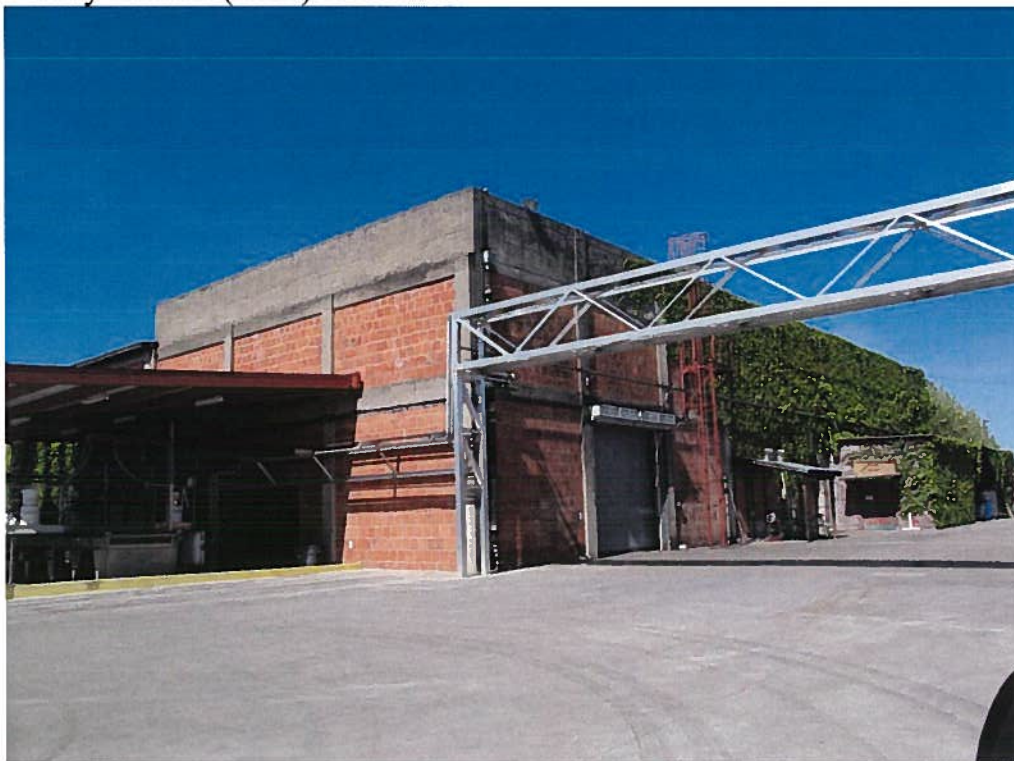
Winery addition (north) to remain:

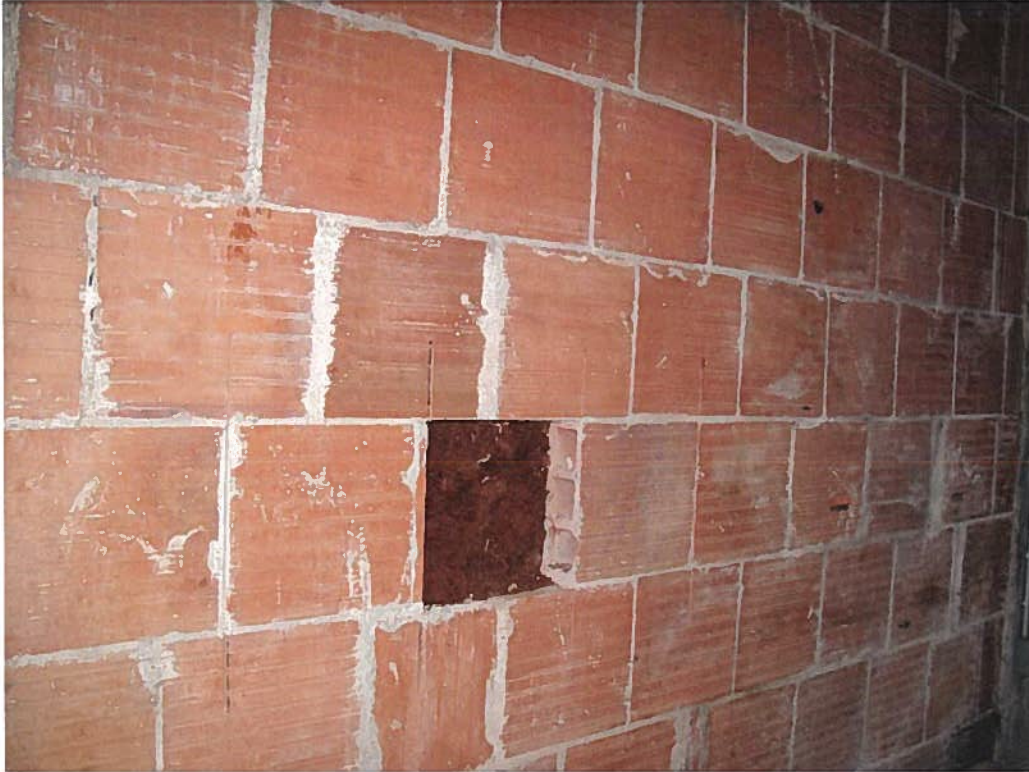
Interior wall finish and shredded bark insulation:
