# Impacts to Circle Oaks Drive

Project No. VV4147  
17 October 2016

Subject: Circle Oaks Drive  
Napa County, California  
**GEOLOGIC AND GEOTECHNICAL REVIEW & RECONNAISSANCE**

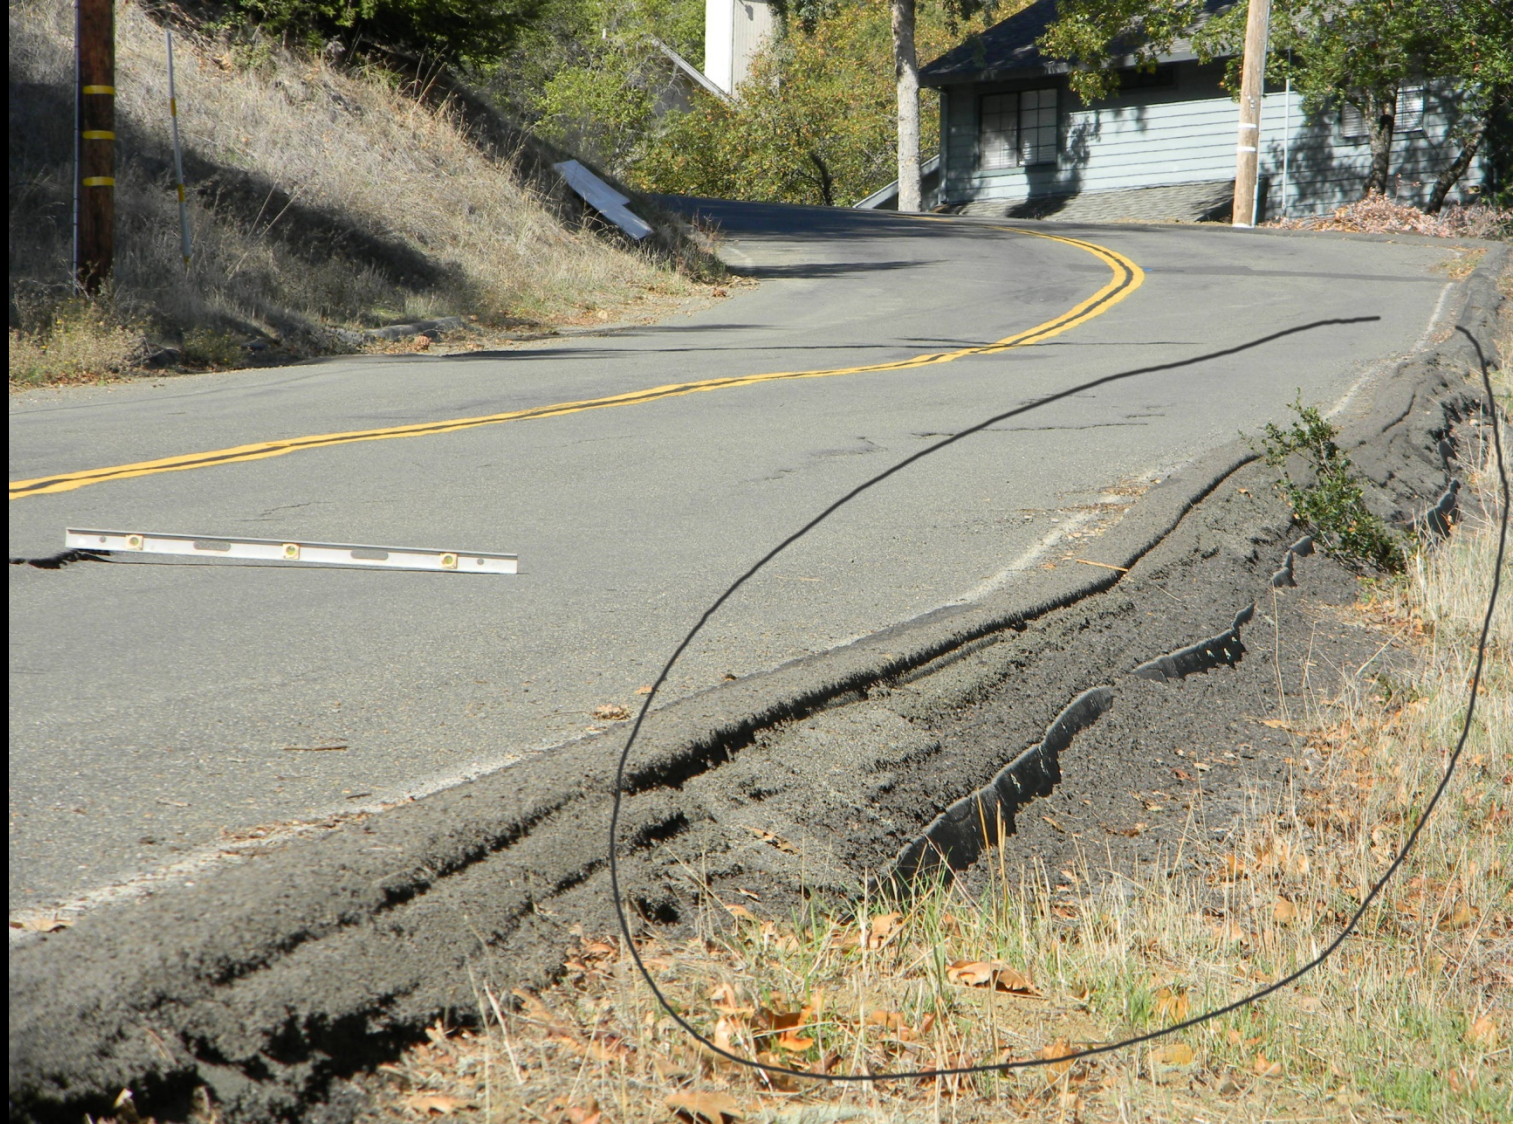
# Road Conditions, 11/2014: 189 – 214 Circle Oaks Drive

Area A includes an area of extensive road settlement and cracking located along a linear portion of Circle Oaks Drive. The road in this area was constructed by cut/fill techniques and the eastern lane consists of a large fill embankment. The fill bank appears to extend down the slope approximately 25 vertical feet and has inclinations of about 1.5H:1V (horizontal to vertical). In this area we observed severe pavement cracks over a zone approximately 300 feet in length (see attached photographs). The cracks range up to approximately 1 inch in width and extend approximately to the centerline of the existing road. Some of these cracks have vertical offsets in excess of 1 inch. In addition, our observations found that the area has been repeatedly repaved to compensate for previous settlement in the area of more than 1 foot. Circle Oaks

**Area A – looking southeast**
