AETNA SPRINGS PRESERVATION PLAN

For:
Aetna Preserve, LLC

Prepared by:
Architectural Resources Group
Smith & Smith

October 3, 2011

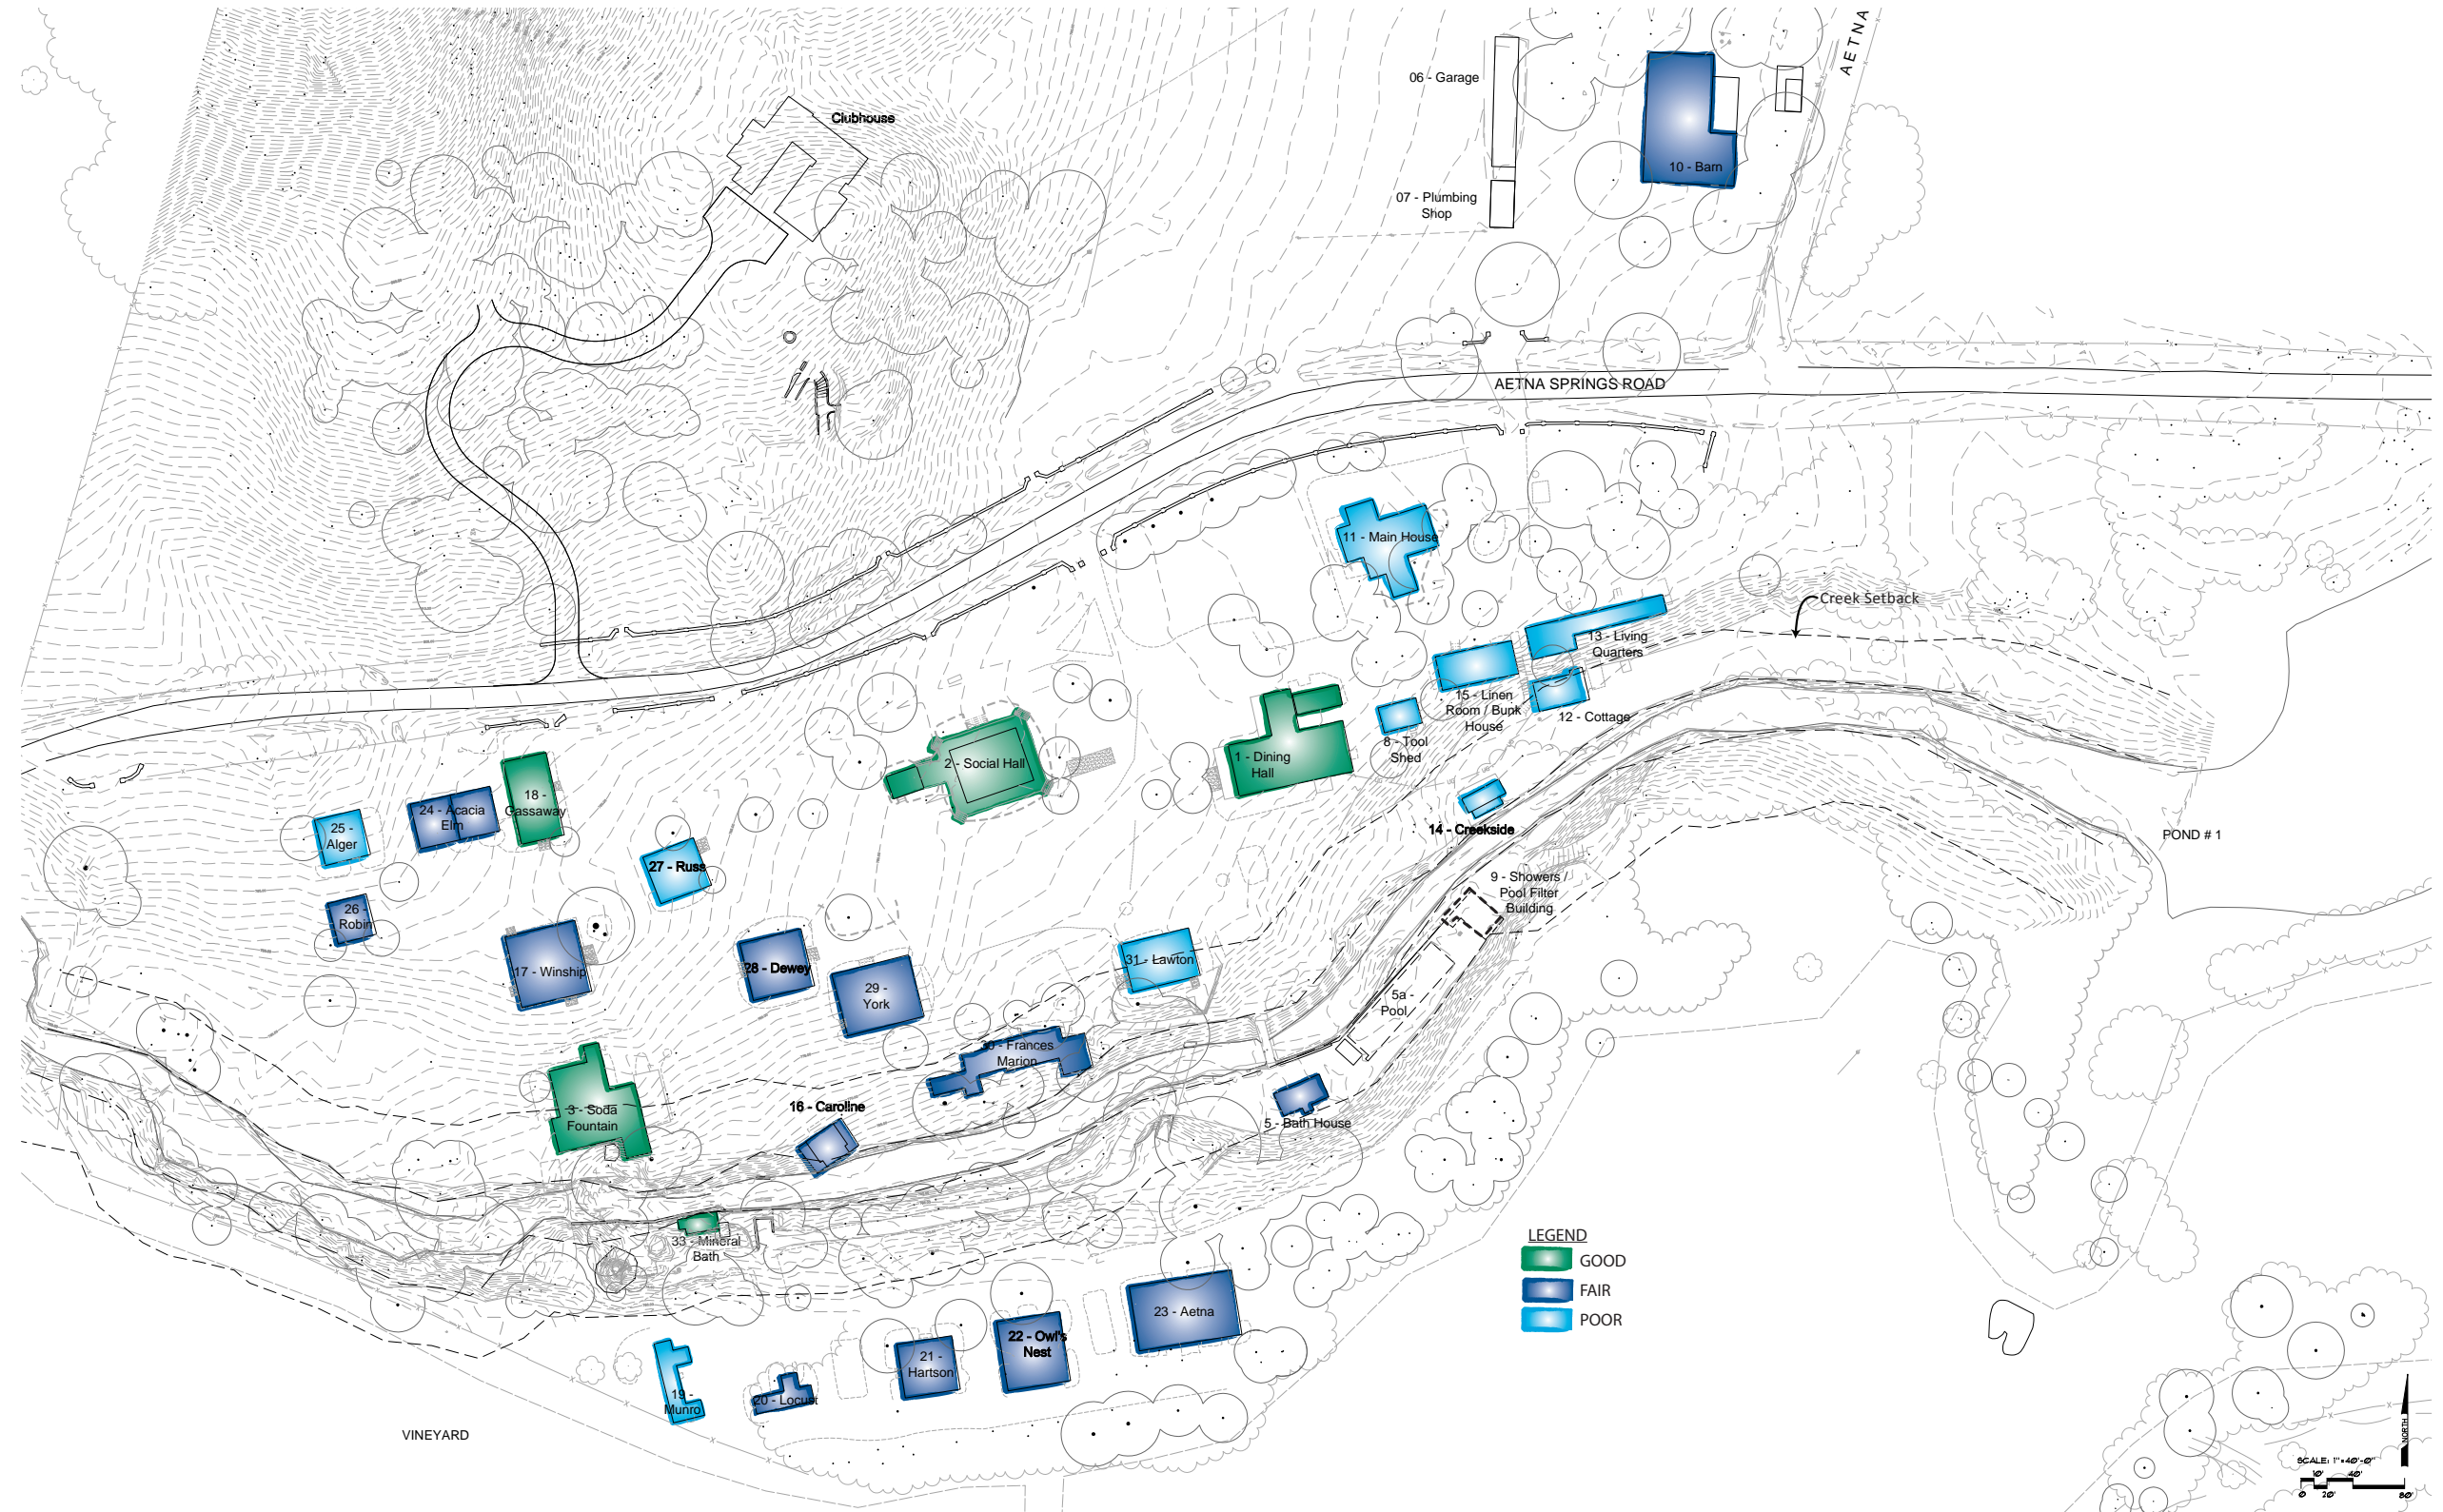
Historic Building Inventory - Integrity Plan

As of 2011, Aetna Springs Historic District completely retains its integrity of location and setting. Due to the substantial deterioration of contributing buildings within the historic district, the design integrity of the property is no longer as high as it was in 1984. Similarly, due to deferred maintenance and associated deterioration, the integrity of materials and workmanship of individual contributing resources is partially diminished. The buildings and structures that contribute at the primary level retain a higher level of these aspects of integrity and, as such, possess greater ability to convey the property's significance.

Although the design integrity of the property as a whole is largely intact, given the considerations above, Aetna Spring's overall integrity is now considered fair with a substantial number of contributing resources in an advanced state of deterioration. Still, the property retains the "identity for which it is significant, " a mineral springs resort of distinguished architectural character.

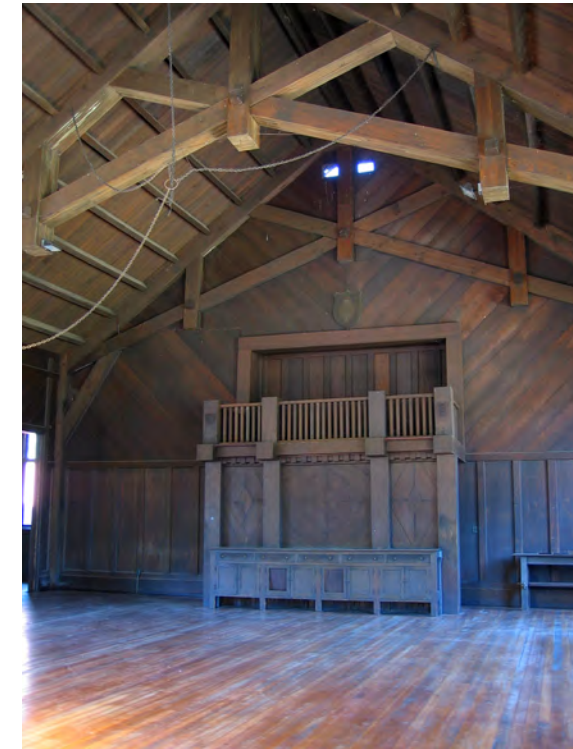
Treatment Level 1 Structure: Dining Hall

Treatment Level 1 will be applied to buildings that retain a 'good' level of integrity at the exterior and interior, are primary or secondary contributors, and are in good-to-poor condition.

Under this treatment buildings will continue their existing use or be rehabilitated to accommodate a compatible new use. Limited alterations will be required, and an emphasis will be placed on retention of existing materials. Primary spatial relationships will typically be retained. Interior and exterior features and finishes will be retained; they will be repaired where deteriorated, and replaced when they are deteriorated beyond repair. Additions will be compatible, yet clearly distinguishable as new.

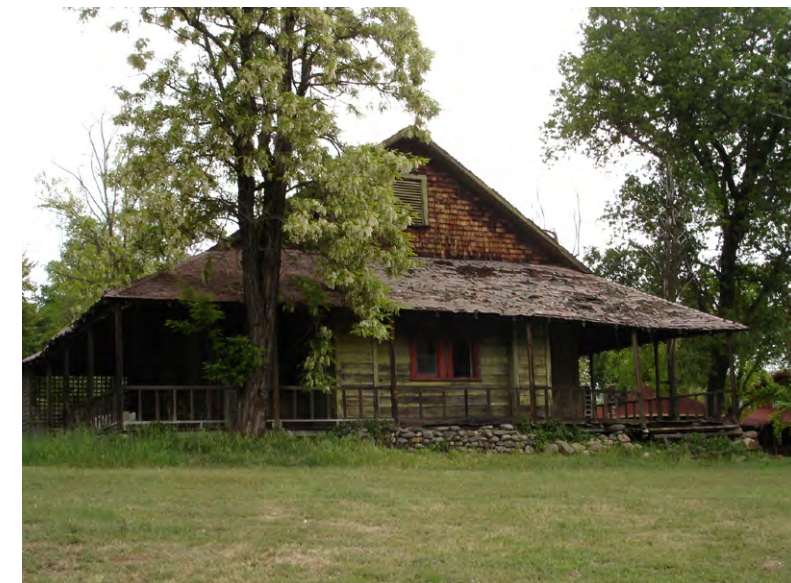
Treatment Level 2A Structure: York cottage

Treatment Level 2A will typically be applied to buildings that retain a 'fair' level of integrity, are secondary contributors to the district, and are in poor condition. These buildings have experienced severe deterioration and degradation, but are still standing.

Under this treatment buildings will continue an existing or new compatible use, yet due to poor condition, will require extensive replacement of materials. This process will involve largely stripping buildings to their frames leaving only non-deteriorated siding and trim in place. New framing will replace or be sistered to deteriorated framing; new siding will replace deteriorated siding and so on. The exterior massing will be retained. Modifications will be made to interior spaces to accommodate contemporary lodging functions. Interior finishes and features will generally be replaced in-kind or with compatible new materials as they are typically missing, severely deteriorated, or non-historic. Door and window openings will generally be retained, but most windows and doors will be replaced (in kind) due to their poor condition. Exterior door openings may be fitted with windows to accommodate modifications to the floor plan. Haphazard porch modifications made after the period of significance will be upgraded to be more consistent with the district's original level of design. Lattice may be relocated to align with floor plan adjustments.

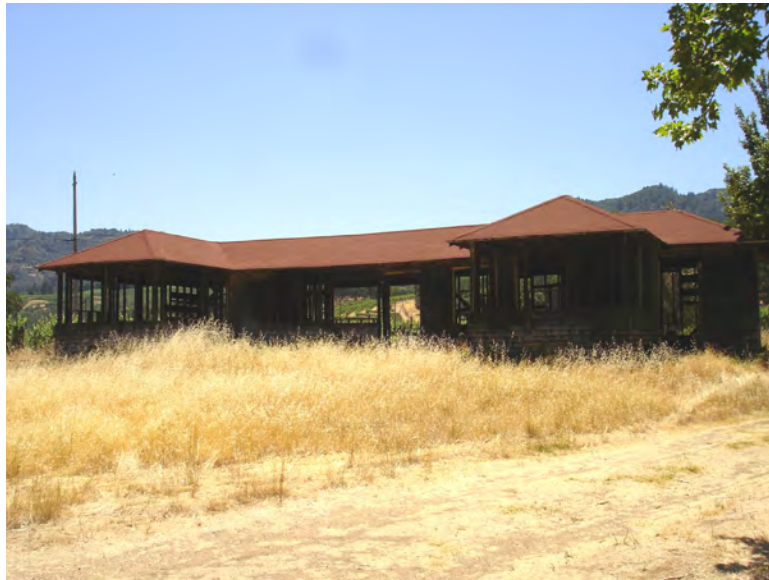
Treatment Level 2B Structure: Munro cottage

Treatment Level 2B will typically be applied to buildings that are tertiary contributors to the historic district. Buildings under 2B have been heavily altered and/or are more deteriorated than those under 2A: they retain a 'poor' level of integrity and are in poor condition. These buildings have extensive alterations (outside the period of significance) and severe deterioration necessitates a more substantial degree of

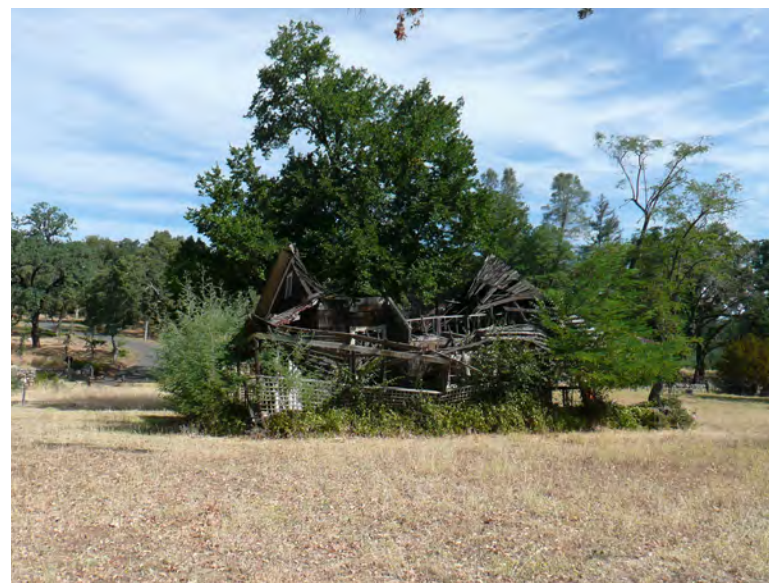
Treatment Level 3A Structure: Russ cottage

Treatment Level 3A will typically be applied to buildings that are no longer structurally sound, have collapsed, or require relocation due to their location within the creek setback. They are secondary and tertiary contributors that are in very poor condition, yet retain a fair-to-poor degree of integrity.

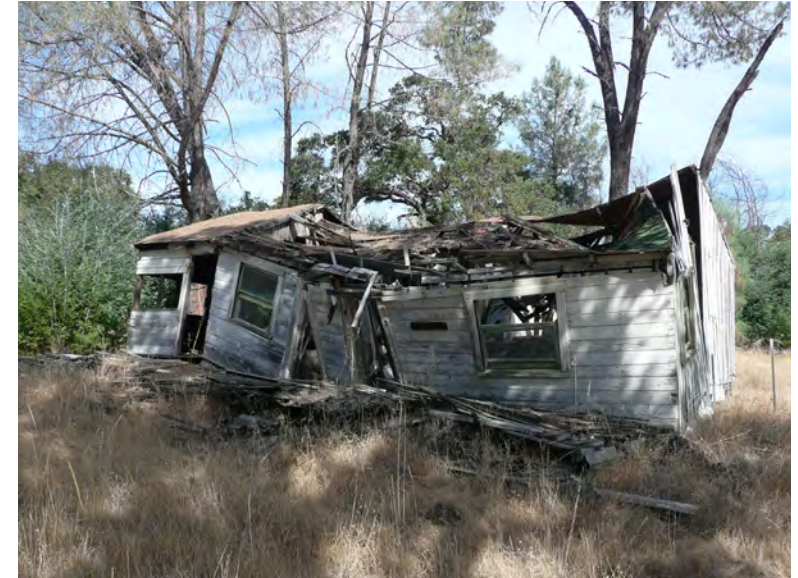
Treatment Level 3A Structure: Alger cottage

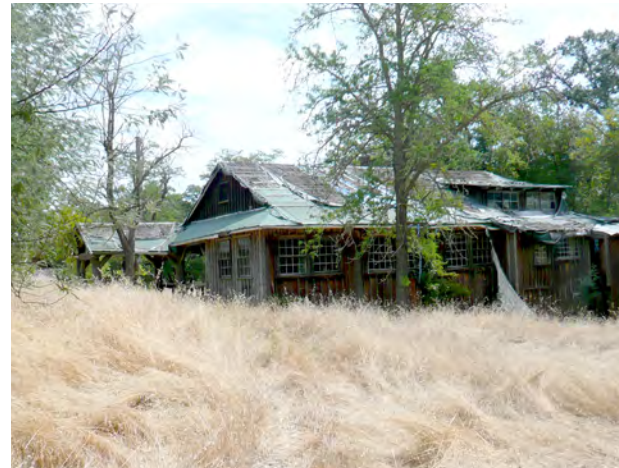
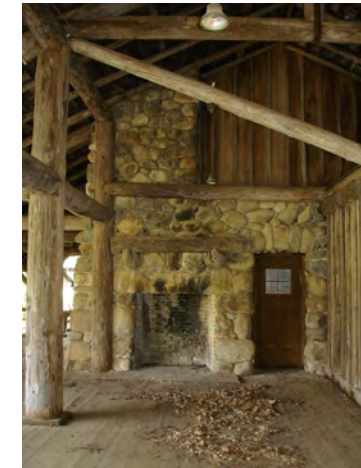
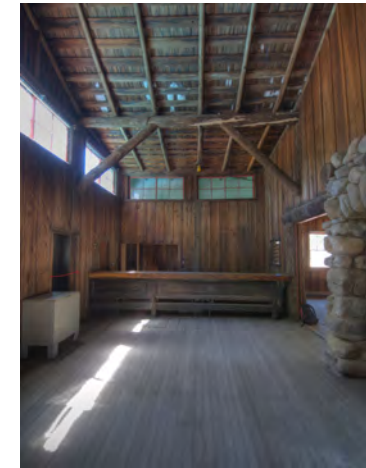
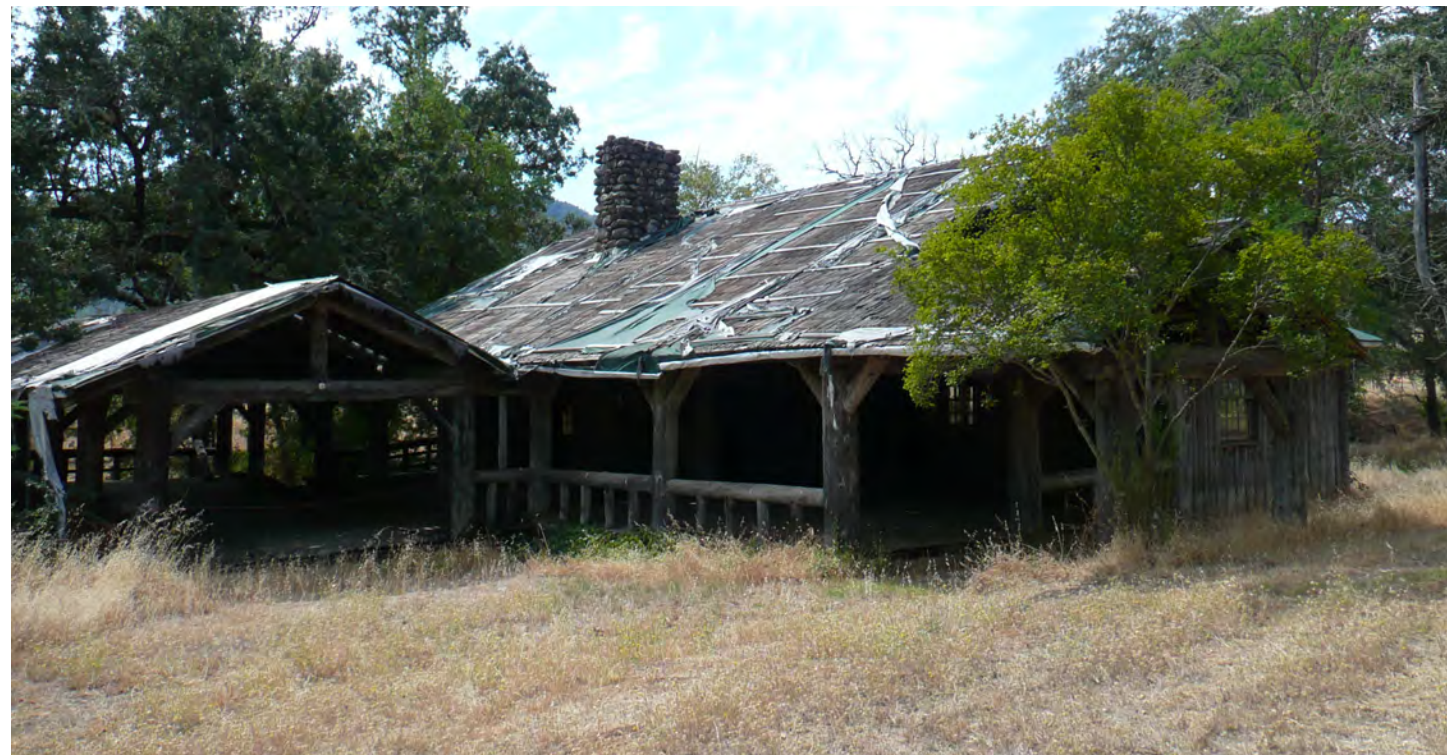
L top - Northwest corner; M top - Stone chimney; R top - Bar room; Bottom - Northeast corner

Due to the open-air nature of this structure and its location near the creekbed, this structure is in various states of deterioration throughout. The lower porch and attached, non-contributing patio are substantially deteriorated. The floors throughout the open pavilion are typically in very poor condition. The southwestern corner of the structure, located on the downhill approaching the creek, has also suffered substantial damage as a result of water and moisture. The roof is currently covered with a tarp due to the advanced deterioration of the roofing.

Due to a lack of maintenance by the previous owners, the building overall is in poor condition. It has not experienced significant modification and therefore has good integrity.

- Stone fireplace will be retained. It will be disassembled and reconstructed to integrate seismic reinforcement.
- The bar will be replaced with a new bar similar in character and detailing to the existing.

A seismic upgrade of the building will be required. A full structural evaluation will be completed at a later date. Modifications will be integrated into the historic fabric to the greatest extent possible.

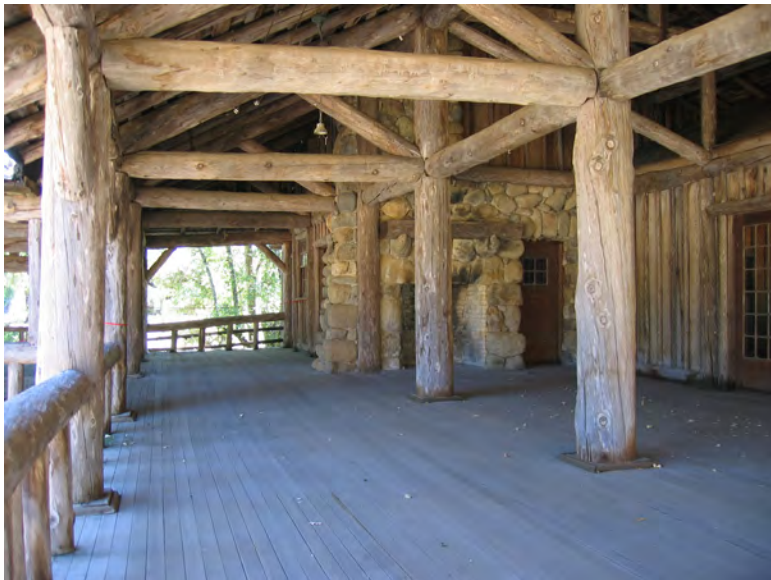
Open air pavilion

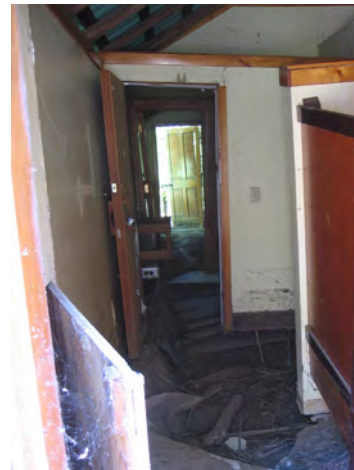
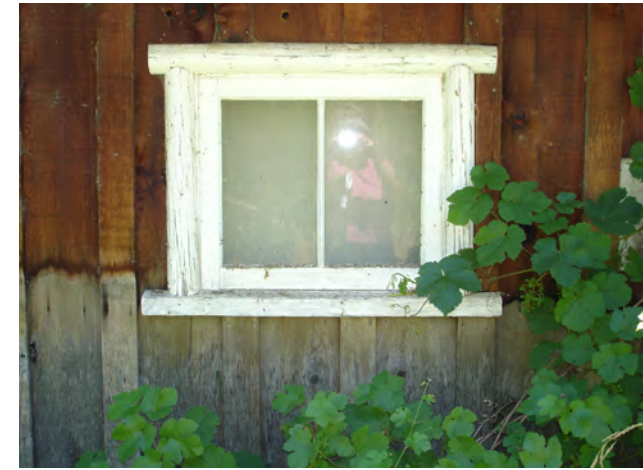
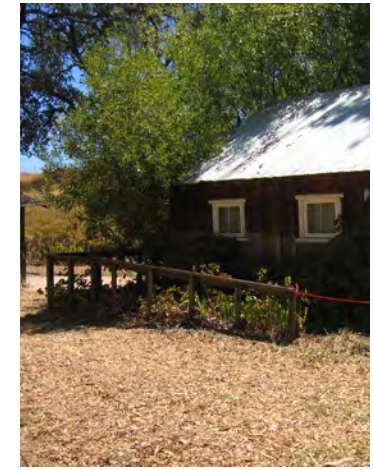
The building is in very poor condition. The interior has been badly damaged by flooding and does not retain its integrity. With the exception of the fiberglass roofing, the exterior appears to retain a majority of its integrity though the wood is quite deteriorated along the base of the

L top - Interior of changing room; M top - Typical window; R top - Ramp to eastern changing room; Bottom - Northwest corner

building and has numerous woodpecker holes. Overall, its integrity is fair.

This proposal removes this structure from within the stream setback and replaces it with a new guest unit building, called “Willow”. The design of the replacement structure will be based on the gable roof of the bathhouse. It will utilize the existing entry door locations for guest unit doors and will have vertical wood siding. Porches will be added to the to the perimeter to create outdoor spaces for guest use similar to the historic lodging. The rear additions will be replaced with new restrooms.

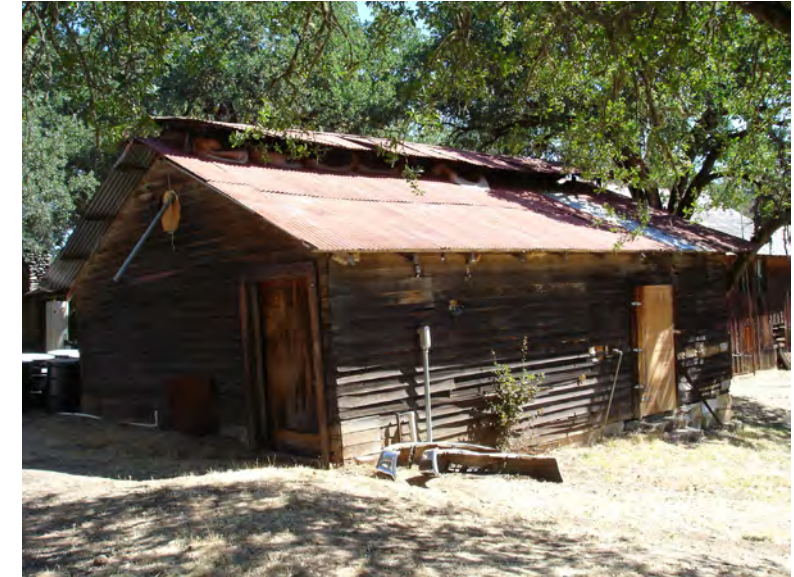
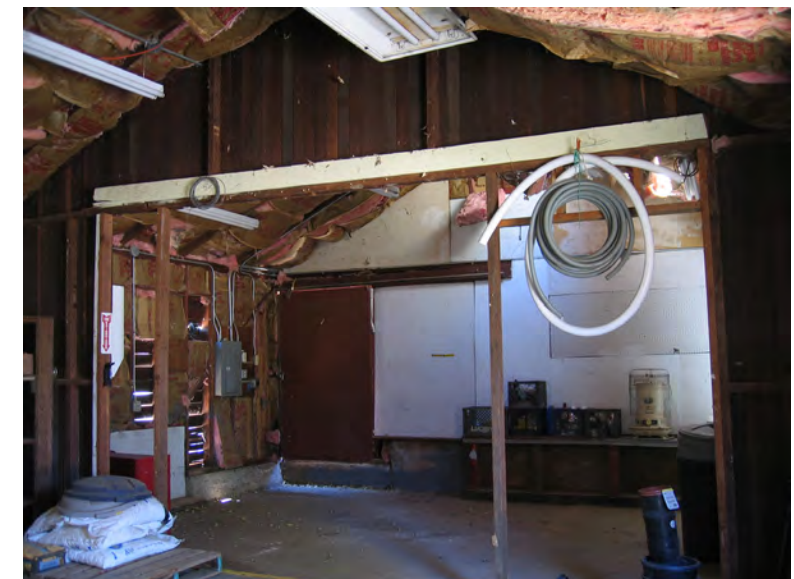
The building is very poor condition, has been modified and therefore has poor integrity.

Southwest corner

As part of the rehabilitation of the historic district, Tool Shed will continue its use as a maintenance, housekeeping, and storage building. It will also function as a central garbage collection area for the retreat. Modifications will include a new large opening will be created to allow for the garbage function, and may include limited additional modifications to openings. Existing boarded windows will be uncovered, and new windows provided where missing.

All character-defining features will be retained or, if deteriorated, repaired or replaced in kind.

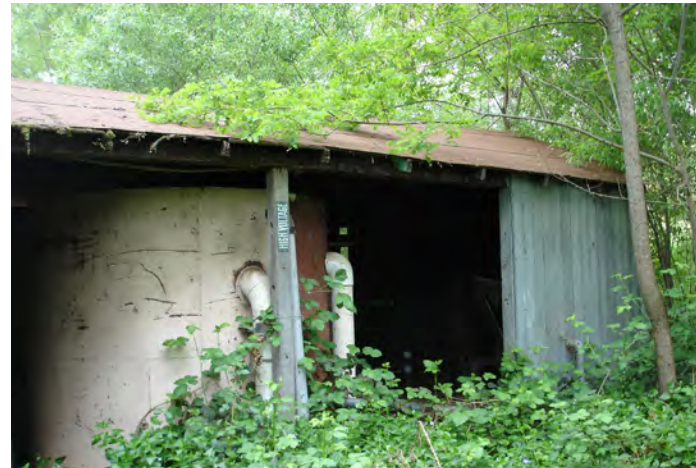
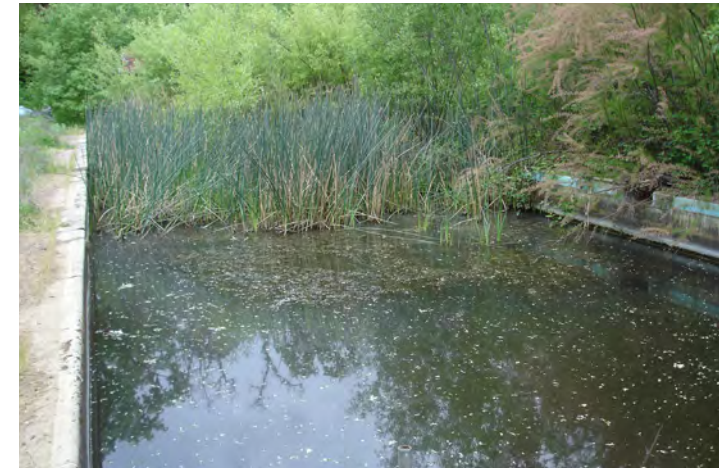
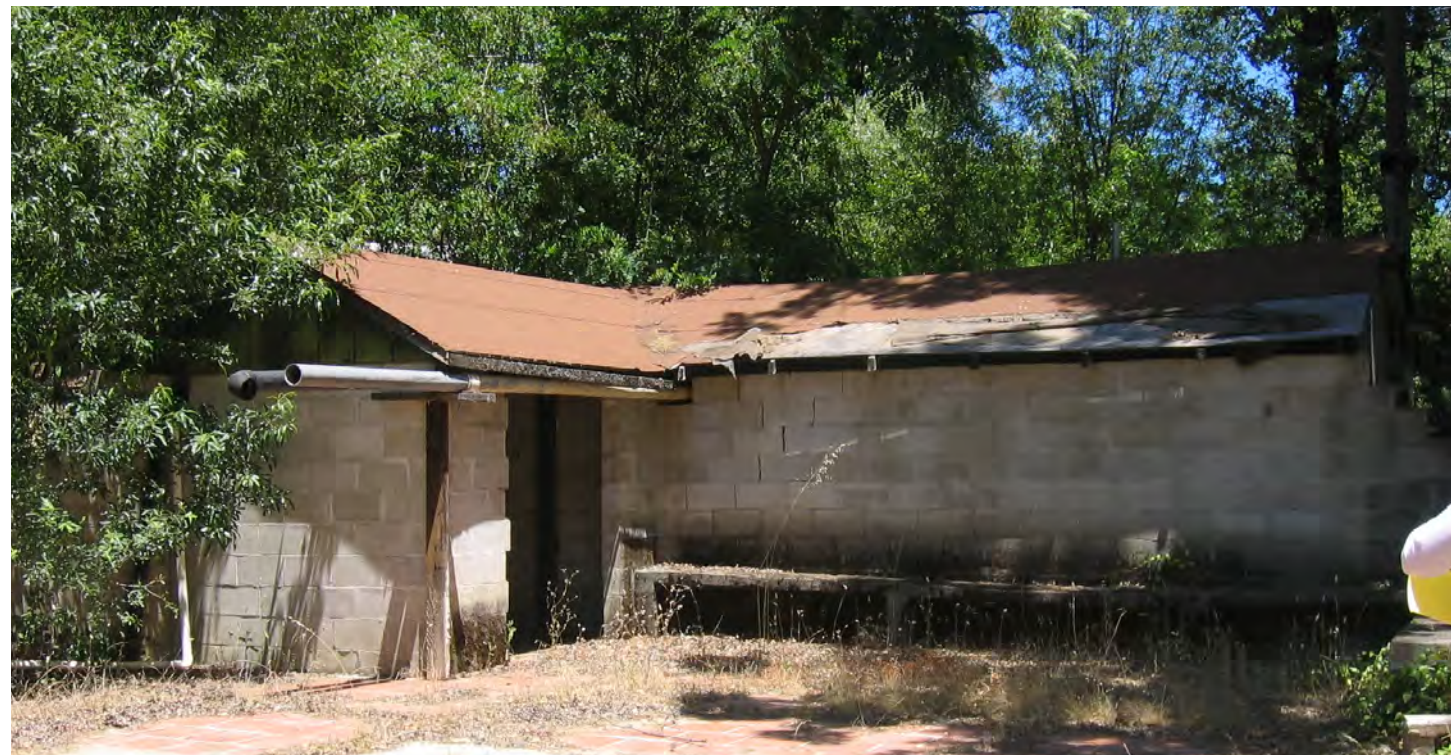
The Showers/Pool Filter Building is located adjacent to the historic swimming pool and Aetna Springs Creek. The building is located within the stream setback, has been flooded, and is in very poor condition. Since the swimming pool will no longer be used for swimming, the shower and pool filter functions are not needed at this location.

L top - View looking southwest; R top - Pool detail; Bottom - View looking north

This proposal removes this structure and replaces it with a new guest unit building located outside of the stream setback just above the Showers/Pool Filter Building location. The new structure, called ‘Heibel’ after the third owner’s of Aetna Springs, will be based on the footprint of the existing Showers/Pool Filtration building, with the addition of porches at the perimeter. It will incorporate design elements compatible with the vocabulary of the historic district.

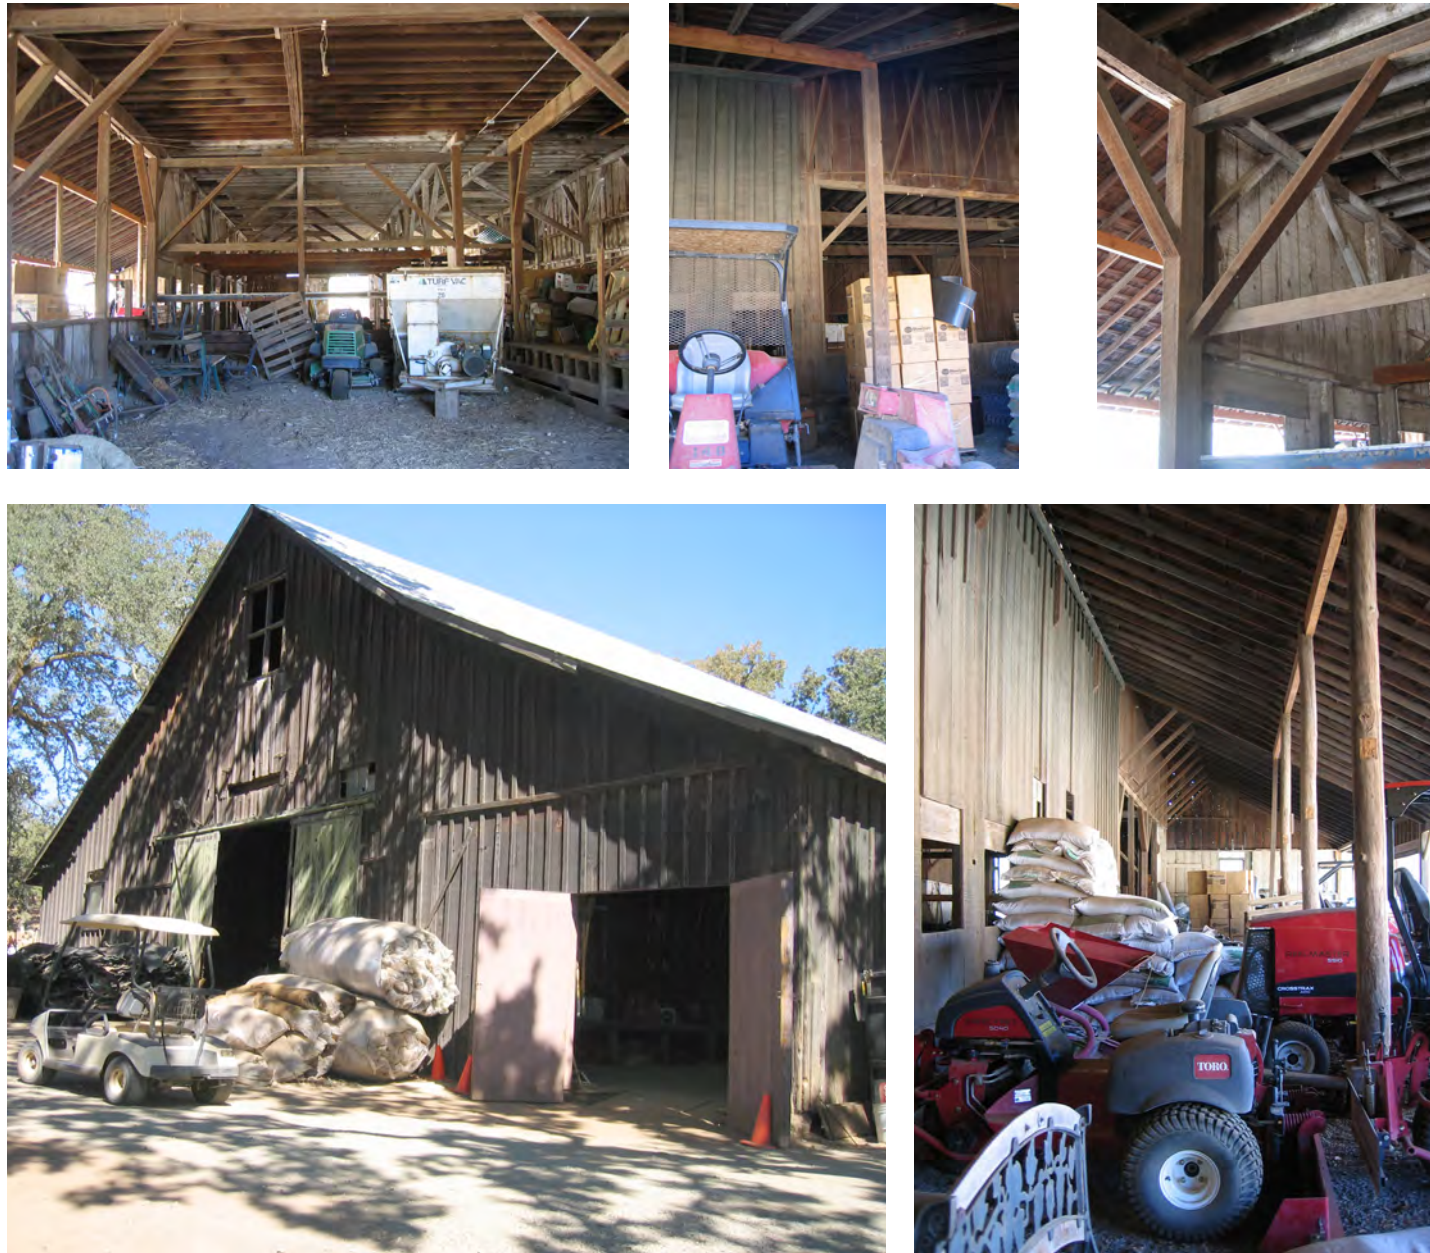
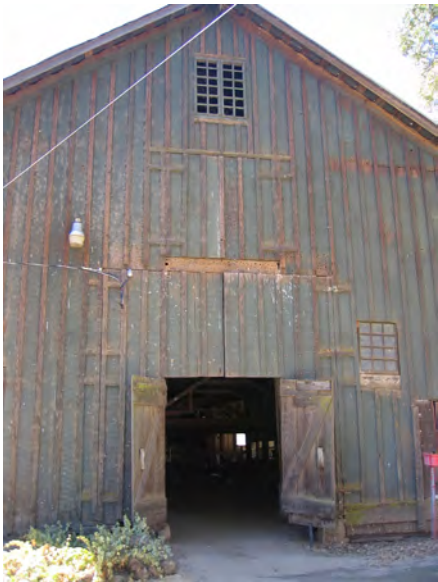
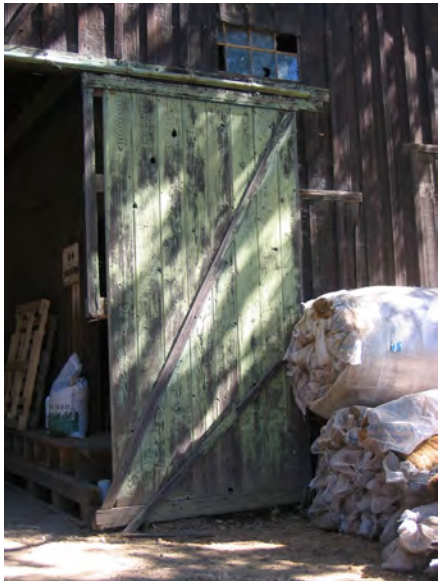
The Barn is in poor condition and its integrity is fair.

L top - Interior looking north; M top - Detail of western shed addition; R top - Meeting of northern 6 bays & southern 4 bays;
L bottom - South facade; R bottom - Western side aisle

The Barn is currently used as a support space for the golf course and will continue in this function for the near term. Its treatment will be determined at a later date.

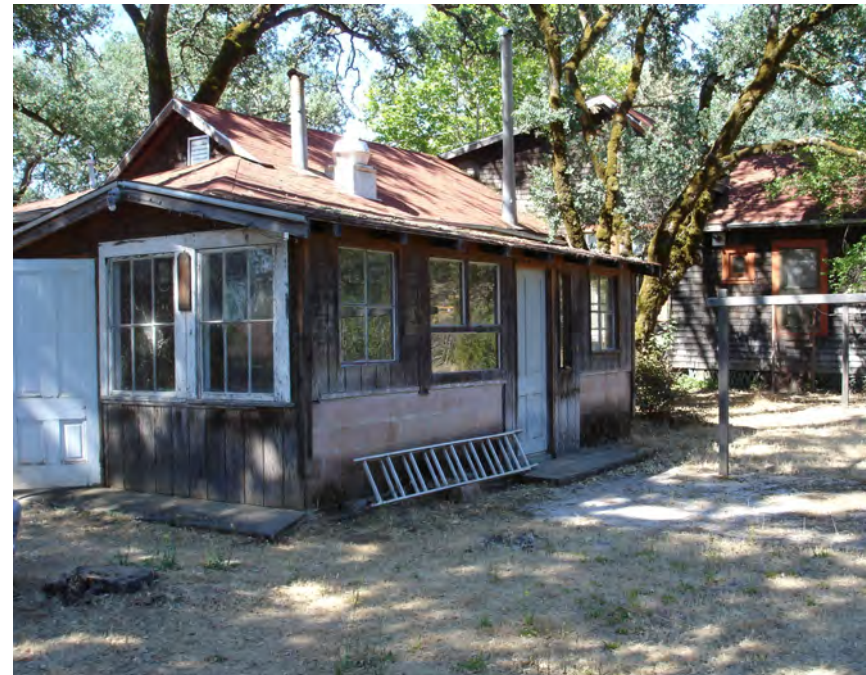
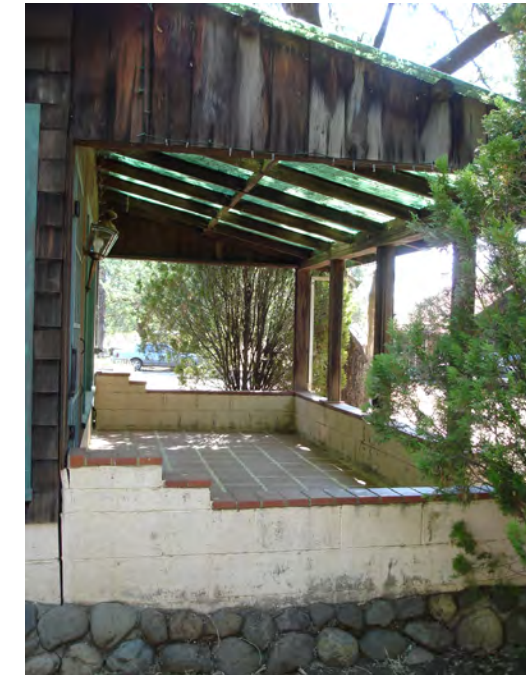
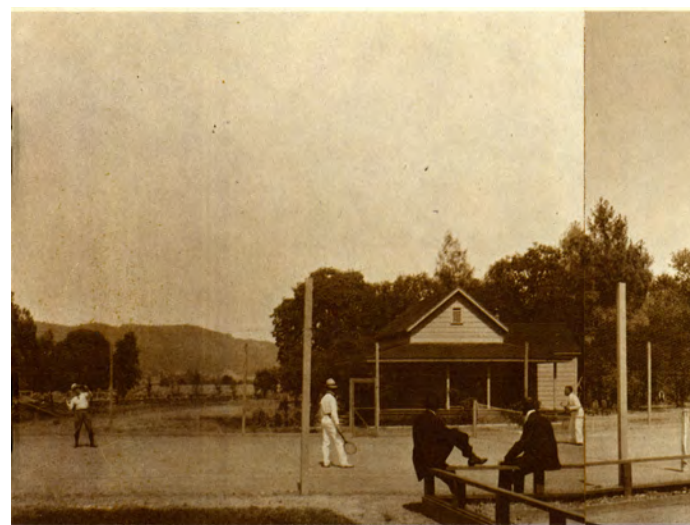
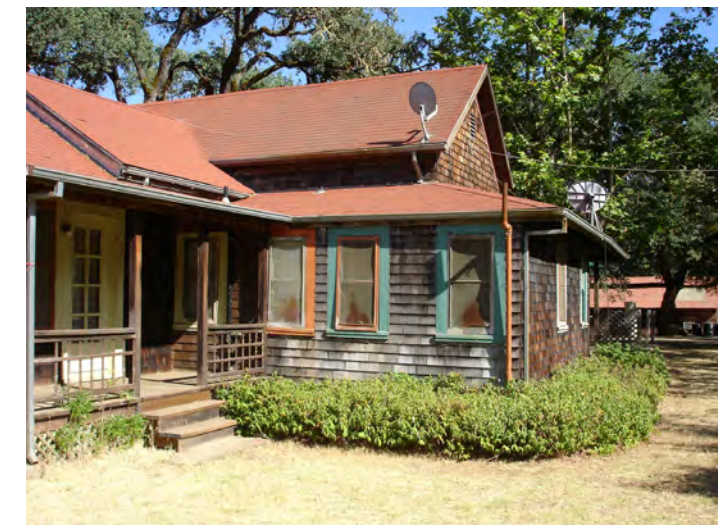
L top - Playroom addition; R top - CMU porch;
L bottom - Historic photo of west facade; R bottom - Northwest corner of now enclosed front porch

house have been significantly remodeled. The original porch has been enclosed and the original entry/living area has been made into a bedroom, so there is no clear main entrance or spatial hierarchy throughout. The interior wall finishes are a mixture of plaster, gypsum board, and wood paneling while the floors are a mixture of wood, tile & vinyl. The building has been fairly well maintained and is therefore in fair condition. However, its integrity is poor due to the significant remodels to the interior and exterior.

and window configurations at this porch and portion of the building will be modified to be more consistent with the character of the district. For example, the existing concrete masonry may be clad with river rock similar to that on other buildings. The additions at the east side of the building will be removed and replaced by compatible construction generally within the same footprint. The additions are of poor quality and are not suitable for lodging use as currently constructed. All three entrances will be defined by wraparound porch roofs similar to the original entrance.

A seismic upgrade of the building will be required. Typical of most buildings on the site, the foundation will need to be upgraded and many of the structural members will need to be repaired or replaced due to deterioration. A full structural evaluation will be completed at a later date. Modifications will be integrated into the historic fabric to the greatest extent possible.

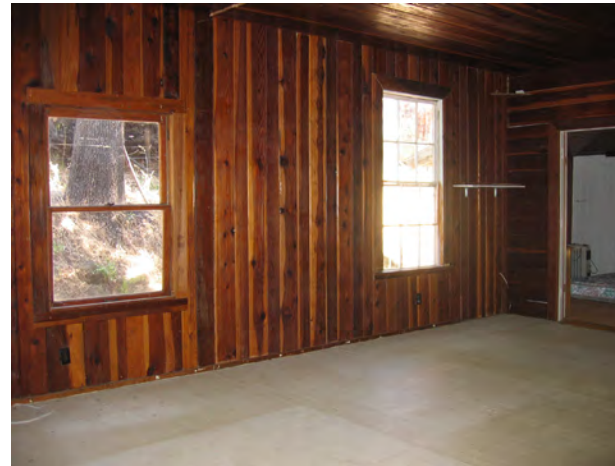
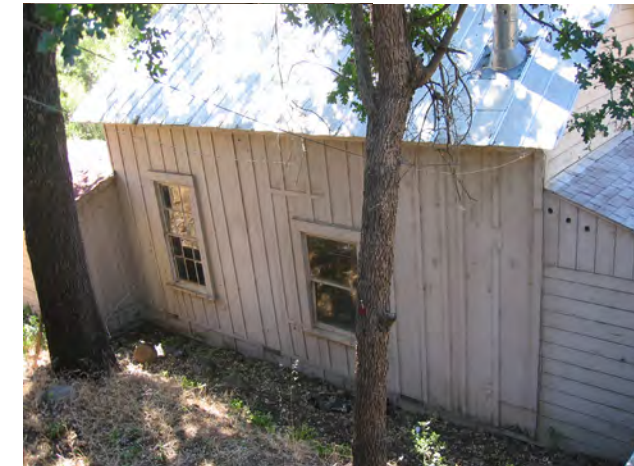
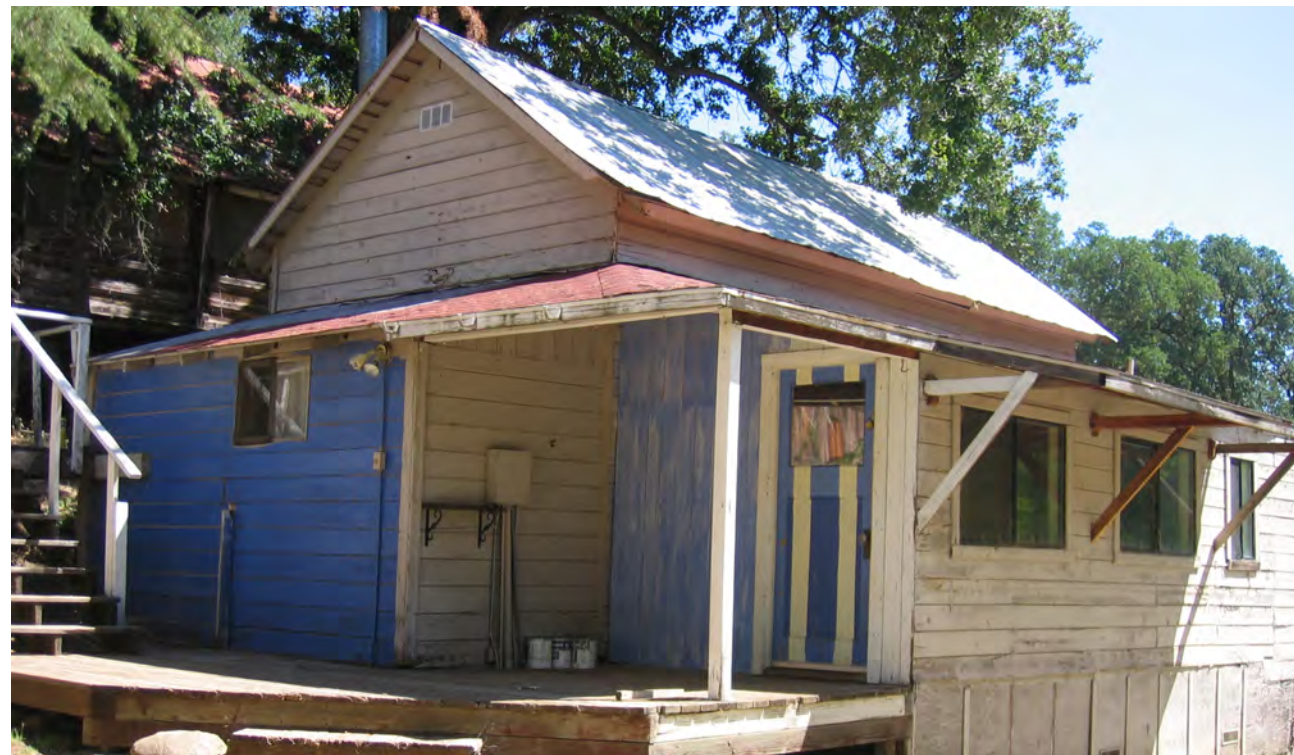
L top - Main room; R top - North facade; Bottom - Southwest corner

Due to multiple additions and remodels, the building has poor integrity. The building is also in poor condition.

The Cottage will be reconstructed in a new location outside of the stream setback. It is located within the stream setback area, is in very poor condition, and retains little integrity. The Cottage will be reconstructed northeast of Living Quarters and at an angle to it. The intent is to more fully enclose the open space that is partially circled by Main House, the stone walls, and original support buildings. This approach will provide a bit more of a central focus to the oak-studded open space.

The south and west porch infill will be modified to integrate into the main living space. As the horizontal siding appears to have been installed over the board-and-batten siding after the period of significance, it will be removed from the original rectangular plan perimeter walls. The board-and-batten siding will be reinstated. It will be repaired and/or replaced as required due to deterioration. As there are multiple window types that do not appear historic, a single window design will be established for Cottage that is consistent with the character of the district. All other character-defining features will be reconstructed.

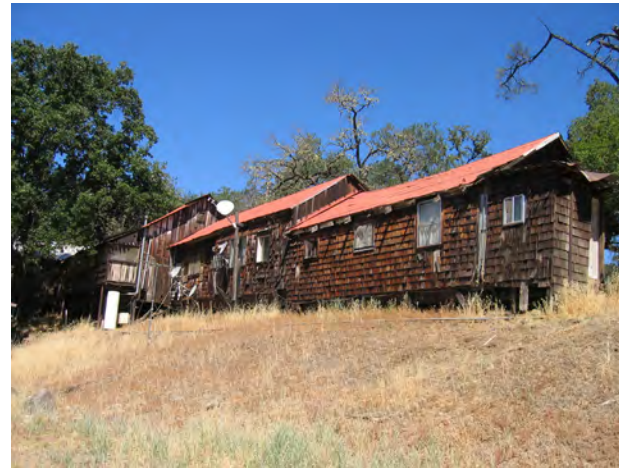
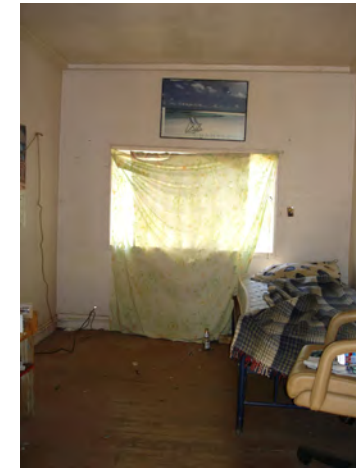
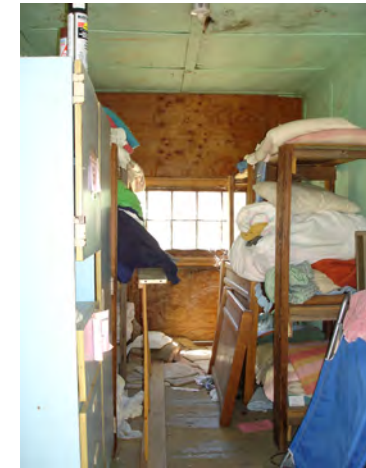
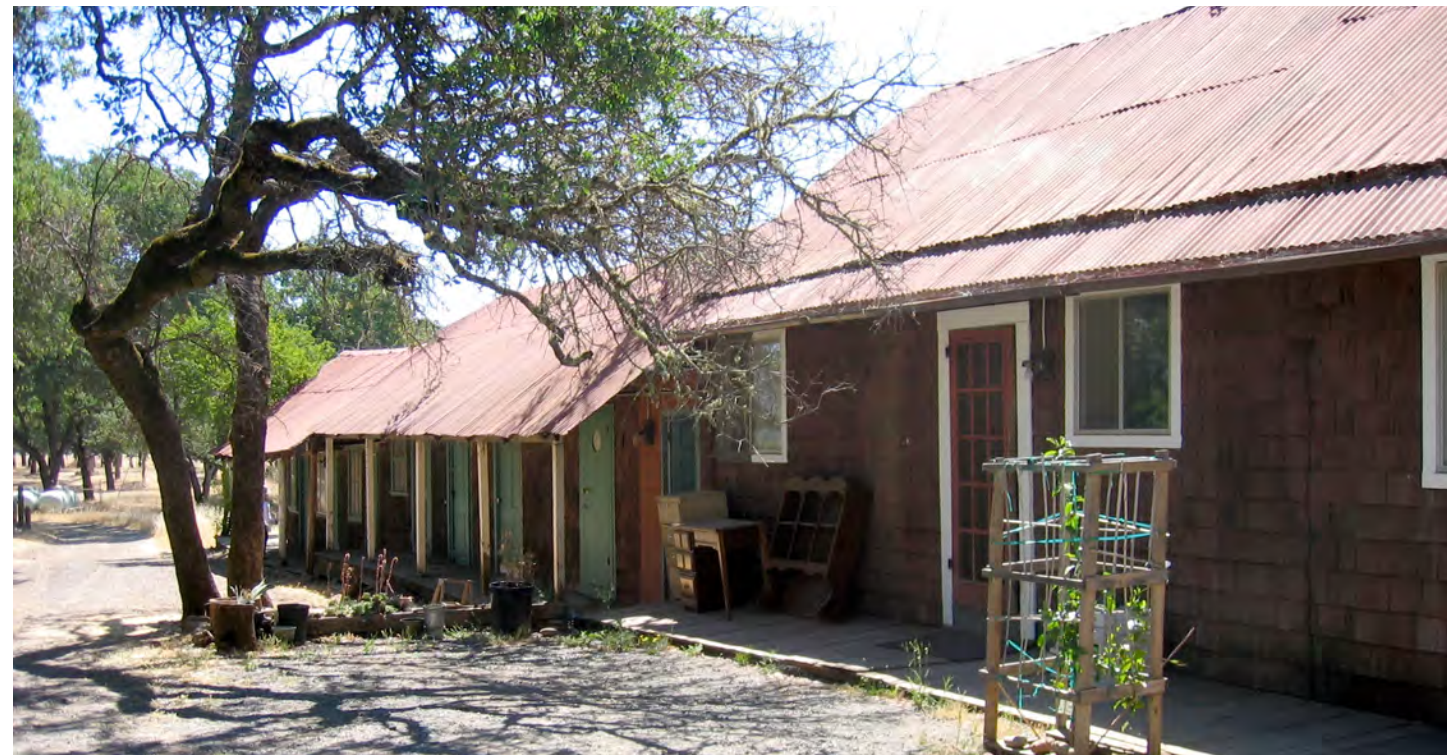
L top - South facade; M top - Gypsum board remodeled room; R top - Masonite board and batten finish; Bottom - North facade

The western building is comprised of three bedrooms along with a bathroom and kitchen. The interior finishes of this building have been stripped and replaced with modern finishes and all the original windows replaced.

The building is in poor condition and has poor integrity.

Living Quarters will be rehabilitated as guest accommodations. Non-historic windows and doors will be removed and replaced with elements that are compatible with the character of the district. A combination of shingle and board-and-batten wall cladding is proposed to express the original board-and-batten and the later shingle siding. Though the shingles are compatible with the Farr and Ward era work, they appear to be a later modification. A wood deck will extend from the rear of the building to provide guests private outdoor space similar to the historic units. Lattice enclosures will be constructed on the decks to provide privacy for outdoor bathing.

A seismic upgrade of the building will be required. Typical of most buildings on the site, the foundation will need to be upgraded and many of the structural members will need to be repaired or replaced due to deterioration. A full structural evaluation will be completed at a later date. Modifications will be integrated into the historic fabric to the greatest extent possible.
