AETNA SPRINGS PRESERVATION PLAN

For:
Aetna Preserve, LLC

Prepared by:
Architectural Resources Group
Smith & Smith

October 3, 2011

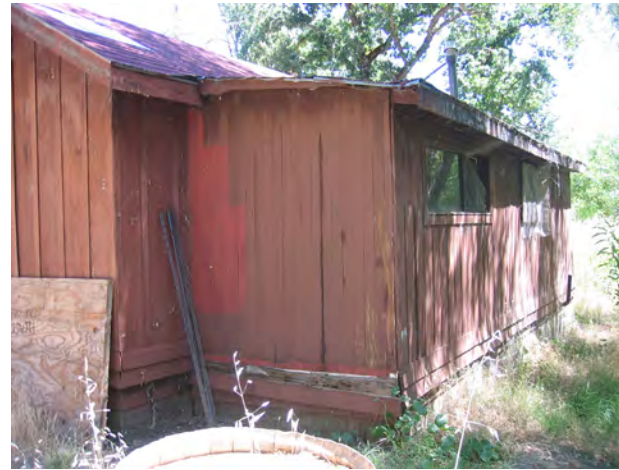
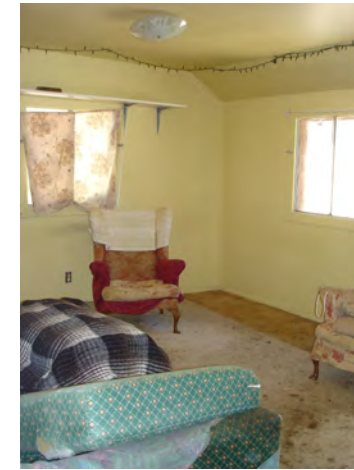
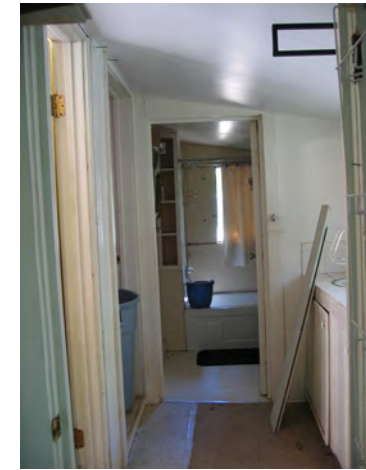
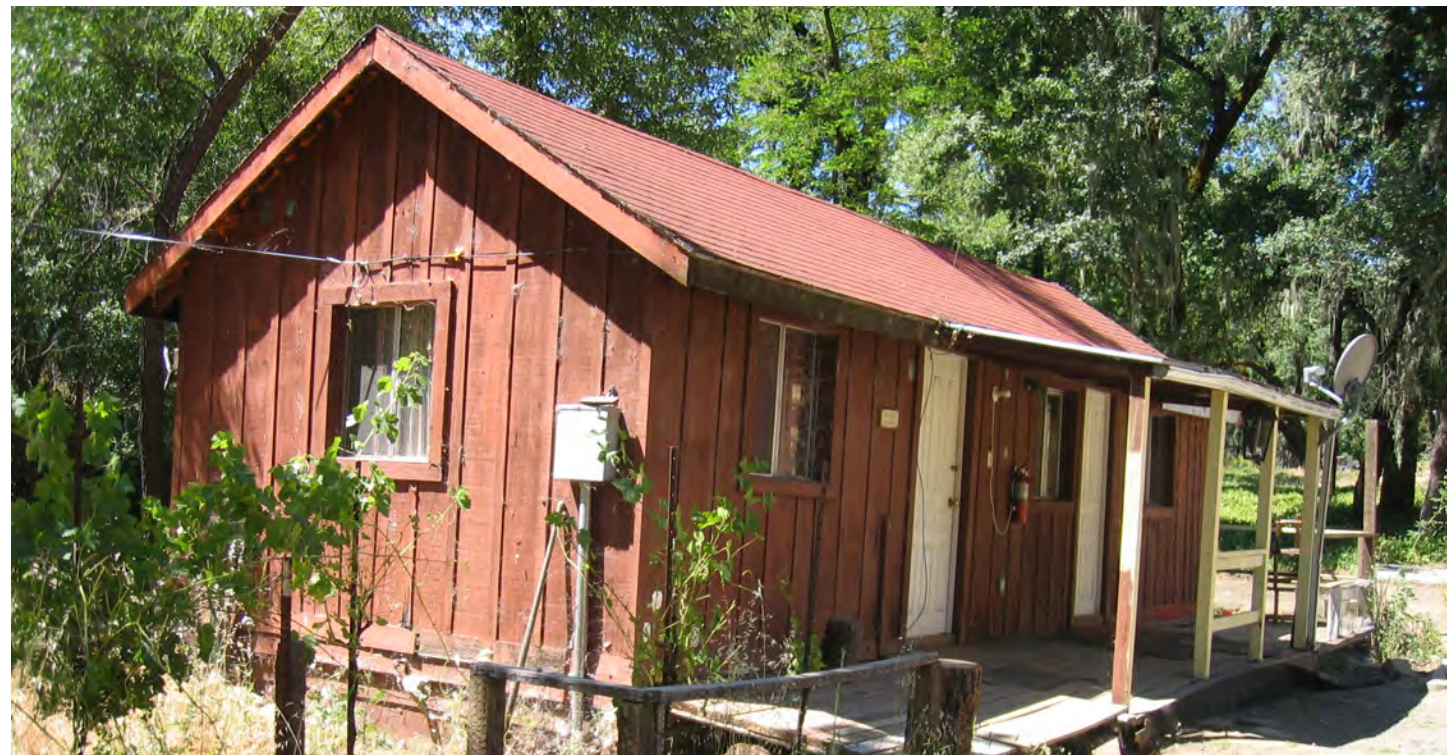
L top - Enclosed sleeping porch; M top - Typical interior remodel; R top - Interior of enclosed sleeping porch; Bottom - Northeast corner

Due to interior remodels and flooding, the building has poor integrity and is in very poor condition.

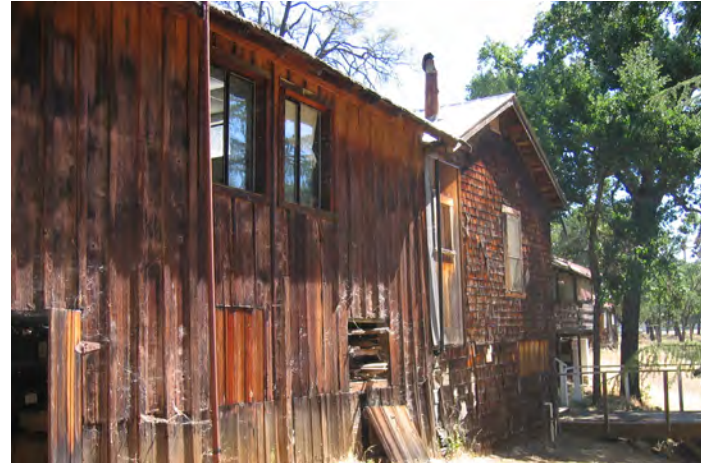
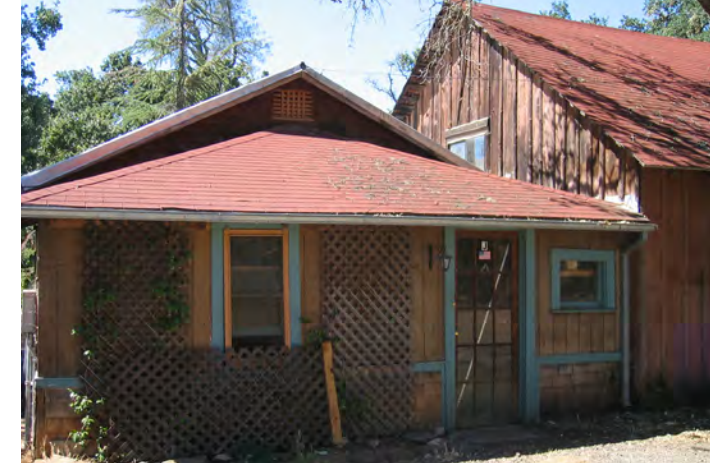
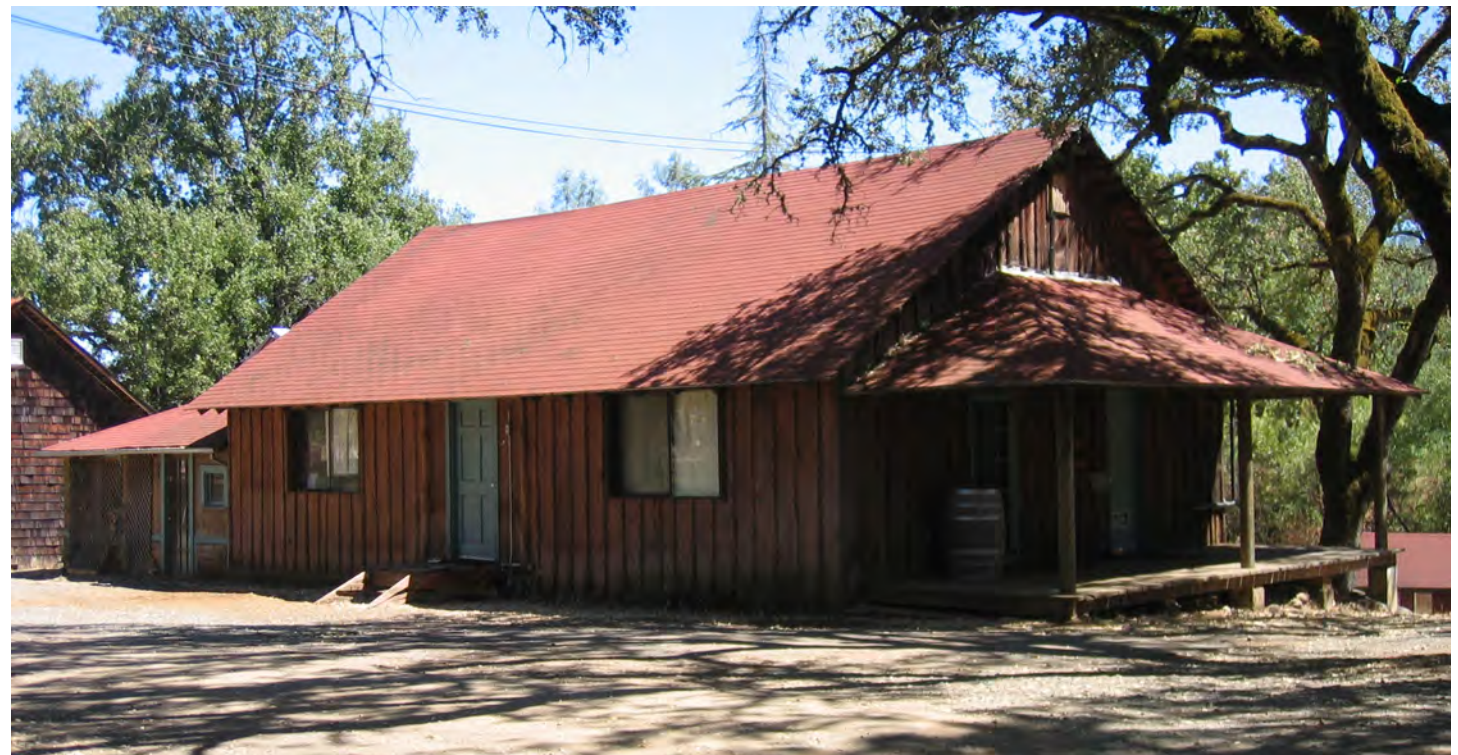
L top - South facade; R top - Northeast corner; Bottom - Northwest corner

Due to interior remodeling and removal of historic windows and doors, the building has poor integrity. The building is also in poor condition.

Linen Room/Bunk House will be rehabilitated to become guest accommodations. Non-historic windows and doors will be removed and replaced with elements that are compatible with the character of the district. A wood deck will extend from the rear of the building to provide guests private outdoor space similar to the historic units. Lattice enclosures will be constructed on the decks to provide

A seismic upgrade of the building will be required. Typical of most buildings on the site, the foundation will need to be upgraded and many of the structural members will need to be repaired or replaced due to deterioration. A full structural evaluation will be completed at a later date. Modifications will be integrated into the historic fabric to the greatest extent possible.

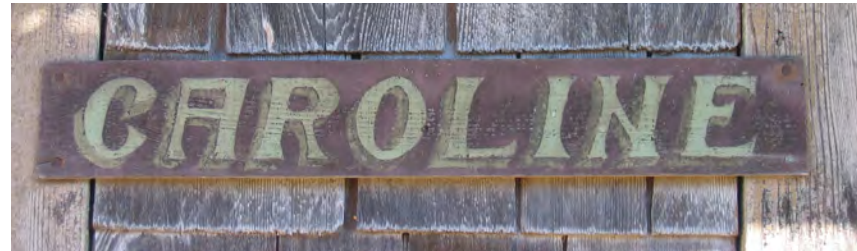
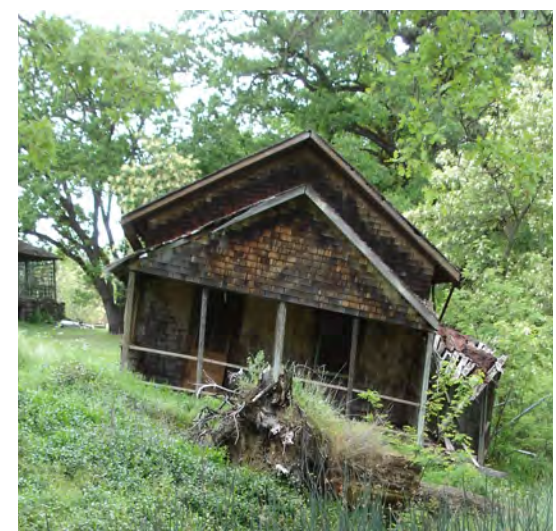
The building is very poor condition. It is heavily deteriorated and has

L top - Name placard; R top - Typical interior; Middle - North facade; L bottom - Southwest corner; R bottom - West facade

partially collapsed towards the creek. Although the building is in very poor condition, it retains much of its original fabric and therefore its integrity is fair.

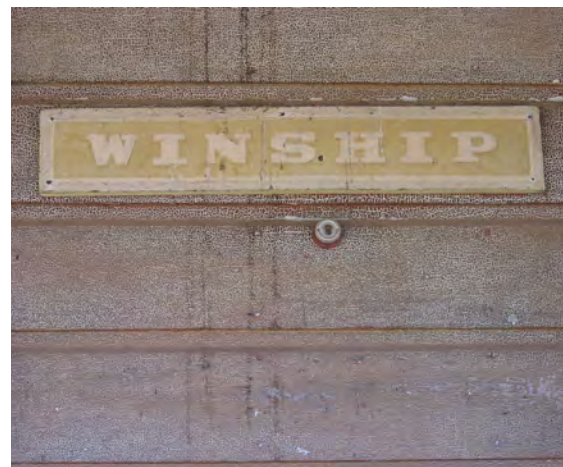
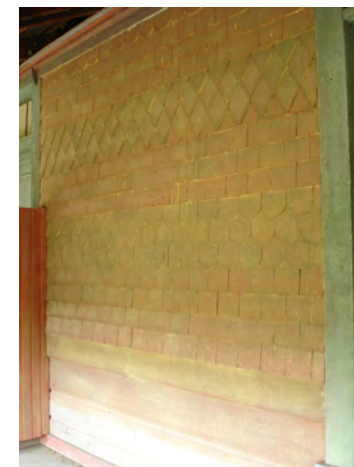
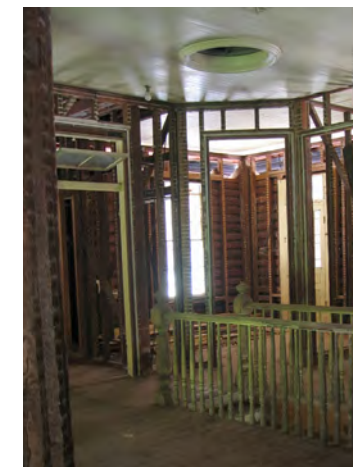
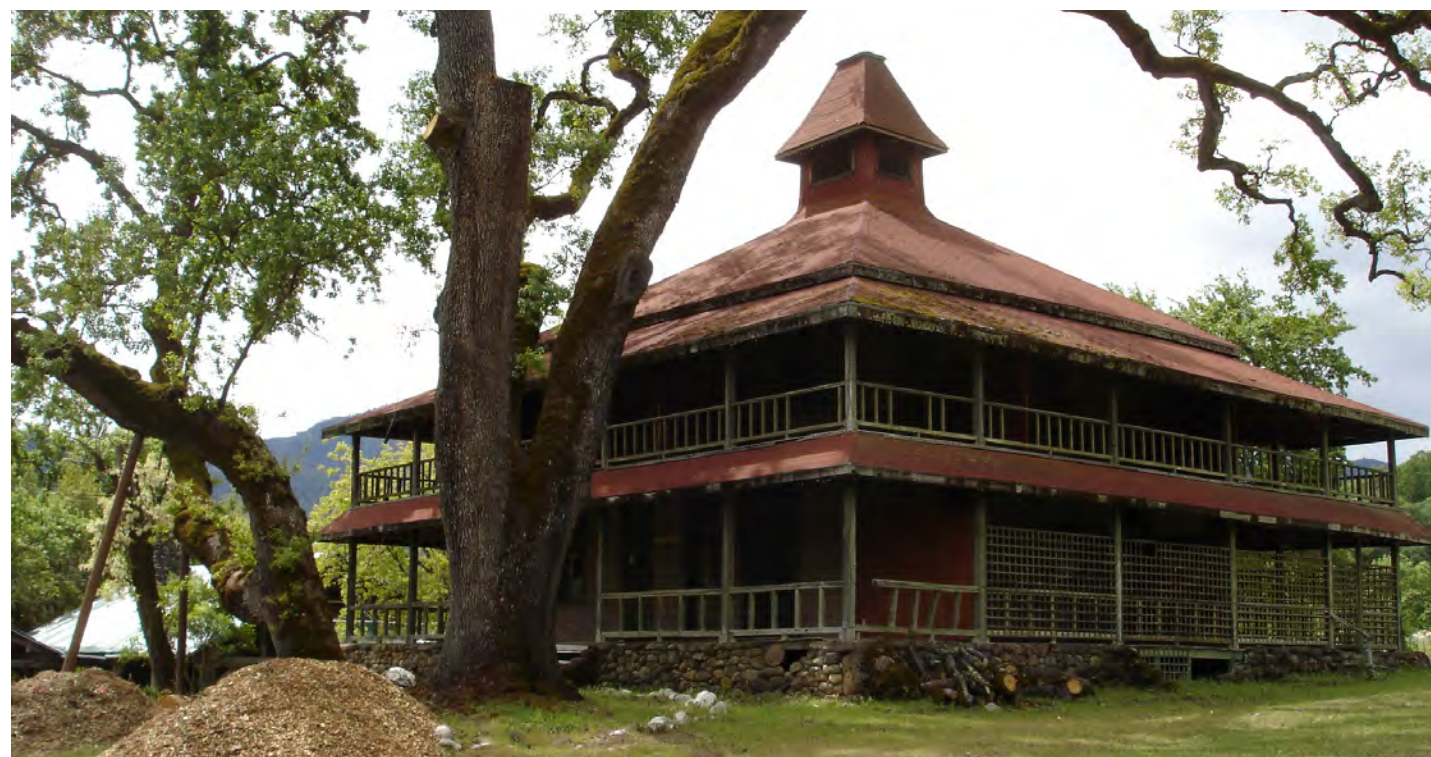
L top - Name placard; M top - Detail of shingle pattern; R top - Second floor interior stripped of finishes; Bottom - Northwest corner

The building is in poor condition. The wood porch steps and flooring are nearly completely deteriorated. Although the interior finishes of the second floor have been almost completely stripped, the buildings integrity is fair.

As part of the rehabilitation of the district, Winship will continue the existing lodging use. The exterior massing, materials, and features will be retained. Roof elements, including the cupola, chimney caps, and eyebrow vents that removed after the period of significance will be recreated. Exterior materials will be replaced in kind where deteriorated. Interior finishes and features will generally be replaced in kind or with compatible materials as they are typically missing, severely deteriorated, or non-historic. Modifications will be made to interior spaces to accommodate contemporary lodging functions while retaining an understanding of the original spatial configurations. Door and window openings will generally be retained, but windows will be replaced due to their poor condition. Exterior door openings may be infilled with windows to accommodate modifications to the floor plan. Lattice screen locations will be altered to suit the updated floor plans.

A seismic upgrade of the building will be required. Typical of most buildings on the site, the foundation will need to be upgraded and many of the structural members will need to be repaired or replaced due to deterioration. A full structural evaluation will be completed at a later date. Modifications will be integrated into the historic fabric to the greatest extent possible.

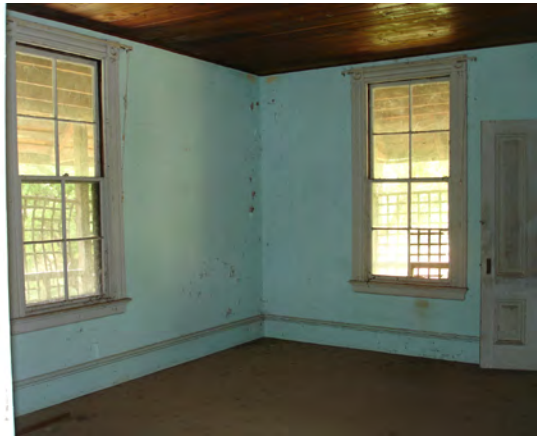
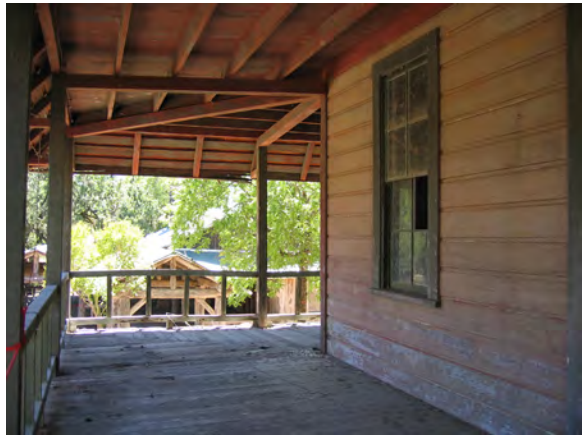
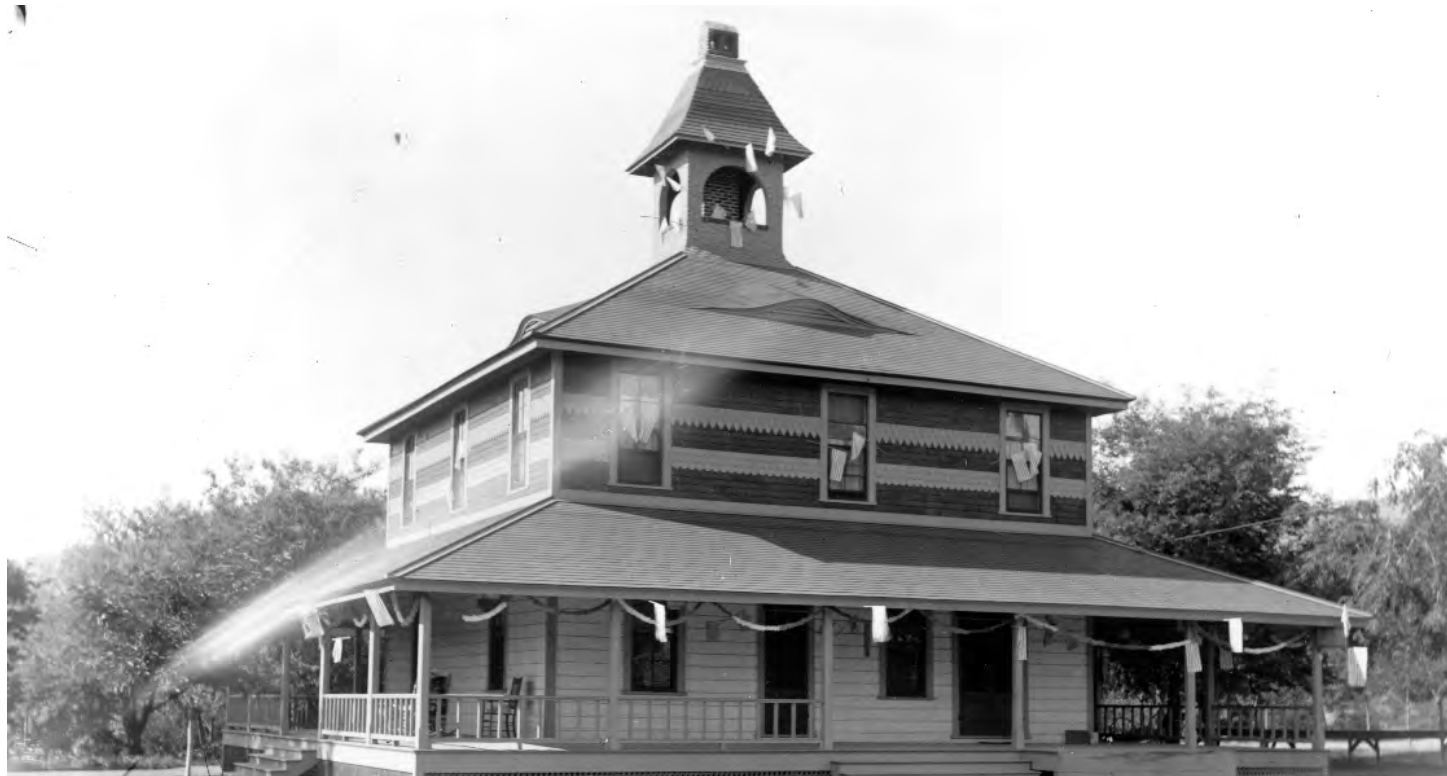
L top - Typical first floor interior; R top - First floor porch; Bottom - Historic photo of Winship in its original location and configuration (California Historical Society Photo GN-01951)

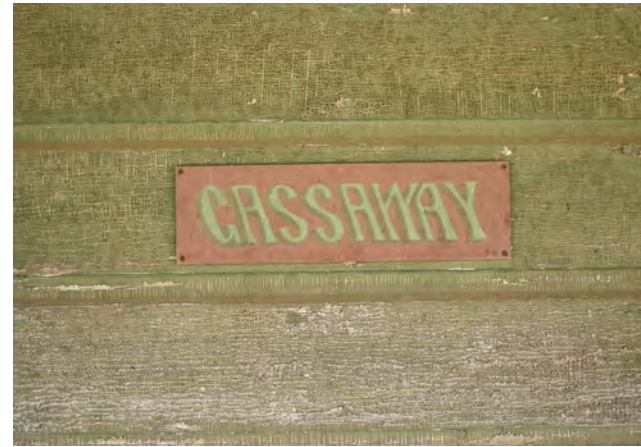
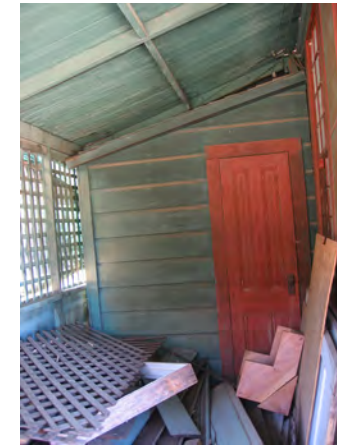
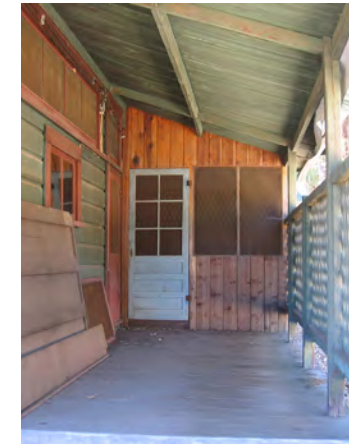
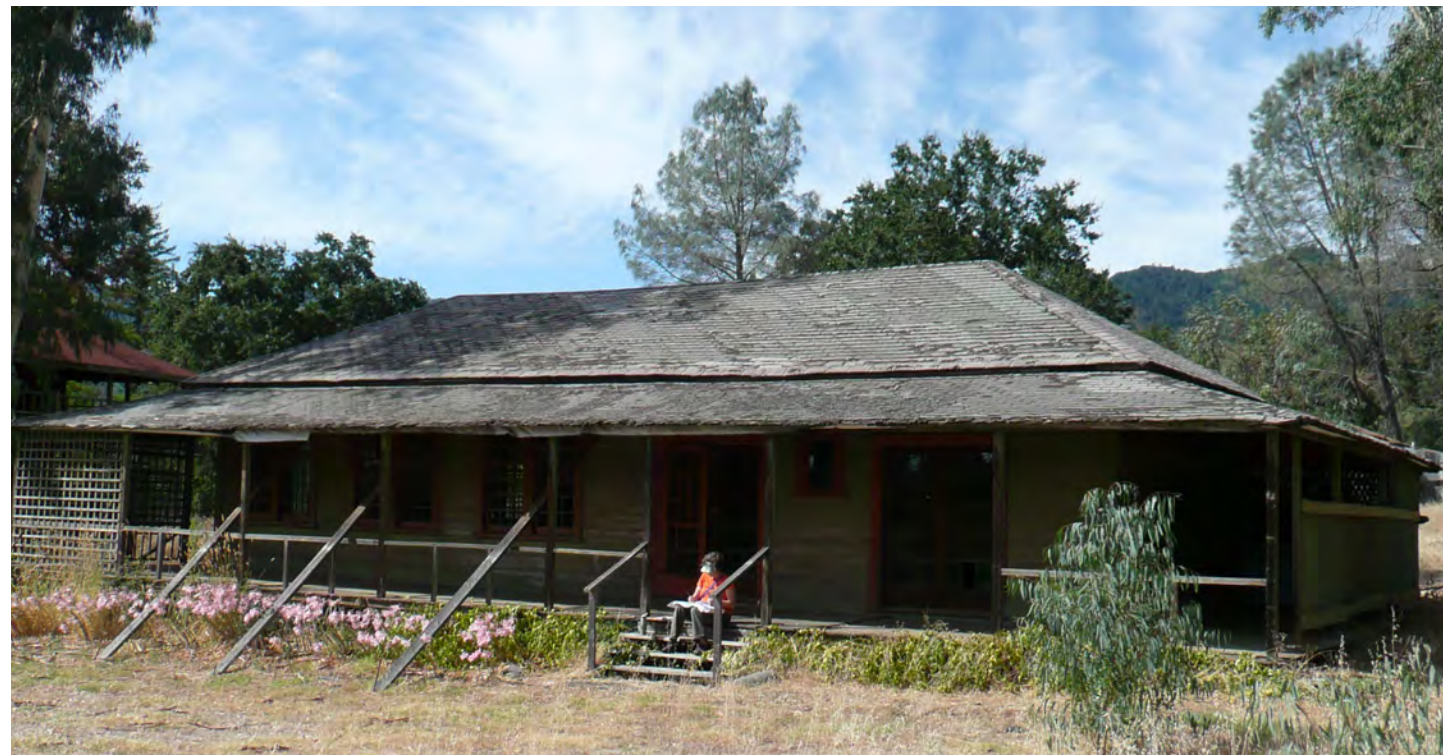
L top - Name placard; M top - bathroom additions on porch; R top - Enclosed porch; Bottom - East facade

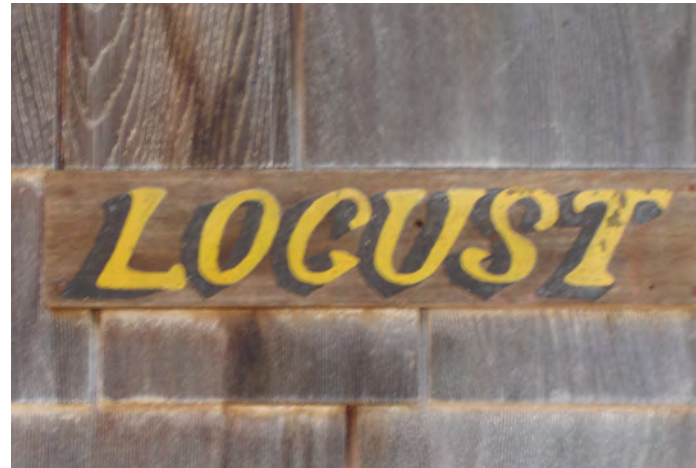
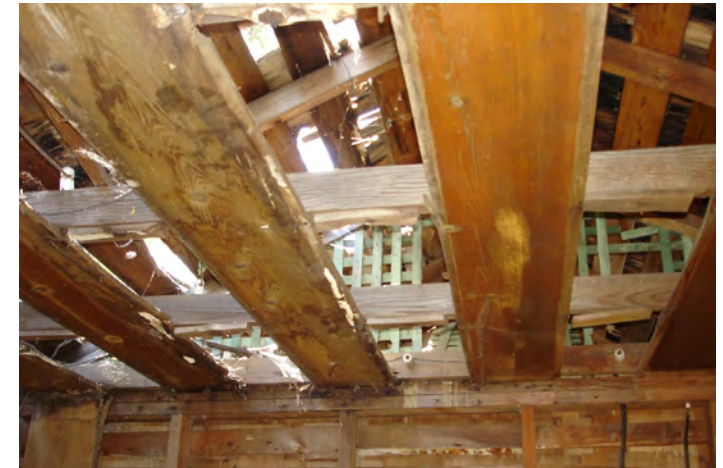
The south wall of the building has buckled and is near failure. The building is in poor condition. Due to the loss of fabric, the building has fair

L top - Name placard; R top - Interior ceiling; Bottom - Northeast facade

All character-defining features will be retained or, if deteriorated, repaired or replaced in kind.

A seismic upgrade of the building will be required. Typical of most buildings on the site, the foundation will need to be upgraded and many of the structural members will need to be repaired or replaced due to deterioration. A

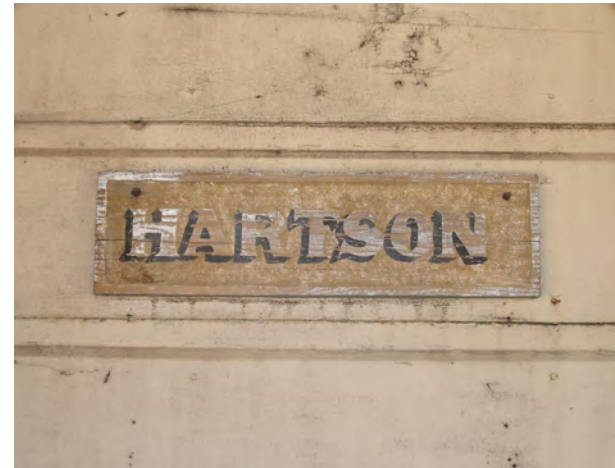
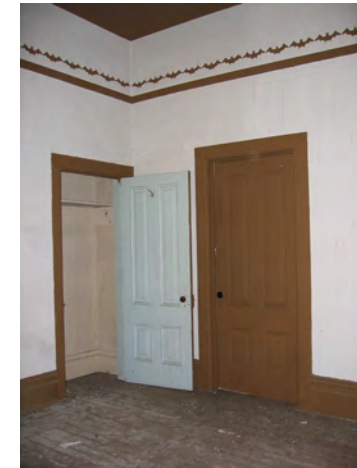
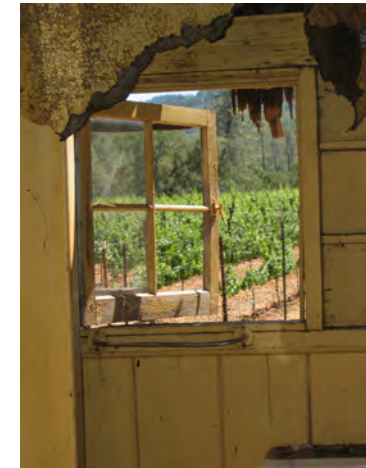
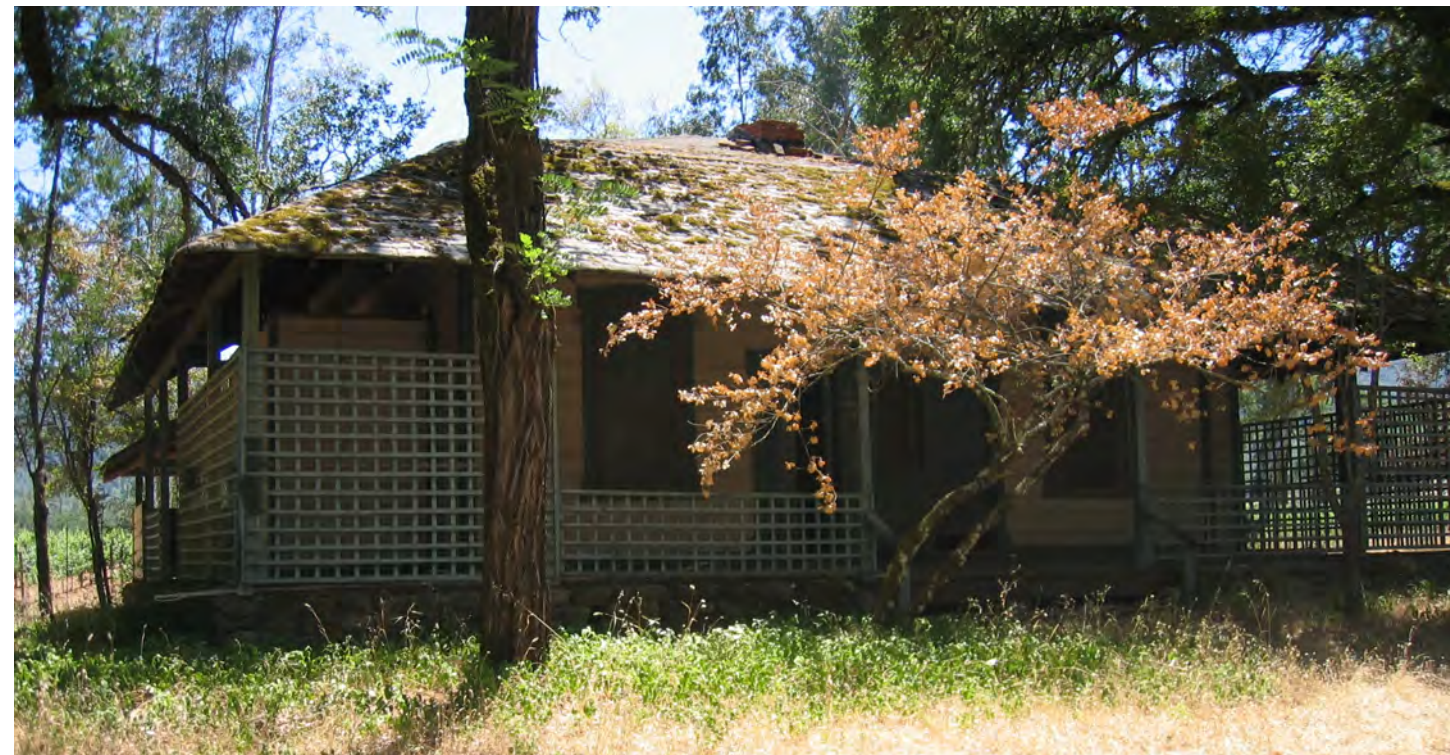
L top - Name placard; M top - Typical interior; R top - Bathroom window in enclosed sleeping porch; Bottom - North facade

The building retains much of its historic fabric but due to a lack of maintenance, the building is in poor condition and has fair integrity. The front porch has some deterioration and portions of the interior ceiling have been removed. The rear (south) porch roof is severely deteriorated, compromising the condition of the bathrooms housed on the porch.

Wood shingles are severely deteriorated and will be replaced with an alternate shingle material.

- Four-over-four double-hung wood sash are severely deteriorated or missing and will be replaced in kind, or with new insulated units matching the configuration of the existing.

A seismic upgrade of the building will be required. Typical of most buildings on the site, the foundation will need to be upgraded and many of the structural members will need to be repaired or replaced due to deterioration. A full structural evaluation will be completed at a later date. Modifications will be integrated into the historic fabric to the greatest extent possible.

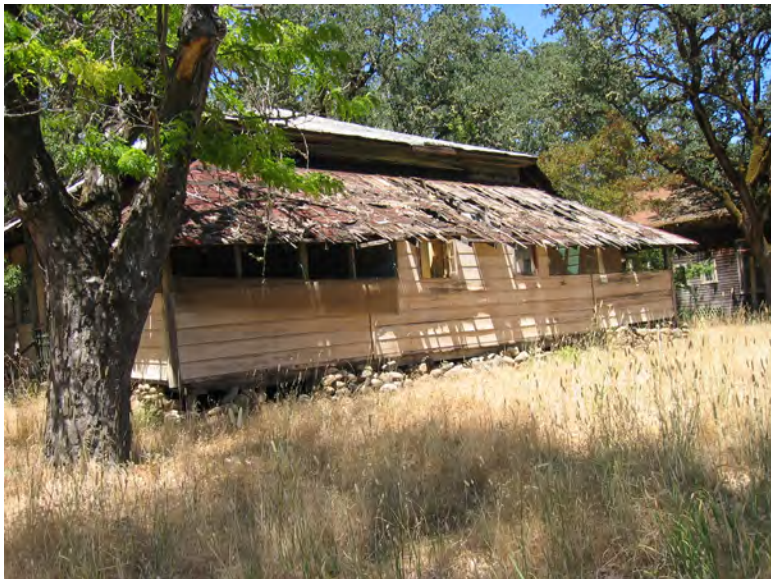
South facade showing dropped porch roof and non-historic porch

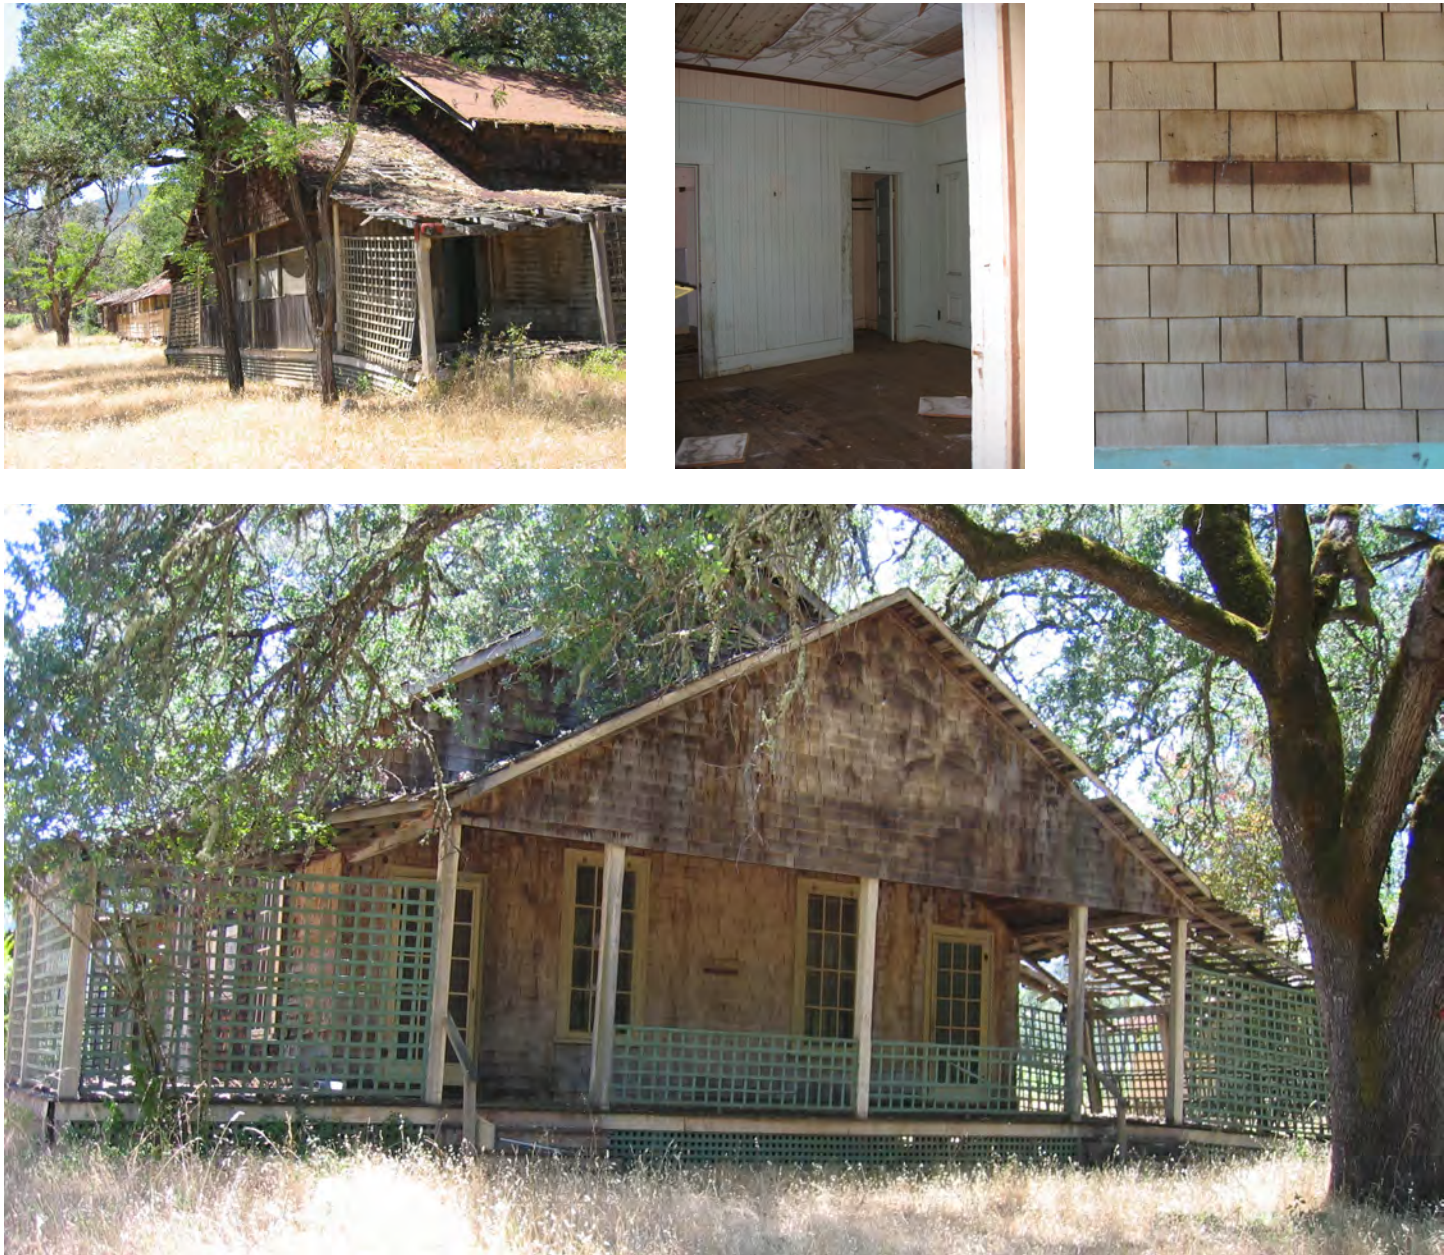
L top - Enclosed south porch; M top - Typical interior; R top - Missing name placard

The building is in poor condition. The porches and the roof are severely deteriorated. There is evidence of water damage all throughout the interior. Although the building is in poor condition, the building does retain much of its historic fabric and therefore has fair integrity.

- Gabled roofs will be retained. Wood shingles are severely deteriorated and will be replaced with an alternate shingle material.
- Four-over-four, double-hung wood sash and eight-light casements are severely deteriorated or missing and will be replaced in kind, or with new insulated units matching the configuration of the existing.

A seismic upgrade of the building will be required. Typical of most buildings on the site, the foundation will need to be upgraded and many of the structural members will need to be repaired or replaced due to deterioration. A full structural evaluation will be completed at a later date. Modifications will be integrated into the historic fabric to the greatest extent possible.

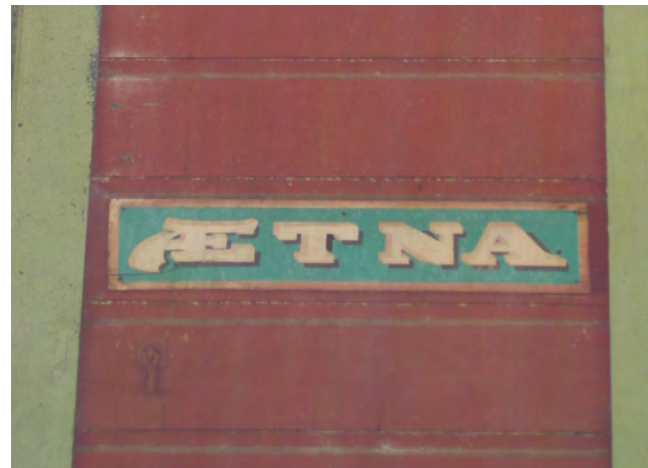
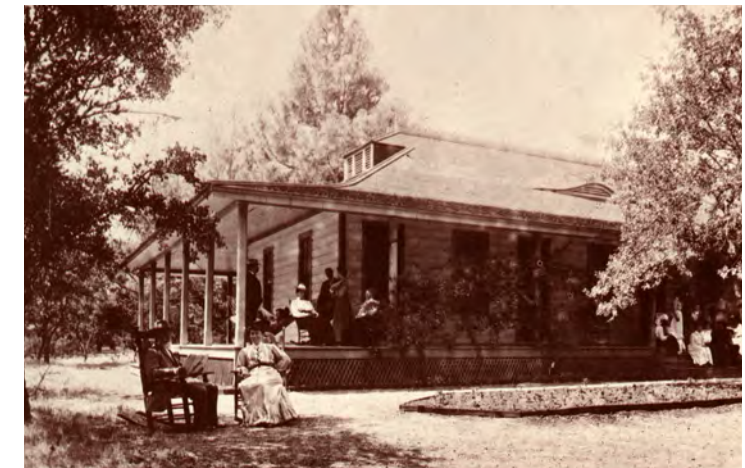
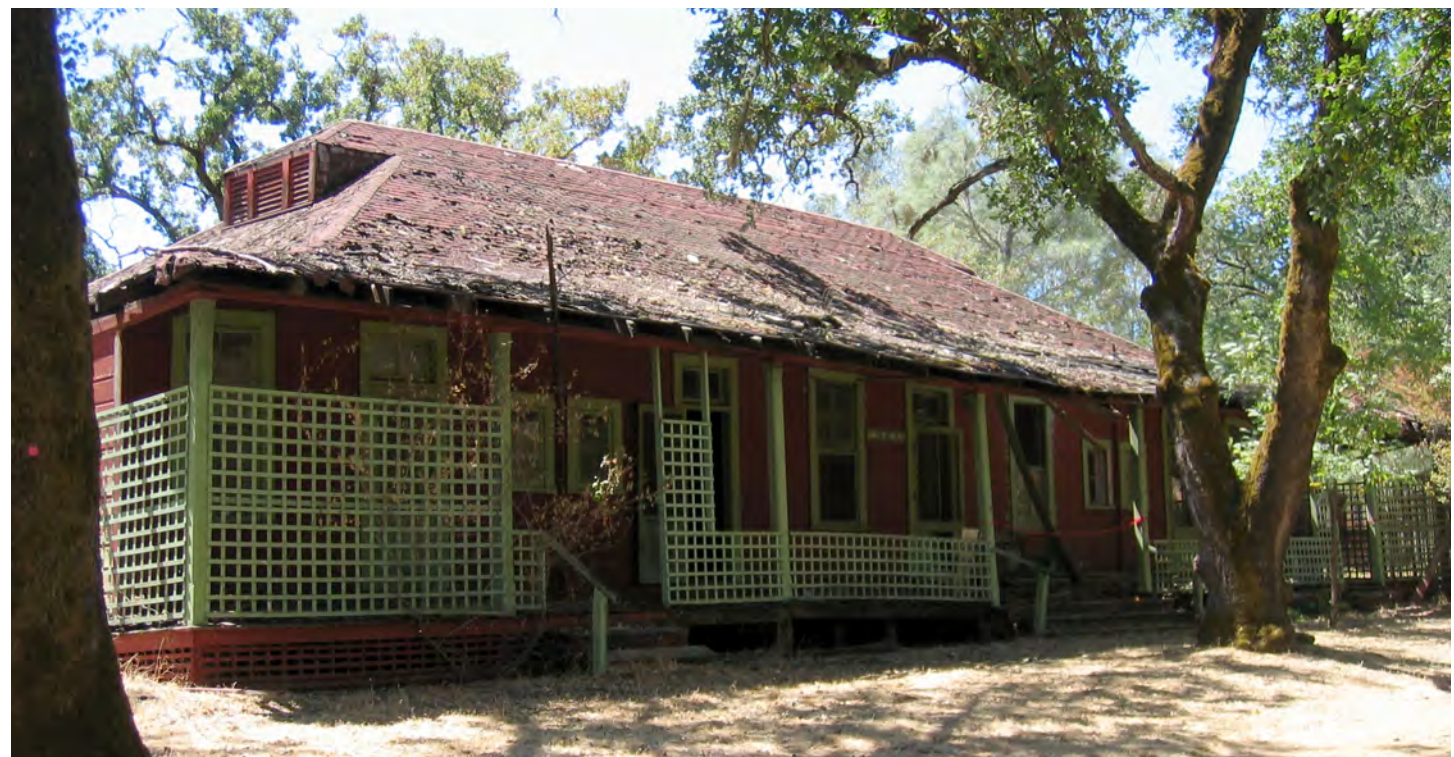
L top - Name placard; R top - Historic photo of northeast corner of Aetna prior to Farr & Ward remodel; Bottom - Northeast corner

The building is in very poor condition. The porches and roof are severely deteriorated. This deterioration has left the interior spaces open to the elements. Although the building is in very poor condition, it has not experienced compromising alterations and therefore retains fair

- Shingled hip roof flared over porches will be retained. Wood shingles are severely deteriorated and will be replaced with an alternate shingle material.
- Four-light casement are severely deteriorated or missing and will be replaced in kind, or with new insulated units matching the configuration of the existing.

A seismic upgrade of the building will be required. Typical of most buildings on the site, the foundation will need to be upgraded and many of the structural members will need to be repaired or replaced due to deterioration. A full structural evaluation will be completed at a later date. Modifications will be integrated into the historic fabric to the greatest extent possible.

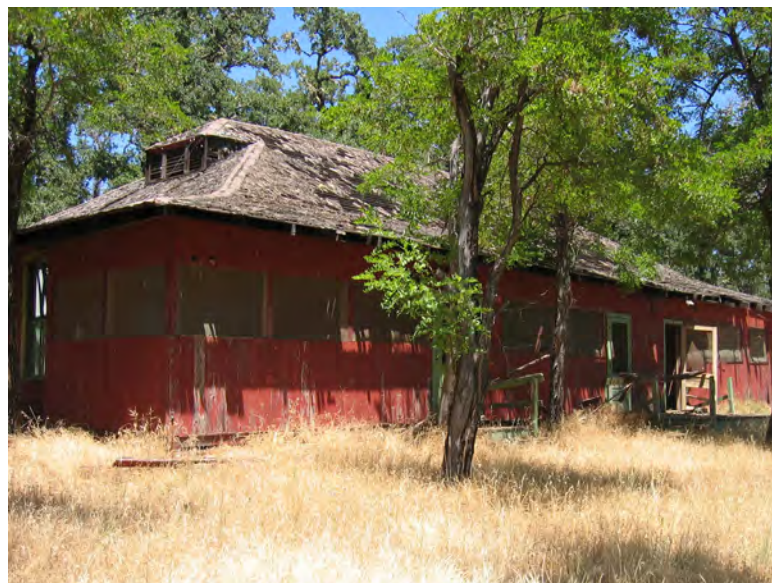
Non-hisotric porch enclosure at south facade

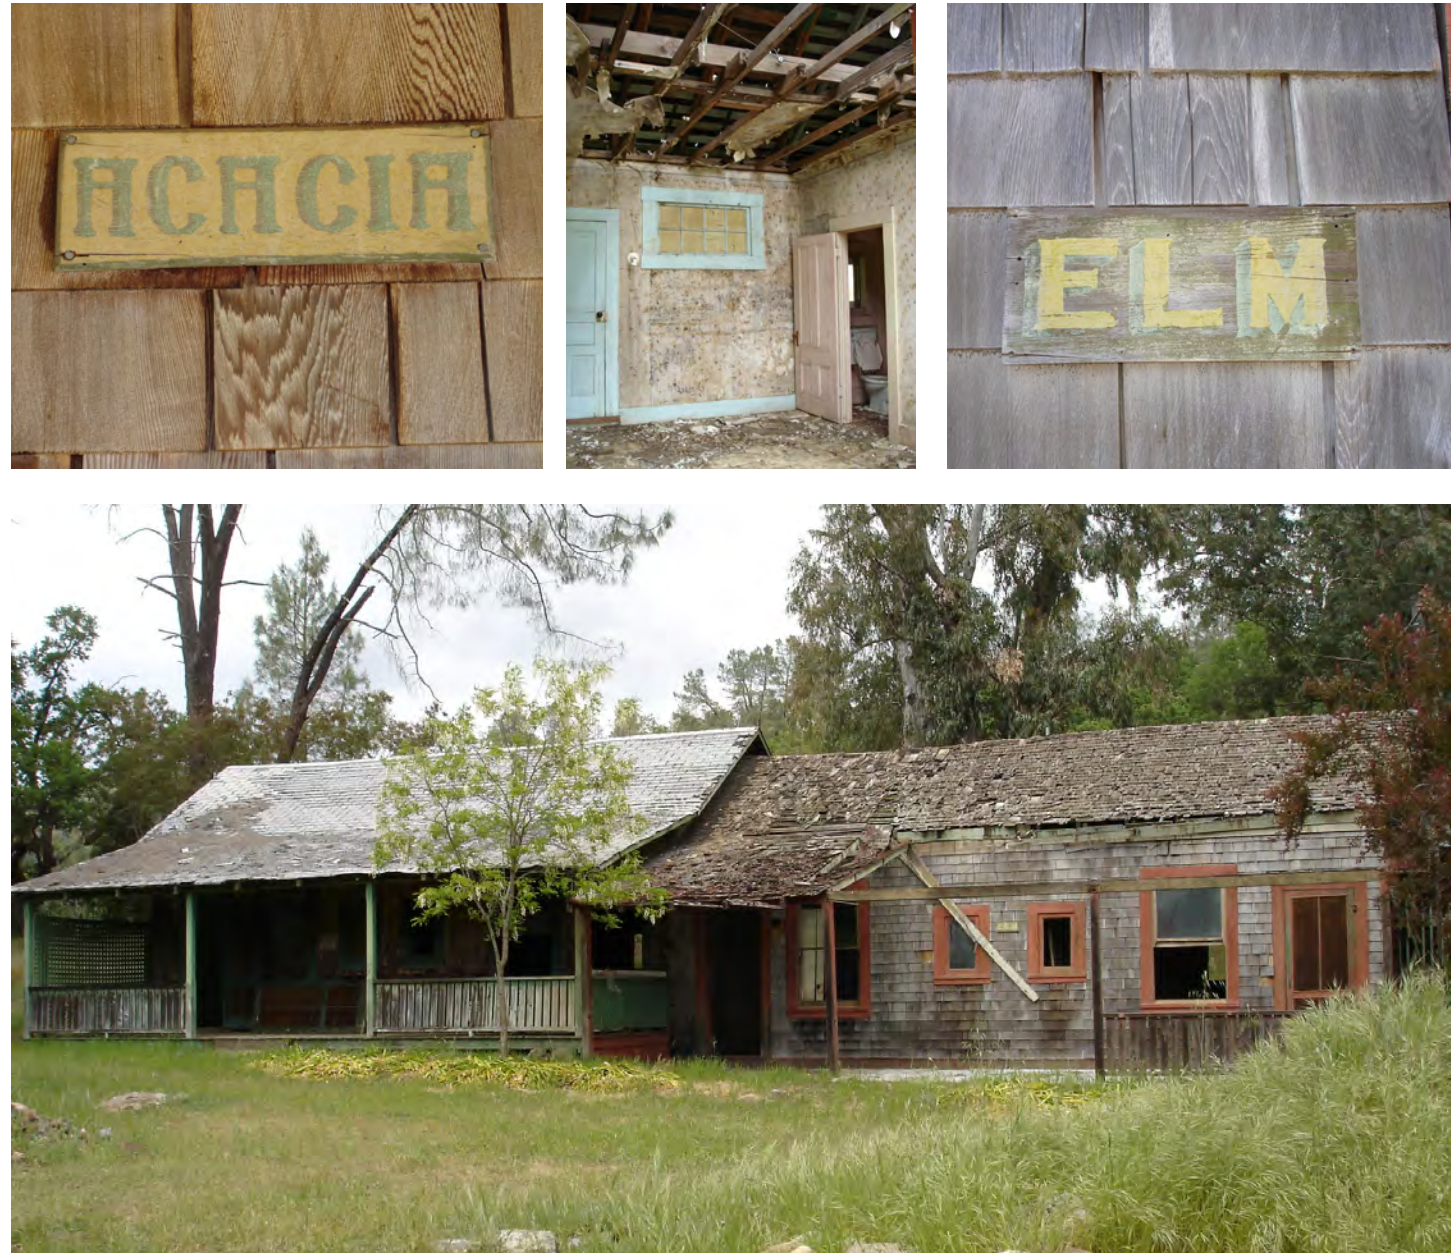
L top - Name placard; M top- Typical interior - Elm; R top - Name Placard; Bottom - South facade

Acacia-Elm is in poor condition. The shingle roof of Elm is in an advanced state of deterioration exposing the interior to the weather, and the front porch roof is almost completely gone. The building's integrity is fair.

- Side-gable shingled roof will be retained. Wood shingles are severely deteriorated and will be replaced with an alternate shingle material.
- Windows combination of one-over-one (main façade) and four-over-four double-hung wood sash are severely deteriorated or missing and will be replaced in kind, or with new insulated units matching the configuration of the existing.

A seismic upgrade of the building will be required. Typical of most buildings on the site, the foundation will need to be upgraded and many of the structural members will need to be repaired or replaced due to deterioration. A full structural evaluation will be completed at a later date. Modifications will be integrated into the historic fabric to the greatest extent possible.

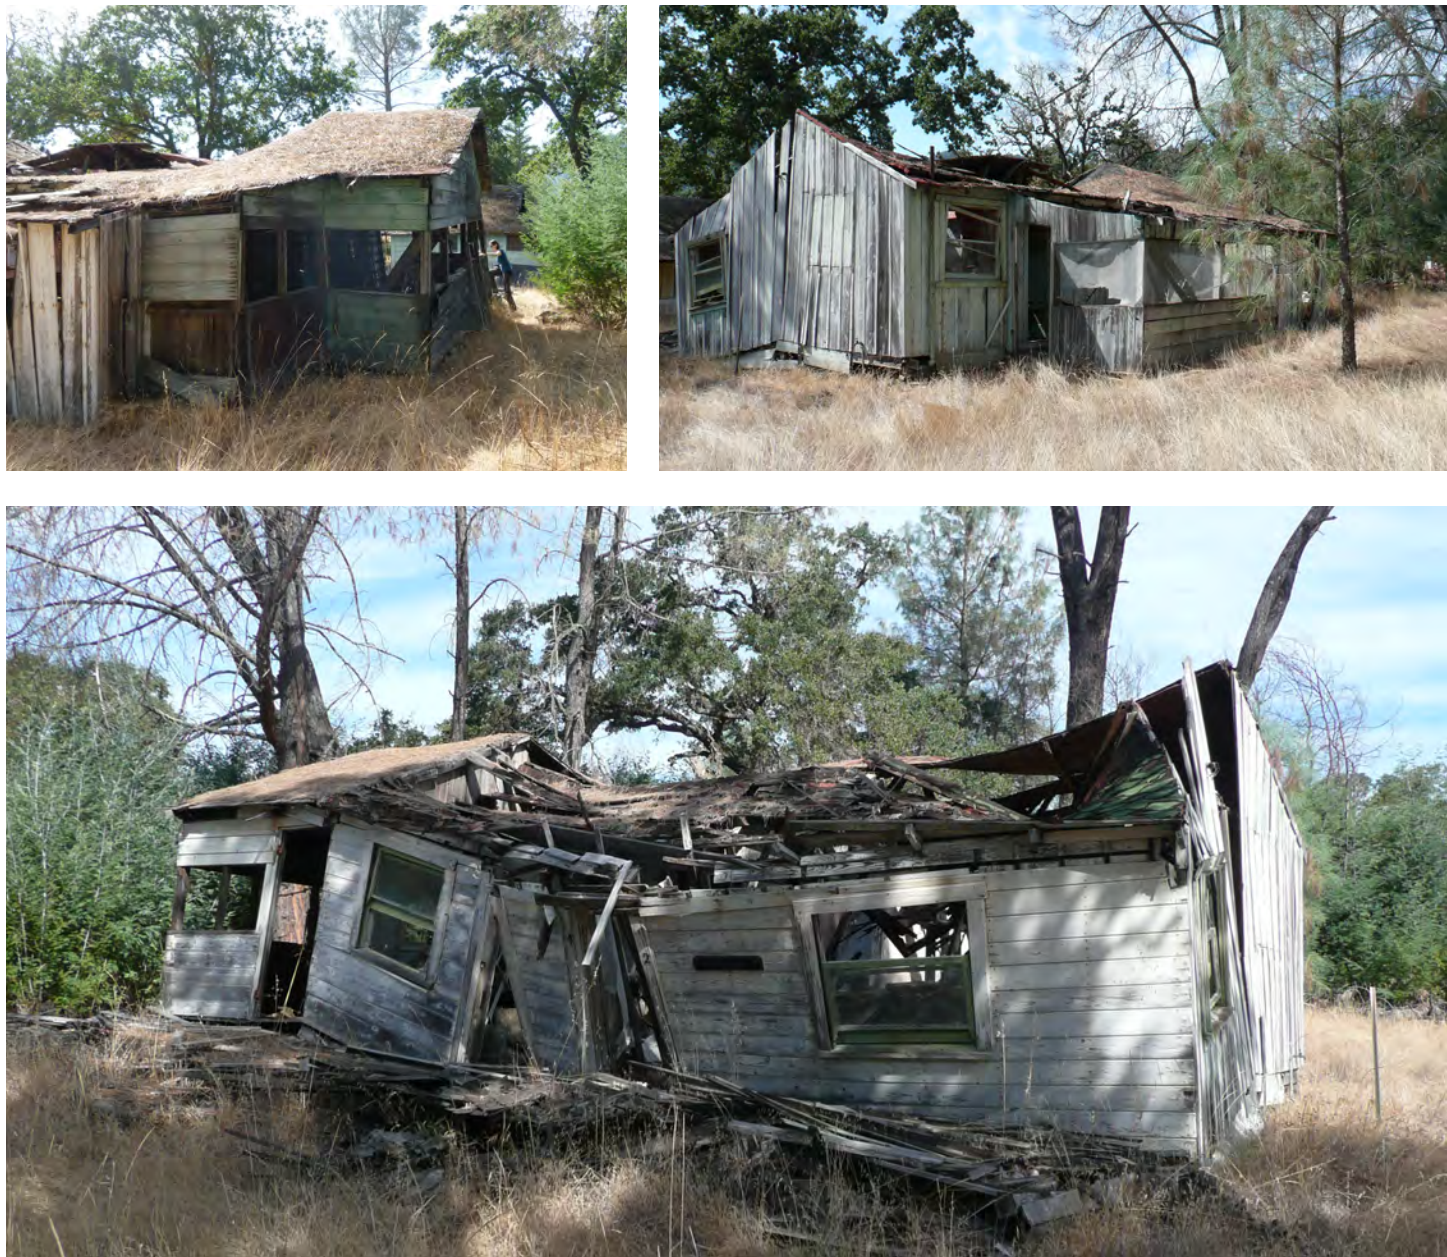
L top - North facade; R top - East and north facades; Bottom - South facade

This building is in very poor condition and has poor integrity. The composition roofing is substantially deteriorated which has resulted in the collapse of the roof. Walls beneath the open portions of the roof have also collapsed. The remnants of the front of the main façade lay on the ground in front of the building. The interior of Alger has been completely stripped and the few remaining features are significantly deteriorated as a result of the roof and wall collapse. The interior is not safely accessible for inspection.

All character defining features will be reconstructed.

The building will be constructed to meet current seismic requirements. New lighting, mechanical, electrical, plumbing and fire protection systems will be provided throughout.
