AETNA SPRINGS PRESERVATION PLAN

For:
Aetna Preserve, LLC

Prepared by:
Architectural Resources Group
Smith & Smith

October 3, 2011

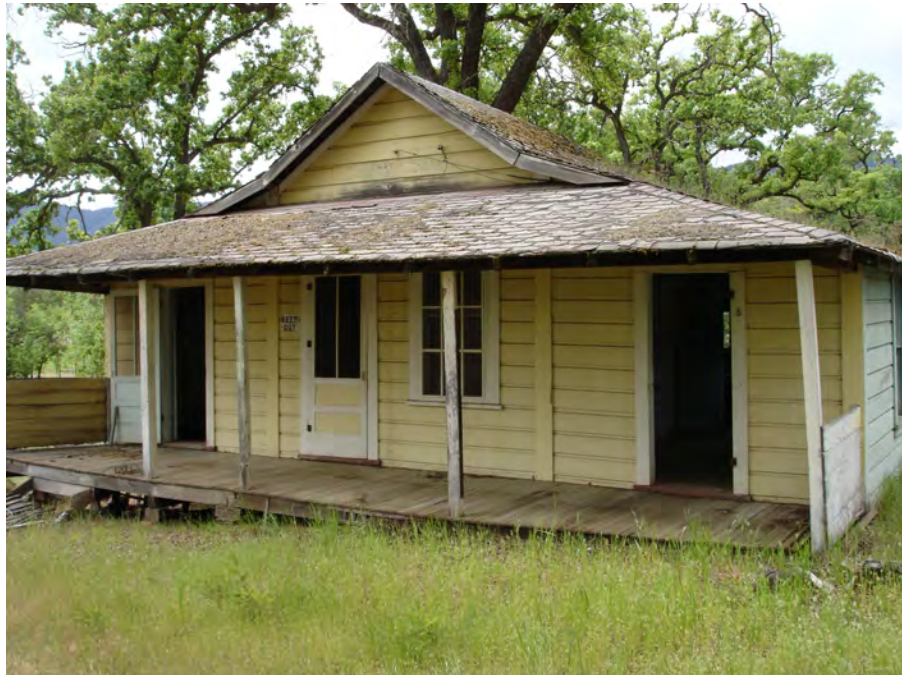
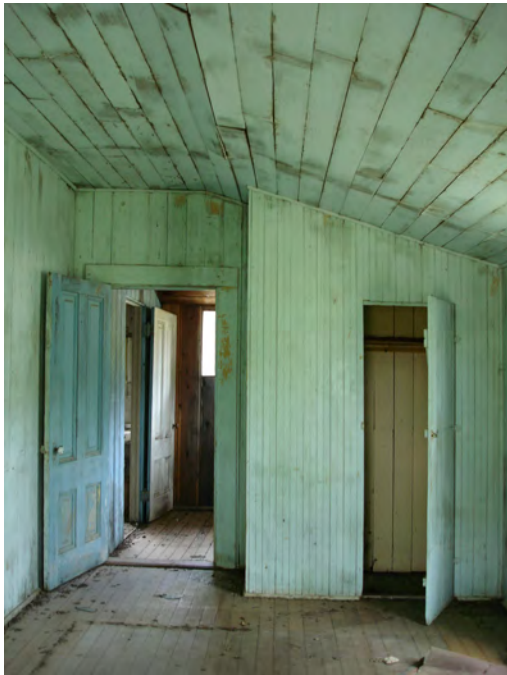
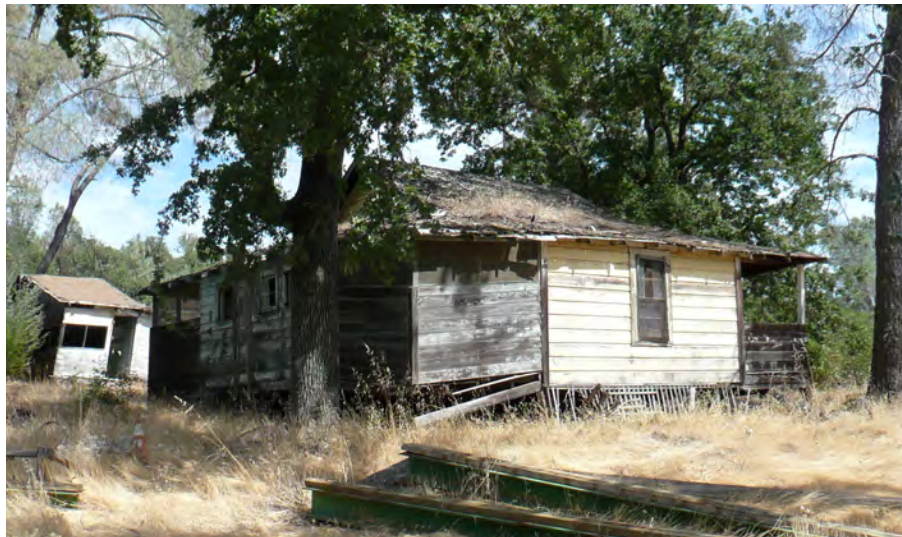
L top - East facade; R top - Typical interior; Bottom - West and south facades

The building is in poor condition but its integrity is fair. The structure's supports appear to be collapsing and there is evidence of water damage.

Rehabilitation of Robin will continue the existing lodging use. The exterior massing, materials, and features will be retained. Exterior materials will be replaced in kind where deteriorated. Interior finishes and features will generally be replaced in kind or with compatible materials as they are typically missing, severely deteriorated, or non-historic. Some modification will be made to interior spaces to accommodate contemporary lodging functions while retaining an understanding of the original spatial configurations. Door and window openings will generally be retained. Exterior door openings may be infilled with windows to accommodate modifications to the floor plan. Haphazard porch modifications made after the period of significance will be upgraded to be more consistent with the district's original level of design. Lattice screen locations will be altered to suit the updated floor plans.

- Double-hung wood sash are severely deteriorated or missing and will be replaced in kind, or with new

insulated units matching the configuration of the existing.

- Four-light wood casements sash are severely deteriorated or missing and will be replaced in kind, or with new insulated units matching the configuration of the existing.

A seismic upgrade of the building will be required. Typical of most buildings on the site, the foundation will need to be upgraded and many of the structural members will need to be repaired or replaced due to deterioration. A full structural evaluation will be completed at a later date. Modifications will be integrated into the historic fabric to the greatest extent possible.

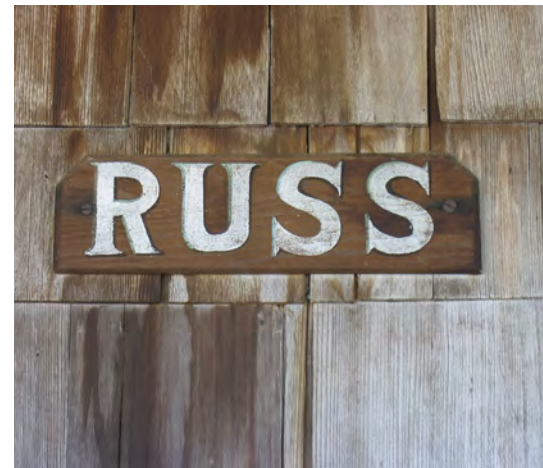
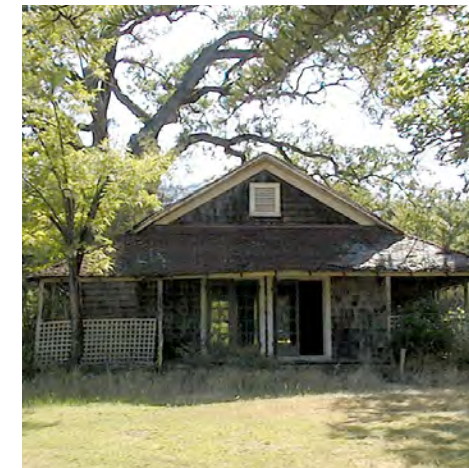
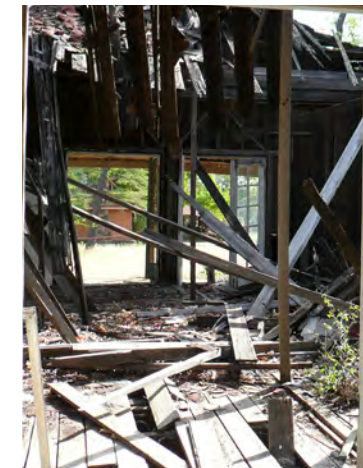
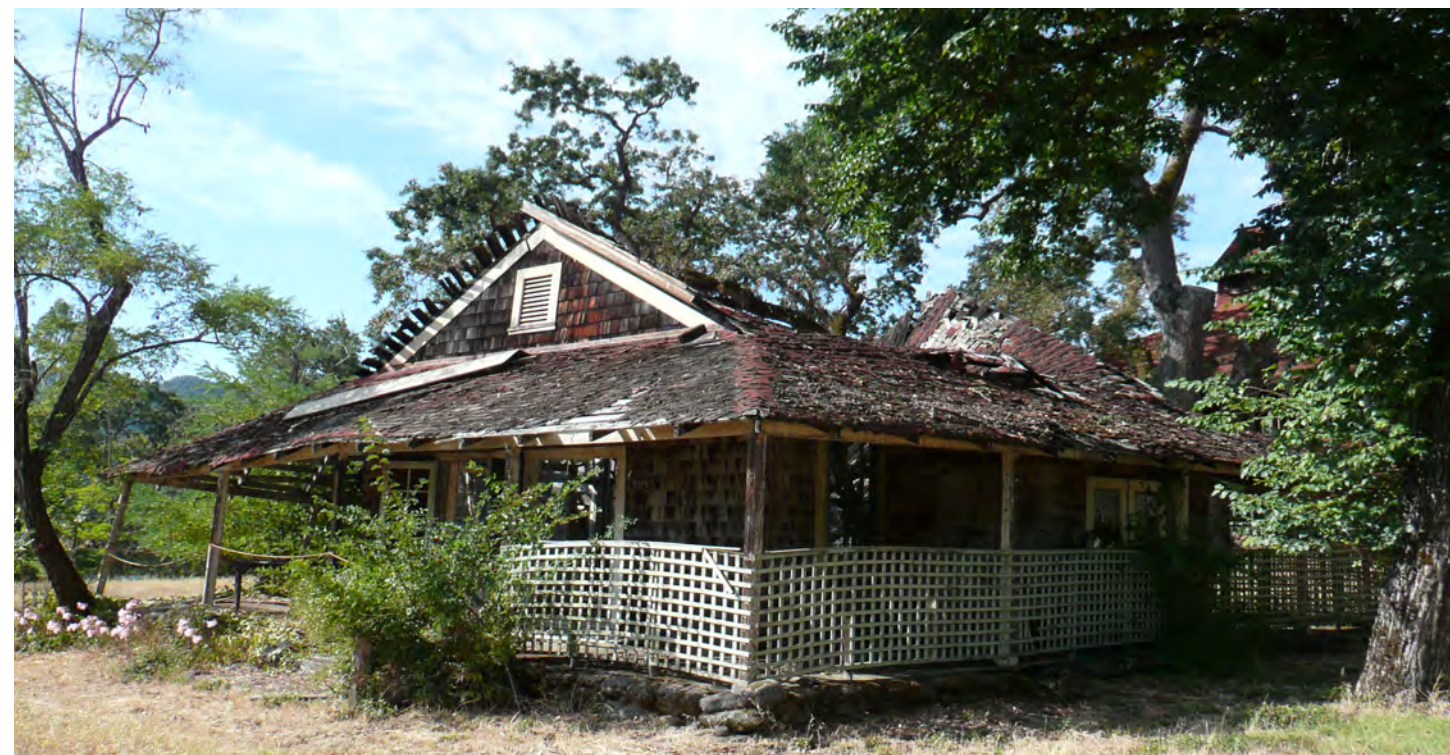
L top - Name placard; M top - East facade in 1997; R top - Interior; Bottom - Southwest corner

The interior of Russ has been completely stripped and any remaining features are significantly deteriorated.

The building is considered to be in very poor condition while its integrity is fair because it has not experienced much alteration. The majority of the roof is uncovered and it has collapsed due to the removal of the perpendicular (north-south) demising wall. As a result of the roof collapse, the building structure has severely deteriorated and the building is not safely accessible for inspection.

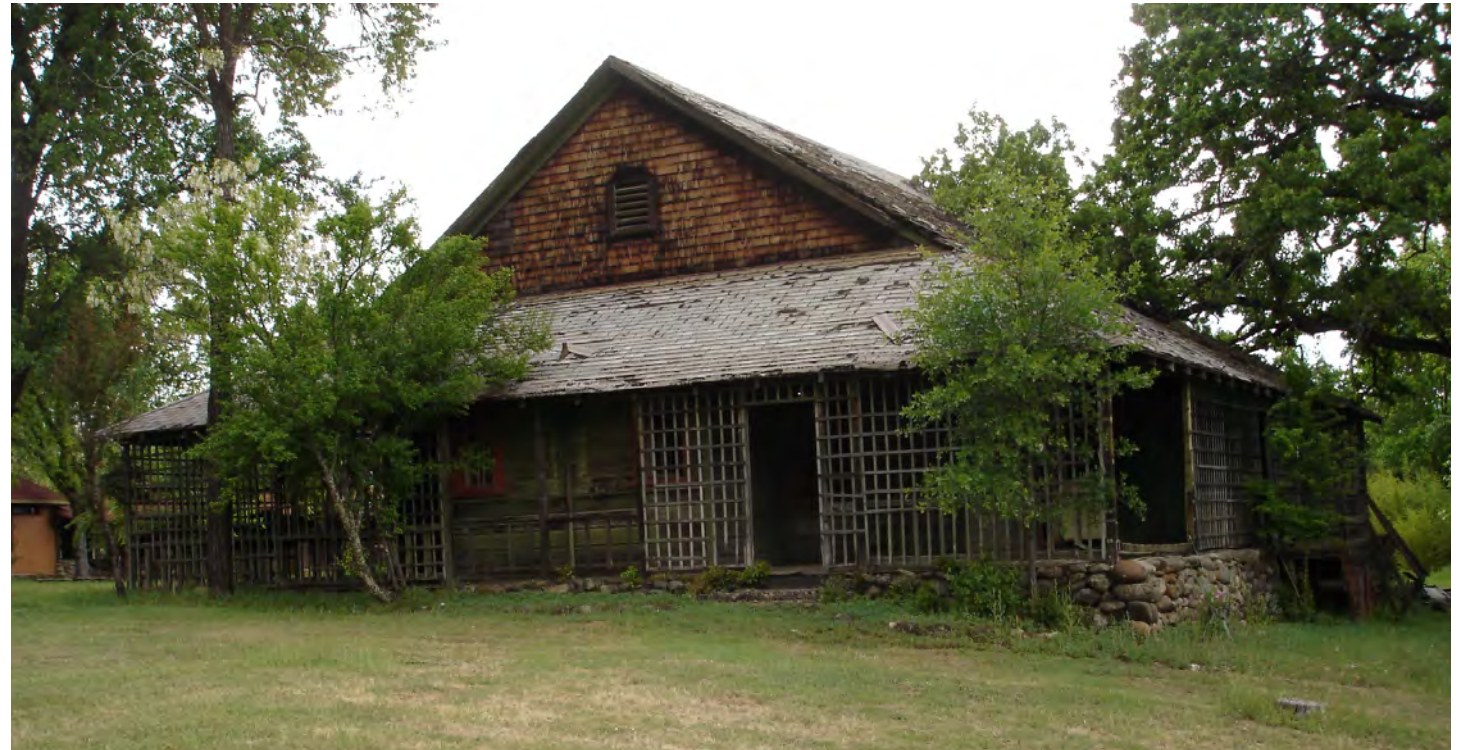
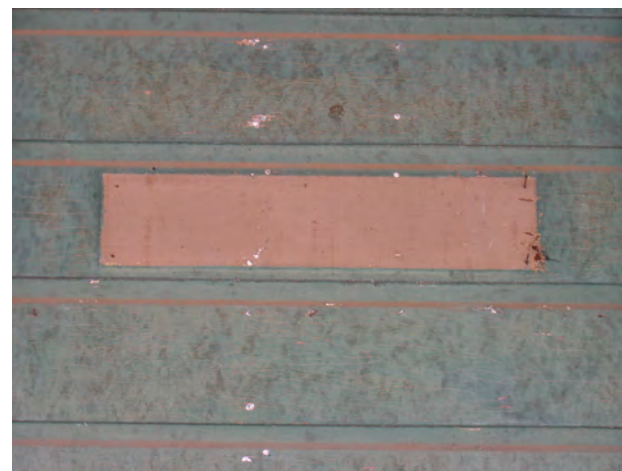
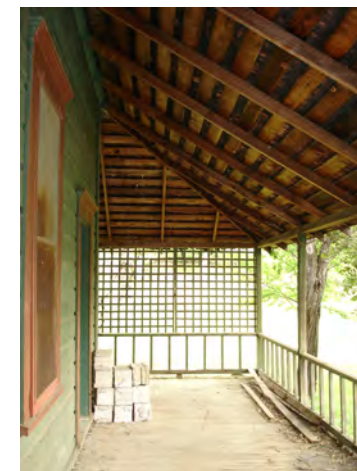
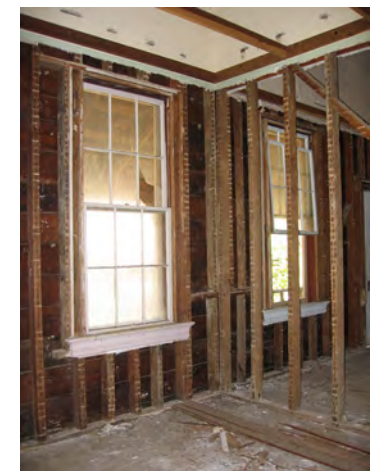
Top - Southwest corner; L bottom - Missing name placard; M bottom - Porch detail; R bottom - typical stripped interior

The building's integrity is fair but due to a lack of maintenance, the building is generally in poor condition. The porch floor is severely deteriorated and portions of the roof are deteriorated.

Rehabilitation of Dewey will continue the existing lodging use. The exterior massing, materials, and features will be retained. Exterior materials will be replaced in kind where deteriorated. Interior finishes and features will generally be replaced in kind or with compatible materials as they are typically missing, severely deteriorated, or non-historic. Modifications will be made to interior spaces to accommodate contemporary lodging functions while retaining an understanding of the original spatial configurations. Door and window openings will generally be retained. Exterior door openings may be infilled with windows to accommodate modifications to the floor plan. Haphazard porch modifications made after the period of significance will be upgraded to be more consistent with the district's original level of design. Lattice screen locations will be altered to suit the updated floor plans.

- Shingled gable-on-hip roof with exposed rafter tails will be retained. Wood shingles are severely deteriorated and will be replaced with an alternate shingle material.
- Four-over-four double-hung wood sash are severely deteriorated or missing and will be replaced in kind, or with new insulated units matching the configuration of the existing.

A seismic upgrade of the building will be required. Typical of most buildings on the site, the foundation will need to be upgraded and many of the structural members will need to be repaired or replaced due to deterioration. A full structural evaluation will be completed at a later date. Modifications will be integrated into the historic fabric to the greatest extent possible.

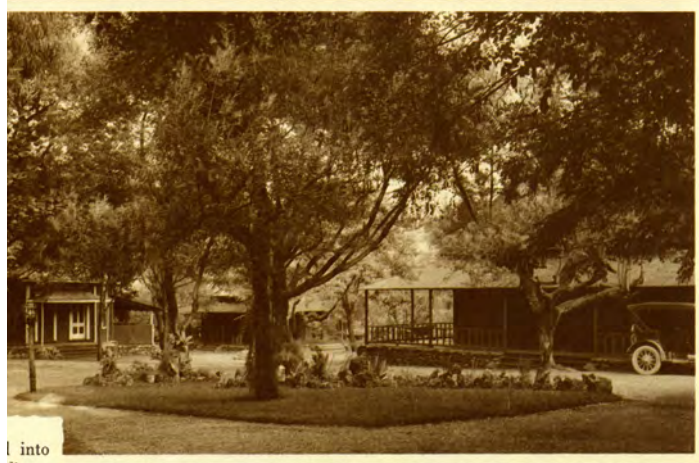
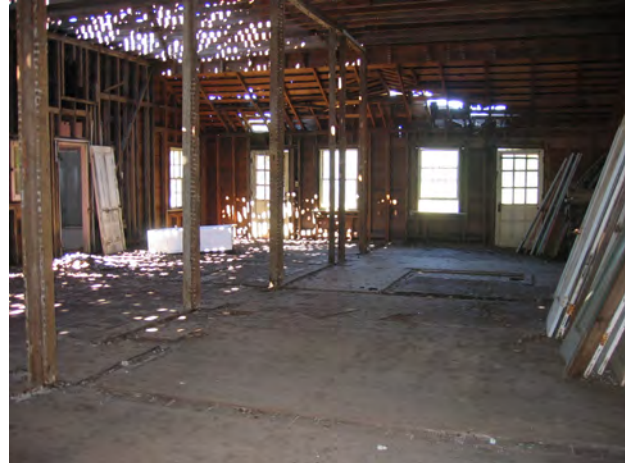
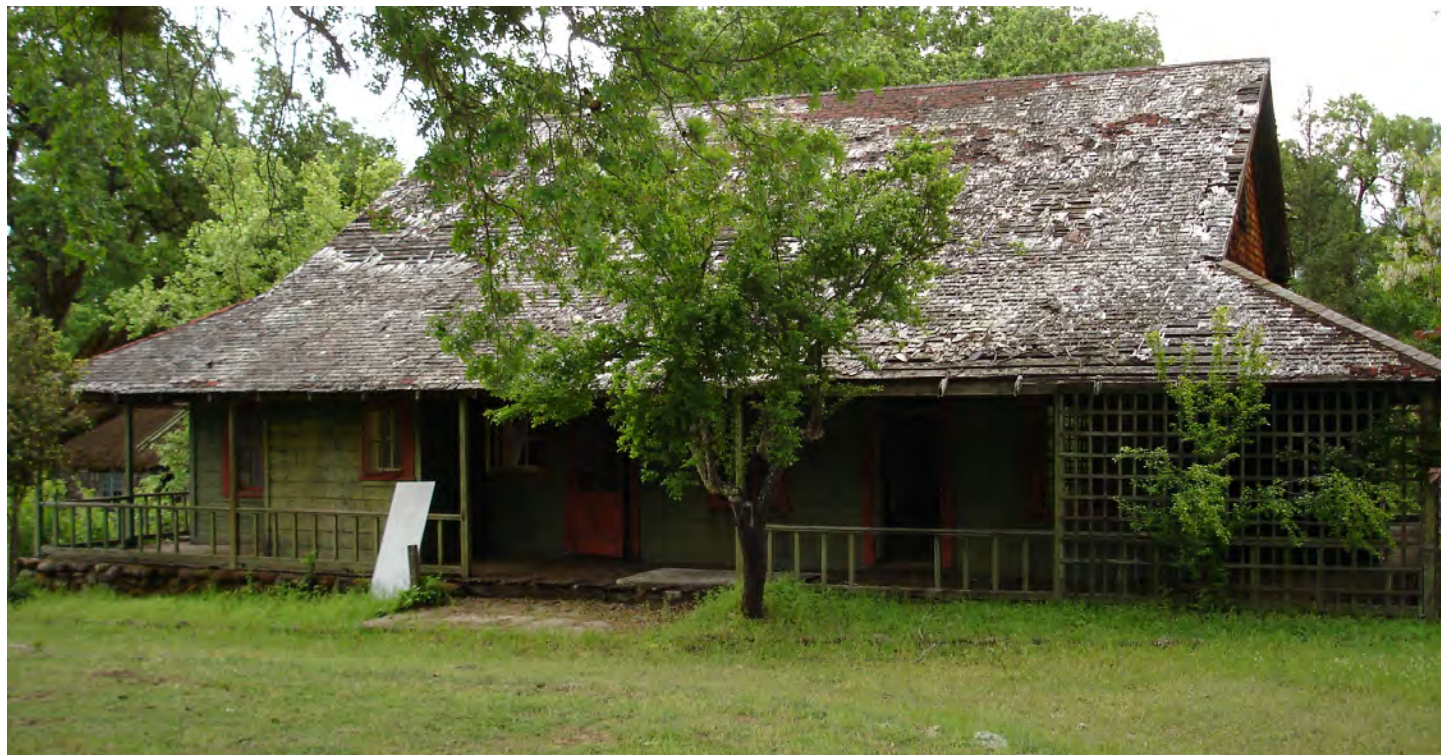
L top - Historic photo of north facade with original Owl's Nest and Woodward beyond; R top - Interior stripped; Bottom - North facade

The interior of York has been stripped of partitions, finishes and most trim. The original six-unit floor plan is visible as a recess where finished wood floors were not installed. Wood floors are intact throughout the interior though in poor condition. Some closets and toilet rooms are intact. Some original interior window trim is intact.

The building's integrity is fair but due to a lack of maintenance, the building is generally in poor condition. The porch floor is severely deteriorated and portions of the roof are deteriorated leaving the interior of the building exposed to the elements.

Rehabilitation of York will continue the existing lodging use. The exterior massing, materials, and features will be retained. Exterior materials will be replaced in kind where deteriorated. Interior finishes and features will generally be replaced in kind or with compatible materials as they are typically missing, severely deteriorated, or non-historic. Some modification will be made to interior spaces to accommodate contemporary lodging functions while retaining an understanding of the original spatial configurations. Door and window openings will generally be retained. Exterior door openings may be infilled with windows to accommodate modifications to the floor plan. Haphazard porch modifications made after the period of significance will be upgraded to be more consistent with the district's original level of design. Lattice screen locations will be altered to suit the updated floor plans.

- Shingled gable-on-hip roof form with exposed rafter tails will be retained. Wood shingles are severely

deteriorated and will be replaced with an alternate shingle material.

- Four-over-four double-hung wood sash are severely deteriorated or missing and will be replaced in kind, or with new insulated units matching the configuration of the existing.
- Fir floors - verify condition of existing floor and retain if possible.

A seismic upgrade of the building will be required. Typical of most buildings on the site, the foundation will need to be upgraded and many of the structural members will need to be repaired or replaced due to deterioration. A full structural evaluation will be completed at a later date. Modifications will be integrated into the historic fabric to the greatest extent possible.

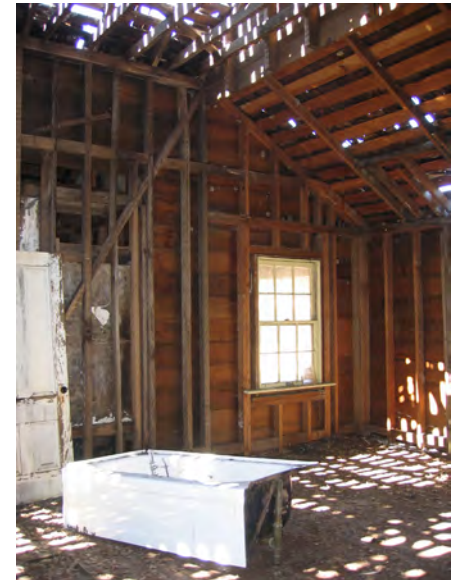
Detail of stripped interior

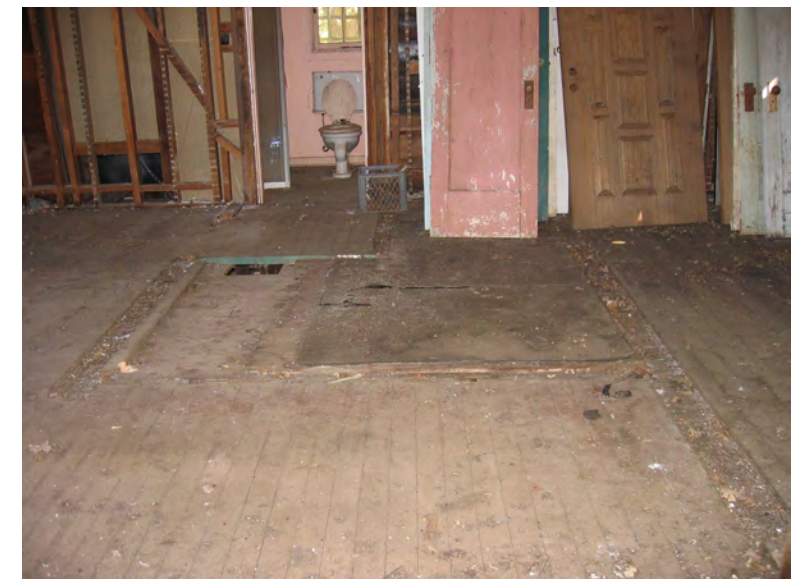
Interior wall layout evident in finish floor

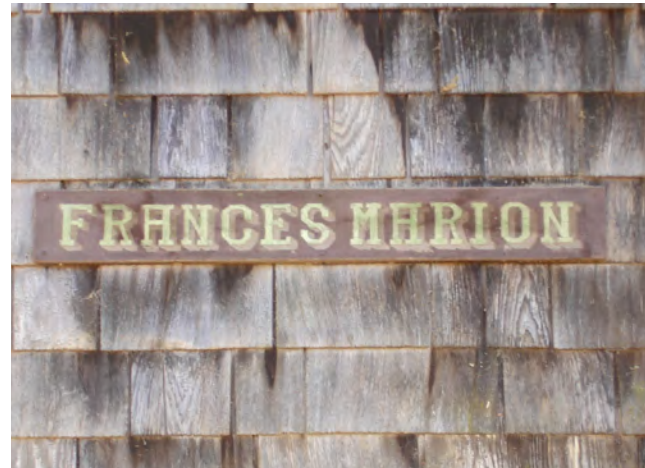
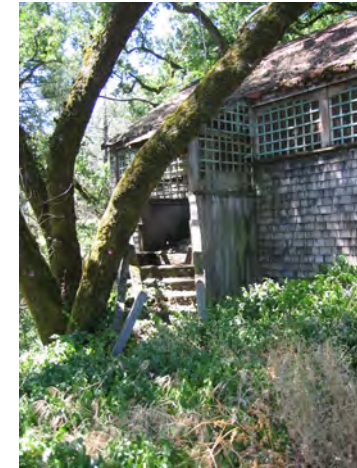
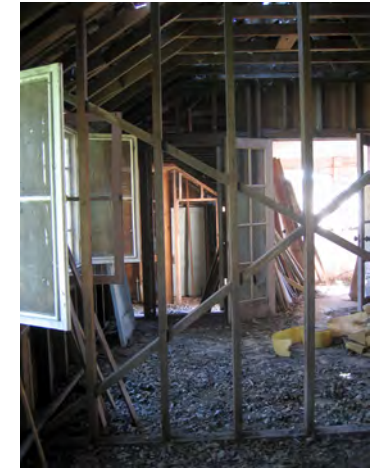
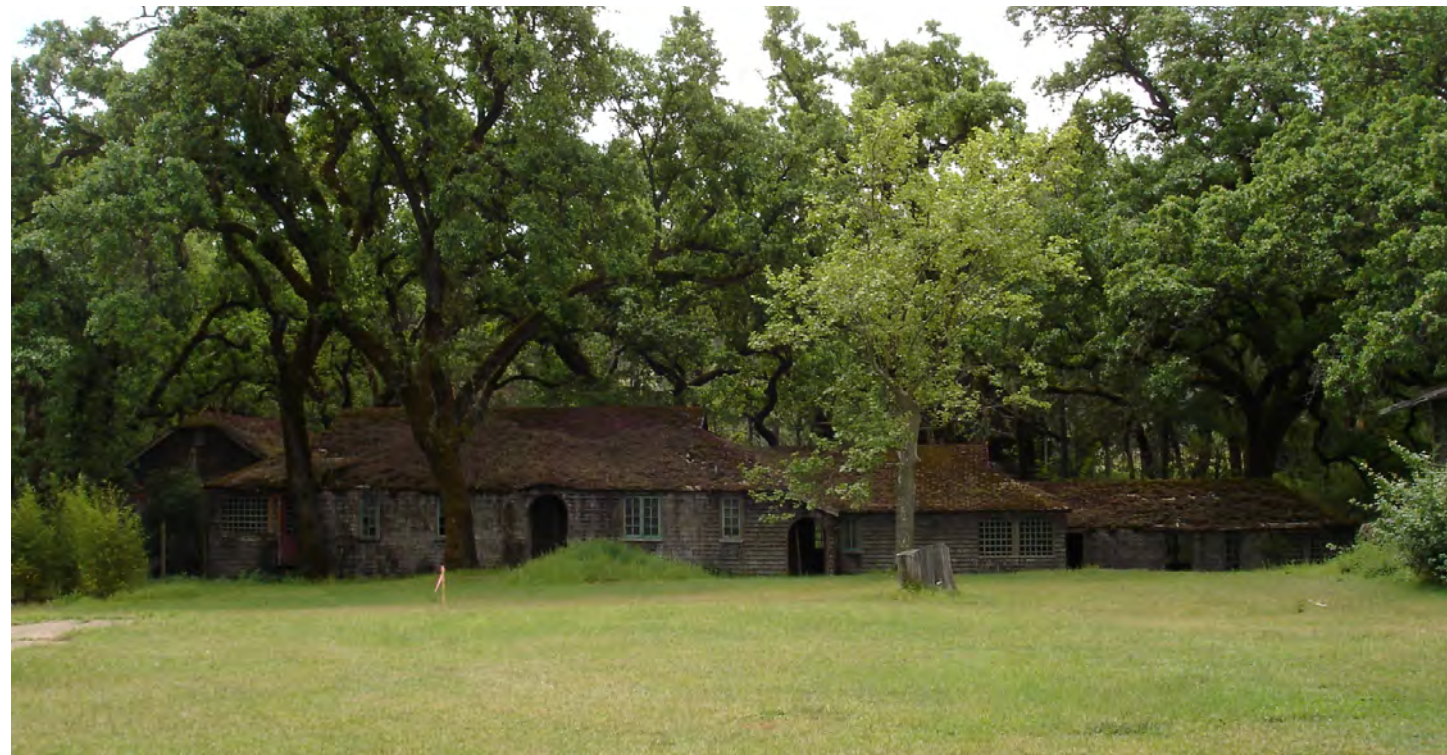
L top - Name placard; M top - Entrance on east facade; L top - Typical interior stripped of finish; Bottom - South facade

The building is in poor condition. It is severely deteriorated in part due to the loss of the roof. All of the interior plaster has been removed. However, as alterations have been limited, the building retains a fair level of integrity.

As part of the rehabilitation of the district, the Frances Marion will continue the existing lodging use. The exterior massing, materials, and features will be retained. Exterior materials will be replaced in kind

where deteriorated. Interior finishes and features will generally be replaced in kind or with compatible materials as they are typically missing, severely deteriorated, or non-historic. Modifications will be made to interior spaces to accommodate contemporary lodging functions while retaining an understanding of the original spatial configurations. Door and window openings will generally be retained, but windows will be replaced due to their poor condition. Exterior door openings may be infilled with windows to accommodate modifications to the floor plan. Operable windows will be placed inside of existing lattice openings to allow porch spaces to be used yearound.

- Eight-light Casement windows (single and paired) are deteriorated and will be replaced in kind, or with new insulated units matching the configuration of the existing.

A seismic upgrade of the building will be required. Typical of most buildings on the site, the foundation will need to be upgraded and many of the structural members will need to be repaired or replaced due to deterioration. A full structural evaluation will be completed at a later date. Modifications will be integrated into the historic fabric to the greatest extent possible.

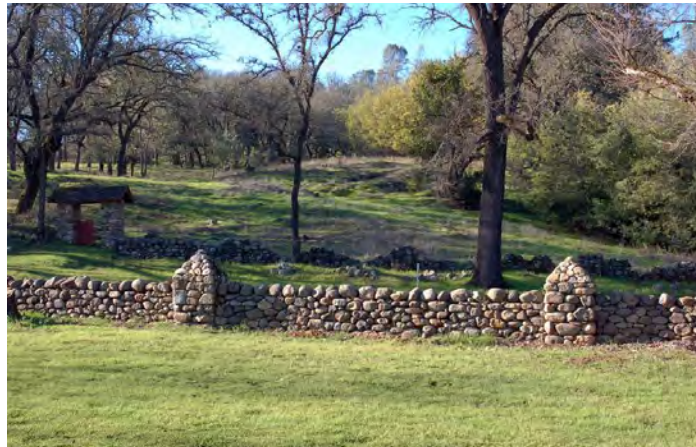
1 River Rock Freestanding Wall

The river rock freestanding and retaining perimeter landscape walls likely date from the Rustic period. They help define spatial organization and strongly contribute to the aesthetic character of Aetna retreat.

Rehabilitate existing perimeter river rock wall. In areas of minor deterioration repair wall using similar materials and workmanship. In areas of major deterioration or where new penetrations through the wall are desired create a new wall using similar materials and workmanship.

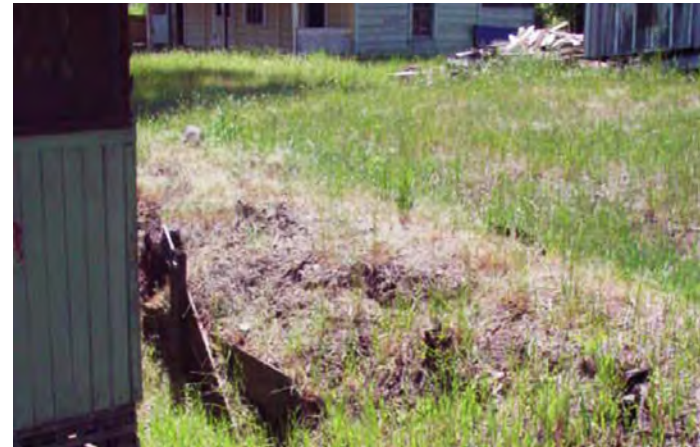
2 Wood Retaining Wall

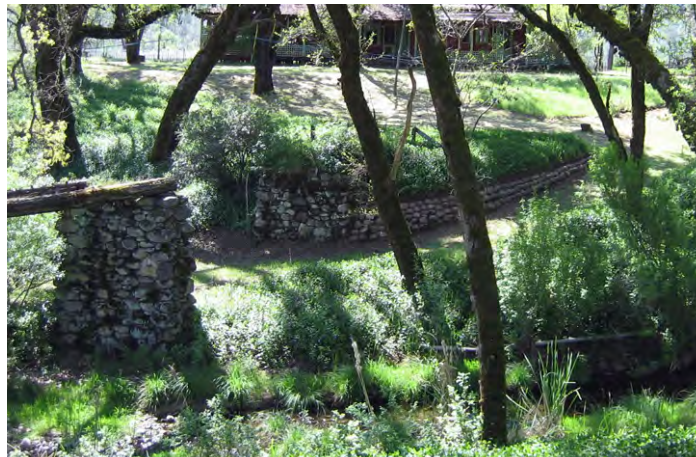
3 Stone Retaining Wall

The stone retaining walls at both the Aetna Springs Creek bank and upland likely date from the Rustic period.

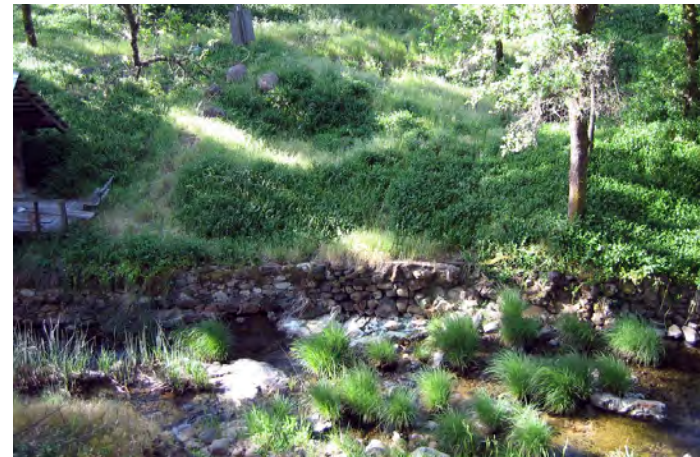
4 Stone Retaining Wall

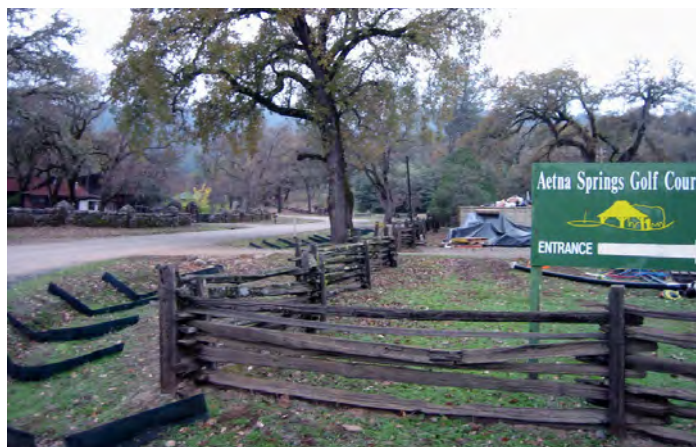
5 Split Rail Fence

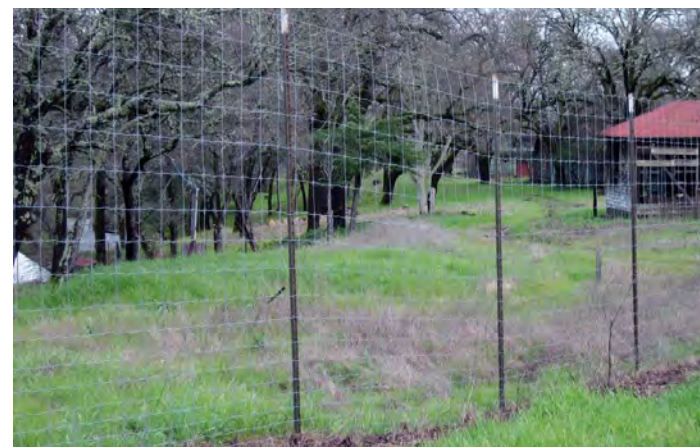
5a Wire Fence

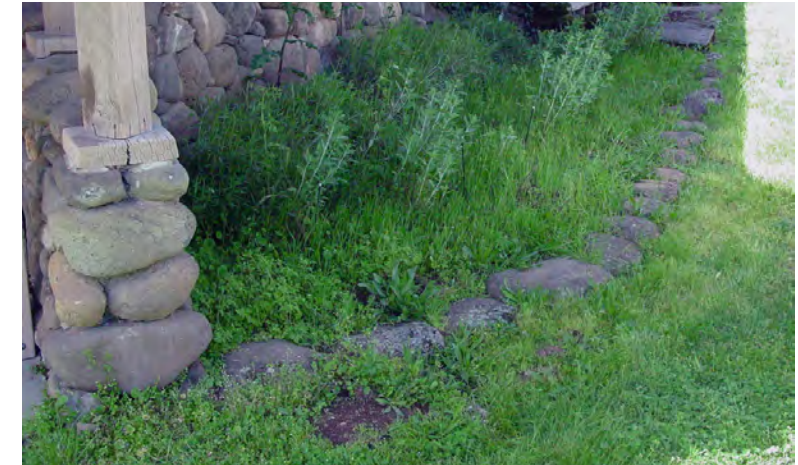
The river rock borders are built with either large or smaller river rocks, and likely date from the Rustic period. The borders help define spatial organization and add to the character of Aetna retreat. River rock borders were a popular Arts & Crafts treatment to mark pathways to buildings, vehicular circulation, planting areas; photos and drawings including river rock borders appear often in popular style magazines and images of that period. At Aetna the borders appear as a rural vernacular pattern. The planting areas they defined typically were planted with ground-oriented shrubs, perennials, etc. (see more under Existing Conditions – Designed Planting).

6 Large River Rock Border defining a planting area (Social Hall)

Salvage all rock borders from historic buildings and paths and stockpile rocks. After construction, replace rocks at perimeters of buildings and paths following typical installation patterns, creating borders at historic and new structures and landscape features.

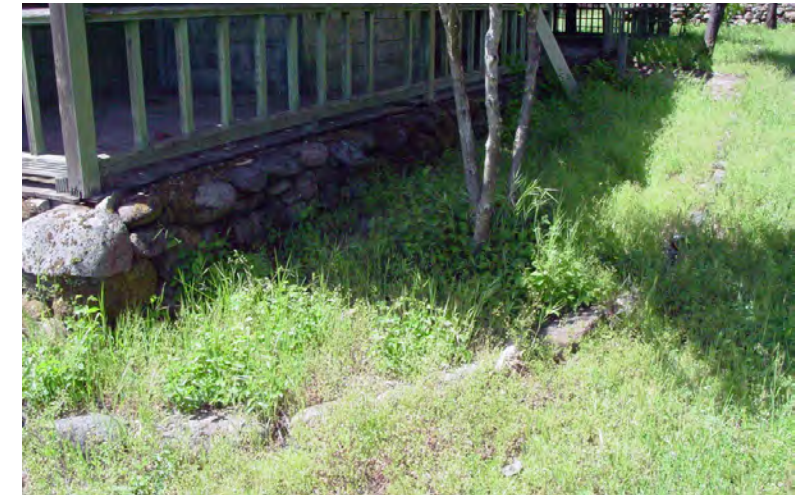
7 Small River Rock Border defining a planting area (York)

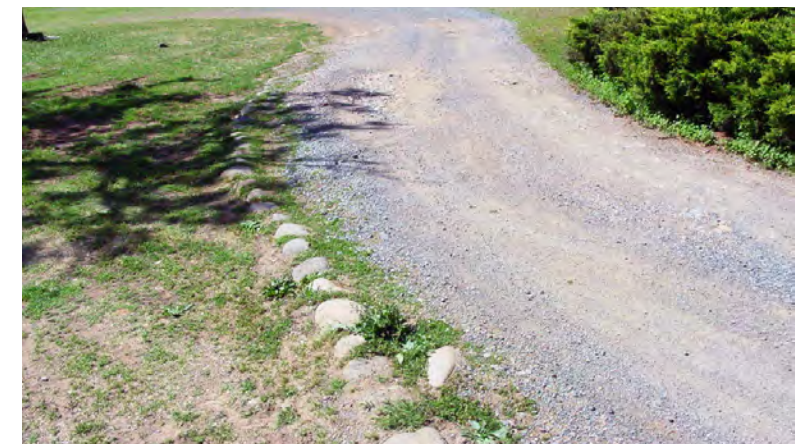
8 River Rock Border defining a road (opposite Dining Hall)

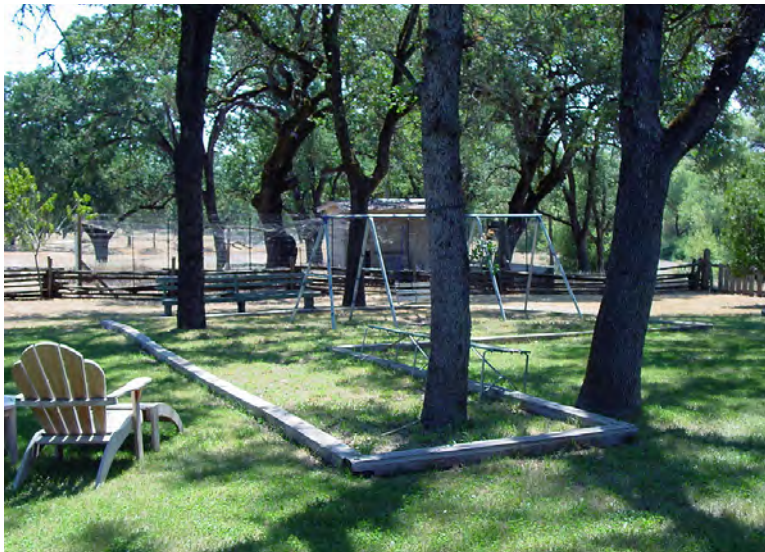
10 Wood Border ~ Playground

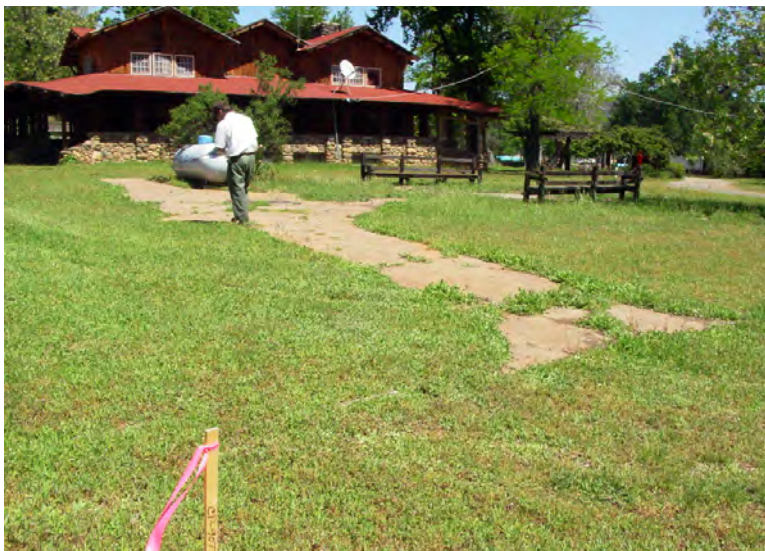
The concrete patio in the Central Commons area south of the Social Hall maintains the location, outline, and surface treatment, and indicates the location of the former arbor known to have existed in this area; the west edge of this patio is a broken edge and a central circular area has been infilled with newer concrete.

11 Concrete Patio in Central Commons

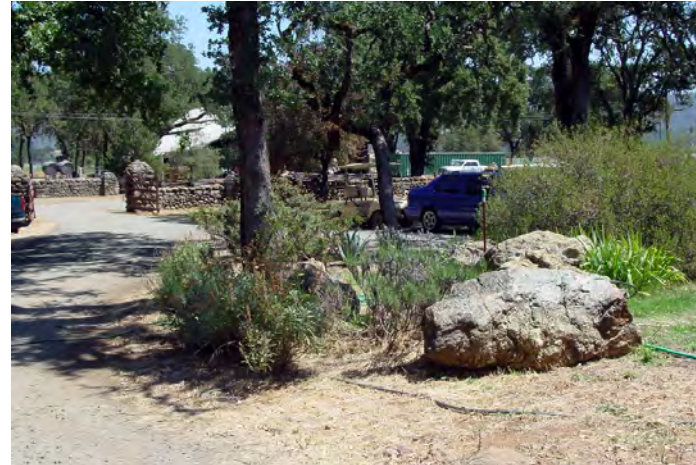
Feature boulders likely date from the Heibel period.

12 Feature Boulder

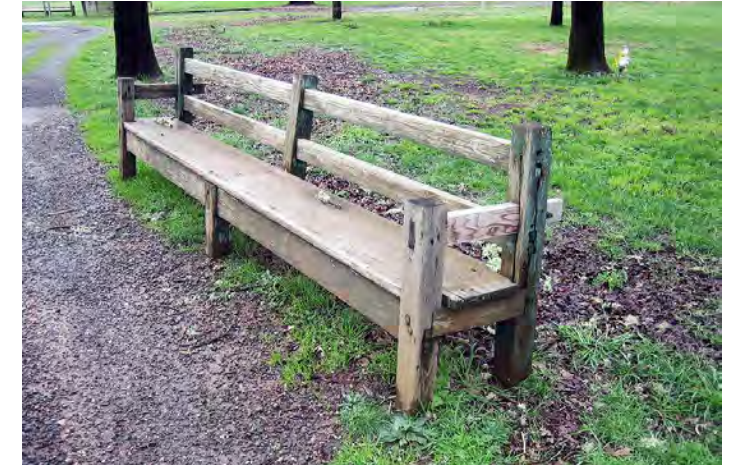
13 Bench with Arm Rest

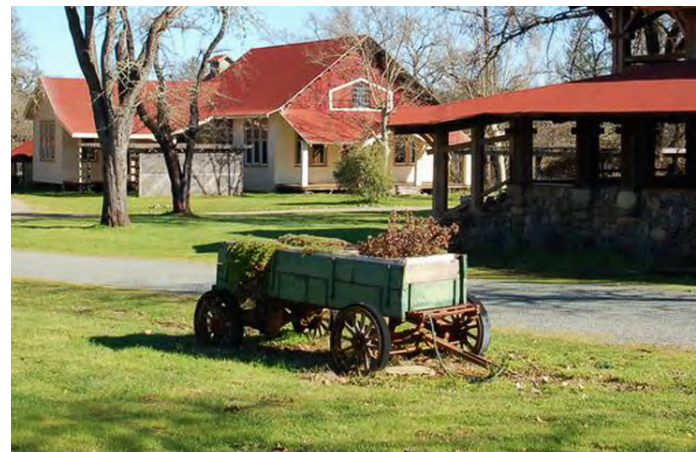
13A Delivery Wagon

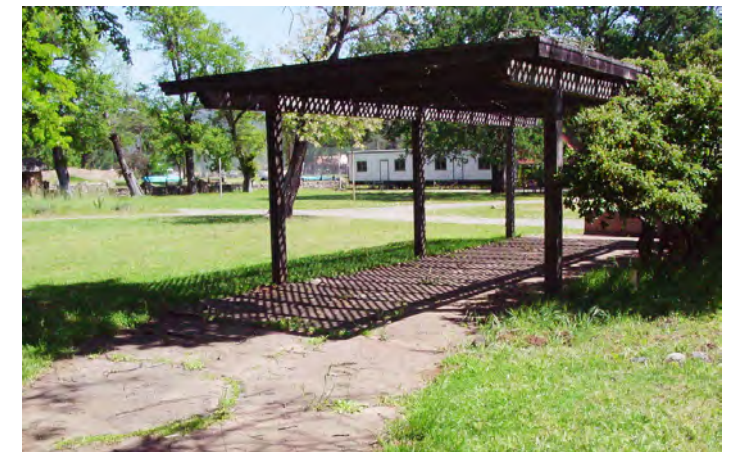
AP2 – The existing Arbor at Social Hall is wood construction. It was constructed within the last 15 years. The poured concrete floor terrace, however, is inscribed “1938” and contains the footings of a previous arbor that can be seen in historic photos. (Image 14)

14 Arbor at Social Hall AP2

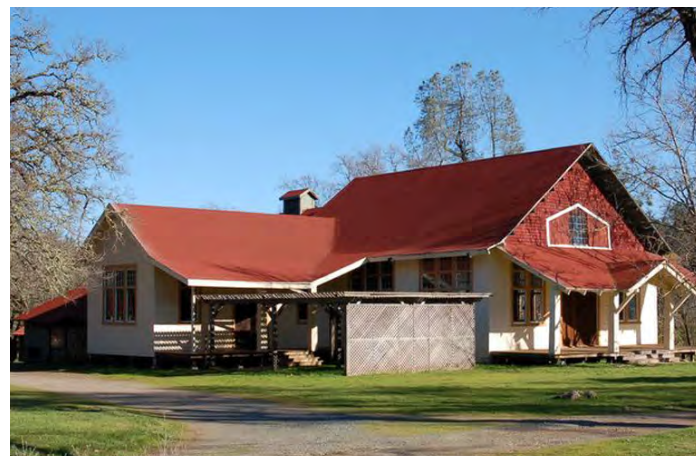
15 Arbor at Dining Hall AP1

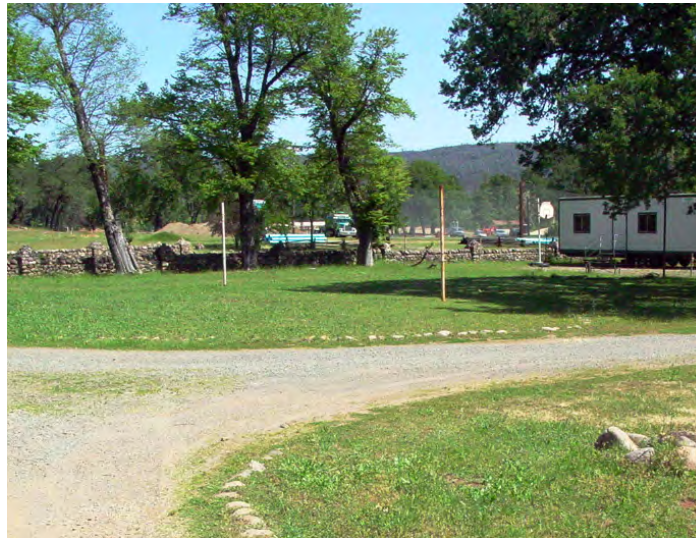
16 Old Croquet Court, Volleyball Poles

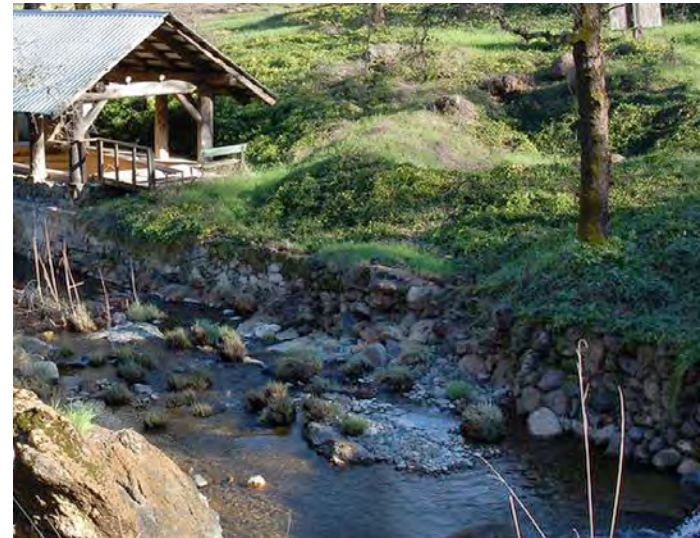
18 Mineral Bath - Note the instream rock work

"Taking the waters" was central to the original establishment of the resort. In addition to the Mineral Bath itself, the Mineral Bath area contains associated in-stream decorative rock improvements, bank-retaining stone walls, and extensive water display; these features extend on both sides of Aetna Springs Creek. There are possible remnants of terraces, patios, pools, rockery seating, and stairs on the north and south sides of the stream located generally between Soda Fountain and Mineral Bath. The existing features appear to date from the Rustic period.

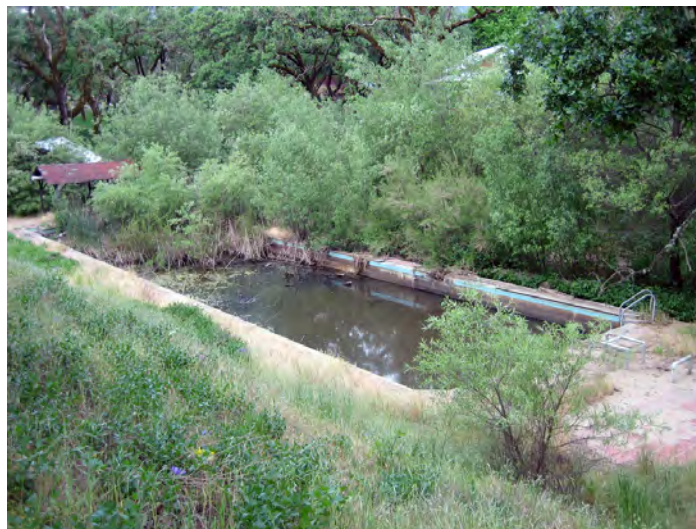
The swimming pool tile terrace (and pool facilities though perhaps not the pool itself) was enlarged several times during the history of the resort, based on the historic photo record. The existing tile terrace appears to date from the Heibel period, after the period of significance. The earth retaining wall has collapsed onto the terrace.

19 Swimming Pool

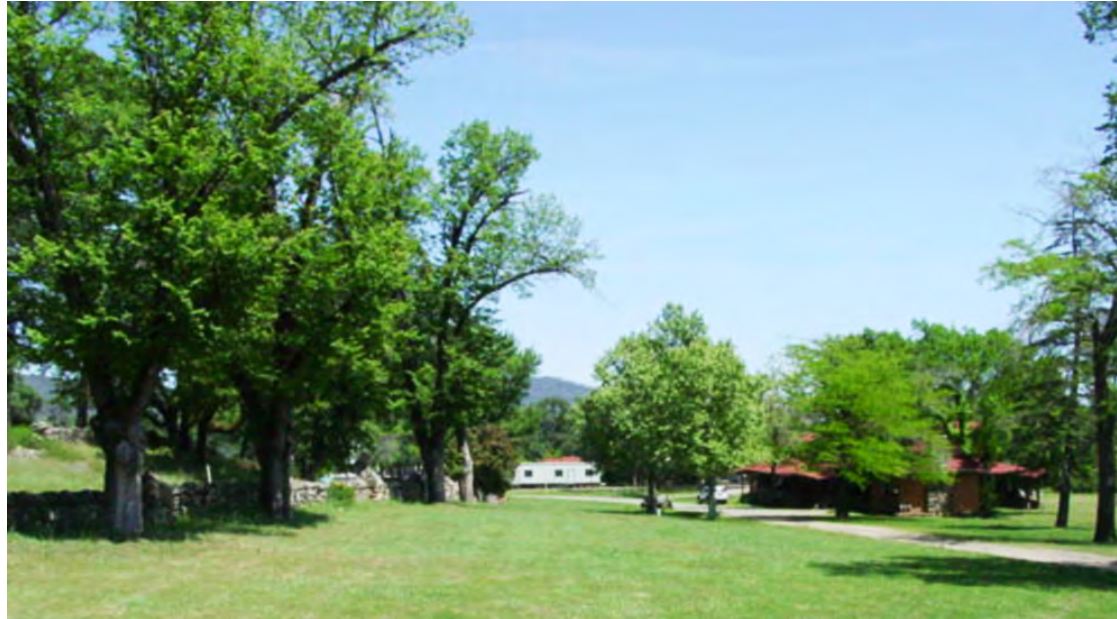
1 Elm allée behind perimeter river rock wall - Gateway Lawn with Plane trees - Locust and Elm ornamental and shade trees providing setting for Social Hall

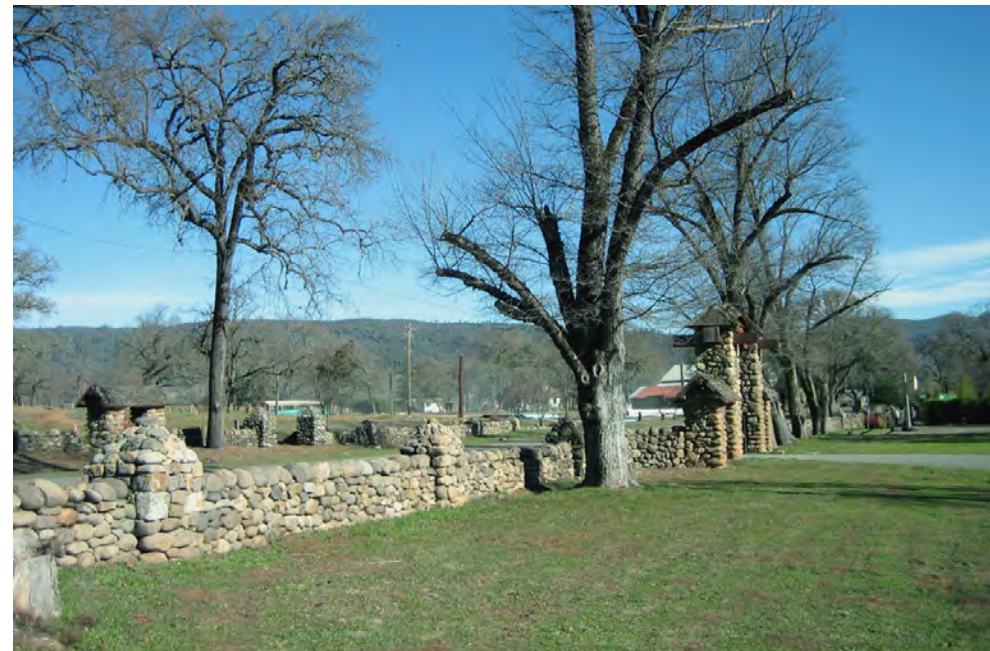
1A Elm allée behind perimeter river rock wall

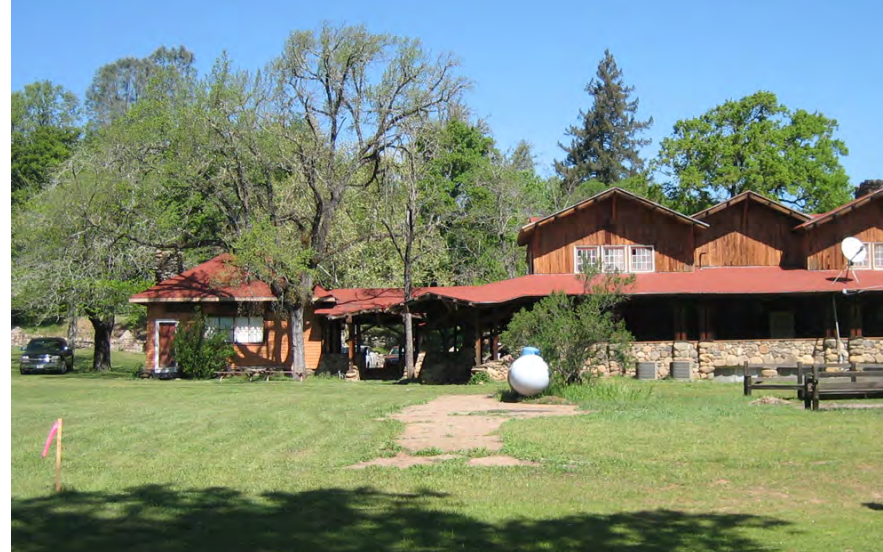
2 Elm, Black Locust as building perimeter shade trees
South Elevation of Social Hall

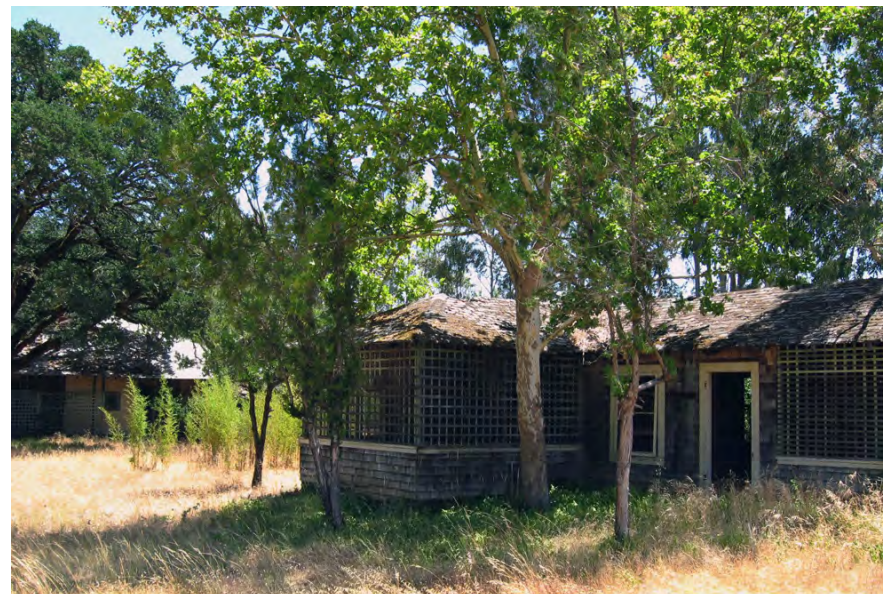
3 Plane Tree as building perimeter shade tree
Overgrown Arborvitae shrubs in border gardens

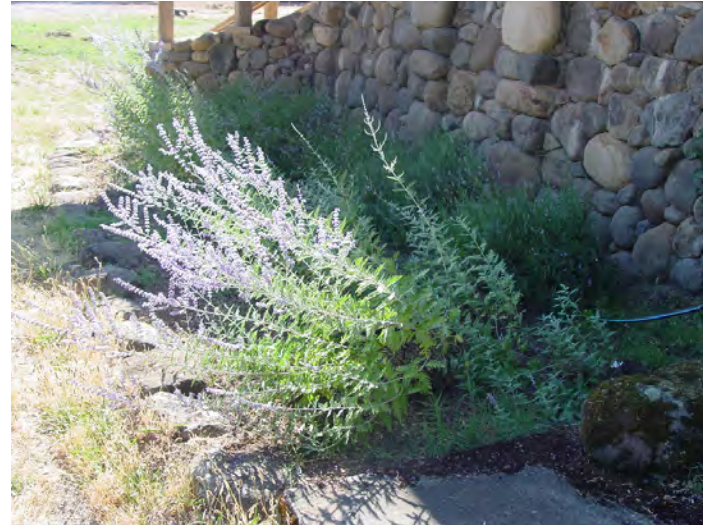
5 Russian Sage and Lavender in Border Garden at Social Hall riverrock border planting area

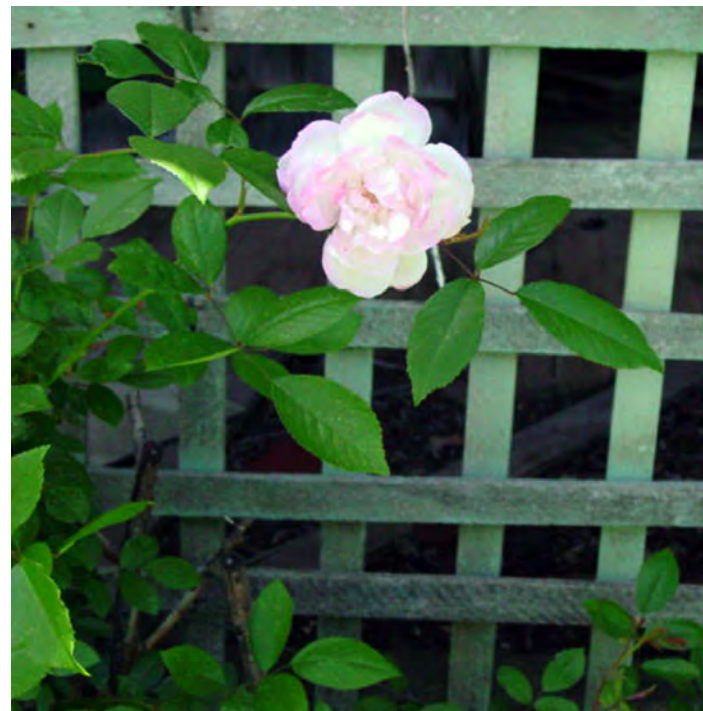
6 Rose at Russ Cottage
