AETNA SPRINGS PRESERVATION PLAN

For:
Aetna Preserve, LLC

Prepared by:
Architectural Resources Group
Smith & Smith

October 3, 2011

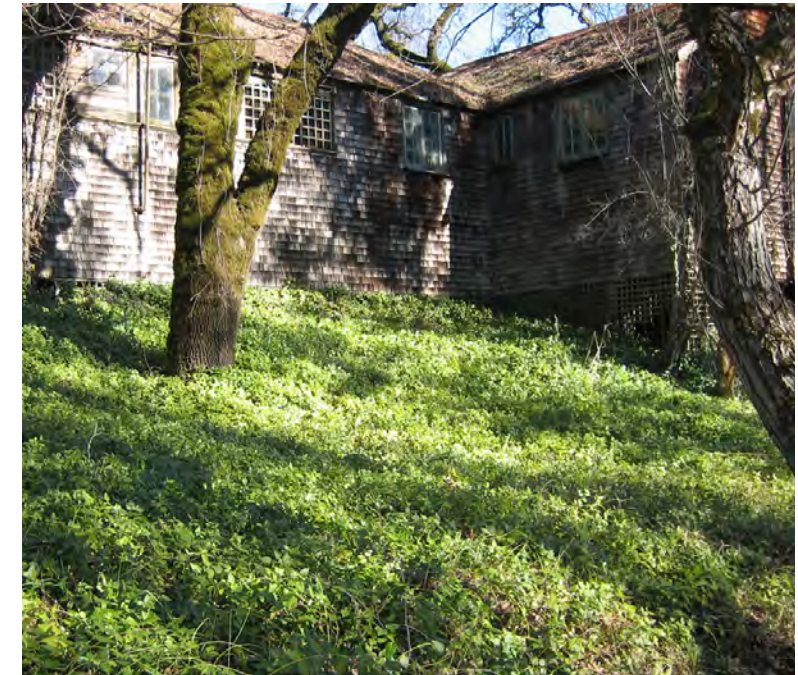
8 Periwinkle - South Elevation of Frances Marion

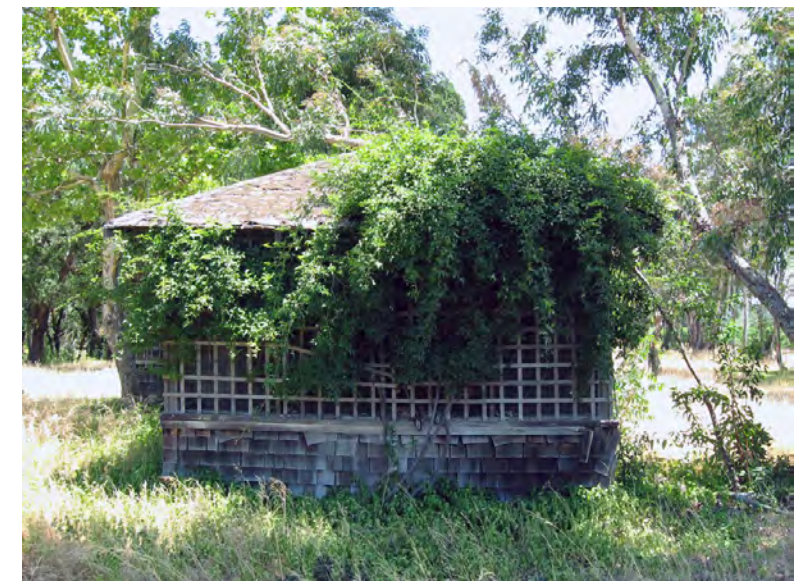
7 Vine on Locust Cottage building trellis
