Geological Study

August 10, 2015

Geologic Assessment of Slope Stability

3646 SMR Vineyard Winery 3646 Spring Mountain Road Saint Helena, CA 94574

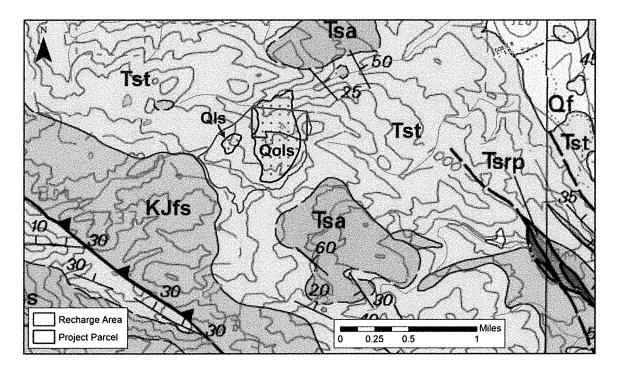
In addition, Delattre and Gutierrez (2013) shows that the project parcel is underlain by geologic map unit *Qols-Older landslide deposits (Pleistocene?)* described as "deeply dissected landslide deposits consisting of undifferentiated Sonoma Volcanics". The map includes a younger landslide unit *Qls-Landslide deposits (historical to Pleistocene)*. The smaller scale geologic map of the area (Graymer et al. 2007) does not include the more detailed surficial mapping of landslides. The landslide deposits mapped by Delattre and

Figure 1. Geologic map of the project site and vicinity (after Graymer et al. 2007 & Delattre and Gutierrez, 2013). Units are as follows: Tst - Pumiceous ash-flow tuff, Tsa - Andesite to basalt lava flows, KJfs - Graywacke and melange, Qf - Alluvial fan deposits, Qls - Landslide deposits, Qols - Older landslide deposits.

that the winery site would be stable. Nevertheless, it is possible that unstable soils and/or large-scale slope deformation could occur within large, deep landslide features such as the mapped landslide (Figure 1). For this reason, my reconnaissance extended across the entire developed portion of the parcel, which corresponds with the body of the mapped ancient landslide. If the landslide remains active at the scale of the mapped feature, I would expect to find small scarps, tension cracks, and deranged drainage patterns on the body of the landslide. These features were absent, indicating that the mapped landslide is inactive with respect to the scale and style of movement associated with the mapped landslide feature.
