Anthem Winery P14-00320-MOD and Exception to Road and Street Standards,
Variance P14-00321-VAR and Viewshed, and
Agricultural Erosion Control Plan P14-00322-ECPA
Planning Commission Hearing Date (Wednesday, October 3, 2018)

**SUPPLEMENTAL FAULT INVESTIGATION REPORT
ANTHEM WINERY AND VINEYARDS, LLC
3454 REDWOOD ROAD
NAPA, CALIFORNIA**

June 30, 2018

Job No. 1354.100

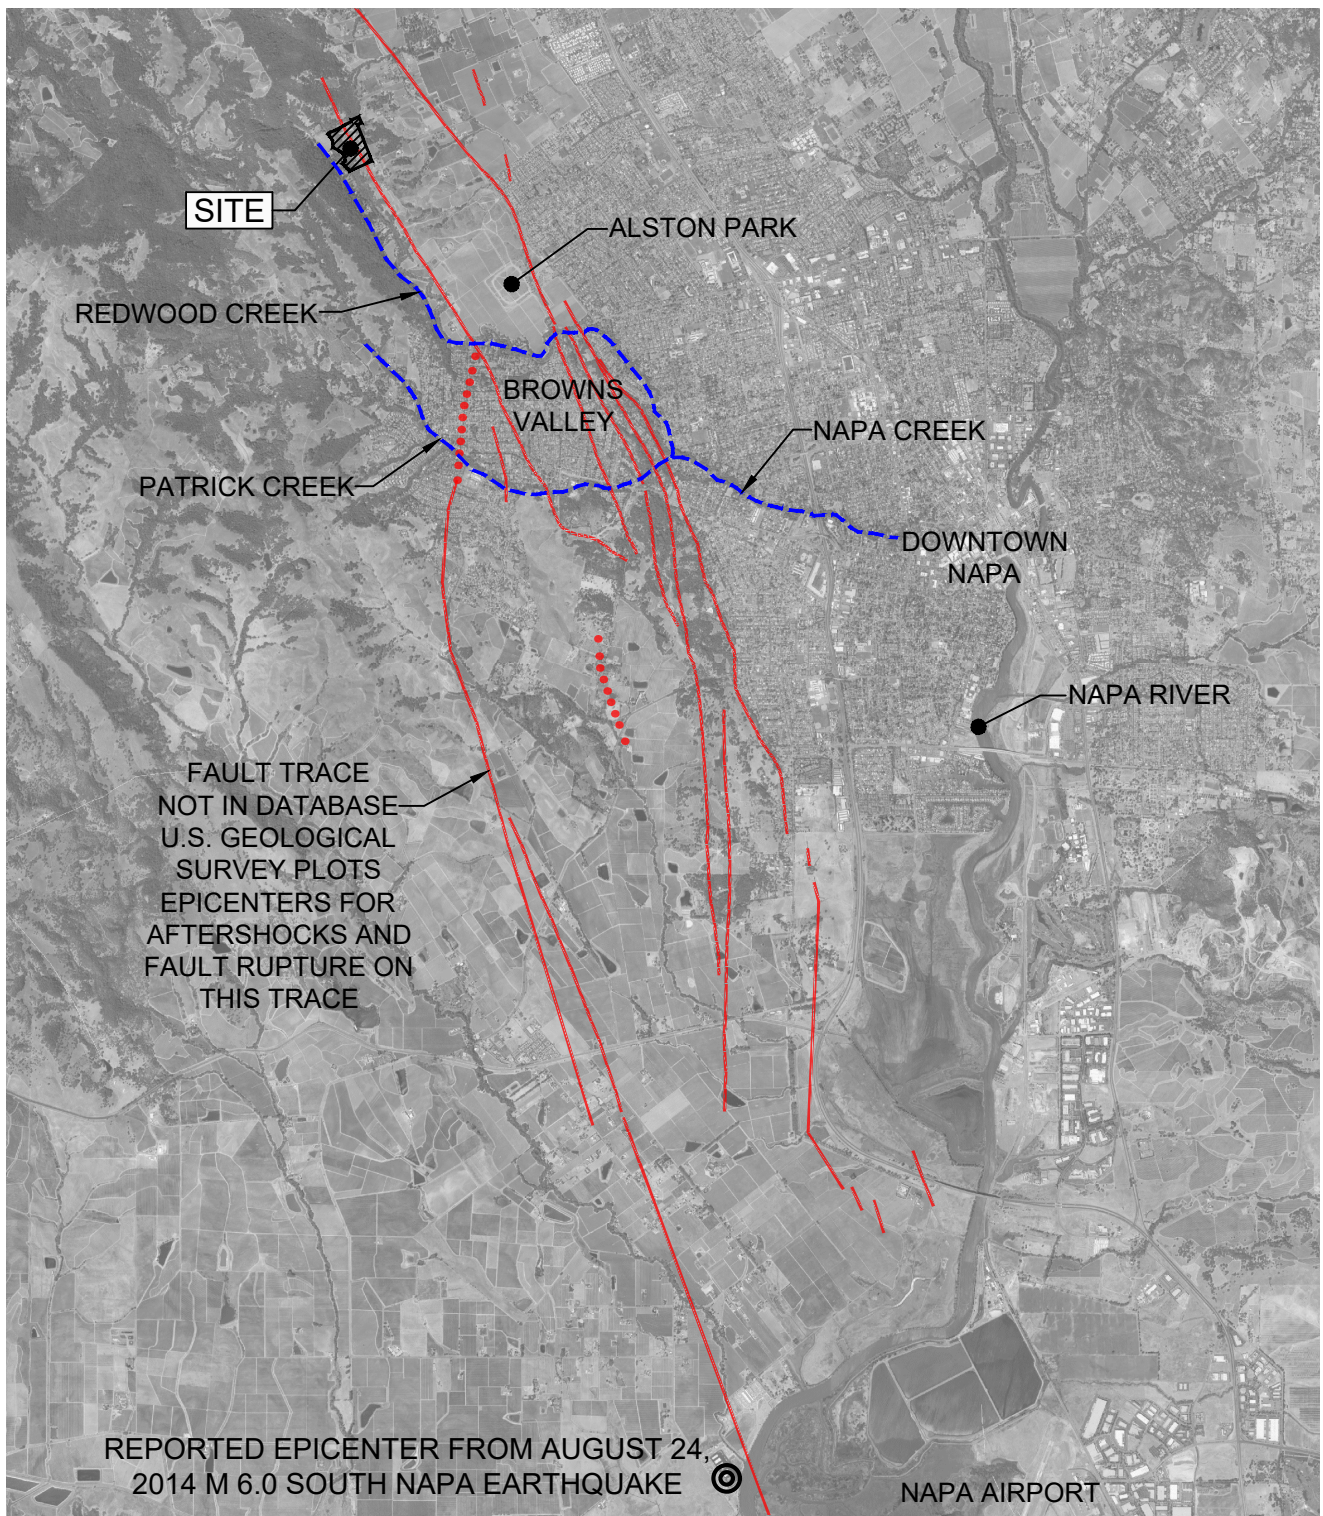
QUATERNARY FAULT MAP		
Anthem Winery and Vineyards, LLC 3454 Redwood Road Napa, California		
DATE: 6-30-18	Project No. 1354.100	Figure 4

The fault zone defined in the Quaternary Fault and Fold Database¹ maintained by the U.S. Geological Survey is shown on Figure 3 for reference. The database shows a fault along the flank of the ridgeline on the east side of Redwood Creek, generally passing through the western portion of the site. The fault is designated as Quaternary, less than 1.6 million years; however the database has not been updated to reflect the 2014 earthquake activity. The database also shows a Late Quaternary fault, less than 1.3 million years, at the base of the hills along the west side of Napa Valley near Alston Park, this splay is also an active fault based on recent information. The locations of faults in the database are shown on Figure 4.

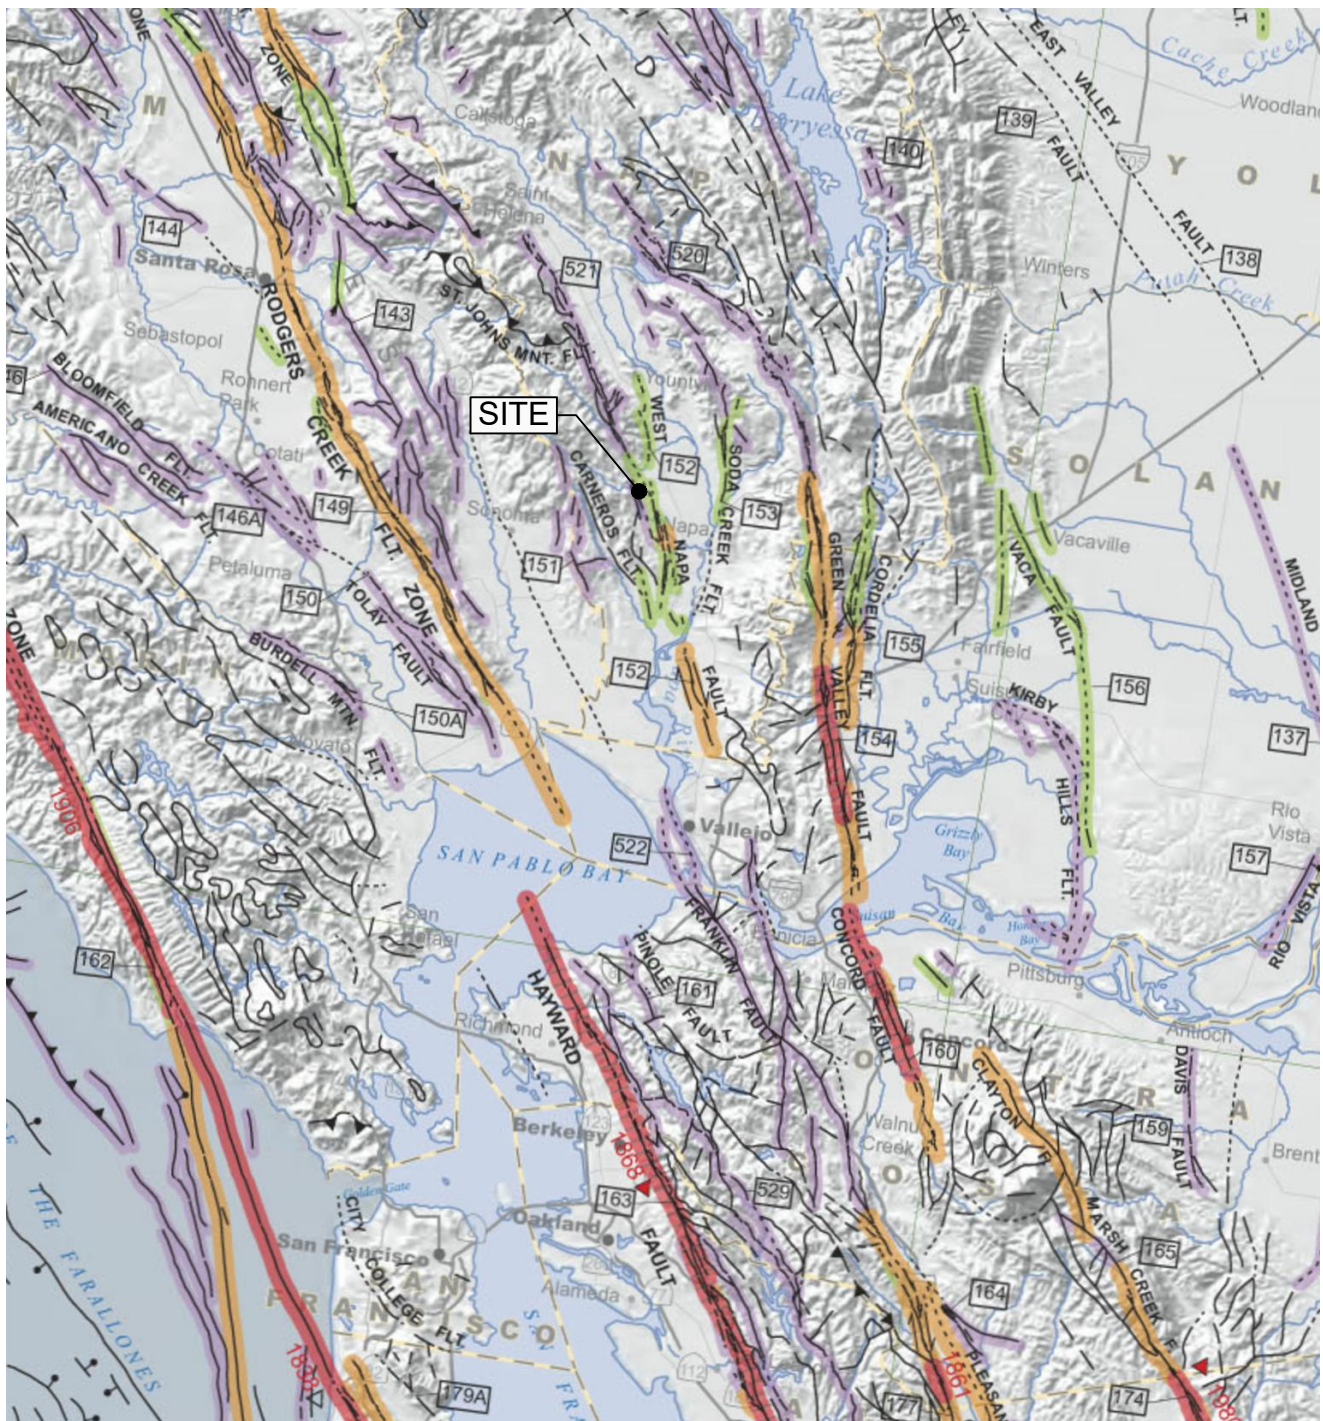
AERIAL PHOTOGRAPH INTERPRETATION		
Anthem Winery and Vineyards, LLC 3454 Redwood Road Napa, California		
DATE: 6-30-18	Project No. 1354.100	Figure 8
RYAN GEOLOGICAL CONSULTING, INC. PROVIDING LOGICAL GEOLOGICAL SOLUTIONS

In general, we interpreted three photo-lineaments⁹ in the aerial photographs that are near the site; however, no one set of photographs were conclusive as the lineaments are vague except for the Alston Park lineament. The photo-lineaments were mapped based on geomorphology and some apparent offset of stream channels as discussed below. It should be noted that mapping lineaments on aerial photographs does not necessarily mean the lineaments are indicative of fault lines, subsurface trenching is needed to confirm the presence of a fault. The approximate locations of the photo-lineaments are shown on Figure 7 for reference. We used a copy of the 1984 photograph as the base for Figure 8 since it was the best reproducible image, not because it depicted conditions better than other photographs.

The western most of the photo-lineaments is along or just upslope of Redwood Creek, near the western site boundary. Redwood Creek is atypically linear along the base of the hills suggesting a structural control for the current creek alignment. Additionally, the hillside along the west flank of the ridge becomes very steep and linear near the tree line above the creek channel. It should also be noted that the geologic map on Figure 5 shows fault contacts bounding the Domengine Sandstone along the west flank of the ridge below the site. This photo-lineament may represent the bedrock fault contact between the two geologic units designated as Quaternary in the Fault and Fold database. Additionally, there are very weak indications of possible photo-lineaments upslope of the tree line which would be well within the site boundaries but not within the area of the proposed buildings.

There is another photo-lineament interpreted just below the east side of the ridgeline, east of the property boundary. This photo-lineament was based on the steep escarpment below the ridge and alignment of saddles. This photo-lineament does not correlate with any mapped fault shown on the regional maps. However, we understand that this photo-lineament may correlate with the UAVSAR lineament inferred near the site by the U.S. Geological Survey. We understand that preliminary interpretations of the UAVSAR lineament are that it bends westward through the site, however; our interpretation of the eastern photo-lineament would trend past the site to the east and connect with the sharp erosion feature to the northeast of the site. The approximate location of the UAVSAR lineament and our photo-lineaments are shown on Figure 8 for reference.

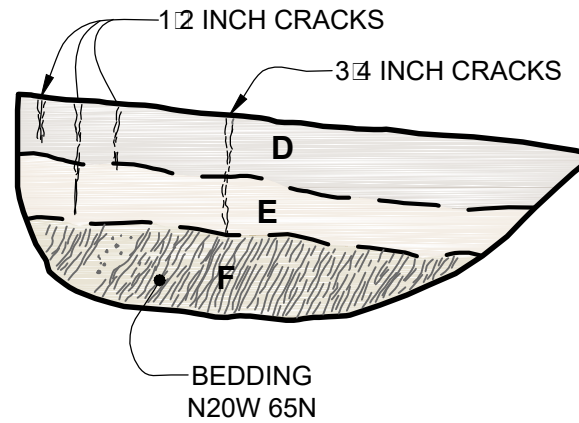
TRENCH T-4 LOG OF SOUTH WALL

1 1/2 INCH CRACK
EXTENDS 1-1 1/2 TO 2
INCHES DEEP ONLY
