# CALIFORNIA REGIONAL WATER QUALITY CONTROL BOARD SAN FRANCISCO BAY REGION

## CLEANUP AND ABATEMENT ORDER NO. R2-2019-0014

### CLOVER FLAT LANDFILL CLASS III SOLID WASTE DISPOSAL FACILITY CALISTOGA, NAPA COUNTY

Photo Log from March 26, 2019

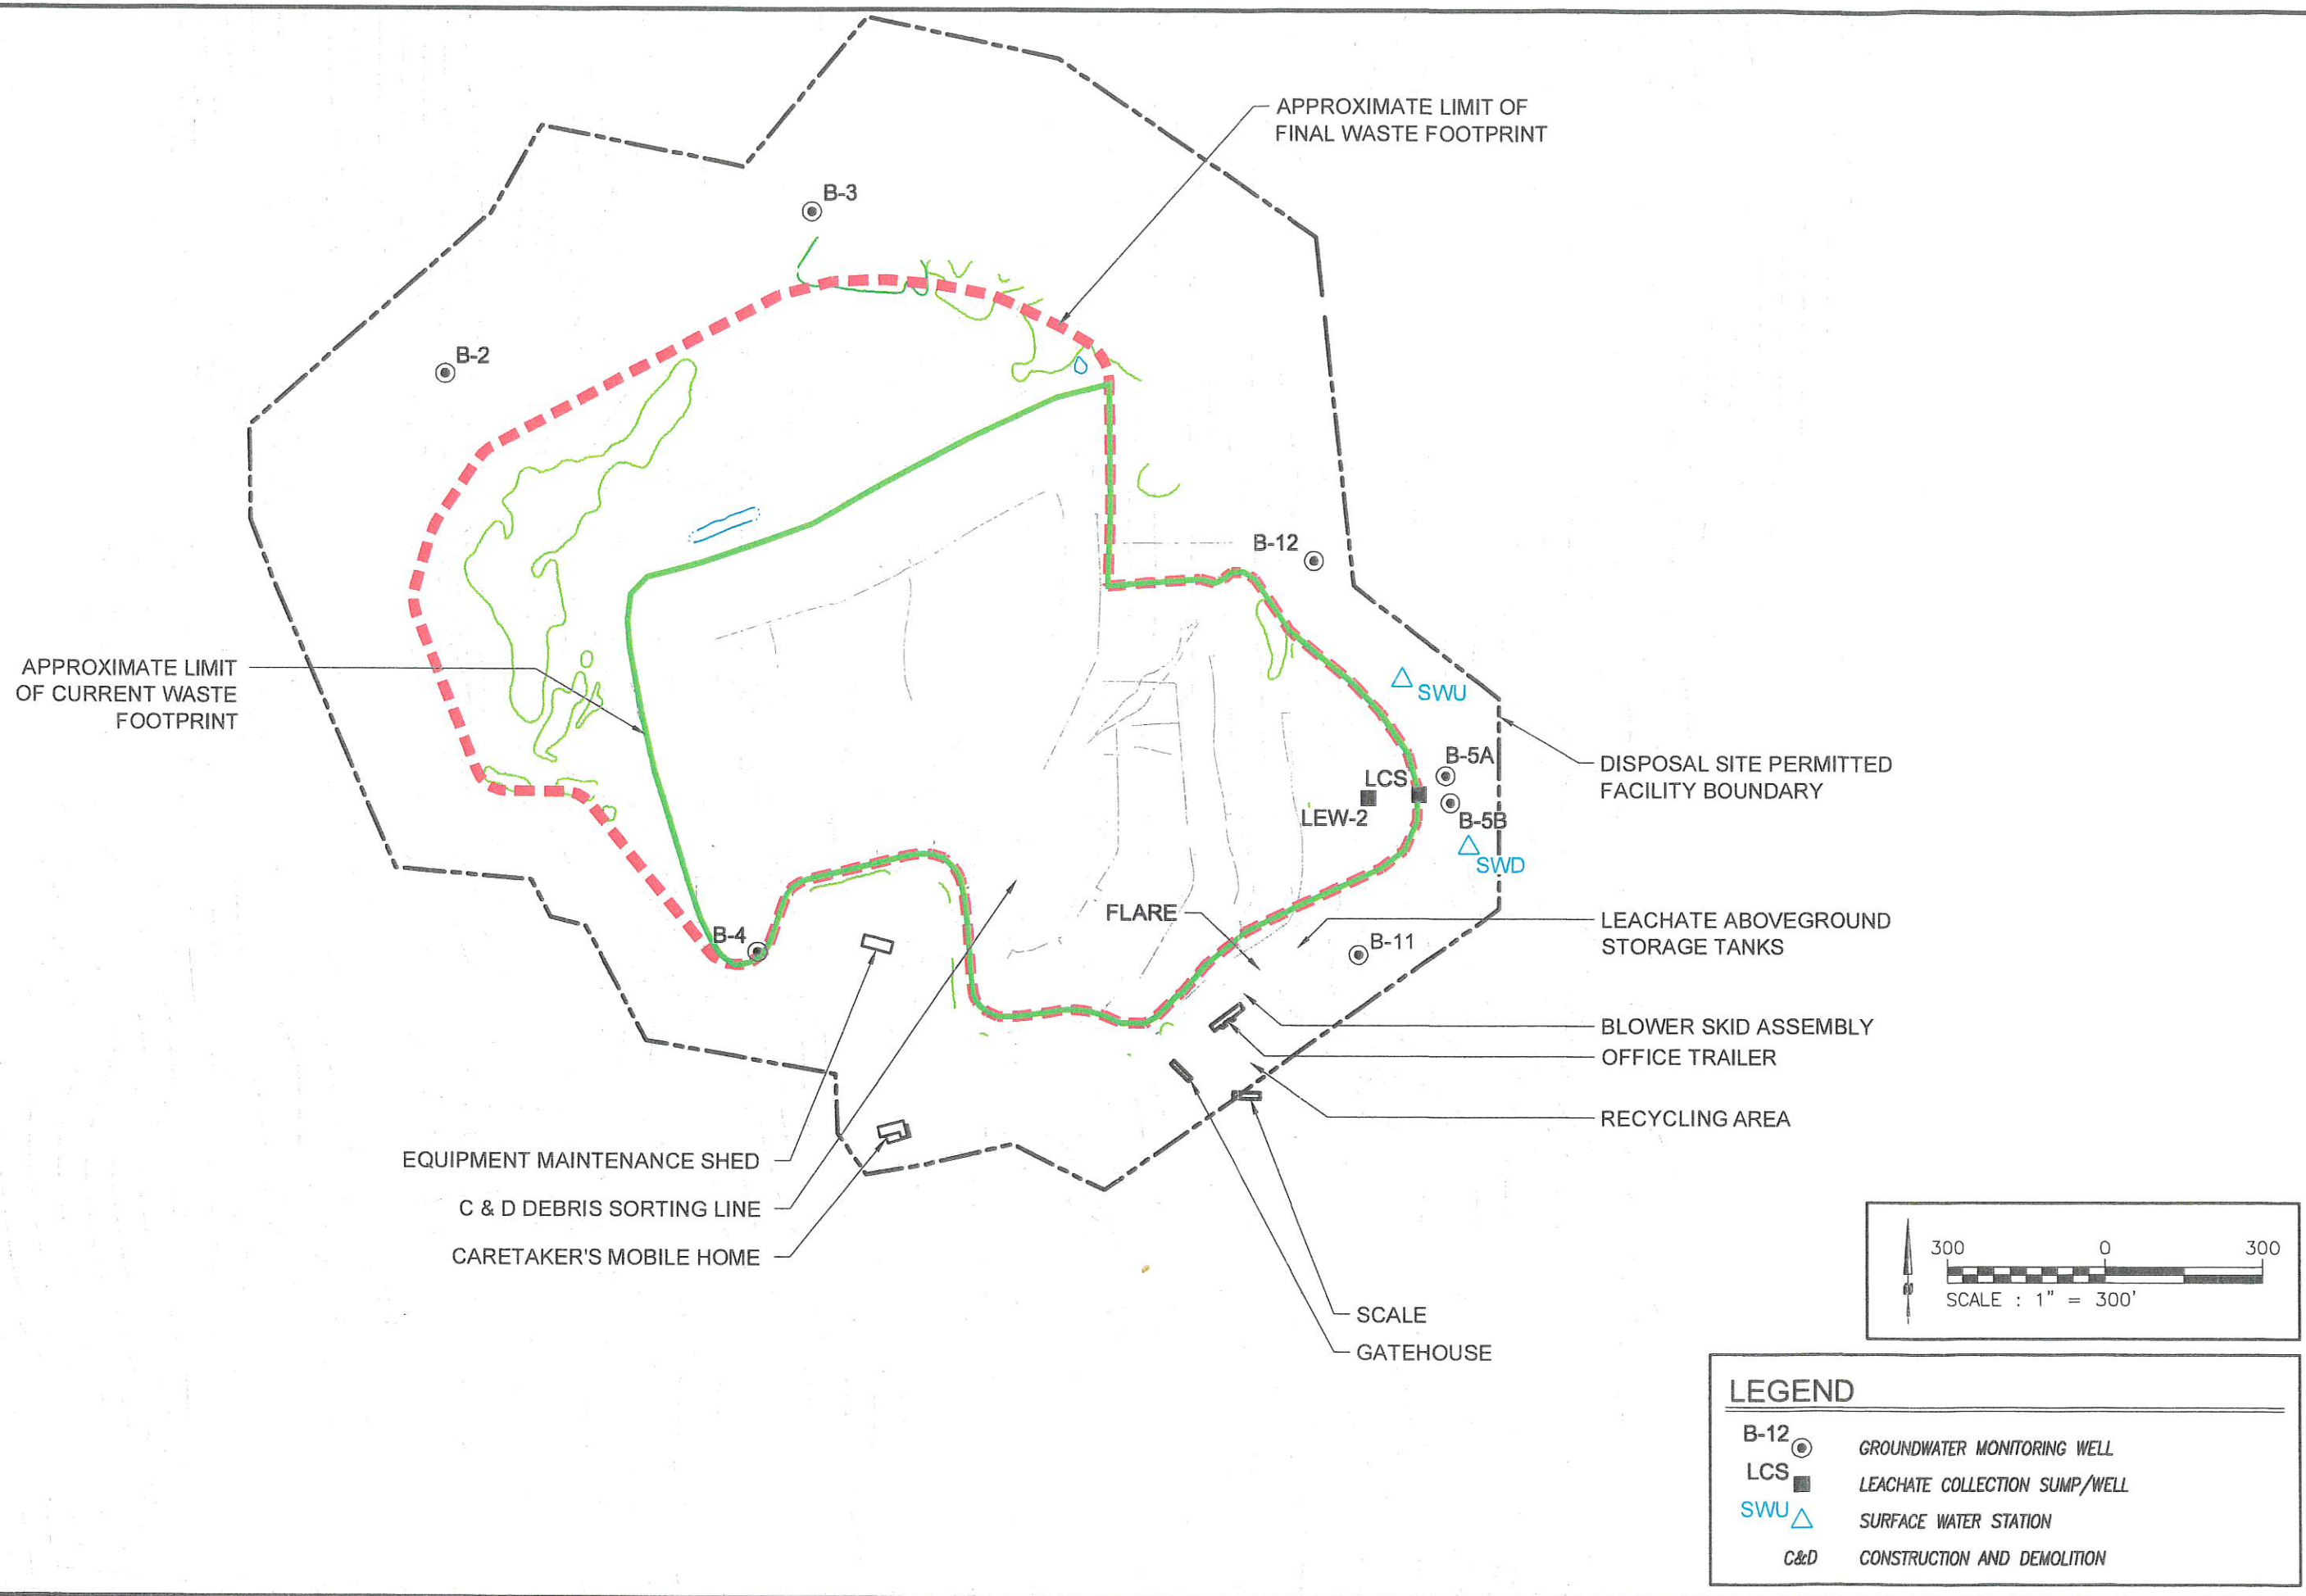
WDR COMPLIANCE MONITORING NETWORK

Water Board staff were also informed during the inspection that the leachate pump located near the toe of the landfill (LEW-2; see Figure 12) had been spraying leachate onto the ground instead of pumping it up to the three concrete holding tanks as intended. The location of the leachate pump is approximately 150 feet from the creek, and Water Board staff observed ponded leachate flowing into the creek from LEW-2 (see photo number 535 in the attached photo log), which was in severe disrepair and completely rusted. During the time that the three concrete leachate tanks were full (approximately two weeks), leachate was being routed into the metal condensate storage tank and mixed with landfill gas condensate. This mixture of leachate and condensate was being used as dust control at the landfill as recently as Monday, March 25, 2019 (despite the fact that a significant amount of rain, 0.65 inches, fell in Calistoga on that day, according to records of the National Weather Service).

Water Board staff also observed severe erosion and rilling on the bench/access road leading to the leachate pump, as well as black oily water actively running down the hill into the creek from the lower leachate collection system (LCS) (see photo number 589 in the attached photo log, as well as Figure 12 for the locations of the leachate pumps.)
