66-inch Trunk Sewer

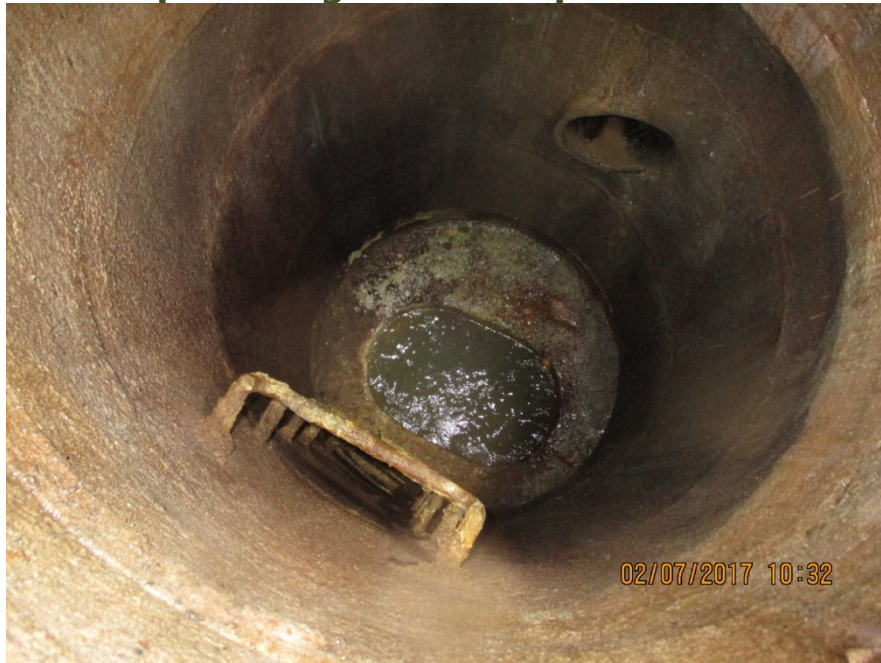
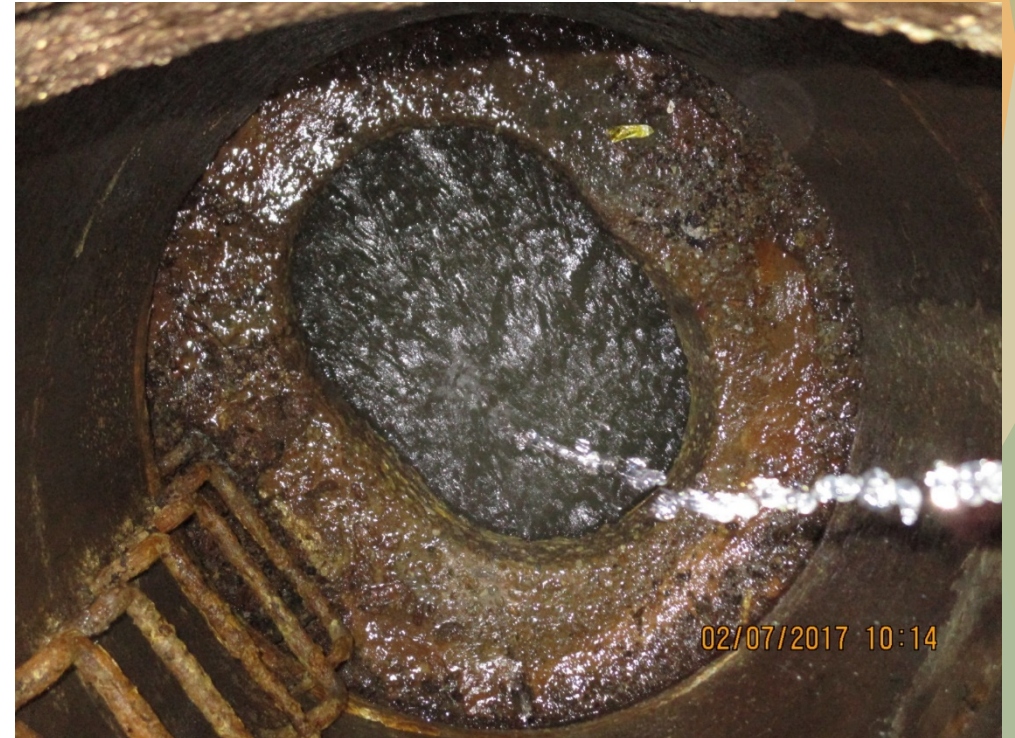
Pipe Condition vs. Capacity

- ▶ The condition assessment established that the pipe needs to be repaired
- ▶ The capacity analysis will determine if additional capacity is required
