RE: Preliminary Geotechnical Investigation  
Fisher Tentative Parcel Map  
APN's 050-010-24,30,31  
Napa, California

Project Number: 5514.01.01.2

PRELIMINARY GEOTECHNICAL STUDY

FISHER PARCEL SPLIT - II  
APN'S 050-010-24, -30 AND -31  
2435 PARTRICK ROAD  
NAPA, CALIFORNIA

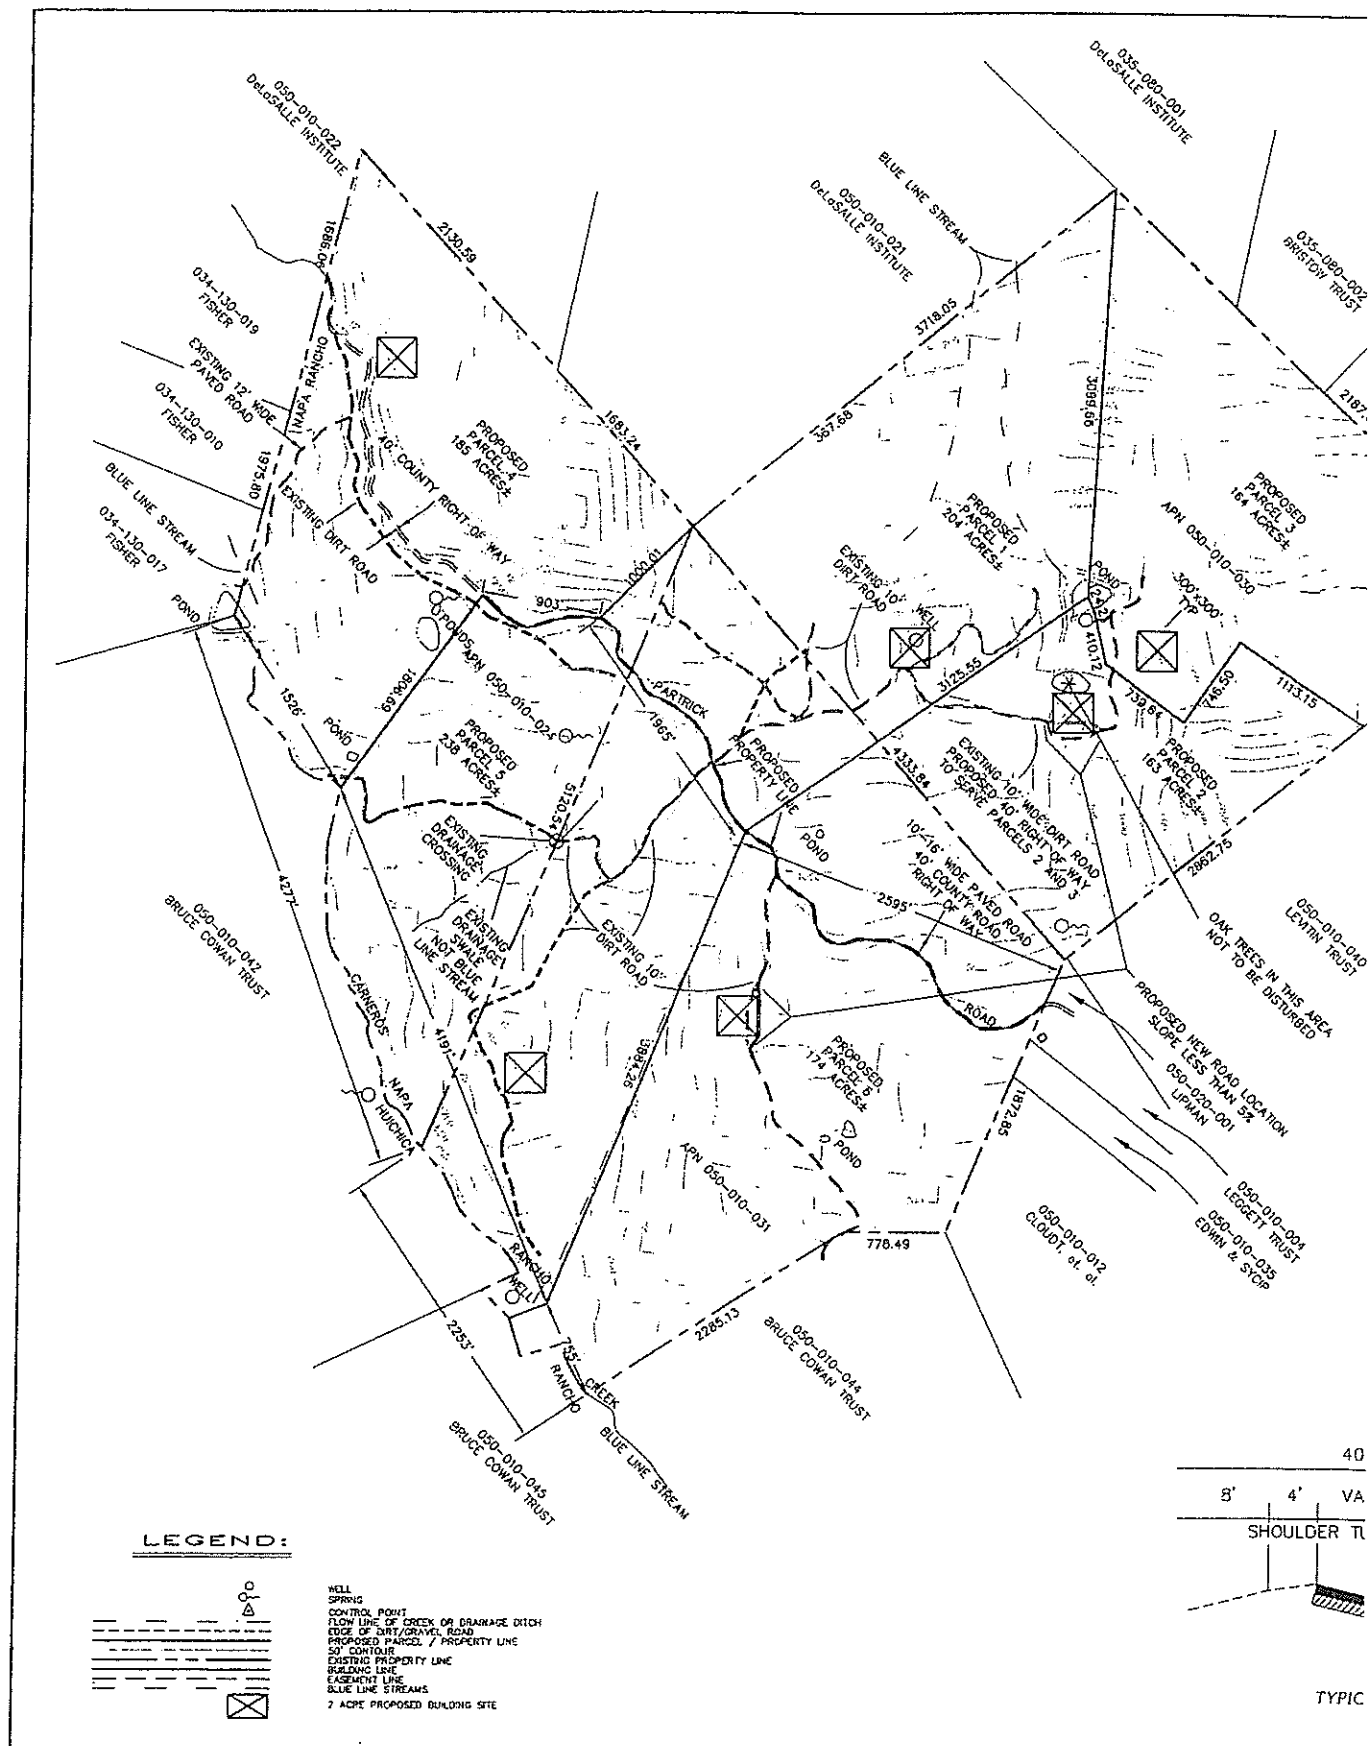
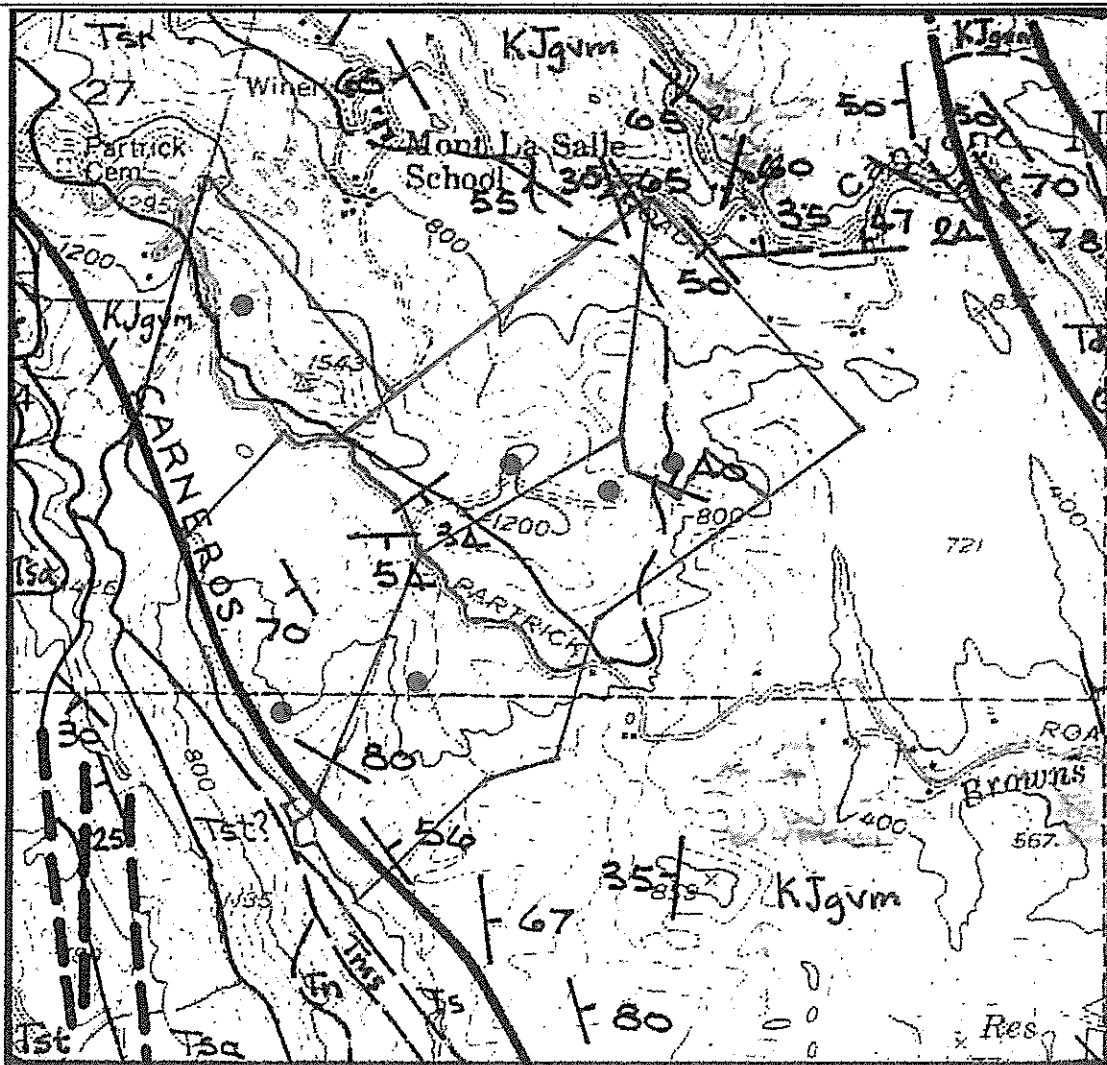
We observed active landslides and landslide complexes on the Fisher property, as shown on Plate 1. The preselected building areas, as shown on Plate 2, are generally located outside of these landslides. The building area on Lot 3 is situated along a stable-appearing ridge. However, the headscarp of a large landslide and a definite landslide zone are situated on the steep flanks southwest (downhill) of the building area. The alternate A and B building areas on Lot 4 are situated near the lower portions of definitely active landslide zones. Alternative B building area on Lot 5 is situated north (uphill) of an active slide complex. In addition, a fresh (recent) scarp was observed on the slopes to the southeast. To minimize the impact of slope instability affecting the building areas, setback zones should be established, as recommended below.

To reduce the risk of slope instability affecting future residences, they should be located in the building areas shown on Plate 2. We anticipate that, in general, spread footings could be used for foundation support in relatively level building areas underlain by shallow bedrock. Where the depth to bedrock exceeds 3 feet, drilled piers and grade beams should be considered for foundation support. Either foundation system will need to derive support in bedrock below the surface soils or in engineered fill keyed into bedrock. Design criteria of such foundation systems should be developed by a site specific geotechnical investigation as recommended in the supplemental services section of this report. Building development setbacks should be established from steep slopes and landslides. We recommend a minimum horizontal setback distance of 50-feet from breaks in slope of 2:1 or steeper, and of 100-feet from landslides.

The building envelopes shown on Plate 2 contain areas that are considered to be outside of slope instability. Because of the introduction of water underground, the installation of leachfields tends to lower the stability of hillsides. Therefore, leachfields should be installed in level to gently sloping relatively stable areas and per the recommendations of the project Civil Engineer. Leachfield areas should be set back a minimum of 50 feet from planned structures to reduce the risk of hillside instability impacting the structure. The stability of leachfields can be enhanced by installing an interceptor drain around the uphill perimeter. The interceptor drain should discharge collected waters onto rock rip rap aprons constructed on erosion resistant areas. Leachfields should not be located in areas of steep to very steep slopes, creeping soils or landslide terrain.
