United States Department of the Interior
National Park ServiceNational Register of Historic Places
Inventory—Nomination FormSee instructions in *How to Complete National Register Forms*
Type all entries—complete applicable sections

historic Aetna Springs Resort

street & number 1600 Aetna Springs Road N/A not for publication

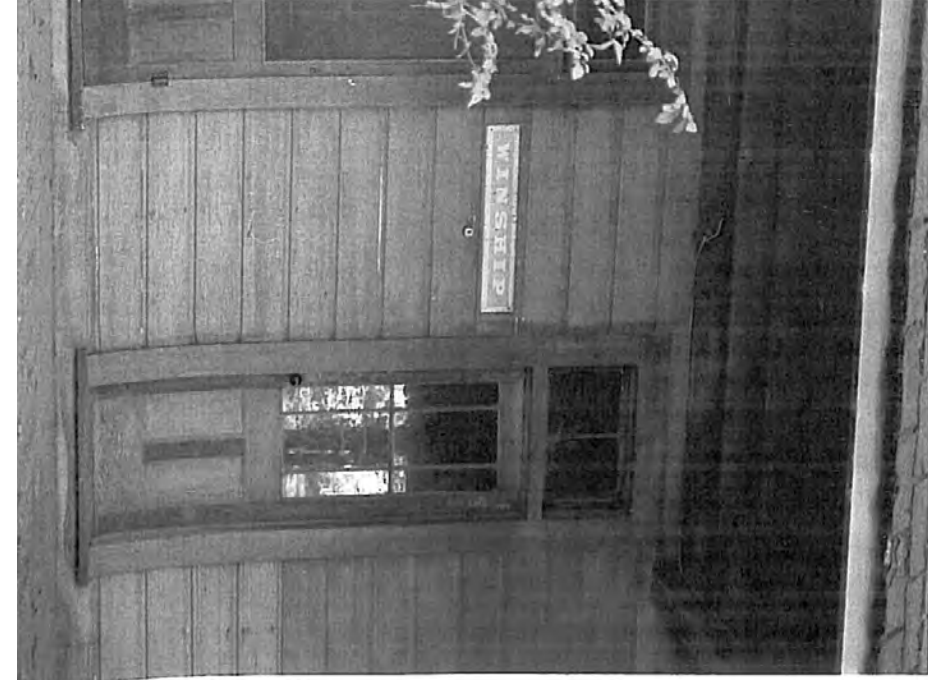
Top - Bldg. #17 - Winship, detail of elevation, porch and doors, Photo #46 of 84 (J. Brundrett photo, October 1983)

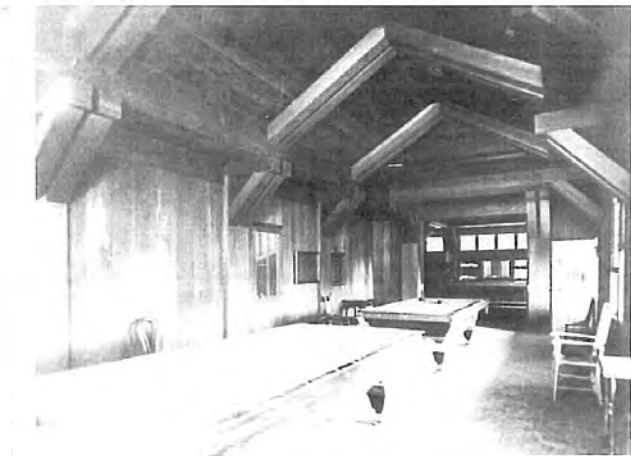
Top - Bldg. #18 - Gassaway, interior after remodeling, Photo #50 of 84 (unknown photographer, c. 1930)

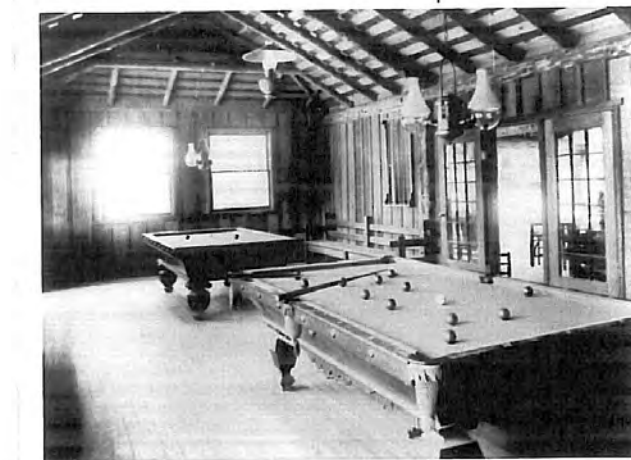
Middle - Bldg. #18 - Gassaway - interior before remodeling, Photo #49 of 84 (unknown photographer and date)

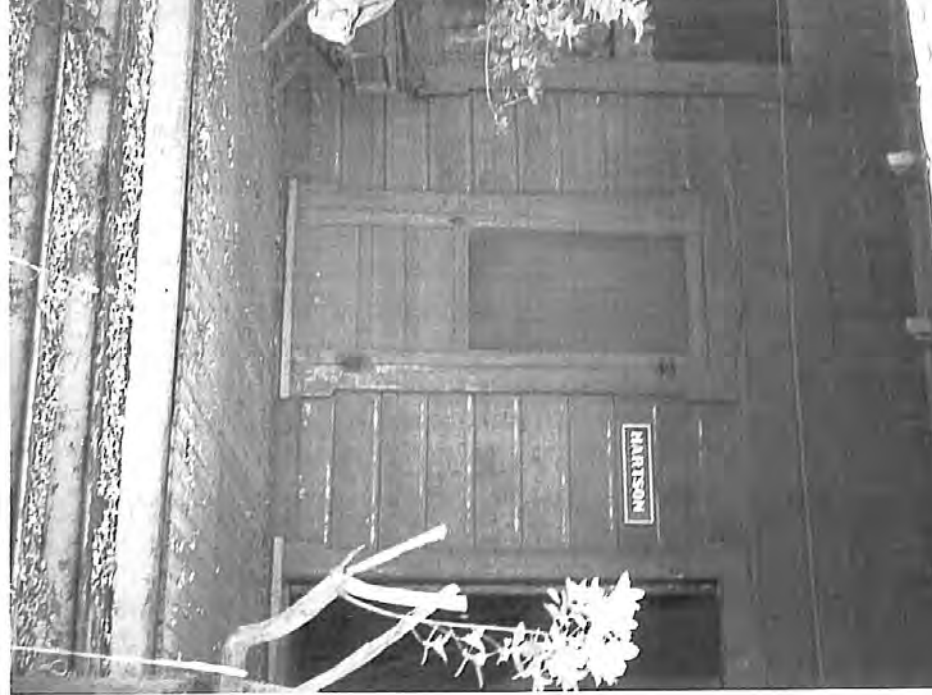
Top - Bldg. #21 - Hartson, detail of N elev. porch and door, Photo #56 of 84 (J. Brundrett photo, October 1983)

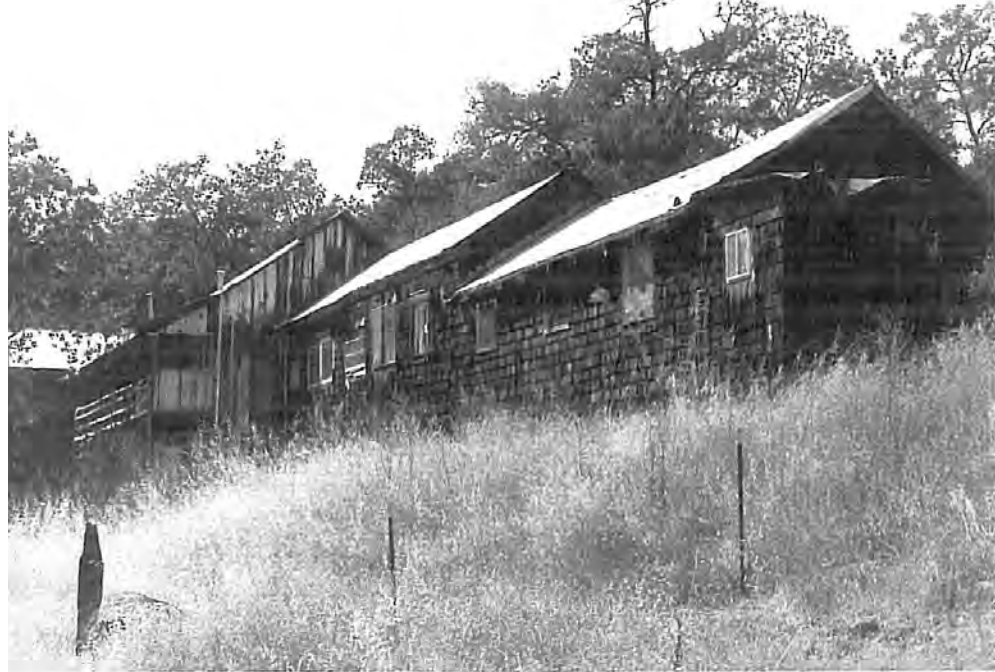
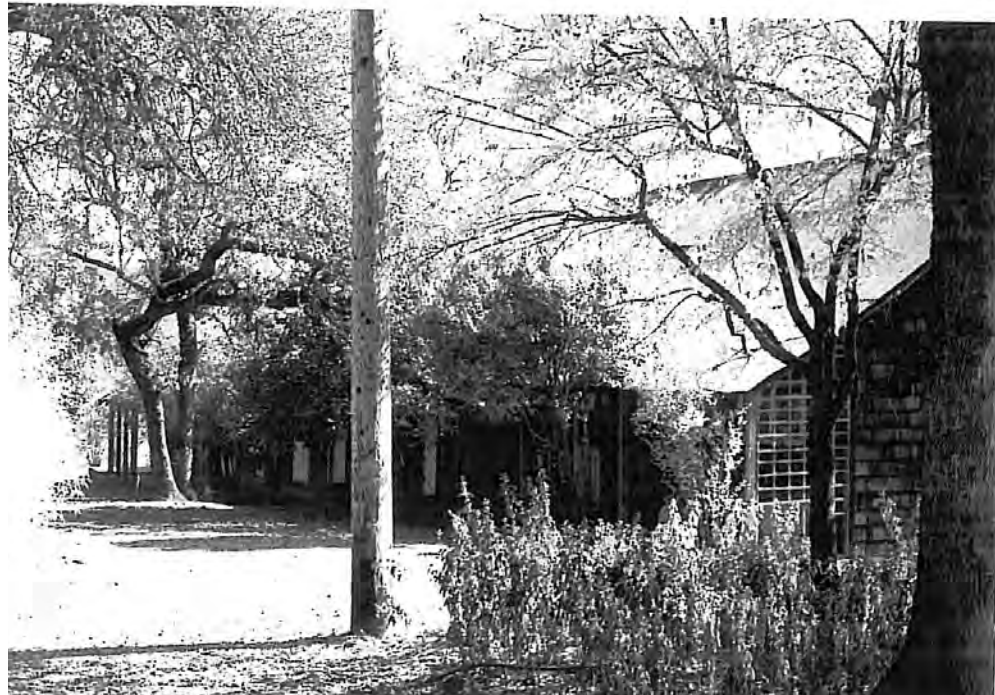
Top - Bldg. #13 - Living Quarters, view from SE, Photo #36 of 84 (Johnathan Brundrett photo, October 1983)

Bottom - Bldg. #13 - Living Quarters, view from NW, Photo #35 of 84 (J. Brundrett photo, October 1983)

Building 13 – Living Quarters*Foundations and Vertical Load Structure*

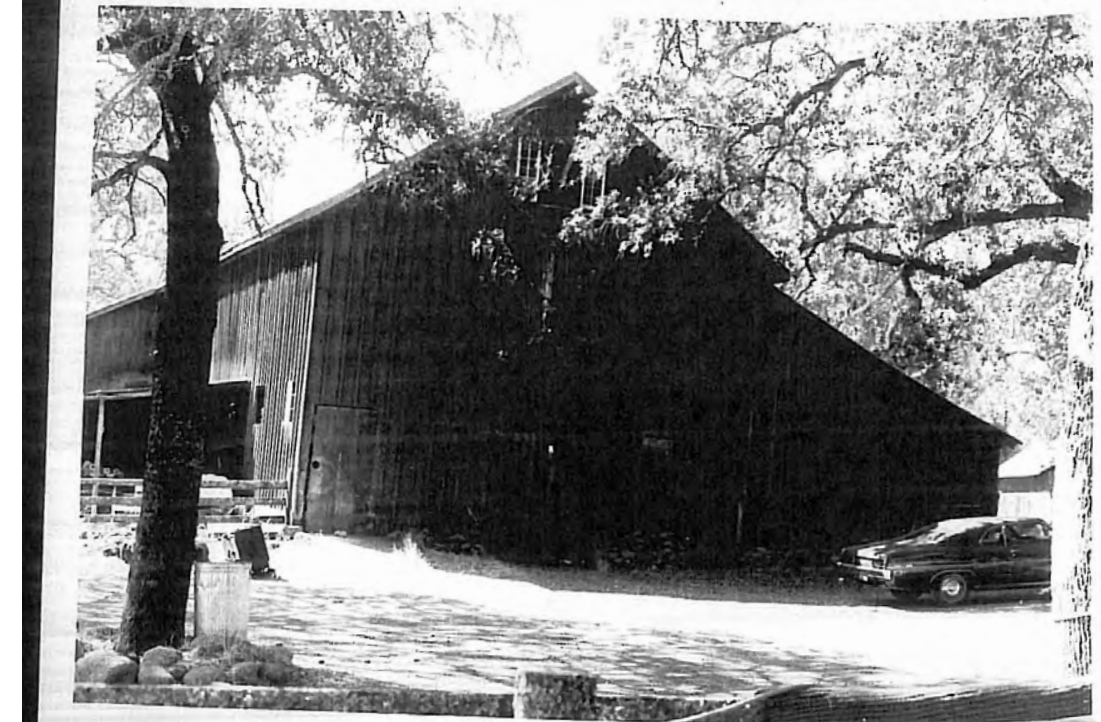
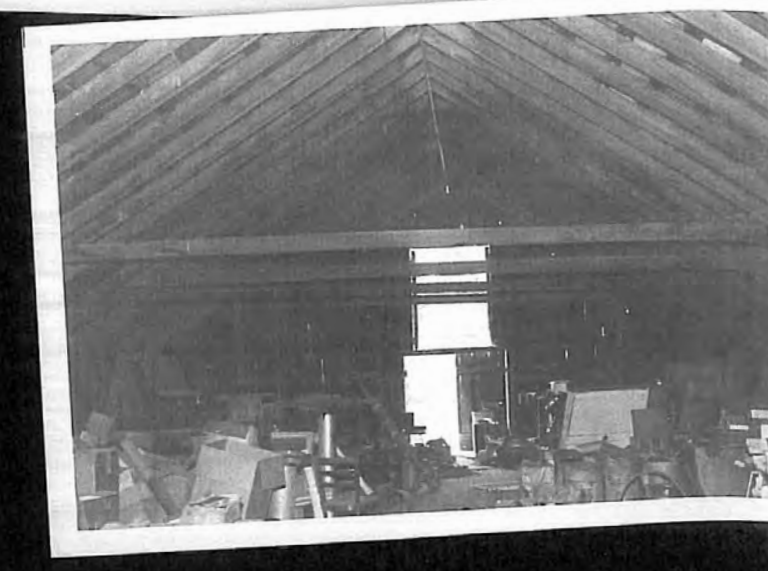
Top - #10 - Barn, view from N, Photo #28 of 84 (Johnathan Brundrett photo, October 1983)

Bottom - #10 - Barn, interior, upper floor, Photo #29 of 84 (Johnathan Brundrett photo, October 1983)

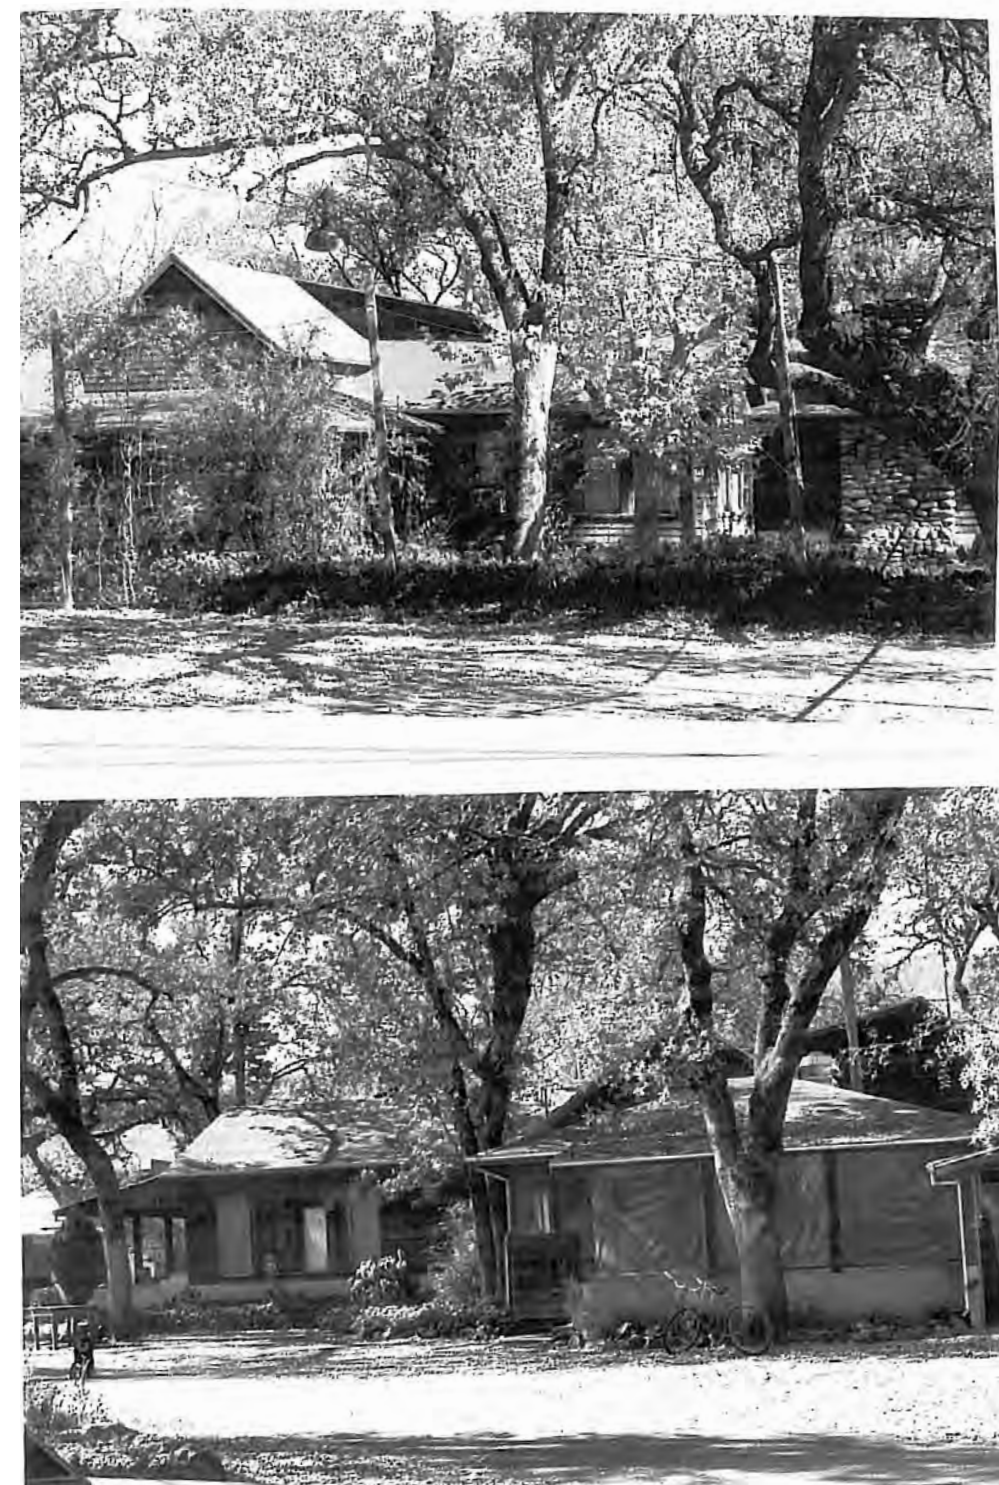
Top - Bldg. #11 - Main House, view from W, Photo #32 of 84 (Johnathan Brundrett photo, October 1983)

Bottom - Bldg. #11 - Main House, view from E, Photo #33 of 84 (Johnathan Brundrett photo, October 1983)

Building 11 – Main House*Foundations and Vertical Load Structure*

The first floor is located varyingly from at grade to approximately 18 inches above grade creating a crawl space. It appears that the original structure has been added onto, most notably a CMU (Concrete Masonry Unit) enclosed porch area to the rear of the building. We also noted an unfinished wood deck (no handrails)

The exterior shear walls are marginally attached to the foundations.

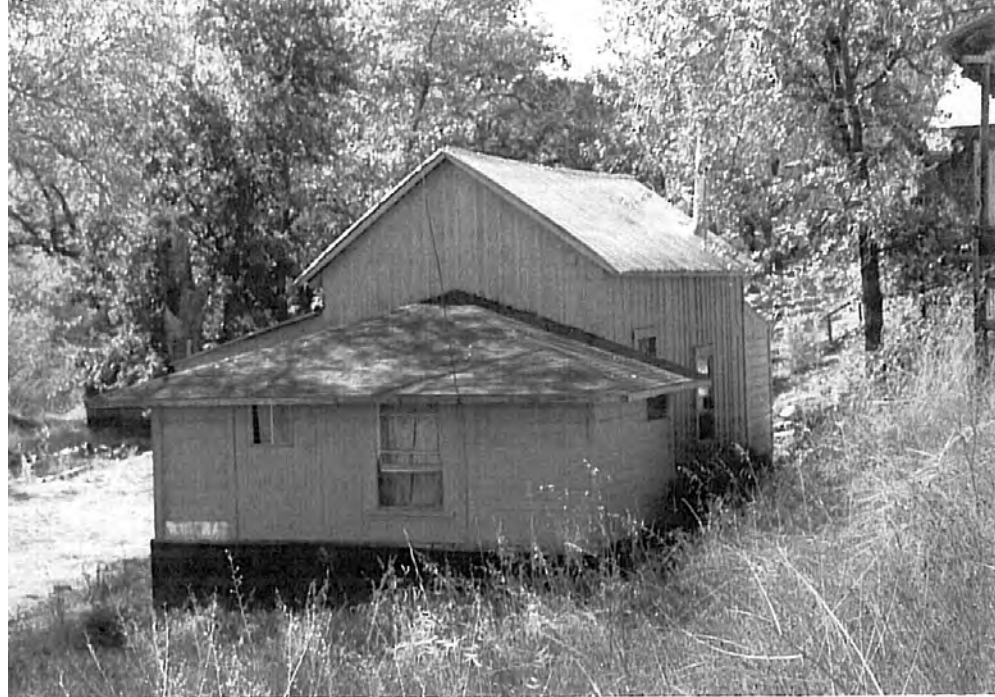
Bldg. #12 - Cottage, view from E, Photo #34 of 84 (Johnathan Brundrett photo, October 1983)

Building 12 – Cottage*Foundations and Vertical Load Structure*

The first floor is located approximately at grade. It appears that the original structure may have been added unto. We noted areas of ground faulting with apparent wood deterioration.

The exterior shear walls are likely only marginally attached to the foundations.

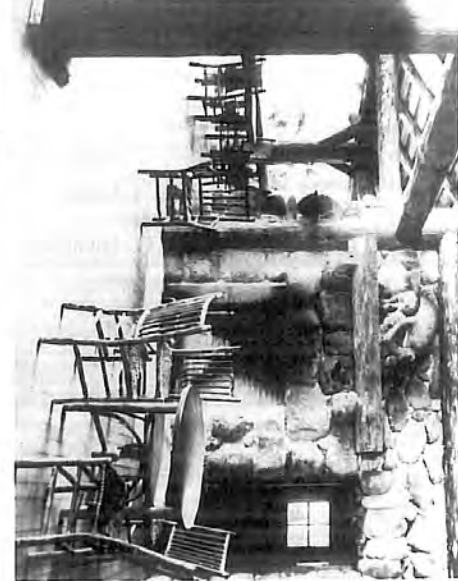
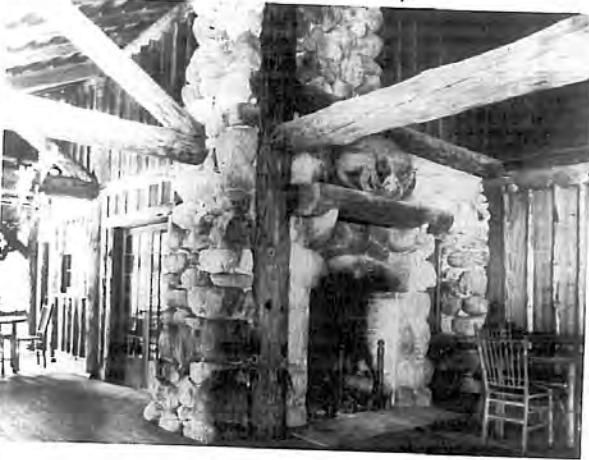
Top L - Bldg. #3 - Soda Fountain, Photo #21 of 84 (historic photo, date unknown)

Middle R - Bldg. #3 - Soda Fountain, Photo #20 of 84 (historic photo, date unknown)

Building 3 - Soda Fountain*Foundations and Vertical Load Structure*

Within the crawl space area, the interior posts appear to be variously supported on concrete, wood and stone pier blocks. The pier blocks are not connected and thus have no lateral restraint. We noted numerous areas of ground faulting with extensive wood deterioration, making portions of the elevated structure unsafe.

We also noted a monumental stone fireplace, the construction details of which are not known.

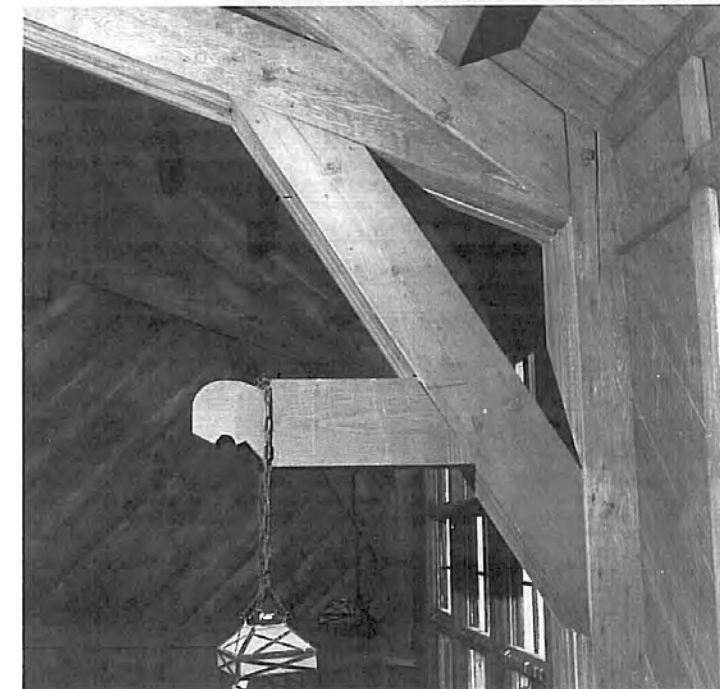
Bottom - Bldg. #1 - Dining Hall, detail - bracket and lamp, Photo #6 of 84 (J. Brundrett photo, October 1983)

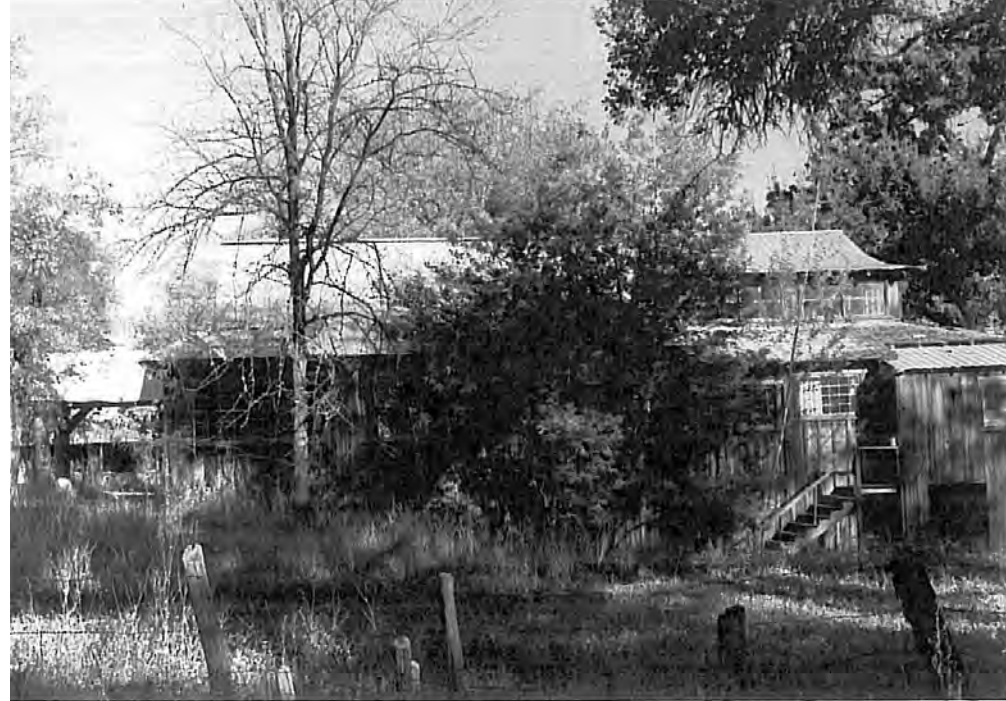
Top - Bldg. #3 - Soda Fountain, view from W, Photo #18 of 84 (Johnathan Brundrett photo, October 1983)

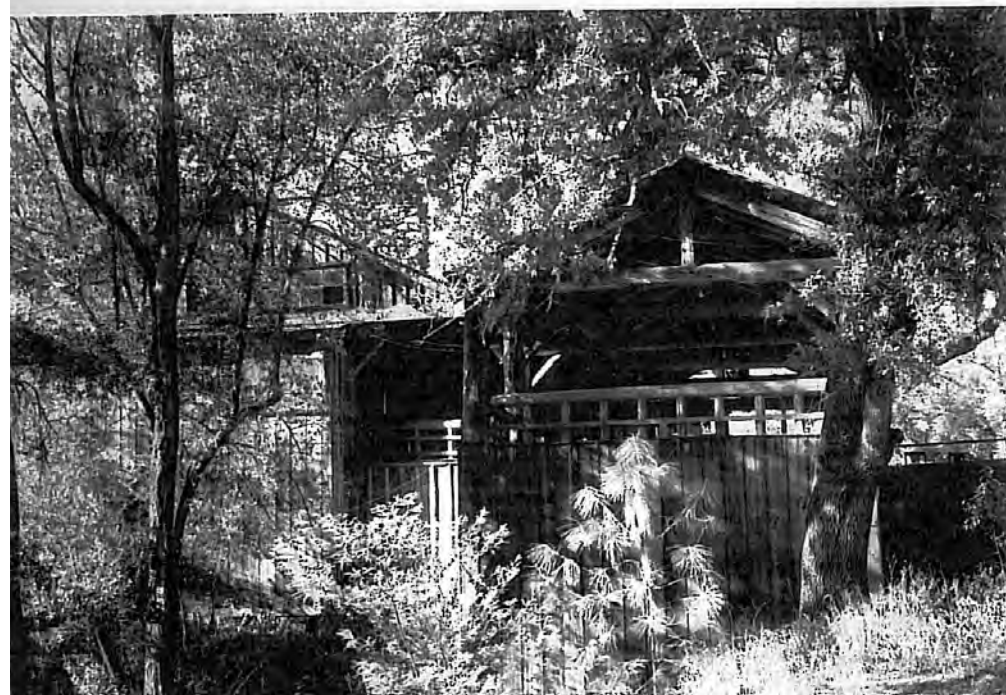
Bottom - Bldg. #3 - Soda Fountain, view from S, Photo #19 of 84 (Johnathan Brundrett photo, October 1983)

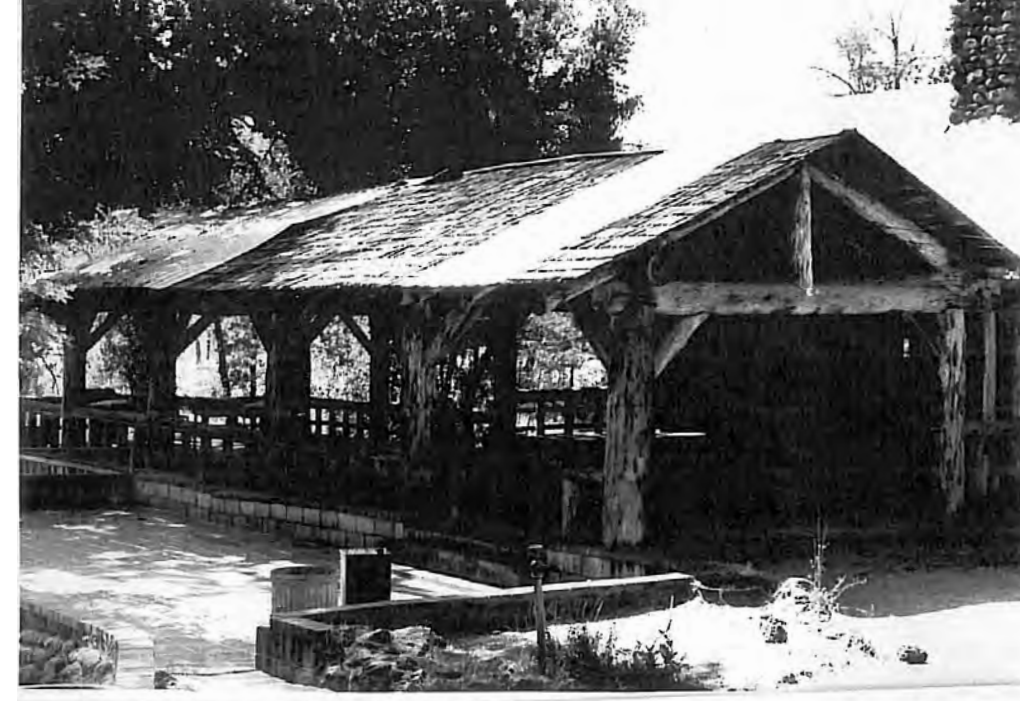
Top - Bldg. #3 - Soda Fountain, vew of log pavilion from NE, Photo #17 of 84 (Jo. Brundrett photo, Oct. 1983)

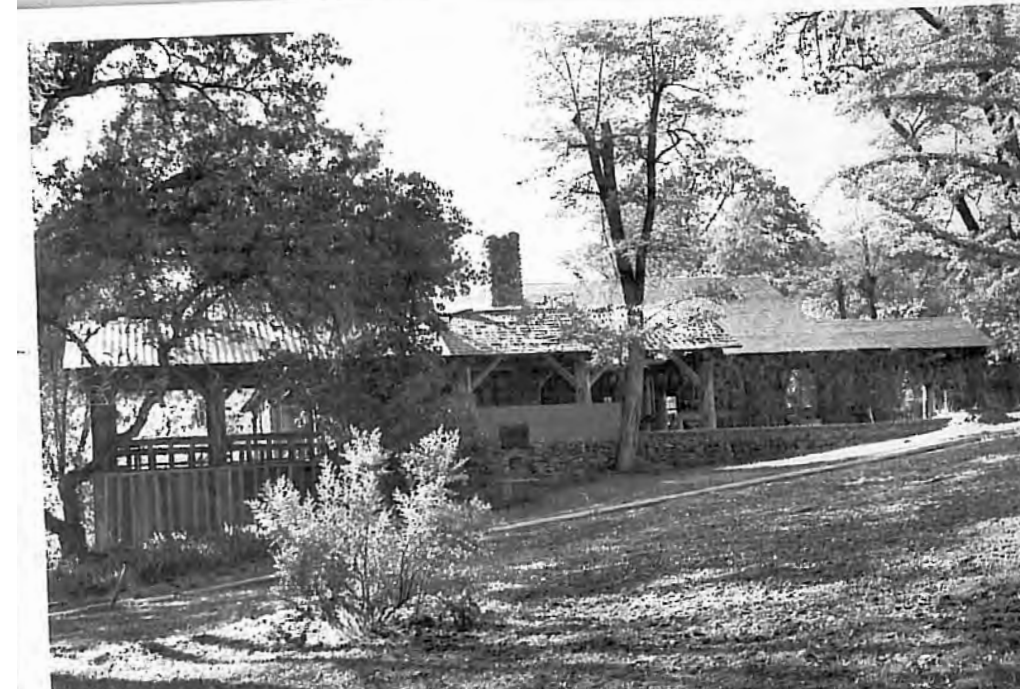
Bottom - Bldg. #3 - Soda Fountain, view from E, Photo #16 of 84 (Johnathan Brundrett photo, October 1983)
