Condor Project No. 6500

Subject: Data and Feasibility Report Wine Cave – Mountain Peak Vineyards 3265 Soda Canyon Road Napa, California

This report presents subsurface data and conclusions by Condor Earth Technologies, Inc. (Condor) for the proposed wine cave at Mountain Peak Vineyards. We performed our work to develop preliminary conclusions regarding subsurface conditions and geotechnical issues for design and construction of the cave. A primary purpose of this report is to provide a basis for Cave Contractor proposals. Condor prepared this report in accordance with our July 3, 2013 Proposal.

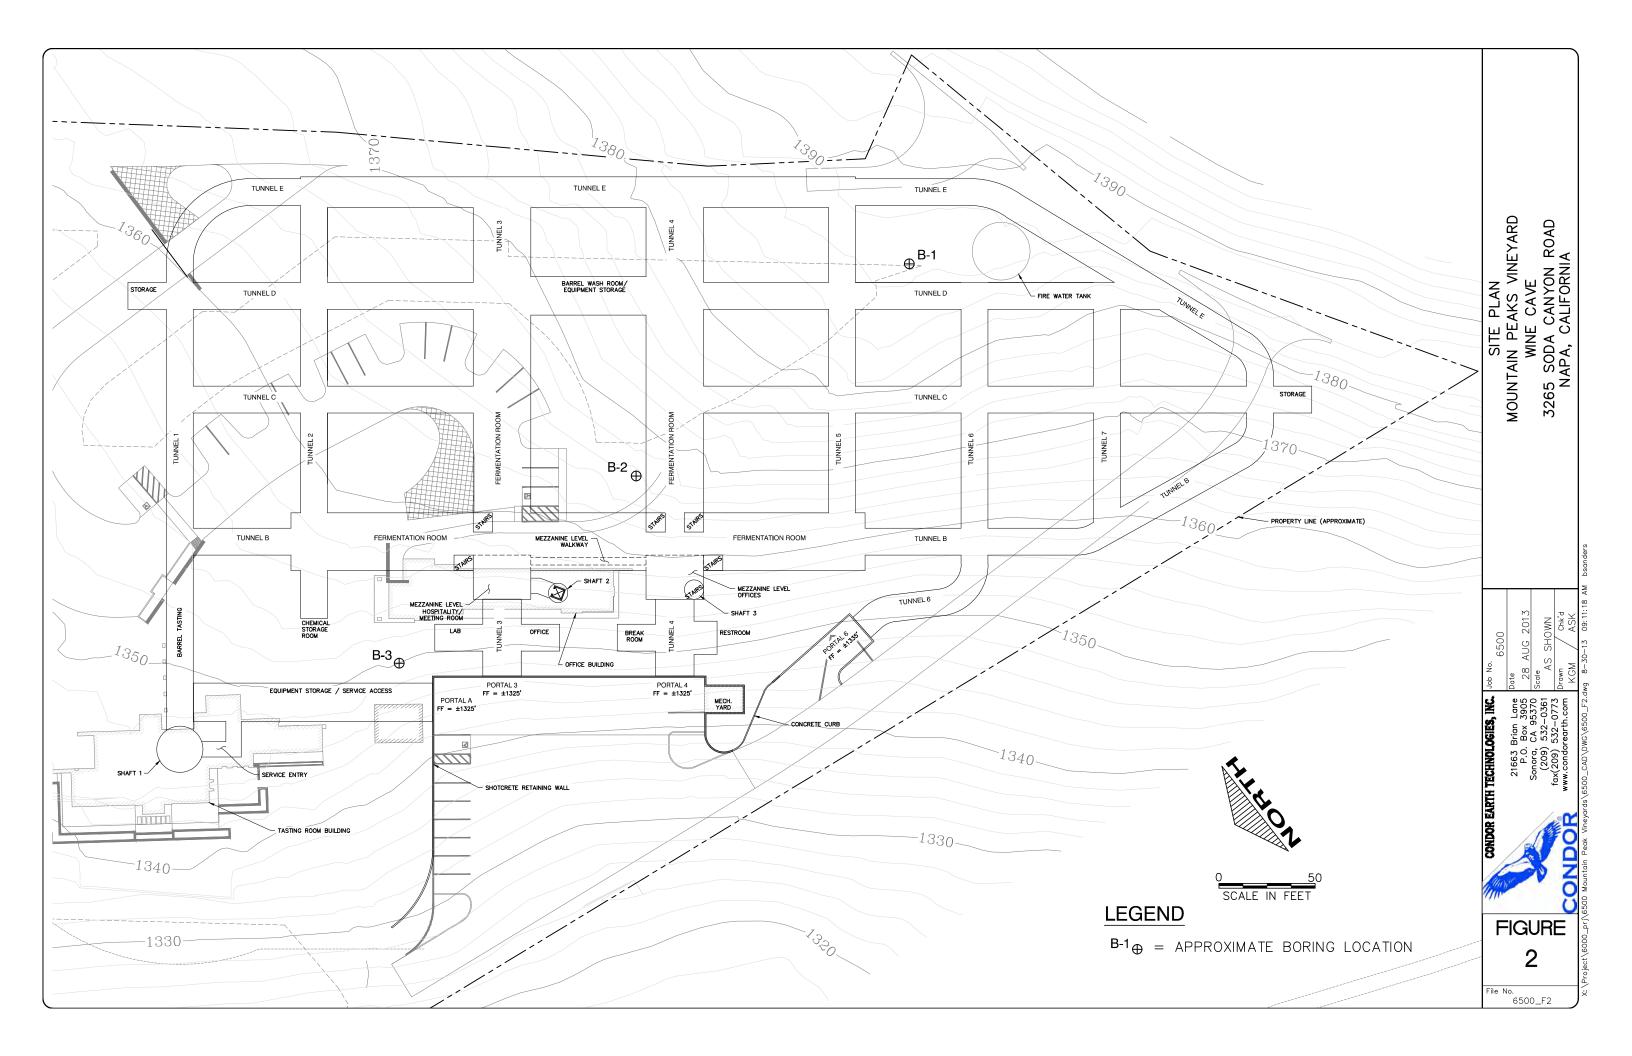
Figure 2 shows the proposed cave and buildings. The project will include construction of a wine cave with shotcrete retaining walls at portals, a tasting room building, an office building, a fire water tank, and other exterior improvements.

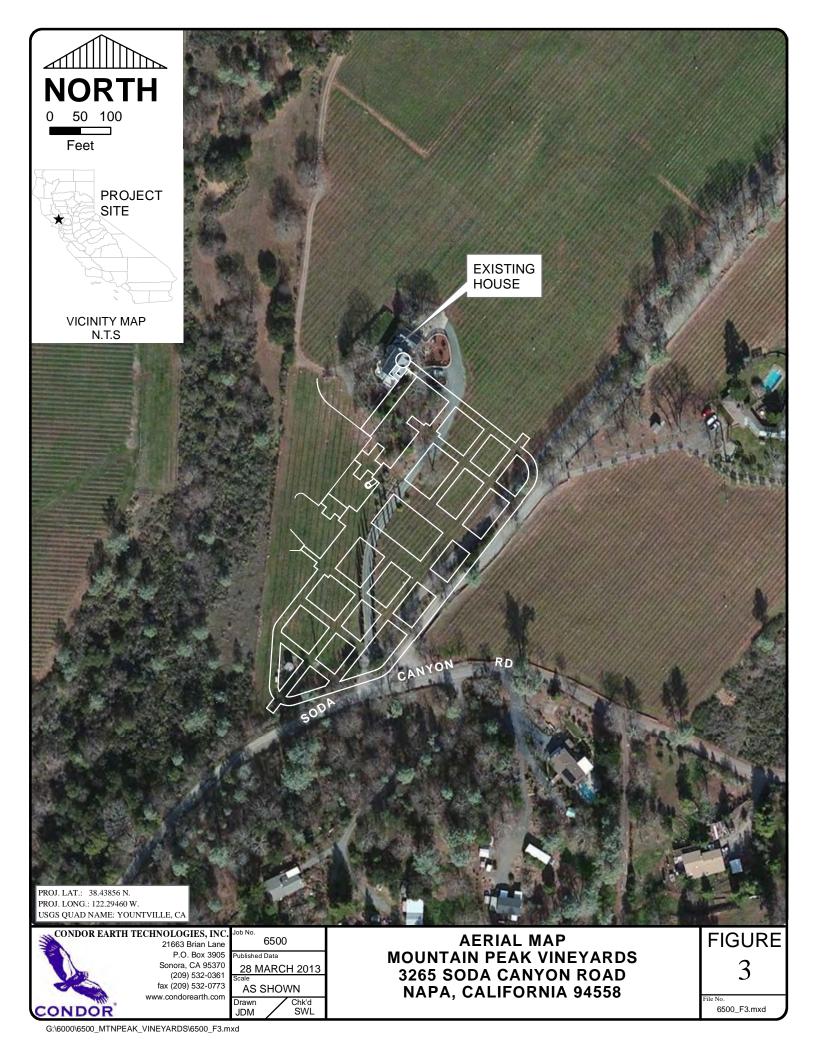
Figure 3 shows the approximate locations of the proposed wine cave elements on an aerial photograph. The cave will be constructed below a hillside that slopes moderately northwesterly. There is an existing house at the site that will be removed for construction of the proposed tasting room building. There are trees around the house, a driveway to the house and vineyard roads at the site. Otherwise, the site is occupied by existing vineyards.

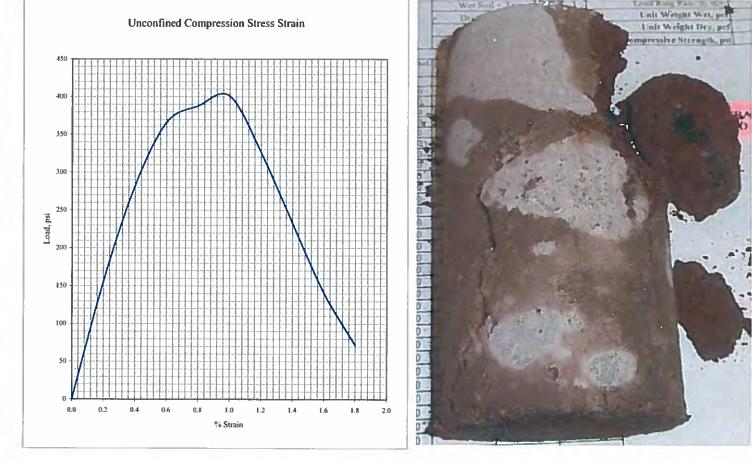
Sample ID.	Sample Location	Diameter, in.	Height, in.	Wet Unit Weight, pcf	Dry Unit Weight, pcf	Moisture Content, %	Unconfined Compressive Strength, psi
B-1		2.40	5.0	136.2	128.8	5.7	401

Elastic Modulus* (psi): 6.767E+04 * using Secant Modulus Method

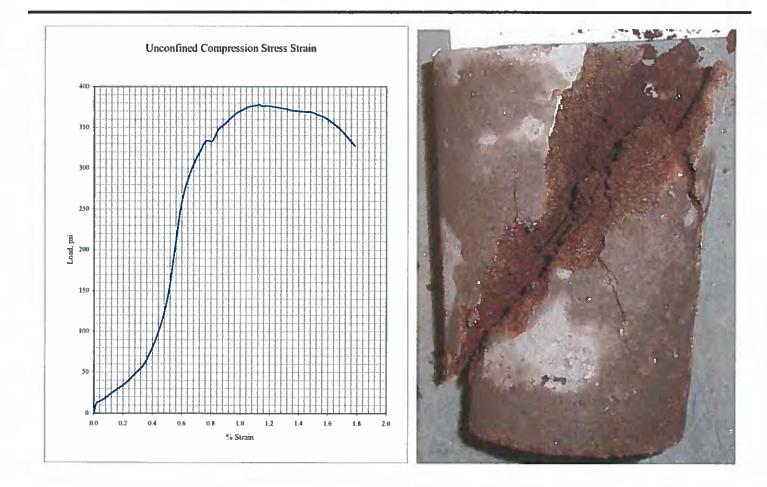
Sample ID.	Sample Location	Diameter, in.	Height, in.	Wet Unit Weight, pcf	Dry Unit Weight, pcf	Moisture Content, %	Unconfined Compressive Strength, psi
B-1		2.40	5.9	112.1	105.8	6.0	378

Elastic Modulus* (psi): 4.448E+04 *using Secant Method

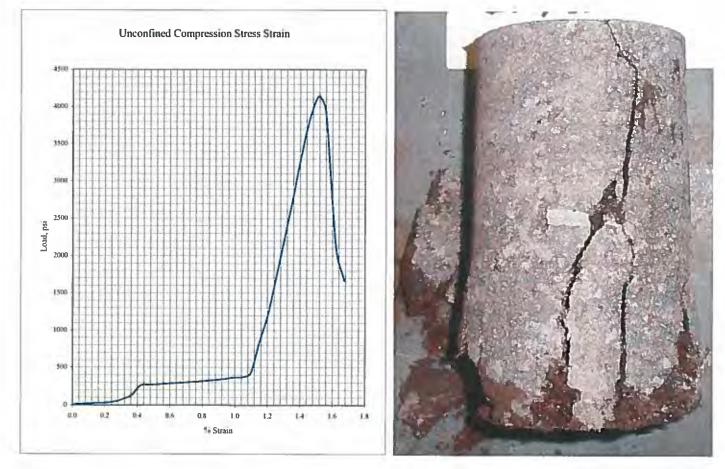
Sample ID.	Sample Location	Diameter, in.	Height, in.	Wet Unit Weight, pcf	Dry Unit Weight, pcf	Moisture Content, %	Unconfined Compressive Strength, psi
B-2		2.40	4.8	145.9	139.0	4.9	4144

Elastic Modulus* (psi): 2.241E+05 *using Secant Modulus Method

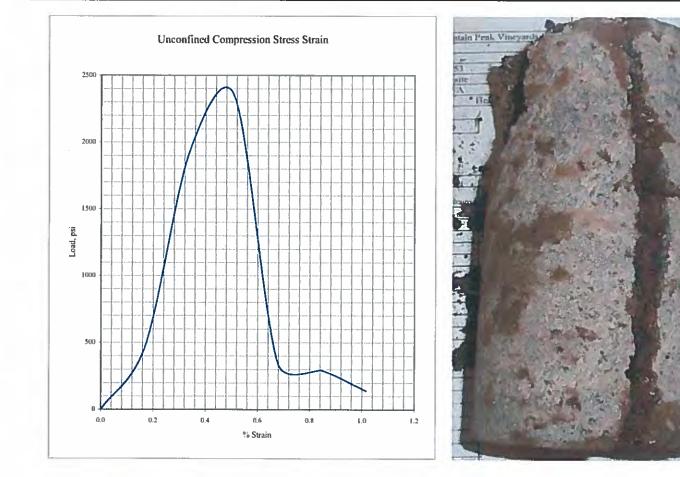
Sample ID.	Sample Location	Diameter, in.	Height, in.	Wet Unit Weight, pcf	Dry Unit Weight, pef	Moisture Content, %	Unconfined Compressive Strength, psi
B-2		2.40	5.9	117.5	113.0	4.0	2348

Elastic Modulus*(psi): 5.519E+05 *Using Secant Method

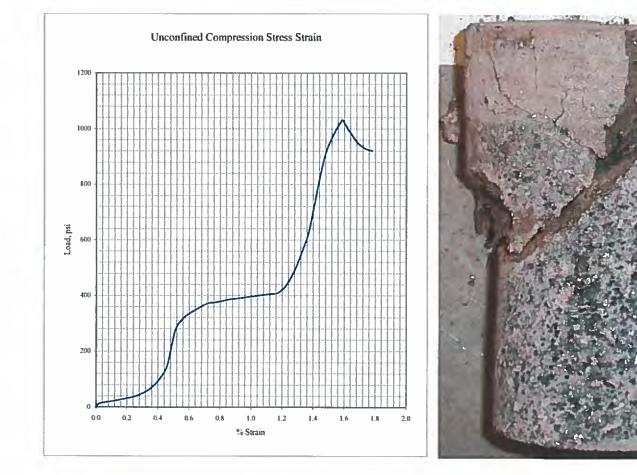
Sample ID.	Sample Location	Diameter, in.	Height, in.	Wet Unit Weight, pcf	Dry Unit Weight, pcf	Moisture Content, %	Unconfined Compressive Strength, psi
B-1		2.40	4.9	142.3	137.8	3.3	1031

Elastic Modulus*(psi): 5.428E+04 *Using Secant Modulus Method

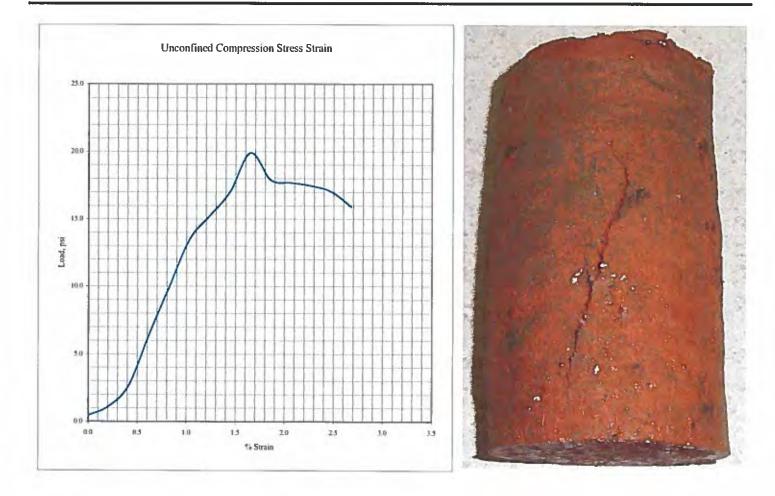
Sample ID.	Sample Location	Diameter, in.	Height, in.	Wet Unit Weight, pcf	Dry Unit Weight, pcf	Moisture Content, %	Unconfined Compressive Strength, psi
B-3		2.40	4.9	97.7	63.1	54.9	20

Elastic Modulus (psi): 1.066E+03 *using Secant Modulus Method
