# CONDITION ASSESSMENT AND IMPROVEMENT FEASIBILITY EVALUATION

# MILLIKEN CREEK BRIDGE AT TRANCAS STREET

BRIDGE No. 21C0051

July 29, 2014

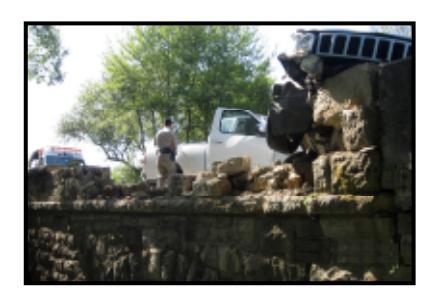
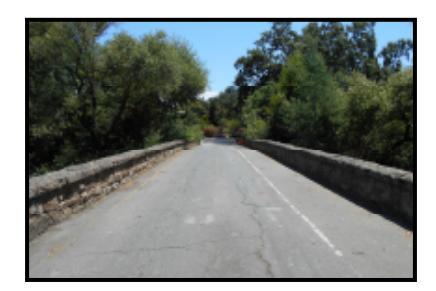
• The structural damage from the accident is limited to the railing and spandrel wall near the accident area at right side of the fifth arch of the southeast segment of the bridge. The stone arch supporting the vertical vehicular loading near the accident area appears to be unaffected.

- 1. **Railing & Spandrel Wall Repair Project** Only repair the damaged railing and spandrel wall with County funds. The estimated project cost is roughly \$500,000, 100% paid by County funds:

- The historic Milliken Creek Bridge will be rededicated for pedestrian and bicycle use only.
- The damage to the Milliken Creek Bridge railing and spandrel wall will be repaired. The repair must comply with the Secretary of Interior's Standards for Rehabilitation. The Milliken Creek Bridge repair is anticipated to be in-kind construction to minimize historical impact and maintain its historical significance.

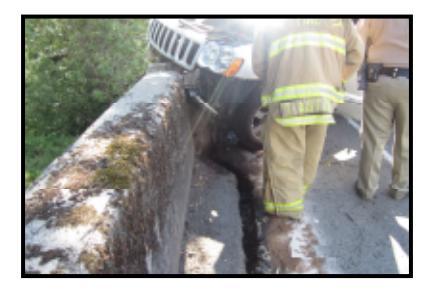
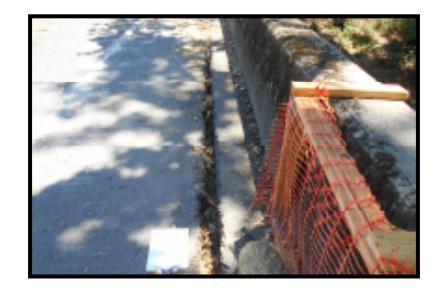
• Approximately 15 feet of the bridge railing beyond Span 5 on each side of the bridge appears to have been previously reconstructed with reinforced concrete. The reinforced concrete railing near the accident area was pushed a few inches away from the bridge deck.

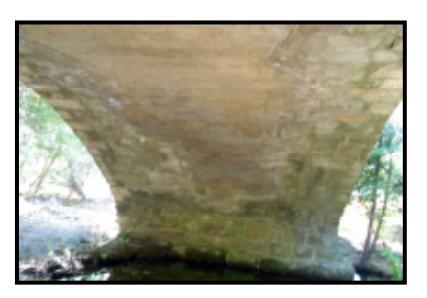
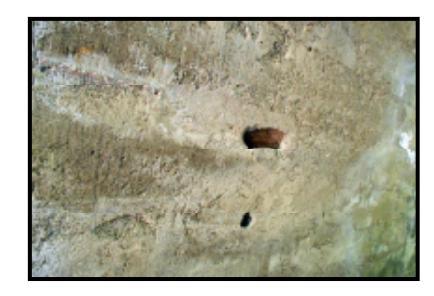
• There is a longitudinal crack and potholes in the mortar finish on the underside of the Spans 1 and 4 arches. These cracks appear to be superficial cracking of the mortar finish possibly due to minor settling of the stonemasonry arch after construction. The potholes also appear to be from poor quality control of the original construction.

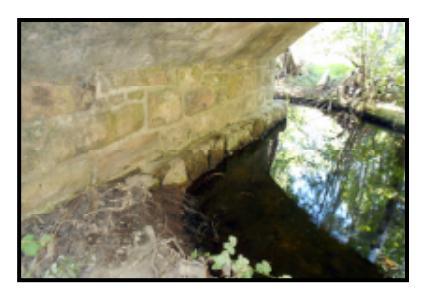
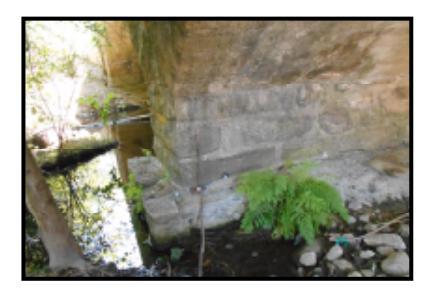
• Scour was observed at Piers 1, 2 and 4. The footing of Pier 4 is exposed on the Span 4 side for its entire length. Undermining of the footing was not observed.

- Mitigate the existing scour at Piers 1, 2 and 4 with the project improvements. The existing Scour Plan of Action inspections will no longer be required minimizing annual maintenance costs.

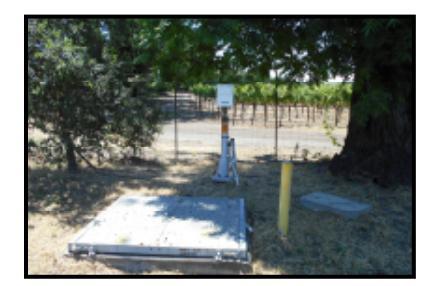
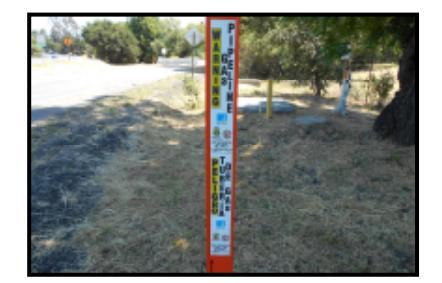
• There is an existing underground PG&E gas line along the south side of the bridge that appears to run beneath the creek that may impact Alternatives 2 and 4.

- The adjacent PG&E gas line may need to be relocated.
- The bridge will not be FO anymore and will be removed from the EBL.
- This is a relatively complicated project alternative with potentially the longest project design schedule (up to several years) to clear the required environmental documents. Construction to fix the damaged railing and spandrel wall will be held-up (potentially years) until the project goes to construction.

- The adjacent PG&E gas line may need to be relocated.
- This is a relatively complicated project alternative with a relatively long project design schedule.

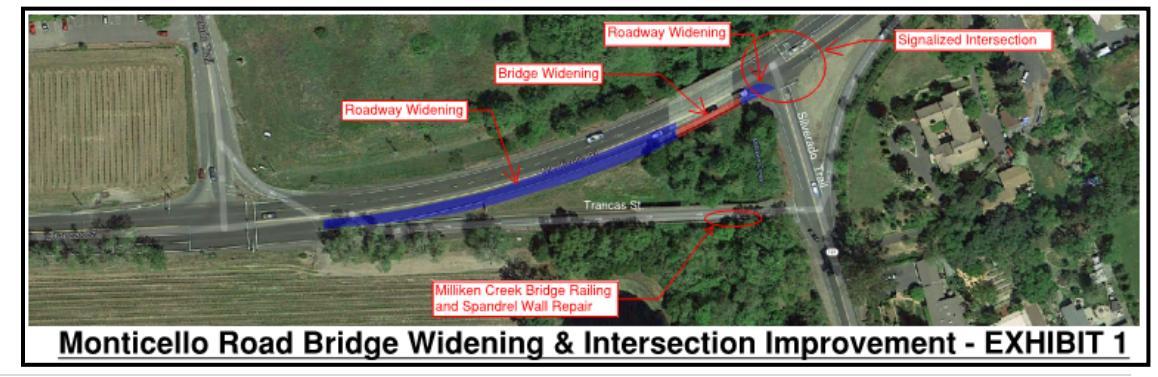
- To accommodate the additional ADT on Monticello Road after closing Trancas Street Bridge to vehicular traffic, two EB lanes on the segment of Monticello Road between the Silverado Trail intersections is anticipated to be required. This alternative would also need to include the widening of Monticello Road Bridge and potentially signalization of the South Silverado Trail intersection.
