Planning, Building & Environmental Services

<u>Subject:</u> Napa County LEA Response to Clover Flat Resource Recovery Park submitted "Erosion Control, Storm Water Management Leachate Management Plan" per Notice and Order No. EA-2019-01

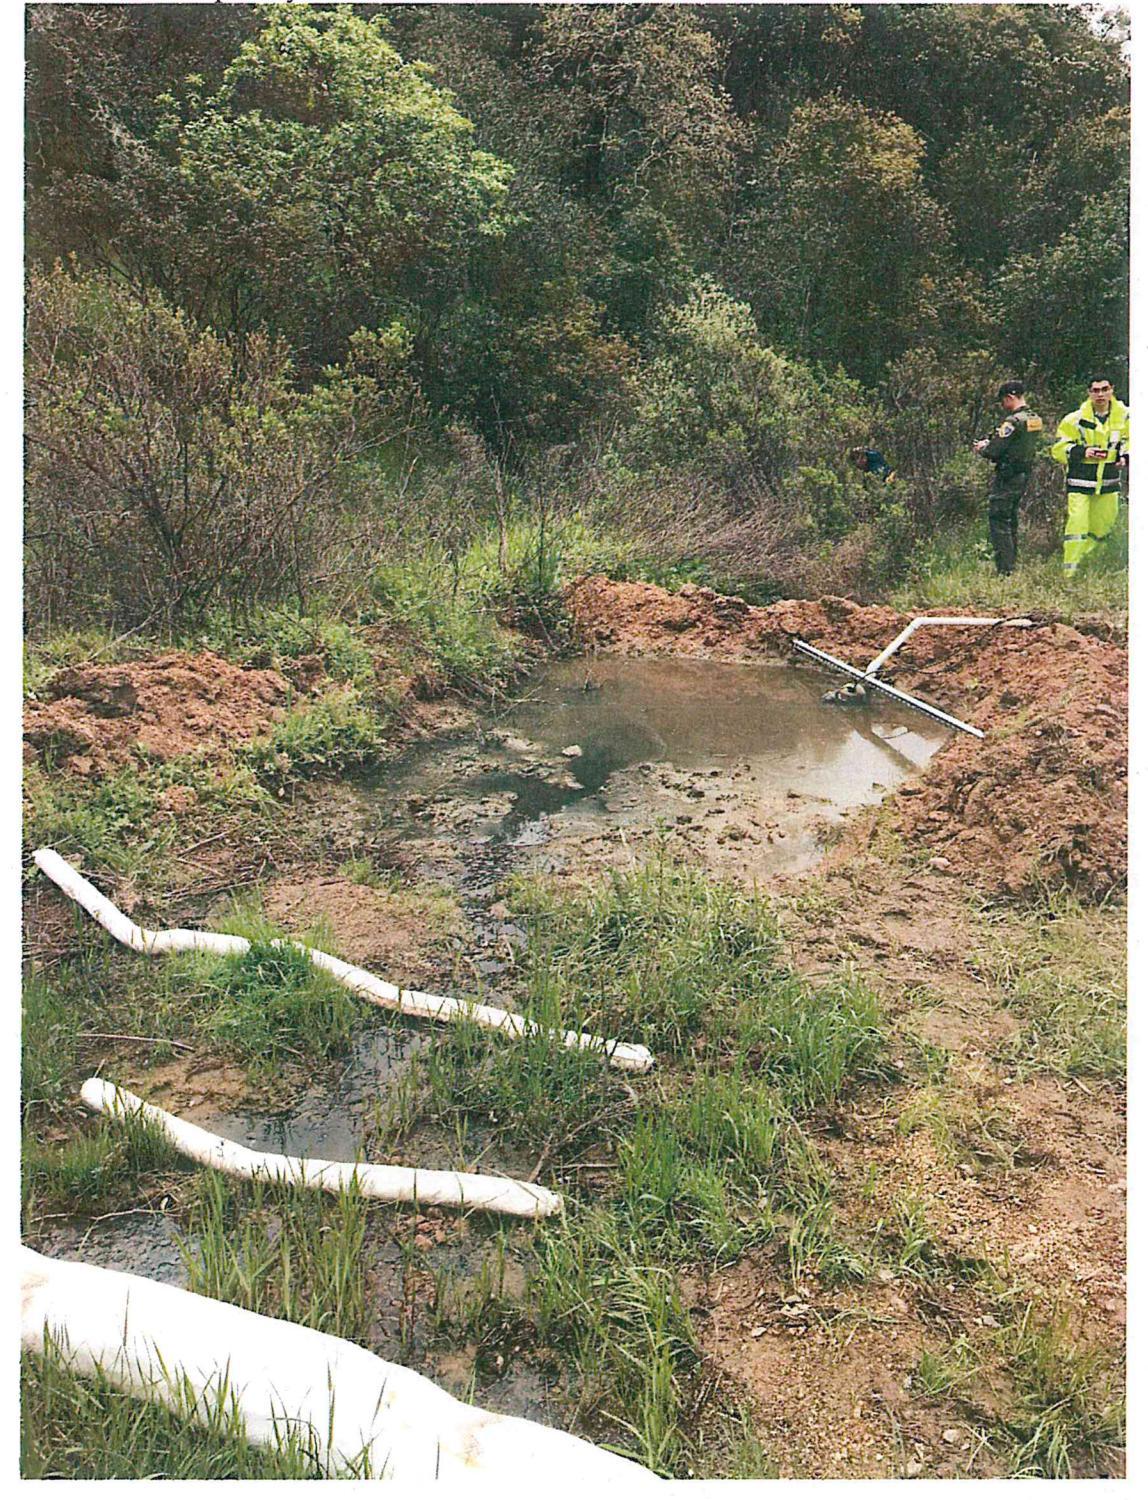
On April 2, 2019, the Napa County LEA observed black oily water and leachate actively entering the creek. CFRRP had excavated a shallow bermed collection basin and installed a sump pump with float to

pump collected contaminated water into a temporary collection tank, which was to then pump the water uphill to existing storage tanks. (See photo "Exhibit 1.") From the time between approximately 11 a.m. to 2:30 p.m. on April 2, 2019, based on flow meter readings out of the temporary tank and tank level gauge indicator on the tank, it appeared that no water had been pumped into the tank from the bermed collection basin. Additionally, contaminated water was observed to be flowing freely around the bermed collection basin and based on the fact that no water had been pumped, through the bermed soil into the creek representing a potential public exposure hazard. (See photos "Exhibit 2, 3, 4, & 5") As of approximately 3:30 p.m., CFRRP had proposed to line the collection basin with an impermeable liner, but the actual installation timeframe for the liner was unknown. Thus, CFRRP has not complied with the corrective action by the deadline required in the Notice, Corrective Action 2(a).

Exhibit 1 - temporary collection basin 4-2-19

As ordered by the Notice, the LEA requires that CFRRP immediately develop and implement functional measures to fully capture and collect contaminated water from entering the creek.

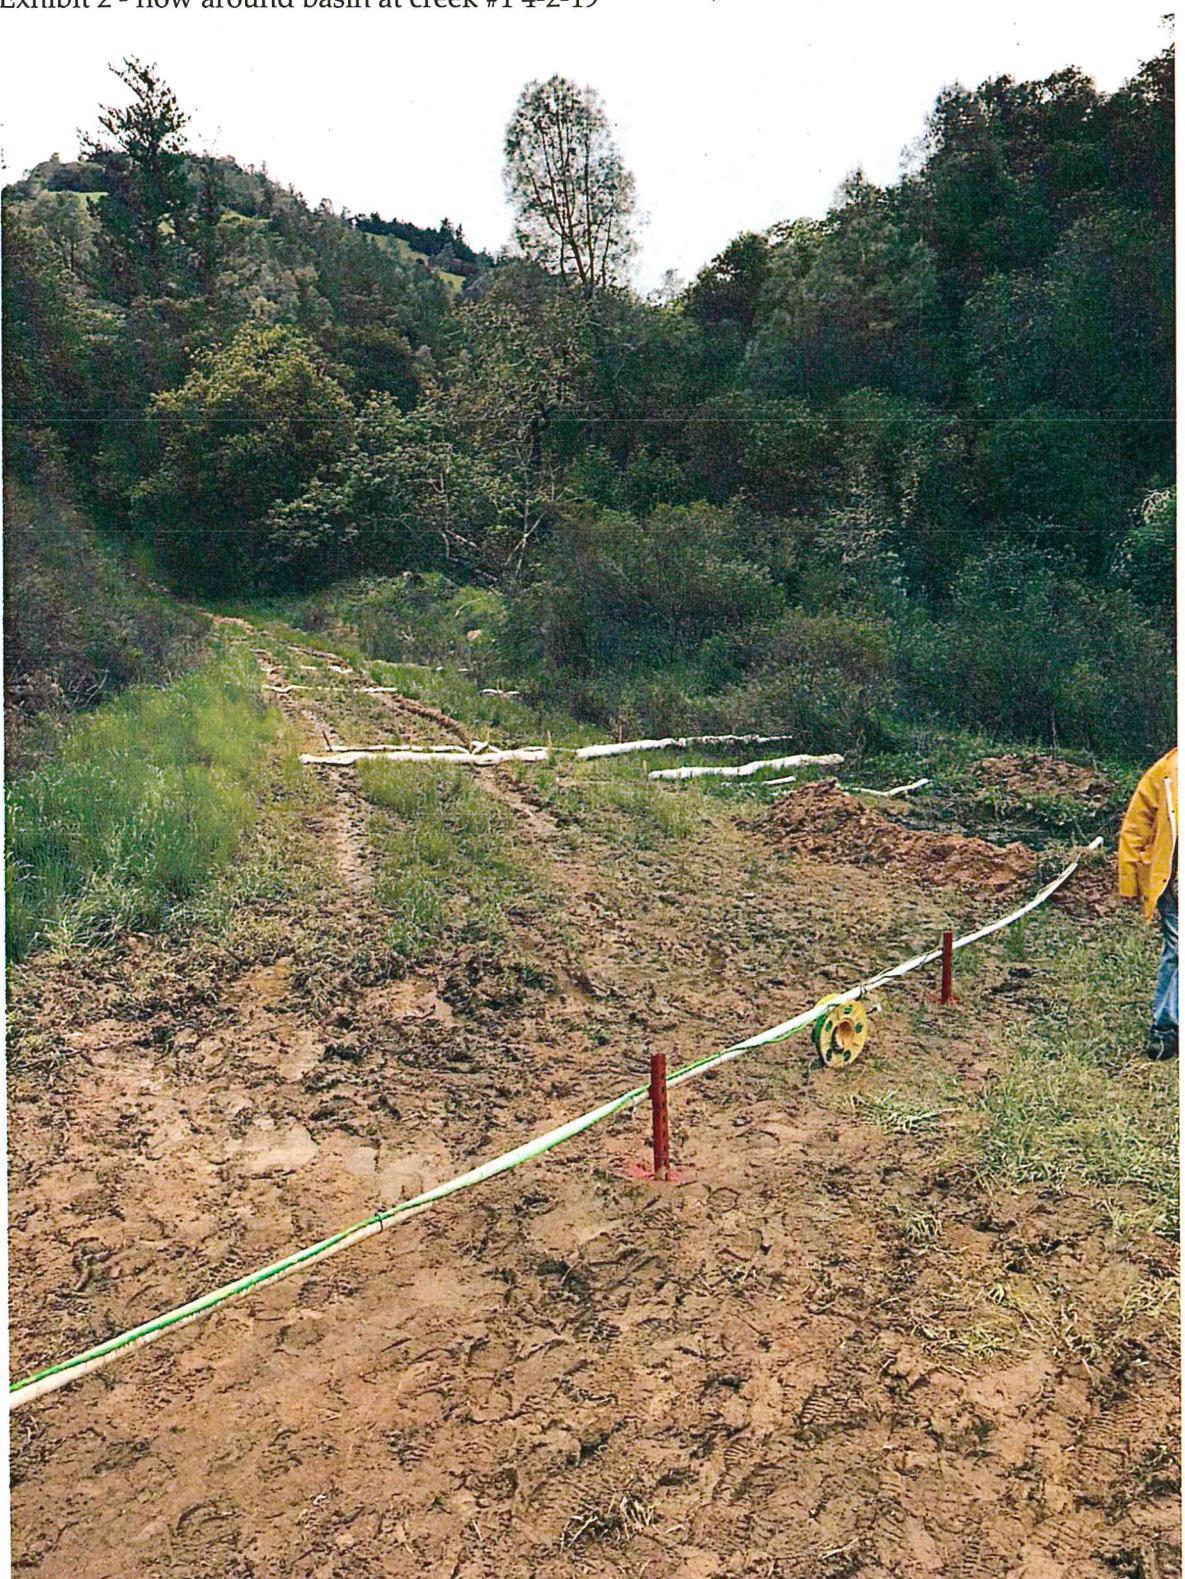
Exhibit 2 - flow around basin at creek #1 4-2-19

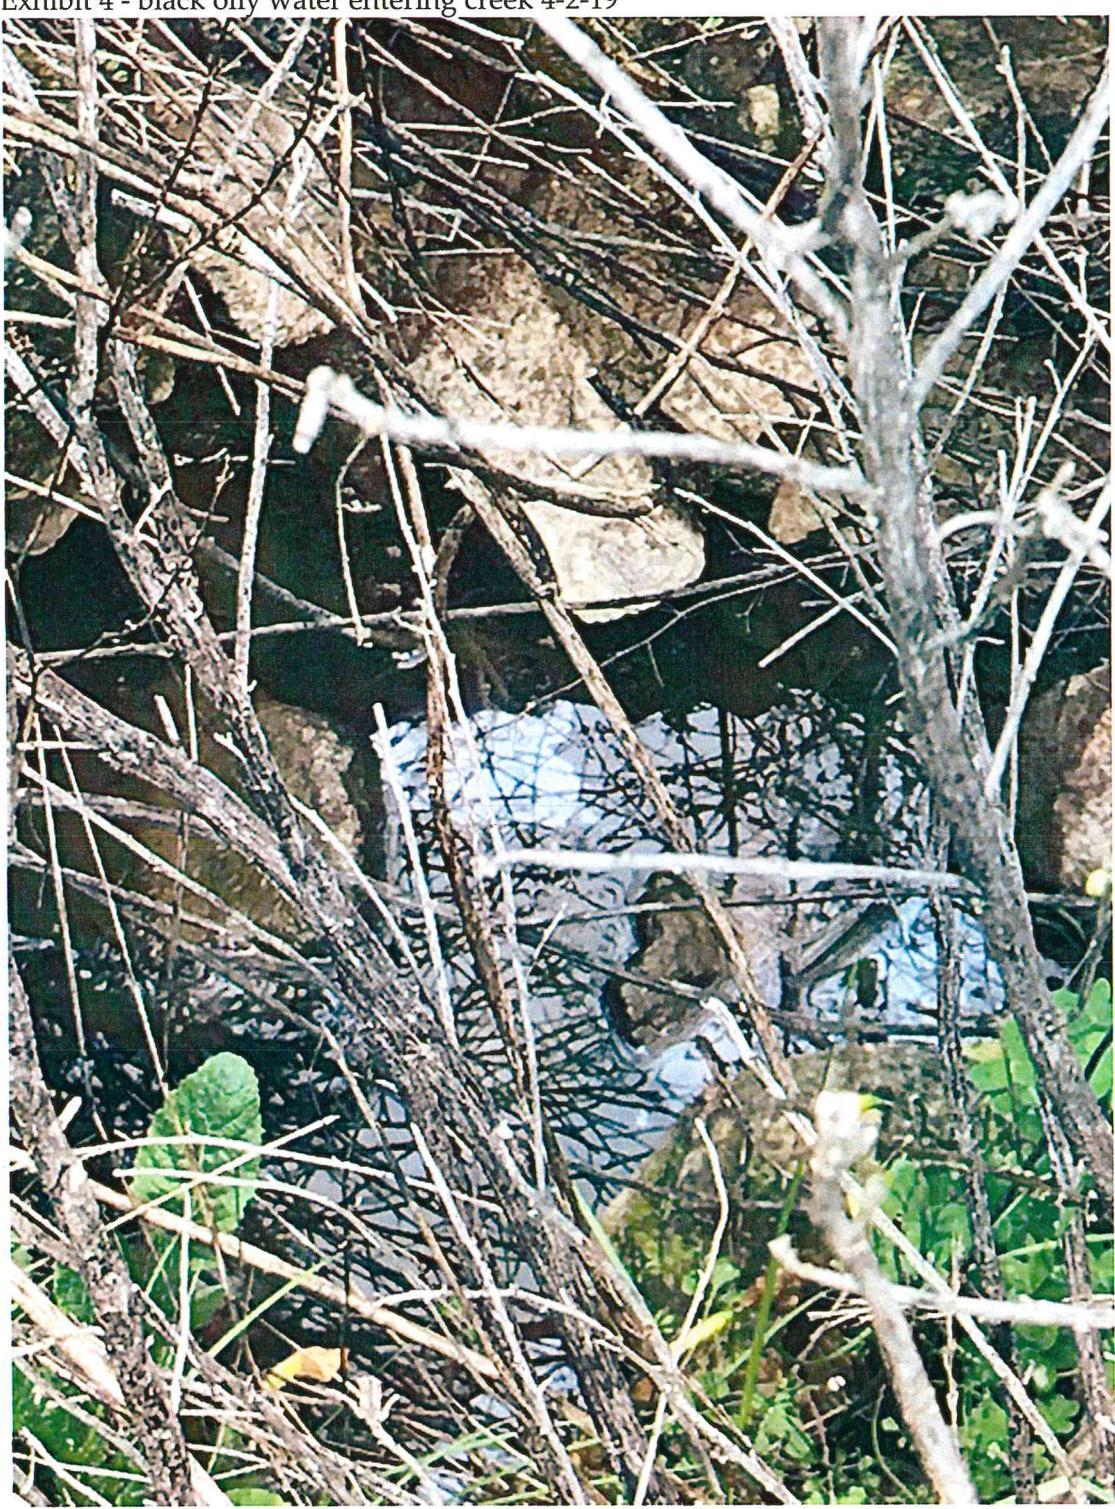
Exhibit 3 - flow around basin at creek #2 4-2-19

Exhibit 4 - black oily water entering creek 4-2-19

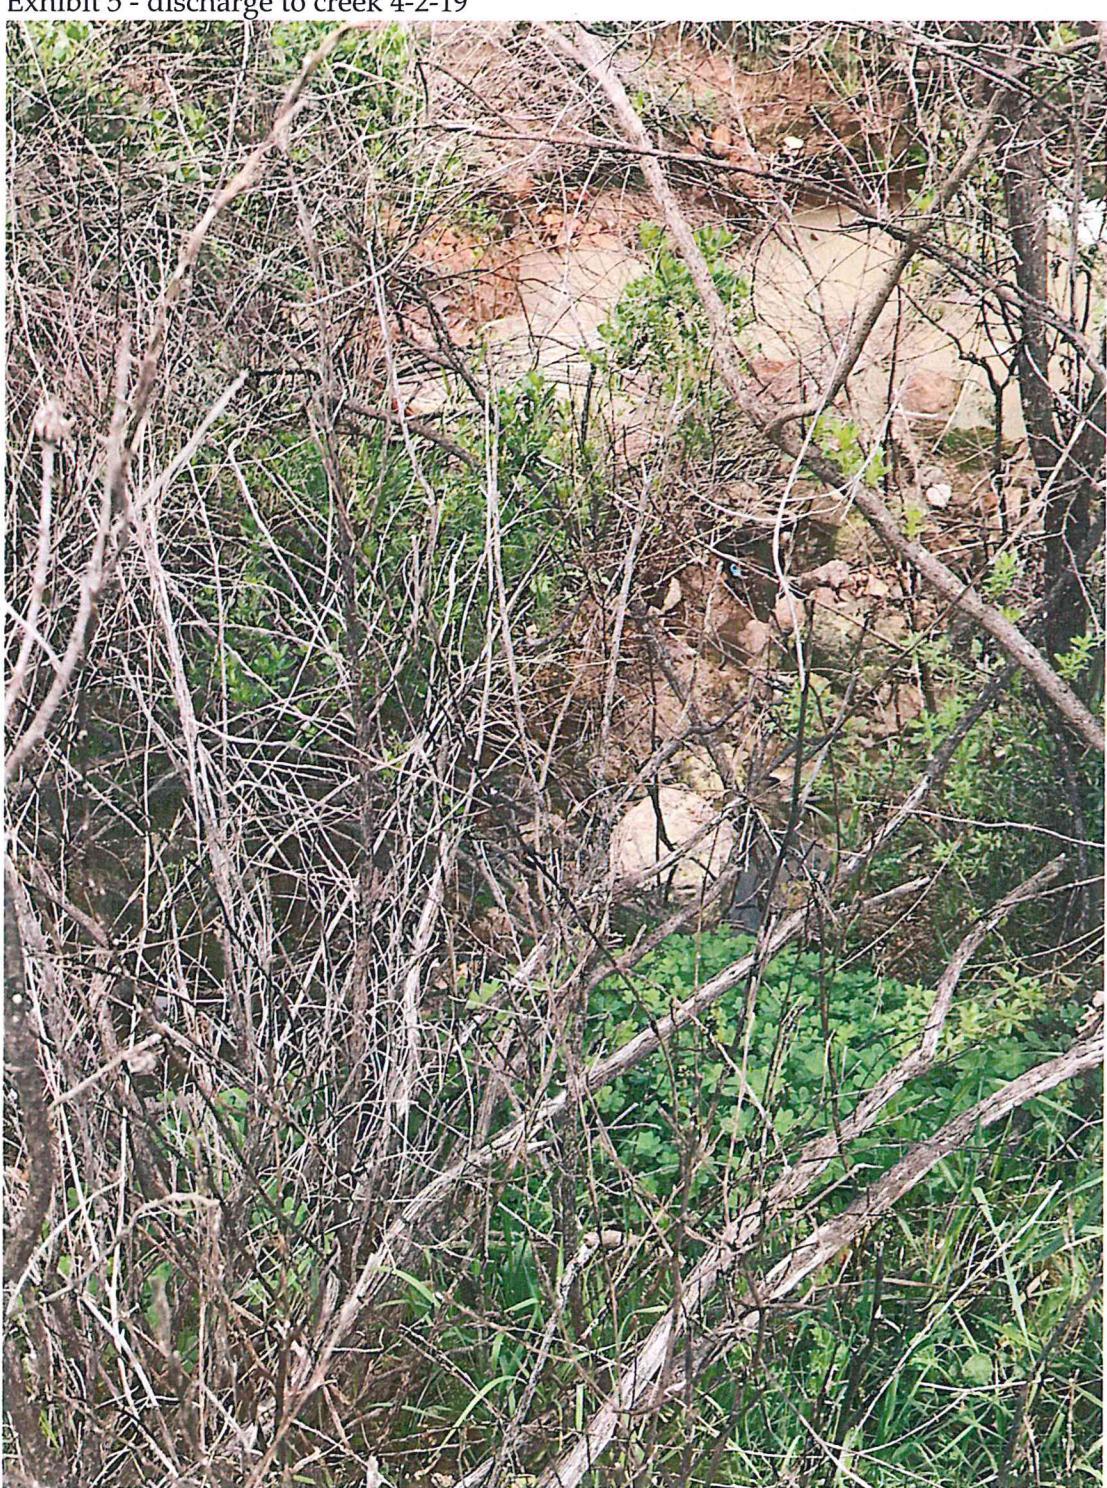
Exhibit 5 - discharge to creek 4-2-19

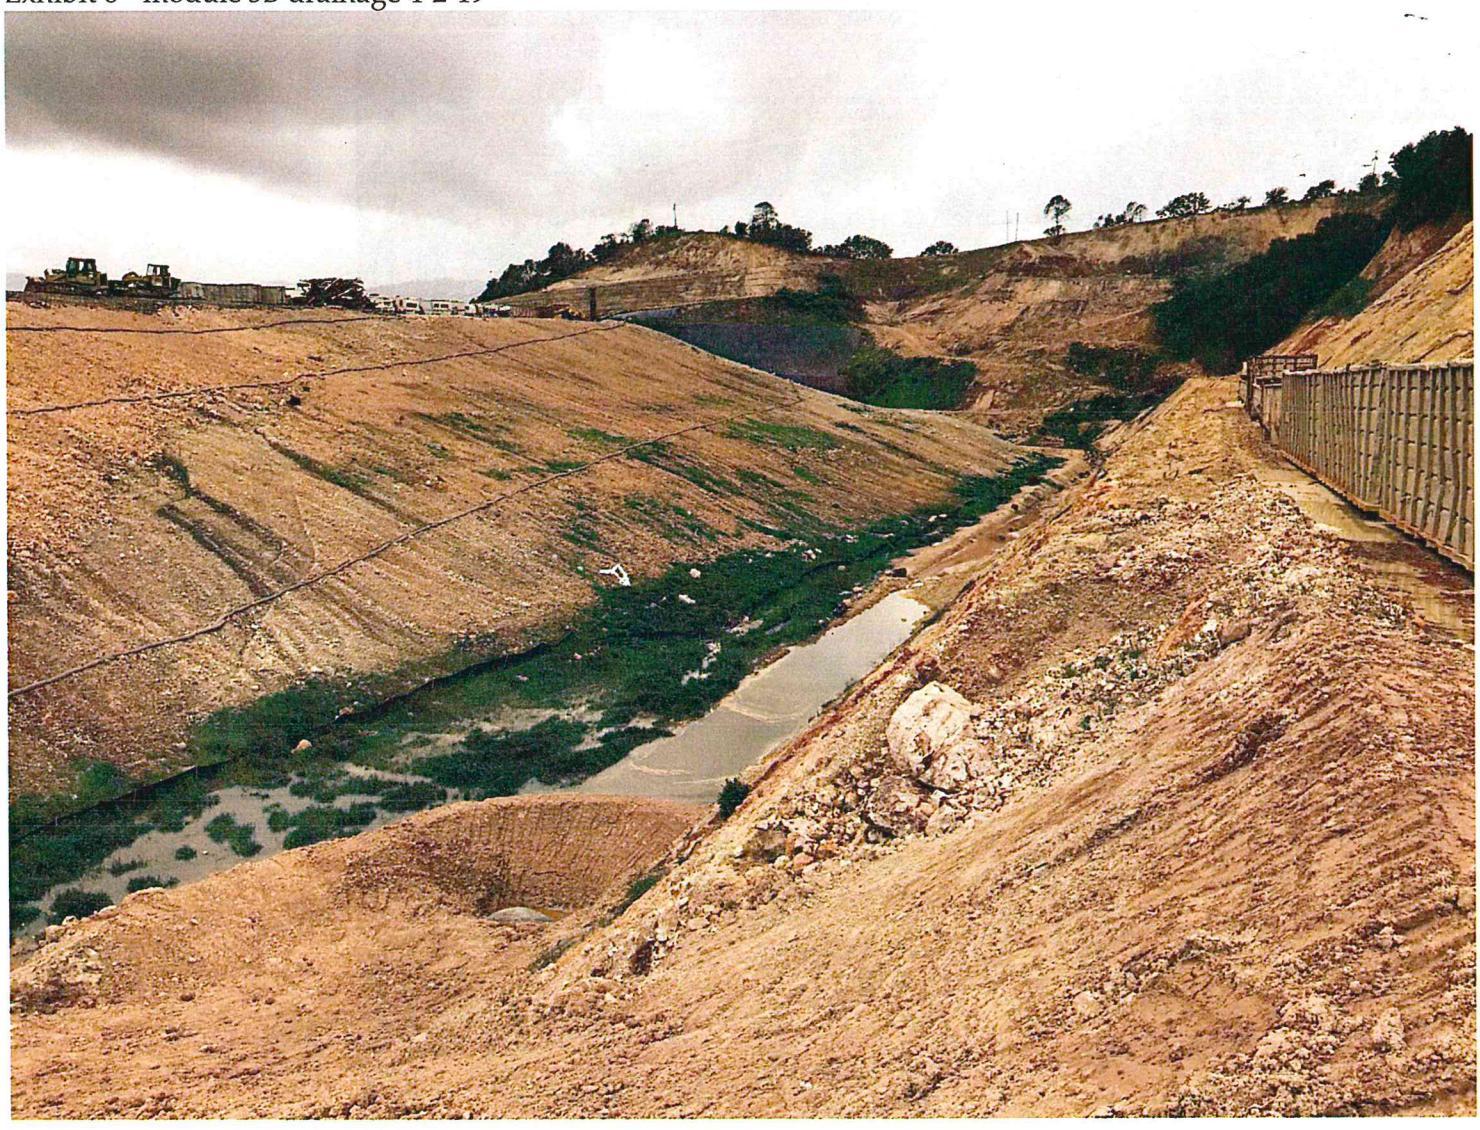
On April 2, 2019, the Napa County LEA observed that the Module 5B drainage storage area drain has been plugged with concrete and that this area is actively filling with storm water comingled with leachate. (See photo "Exhibit 6") The LEA is concerned that the existing "dam" which separates this area from the creek below has not been evaluated for its integrity. The LEA is also informed that as of April 2, 2019, EBMUD could not approve disposal of collected leachate based upon current water quality testing results. Thus, CFRRP has not complied with the Notice, Corrective Action 2(f).

Exhibit 6 - module 5B drainage 4-2-19

As ordered by the Notice, the LEA requires that CFRRP submit sufficient documentation to PBES, RWQCB, and CalRecycle demonstrating that the Module 5B drainage storage area is not only engineered to serve as a "water retention basin", but also provide documentation that addresses what potential negative impacts, if any, both the operation and potential failure of the basin may cause to the integrity of the landfill and leachate generation, collection, and storage infrastructure.
