Report  
Geotechnical Reconnaissance  
Planned New Winery  
APN: 031-100-031  
7554 St. Helena Highway  
Napa, California

Progress Report  
Geotechnical Investigation  
Planned Winery  
APN: 031-100-031  
7554 St. Helena Highway  
Napa, California

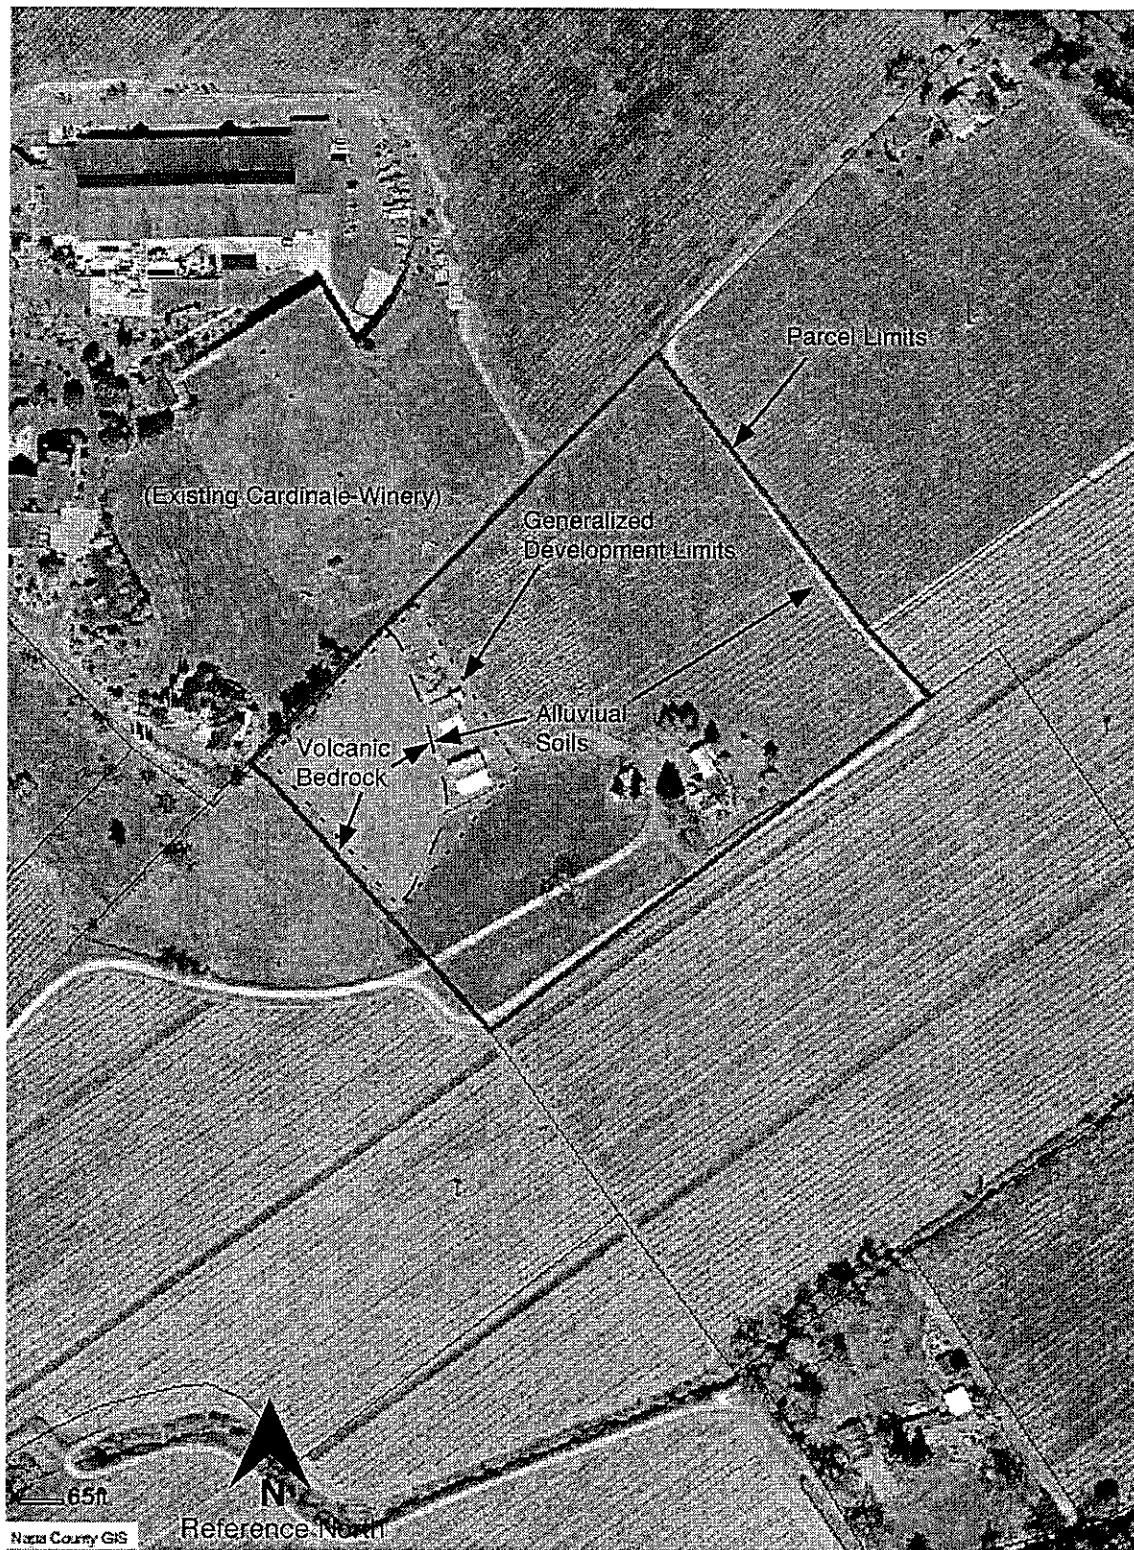
<b>BAUER ASSOCIATES</b>	Job No: 2595.0	<b>SITE PLAN</b>	PLATE <b>1</b>
GEOTECHNICAL CONSULTANTS	Date: 6/08  By: CLK

This report presents the results of our geotechnical reconnaissance for the subject project. We understand that a new winery is being planned at the northwest portion of the property, in the vicinity of the existing barns and the upslope area. A cut-and-cover structure is being considered as a potential development method. A site plan presented on Plate 1 indicates the generalized limits of the planned development.

The property is located about one mile southeast of the Highway 29 and Oakville Cross Road intersection. The northern property line adjoins the Cardinale Winery property. Most of the property is situated on the relatively level valley floor. The northwest corner of the property extends onto an isolated knoll that punctuates the valley floor. A copy of the Napa County GIS, indicating the property, referenced features, and generalized development area is presented on Plate 1.

The geologic maps reviewed indicate that the site is underlain by volcanic bedrock of the Sonoma Volcanics. Volcanic bedrock is exposed at several locations on the knoll as outcrops and is exposed within the test pits. The bedrock typically consists of hard, strong, and moderately weathered rhyolite and tuff. The exposures indicate that the bedrock is generally closely to moderately fractured. We understand that excavation refusal was encountered within the test pits that were excavated with a 'light-duty' farm tractor. At the valley floor, the bedrock is overlain by alluvium. The alluvial sediments are expected to vary, but often consist of lensing and interfingering units of clays, silt, sands, and gravels. The alluvium is expected to thicken away from the knoll. The estimated limits of the volcanic bedrock and alluvium is presented on Plate 1.
