Performance Measurement Report

Calendar Year 2018 Performance Measurements Using the "Effective Utility Management" Framework

Issue Date: February 20, 2019

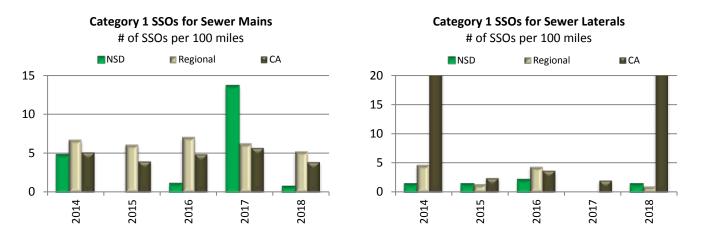
NapaSan's goal is to maintain the sewer collection system so that there are no SSOs. Especially important is to prevent overflows that reach a creek, river or other body of water, or overflows that reach a storm drain and were not fully recovered, both of which are considered "Category 1 SSOs". While the overall goal is to prevent all overflows, the operational goal of NapaSan is to have fewer overflows than the industry average in the San Francisco Bay Region and in California as a whole.

For 4 of the last 5 years, NapaSan performed better than the state and regional averages. In 2018, there were considerably fewer overflows than the prior year and compared to regional and state averages.

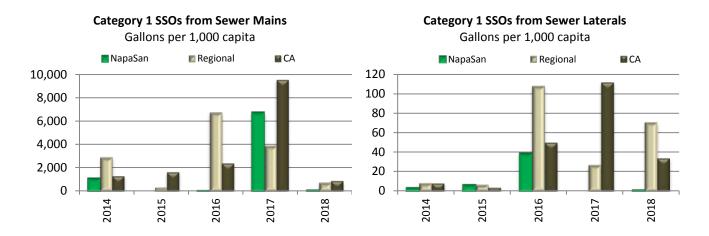
It is NapaSan's goal to prevent Sanitary Sewer Overflows. However, when an SSO occurs, the NapaSan strives to respond quickly to prevent as much spillage from reaching a body of water as possible. This measure is the volume (in gallons) of sewage spilled reaching surface water as a Category 1 SSO per 1,000 residents, and is compared to the San Francisco Bay Region and California statewide averages.

NapaSan has generally been very successful in keeping the amount of Category 1 sewage spilled per at levels significantly below the San Francisco Bay Region and California state averages. In 2018, there was an average 76 gallons overflowed (Category 1 from sewer mains) per 1,000 population, compared to about ten times that amount for the regional and California averages. For Category 1 overflows from laterals, NapaSan averaged just over 1 gallon per 1,000 population, compared to the regional average of over 70 gallons and the state average of over 33 gallons.

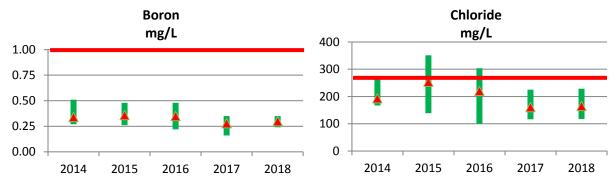
These are two measures of recycled water constituents, chloride and boron. In a study of the impact of NapaSan's recycled water on wine grapes, it was noted that while maximum chloride levels for most winegrape varietals have yet to be determined, it appears that the most sensitive species can tolerate up to 262 mg/L of chloride. It was also noted that boron tends to develop injury (i.e., foliar burn) when concentrations are above 1 mg/L. The maximum thresholds noted in the charts are based on these study findings.

Boron levels in NapaSan's recycled water historically have been below the levels generally considered harmful to winegrapes and other common foliage and turf irrigated by recycled water.

Chloride levels saw an upward trend from 2012 through 2015. Based on this trend, NapaSan staff took directed measures in the last four years to reduce chlorides in the recycled water. These efforts included emergency repairs of collection system pipes and manholes showing infiltration of saline groundwater, as well as proactive enforcement of BMPs and local limits compliance with commercial and industrial customers. These efforts seem to have made a difference in reversing the trend of increased chlorides, but the measure remains on the "watch" list as more efforts are necessary to continue a downward trend.

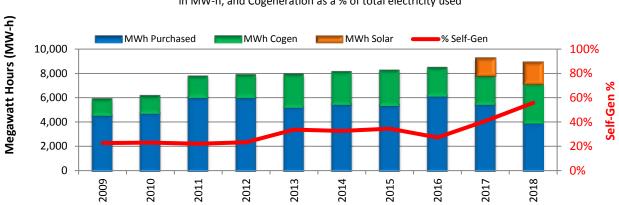
Electricity Consumed by Source in MW-h, and Cogeneration as a % of total electricity used

Electricity is one of the largest expenses in the treatment process. The treatment plant uses a cogeneration engine ("Cogen") powered by captured and compressed biogas gas to create electricity. The goal is to generate as much electricity as possible from the Cogen system, to offset purchased electricity. In 2016, the NapaSan's solar array completed constructed, but did not come on line until the end of March 2017. This chart shows the total megawatt hours of electricity purchased, electricity produced by cogeneration, electricity produced by solar, and the percentage of total electricity that was self-generated (cogen and solar).

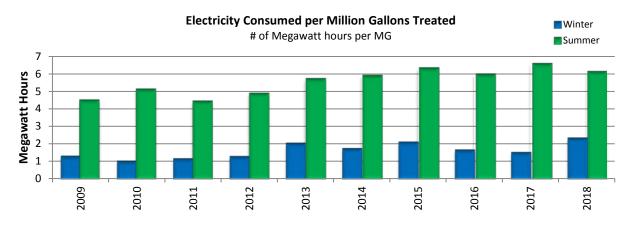
This chart shows overall electricity efficiency by measuring the amount of electricity consumed per million gallons of wastewater effluent. Winter months (November-April) represent wastewater processed and discharged to the river. Summer (May-October) represents wastewater processed to recycled water standards and either sold to customers or applied to spray fields.

Electricity consumption per million gallons treated has increased slightly at the plant compared to 2011 and 2012, which may be drought related, as the same amount of solids need to be processed, but with lower flows. Overall the rates have stayed relatively constant.

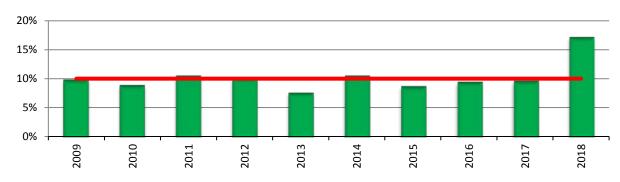
Main Line Condition Assessment % of sewer main lines video inspected each year

NapaSan has consistently met or come close to its goal of 10% annually. The 2013, 2015 and 2016 drops in assessments were due to fewer people than usual (injuries and position vacancies) able to complete this task. In 2015, there was also additional effort put toward system repairs (lateral and manhole repairs and replacements) in specific areas to keep ahead of the City's road paving schedule, which pulled staff away from this activity.

In 2018, additional assessments were available due to the Collections Department having full staffing and with the replacement of its CCTV equipment, which increased reliability. Additional inspection was also done in support of future I&I and sewer replacement projects. The additional inspections assist the project engineers in designed better projects.

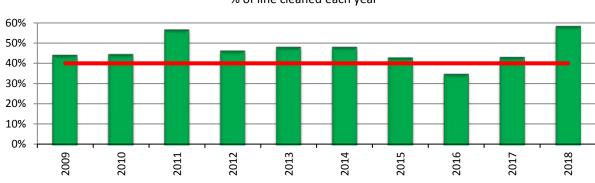
Sewer Main Line Cleaning % of line cleaned each year

Over the past decade, NapaSan has maintained its efforts in preventive maintenance and cleaning of sewer mains, with the goal of cleaning the equivalent of 40% of its sewer mains every year. In 2016, NapaSan did not meet this goal because of staffing vacancies. This deficiency was corrected in 2017. In 2018, new equipment (combination truck) was procured that is more reliable, allowing for increased productivity.

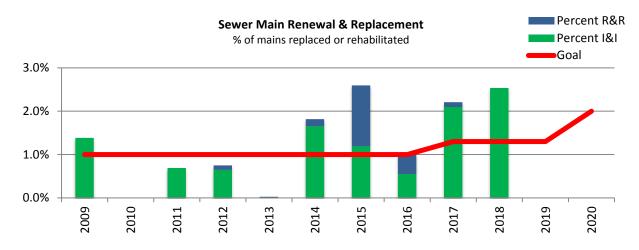
This graph shows the percent of sewer mains maintained by NapaSan that have been replaced or rehabilitated annually. Inflow and infiltration (I&I) projects are predominantly lining projects designed to decrease stormwater and groundwater intrusion into the sewer pipes. Rehabilitation and replacement (R&R) projects line or replace sewer pipes based on condition assessment showing them to be deteriorating and losing structural integrity.

NapaSan has met its I&I/renewal and replacement target in the past five years, reversing the trend seen the previous five years. NapaSan has set future targets to increase the total replacement goal over the next five years to 2%, and has established future sewer service rates to meet this goal. NapaSan has been able to meet the 2% goal sooner than originally planned.

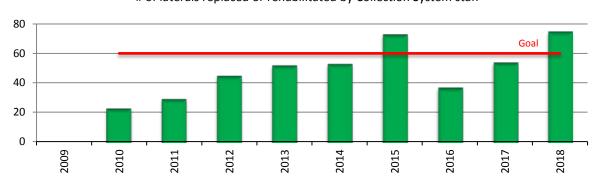
Lower Lateral Renewal & Replacement # of laterals replaced or rehabilitated by Collection System staff

This graph shows the number of lower sewer laterals maintained by NapaSan that have been replaced annually by the Collection Department, understanding that lower laterals are also replaced when sewer mains are replaced as part of capital improvement projects. The aspirational goal is for the Collection Department to rehabilitate or replace at least 60 lower laterals annually.

In 2018, NapaSan Collection System staff completed 74 rehabilitations through 73 lateral lining projects and 1 lateral replacement, exceeding its aspirational goal of 60 rehabilitations per year.

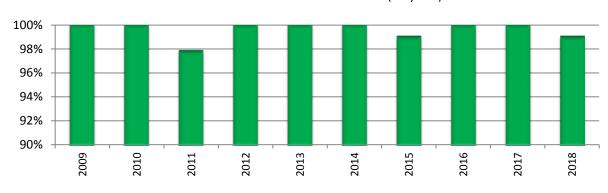
Recycled Water Service Availability % of time RW available to customers (May-Oct)

The availability of summer recycled water has been at least 98% for the past decade. In 2011, the system was down for 4 days to repair a leak in a recycled water main line, and down for two days in 2015. In 2018, the system was down for 1 day due to a power outage at the treatment plant that took the recycled water pumping station offline.
